Road Inventory and Condition Assessment

Steamtown National Historic Site STE A

Cycle 5 Report

**Prepared By: Federal Highway Administration
Road Inventory Program (RIP)
Data Collected: 04/2013
Report Date: 11/2013**

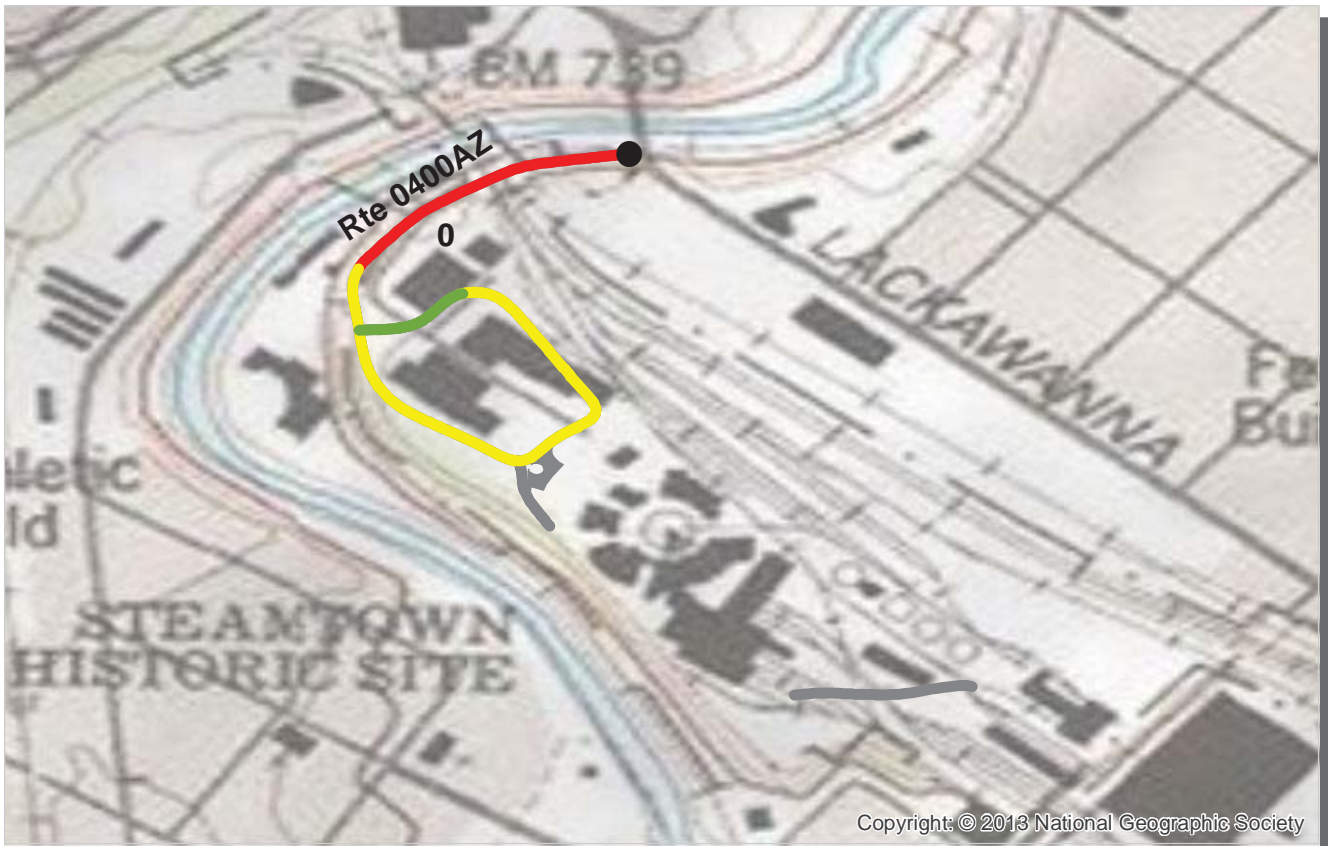
ROUTE: 0400AZ MAIN ENTRANCE ROAD A

Section Number	0				
Section Length (mi)	0.53				
Cross Section Information					
Number of Lanes	2				
Paved Width (ft)	26				
Lane Width (ft)	12				
Roadway Condition Information					
SCR (Surface Condition Rating)	70				
PCR (Pavement Condition Rating)	70				
Distress Index Values					
Structural Crack Index	70				
Transverse Cracking Index	78				
Patching Index	100				
Rutting Index	95				
Roughness Condition Index (RCI)	N/A

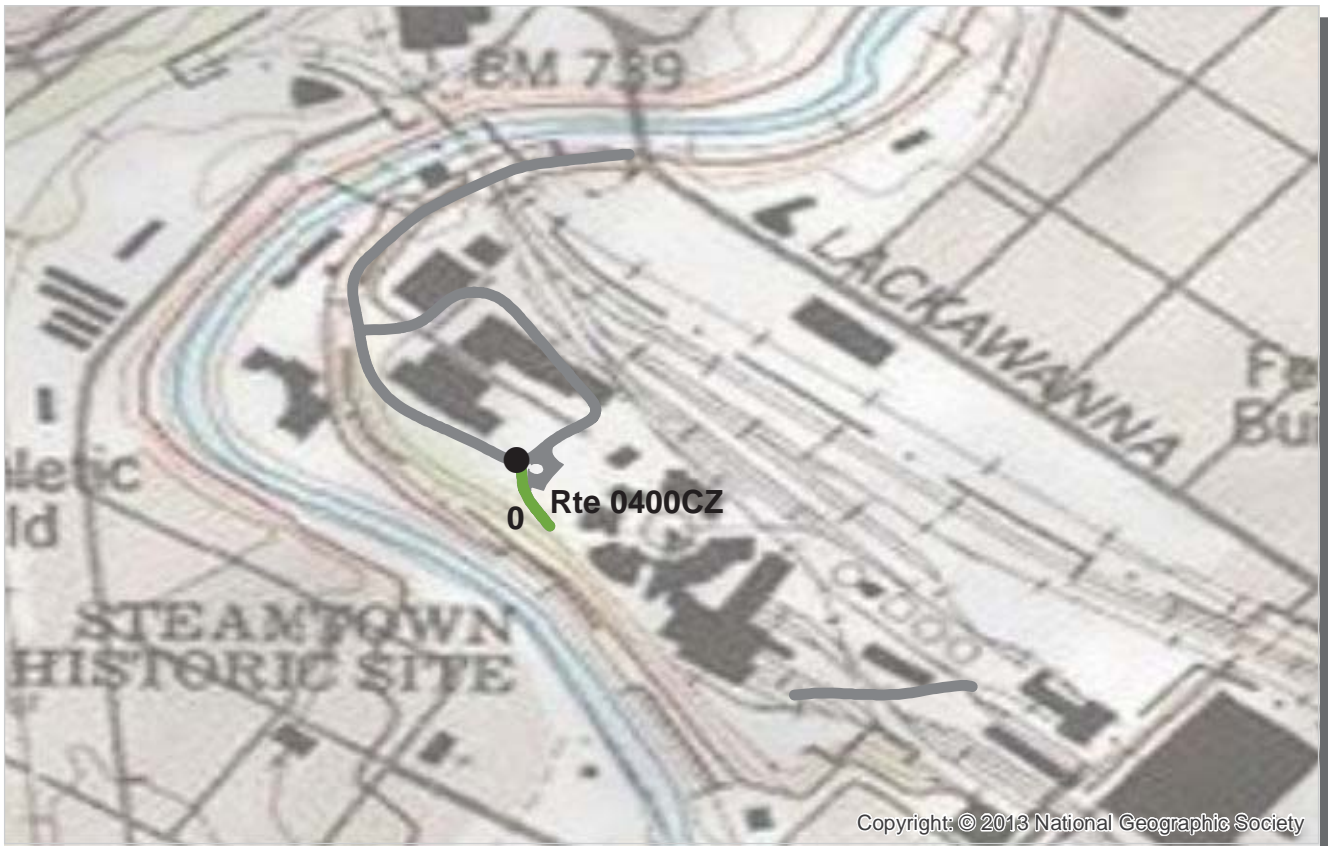
ROUTE: 0400CZ MAIN ENTRANCE ROAD C

Section Number	0				
Section Length (mi)	0.05				
Cross Section Information					
Number of Lanes	2				
Paved Width (ft)	21				
Lane Width (ft)	10				
Roadway Condition Information					
SCR (Surface Condition Rating)	92				
PCR (Pavement Condition Rating)	92				
Distress Index Values					
Structural Crack Index	100				
Transverse Cracking Index	92				
Patching Index	100				
Rutting Index	98				
Roughness Condition Index (RCI)	N/A

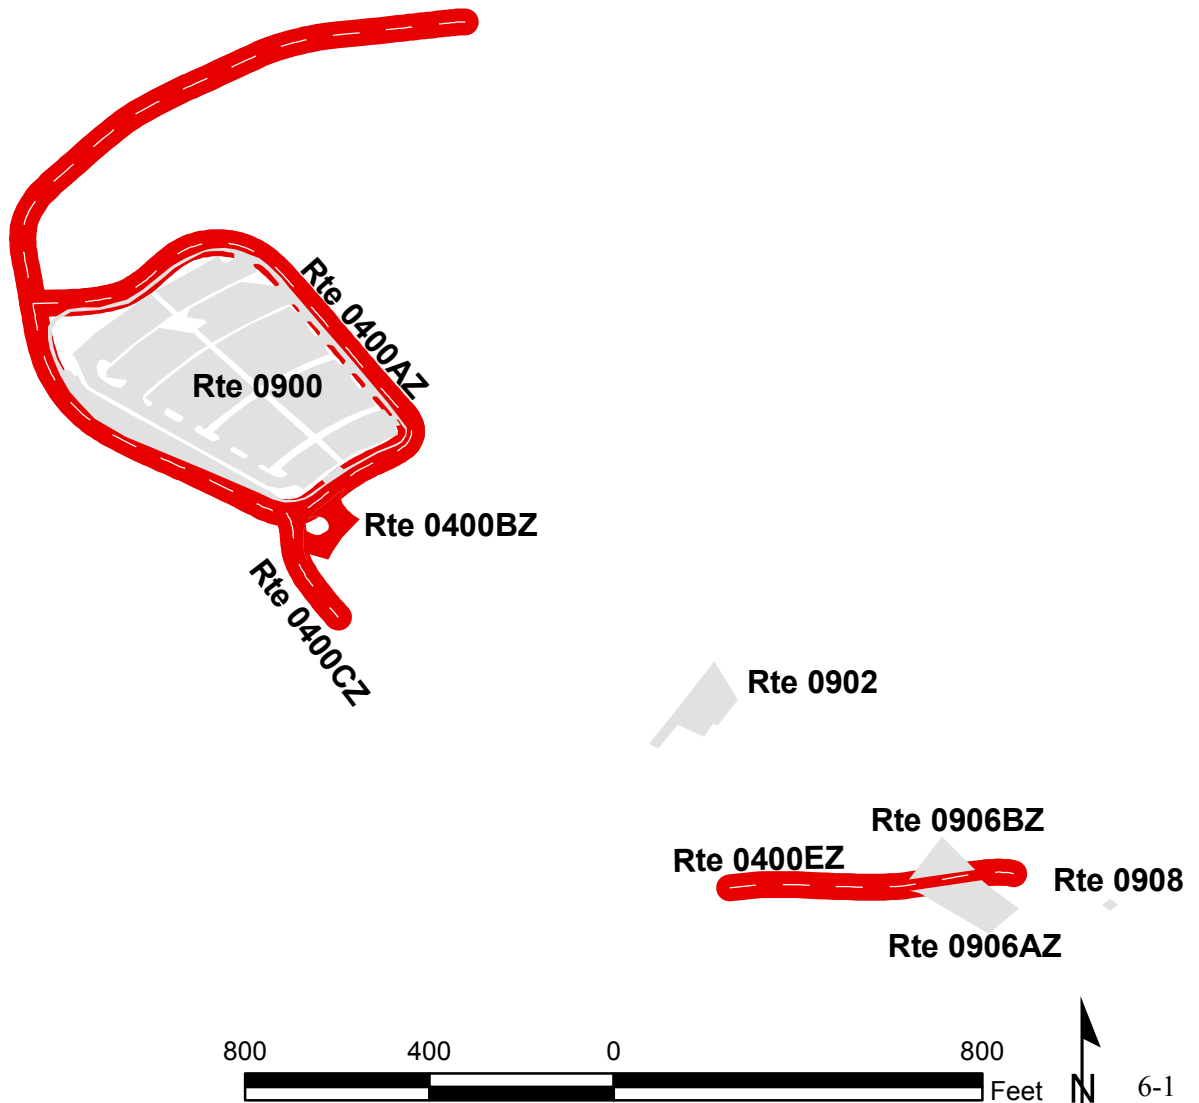
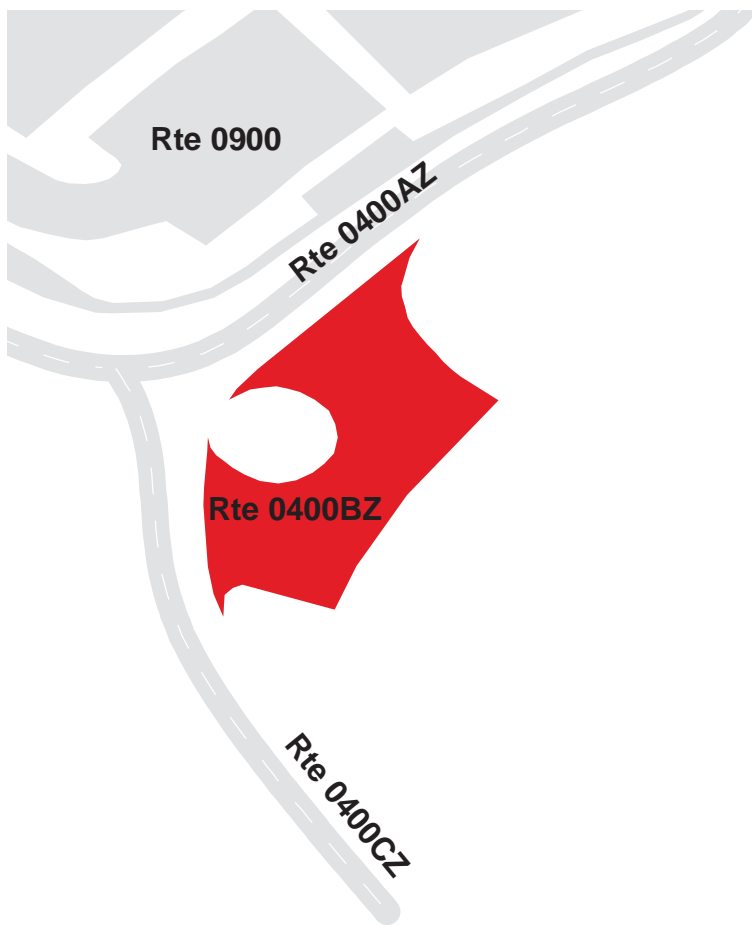
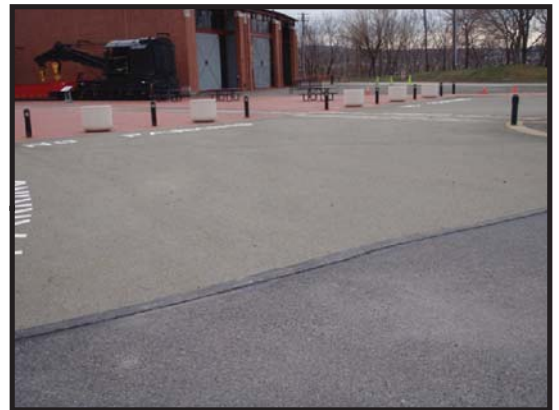
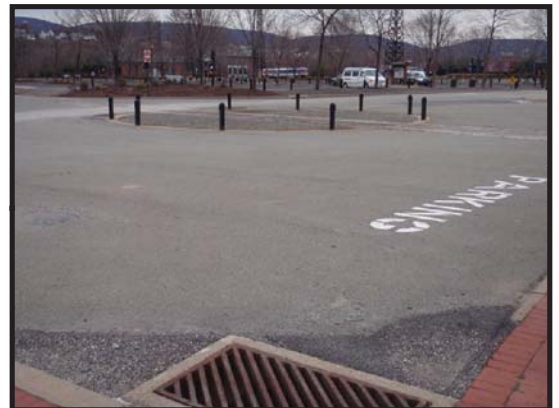
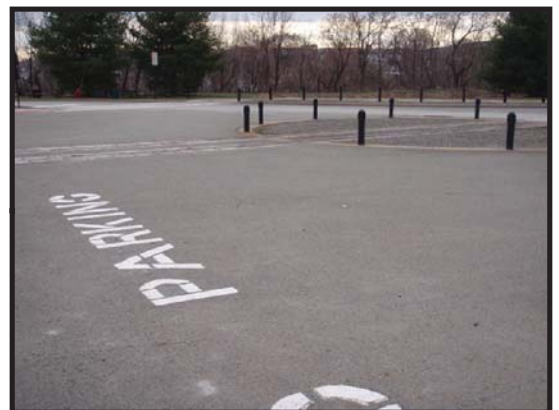
Route 0400BZ

Route Number	Public / NonPublic	Date Visited	Area (sq ft)	Lane Miles *	Surface Type
0400BZ	PUBLIC	4/15/2013	6,230	0.11	AS
Culverts	Drop Inlets	Gates	Curb & Gutter	Curb	PCR
0	2	0	NO CURB AND GUTTER	NO CURB	GOOD/90

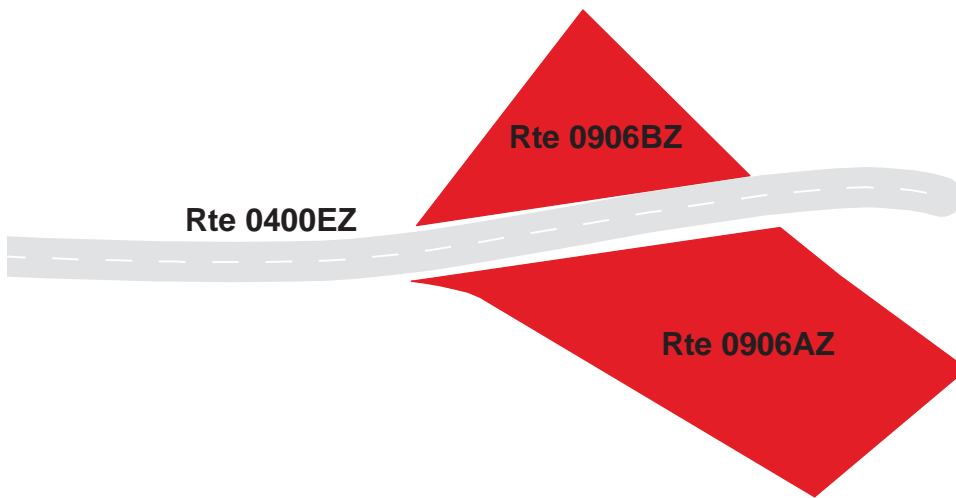
Route 0906ZZ

Route Number	Public / NonPublic	Date Visited	Area (sq ft)	Lane Miles *	Surface Type
0906ZZ	NONPUBLIC	4/15/2013	14,208	0.24	AS
Culverts	Drop Inlets	Gates	Curb & Gutter	Curb	PCR
0	1	0	NO CURB AND GUTTER	NO CURB	SUMMARY/45

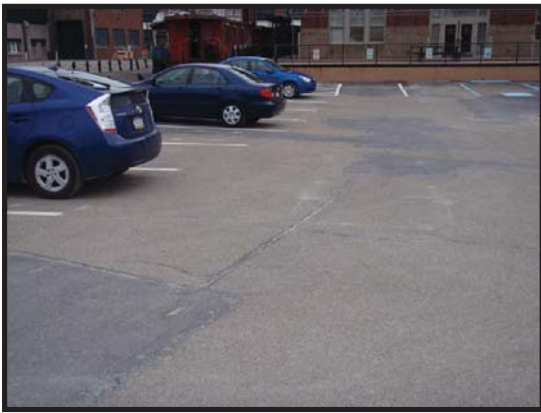
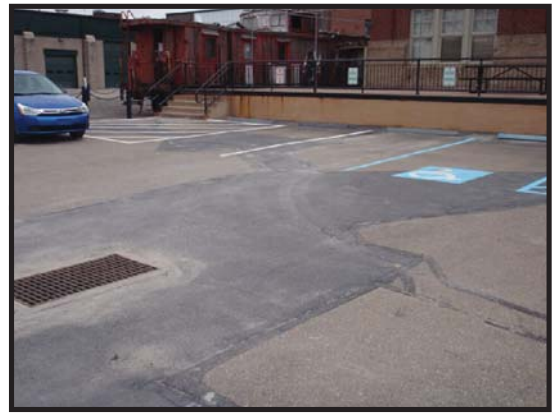
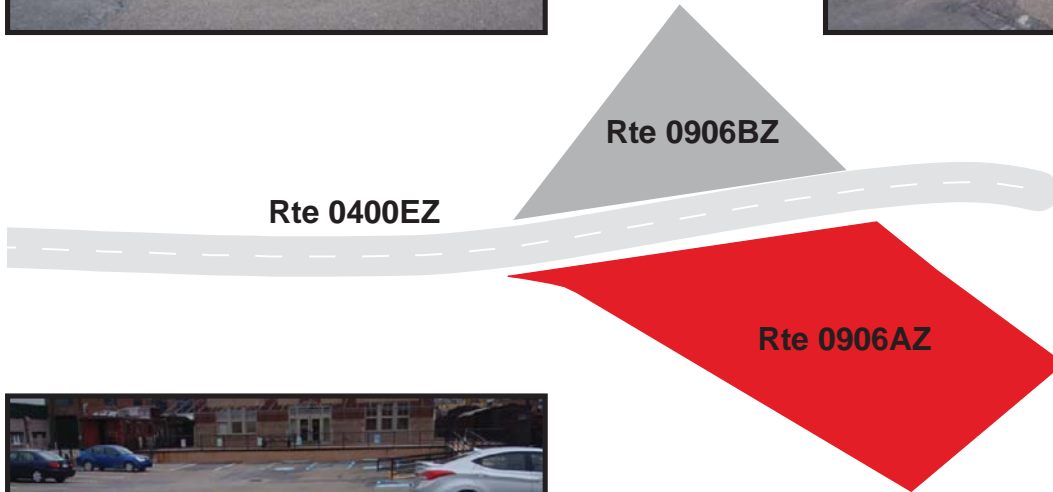
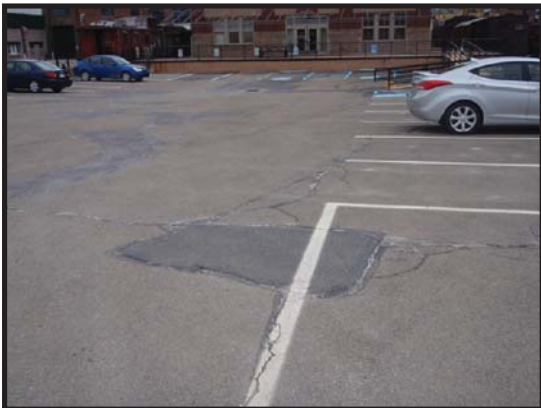
Route 0906AZ

Route Number	Public / NonPublic	Date Visited	Area (sq ft)	Lane Miles *	Surface Type
0906AZ	NONPUBLIC	4/15/2013	9,713	0.17	AS
Culverts	Drop Inlets	Gates	Curb & Gutter	Curb	PCR
0	1	0	NO CURB AND GUTTER	NO CURB	POOR/45

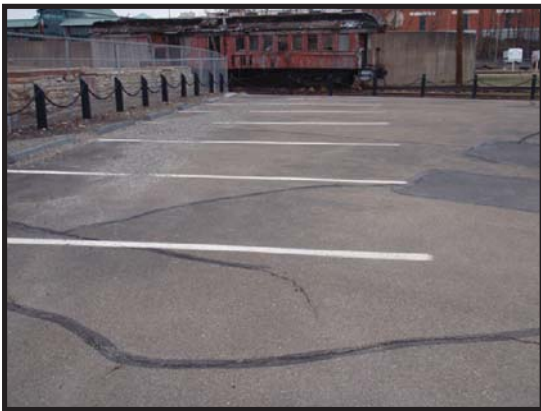
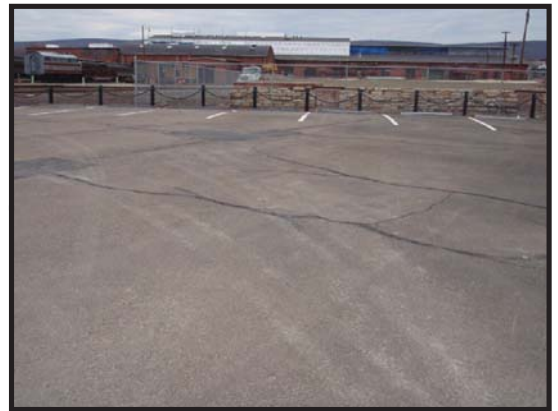
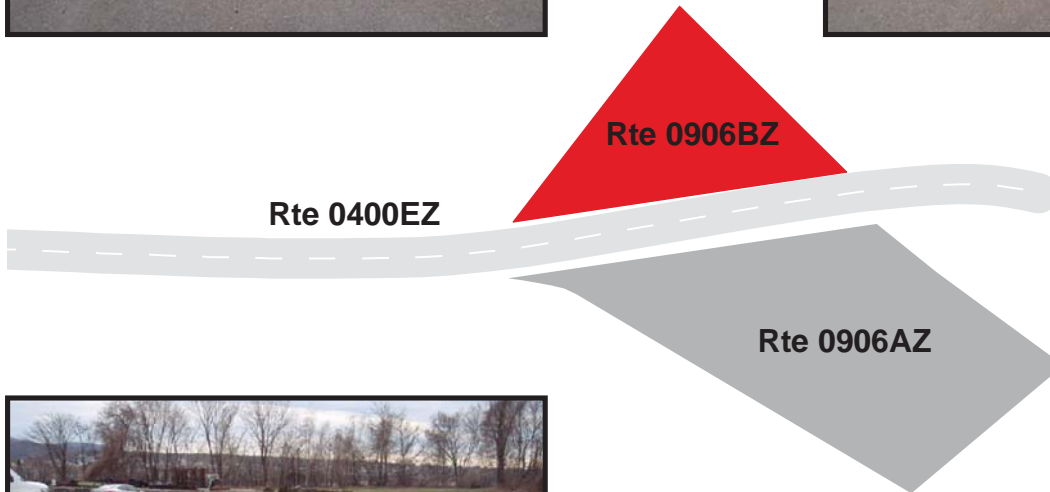
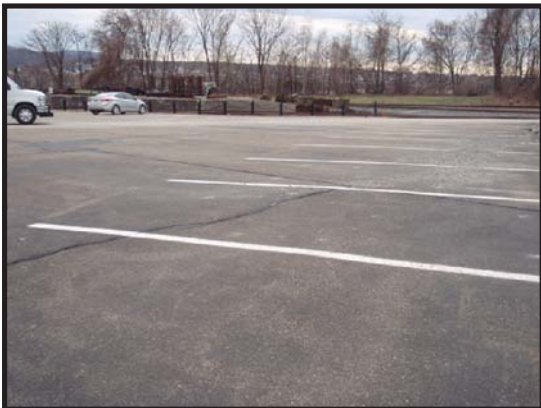
Route 0906BZ

Route Number	Public / NonPublic	Date Visited	Area (sq ft)	Lane Miles *	Surface Type
0906BZ	NONPUBLIC	4/15/2013	4,495	0.08	AS
Culverts	Drop Inlets	Gates	Curb & Gutter	Curb	PCR
0	0	0	NO CURB AND GUTTER	NO CURB	POOR/45

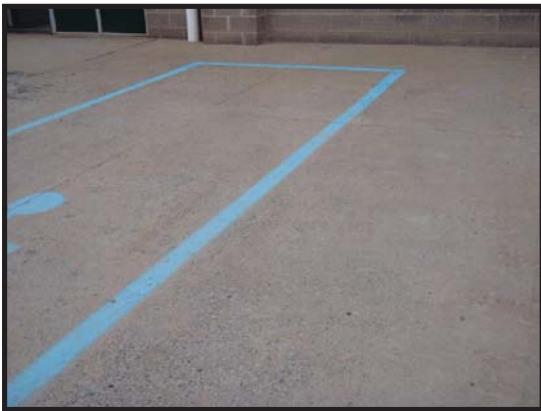
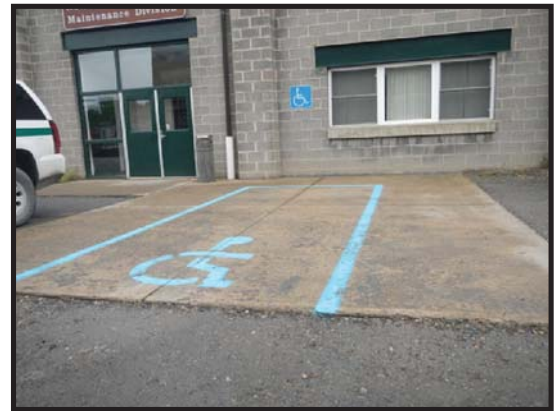
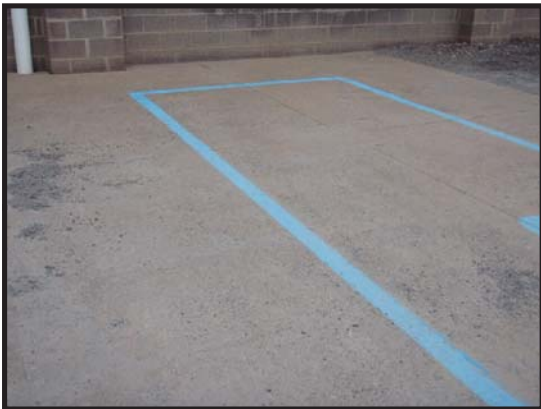
Route 0908

Route Number	Public / NonPublic	Date Visited	Area (sq ft)	Lane Miles *	Surface Type
0908	PUBLIC	4/15/2013	356	0.01	CO
Culverts	Drop Inlets	Gates	Curb & Gutter	Curb	PCR
0	0	0	NO CURB AND GUTTER	NO CURB	FAIR/73
