Federal Lands Highway Road Inventory Program

Road Inventory and Condition Assessment

National Capital Parks - East Suitland Parkway SUIT

Cycle 5 Report

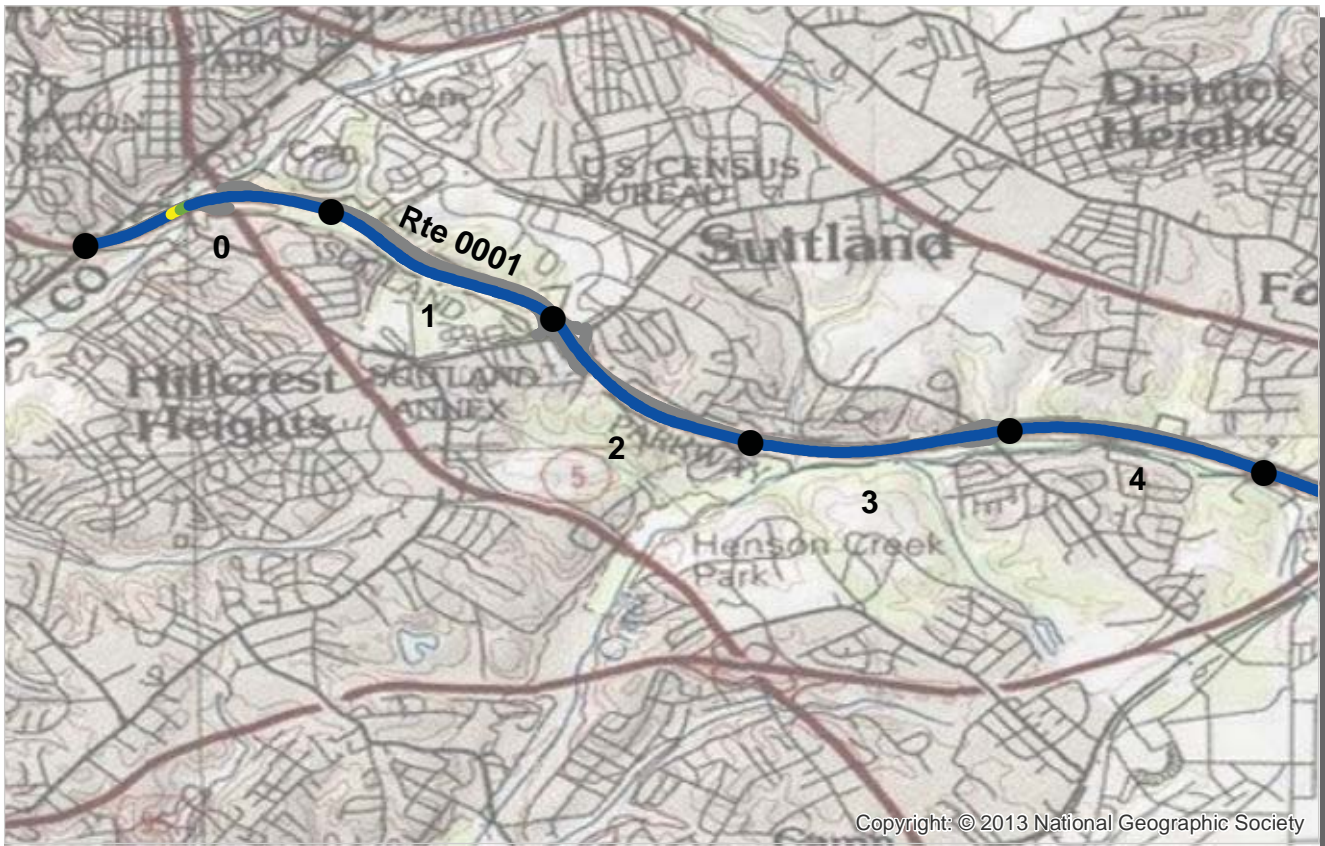
Section Number	0	1	2	3	4
Section Length (mi)	1.00	1.00	1.00	1.00	1.00
Cross Section Information					
Number of Lanes	2	2	2	2	2
Paved Width (ft)	29	29	33	30	29
Lane Width (ft)	13	12	13	13	13
Roadway Condition Information					
SCR (Surface Condition Rating)	98	98	98	99	98
PCR (Pavement Condition Rating)	99	99	99	99	99
Distress Index Values					
Structural Crack Index	100	100	100	100	100
Transverse Cracking Index	99	98	98	99	98
Patching Index	100	100	100	100	100
Rutting Index	98	100	100	100	100
Roughness Condition Index (RCI)	100	100	100	100	100

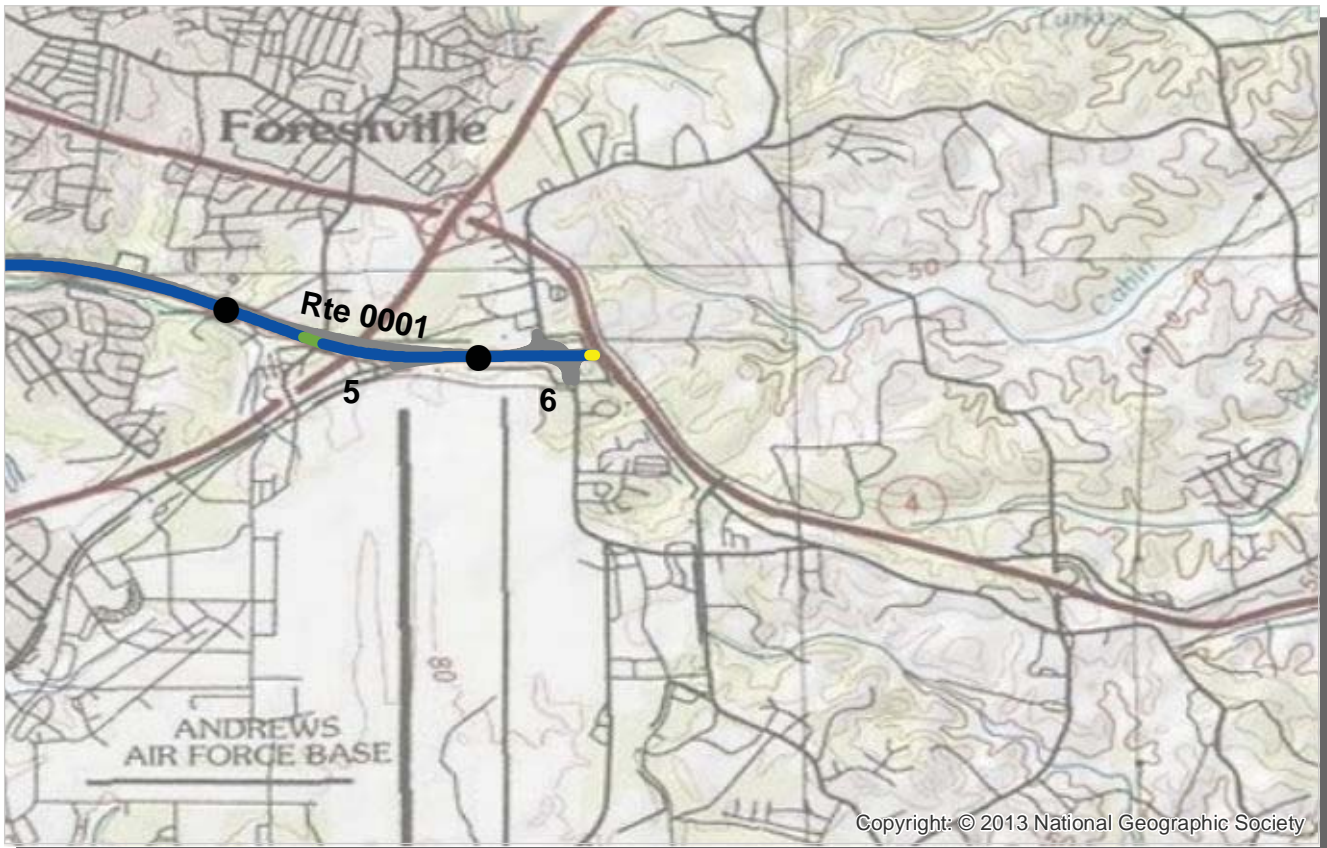
ROUTE: 0001 EASTBOUND SUITLAND PARKWAY

<i>Section Number</i>	5	6			
<i>Section Length (mi)</i>	1.00	0.44			
<i>Cross Section Information</i>					
Number of Lanes	2	2			
Paved Width (ft)	33	31			
Lane Width (ft)	14	14			
<i>Roadway Condition Information</i>					
SCR (Surface Condition Rating)	98	99			
PCR (Pavement Condition Rating)	99	99			
<i>Distress Index Values</i>					
Structural Crack Index	100	100			
Transverse Cracking Index	100	99			
Patching Index	100	100			
Rutting Index	98	100			
Roughness Condition Index (RCI)	100	100

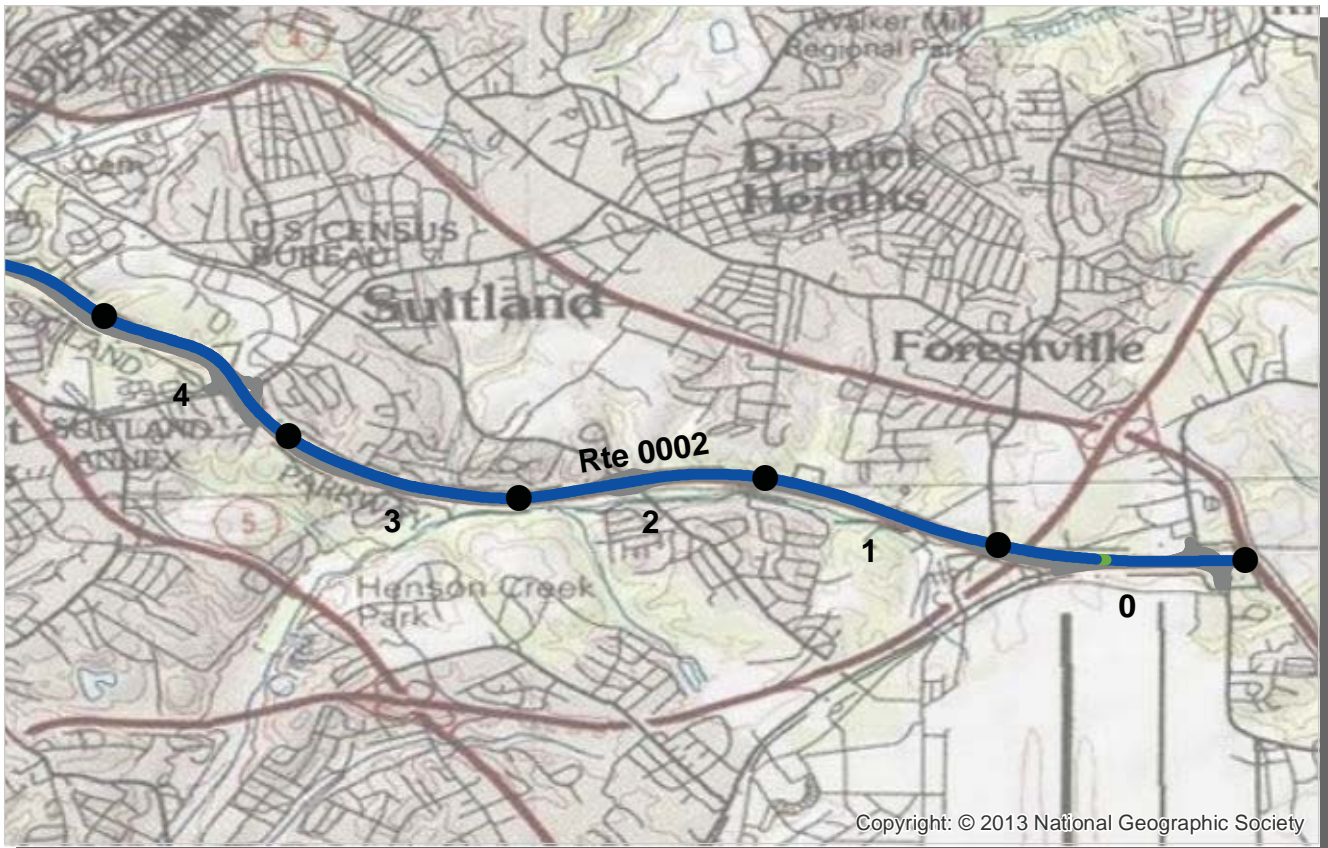
ROUTE: 0001 EASTBOUND SUITLAND PARKWAY

<i>Section Number</i>	0	1	2	3	4
<i>Section Length (mi)</i>	1.00	1.00	1.00	1.00	1.00
<i>Cross Section Information</i>					
Number of Lanes	2	2	2	2	2
Paved Width (ft)	32	30	30	33	31
Lane Width (ft)	14	12	13	12	14
<i>Roadway Condition Information</i>					
SCR (Surface Condition Rating)	99	99	100	100	97
PCR (Pavement Condition Rating)	99	99	100	100	98
<i>Distress Index Values</i>					
Structural Crack Index	100	100	100	100	100
Transverse Cracking Index	99	100	100	100	97
Patching Index	100	100	100	100	100
Rutting Index	99	99	100	100	100
Roughness Condition Index (RCI)	100	100	100	100	100

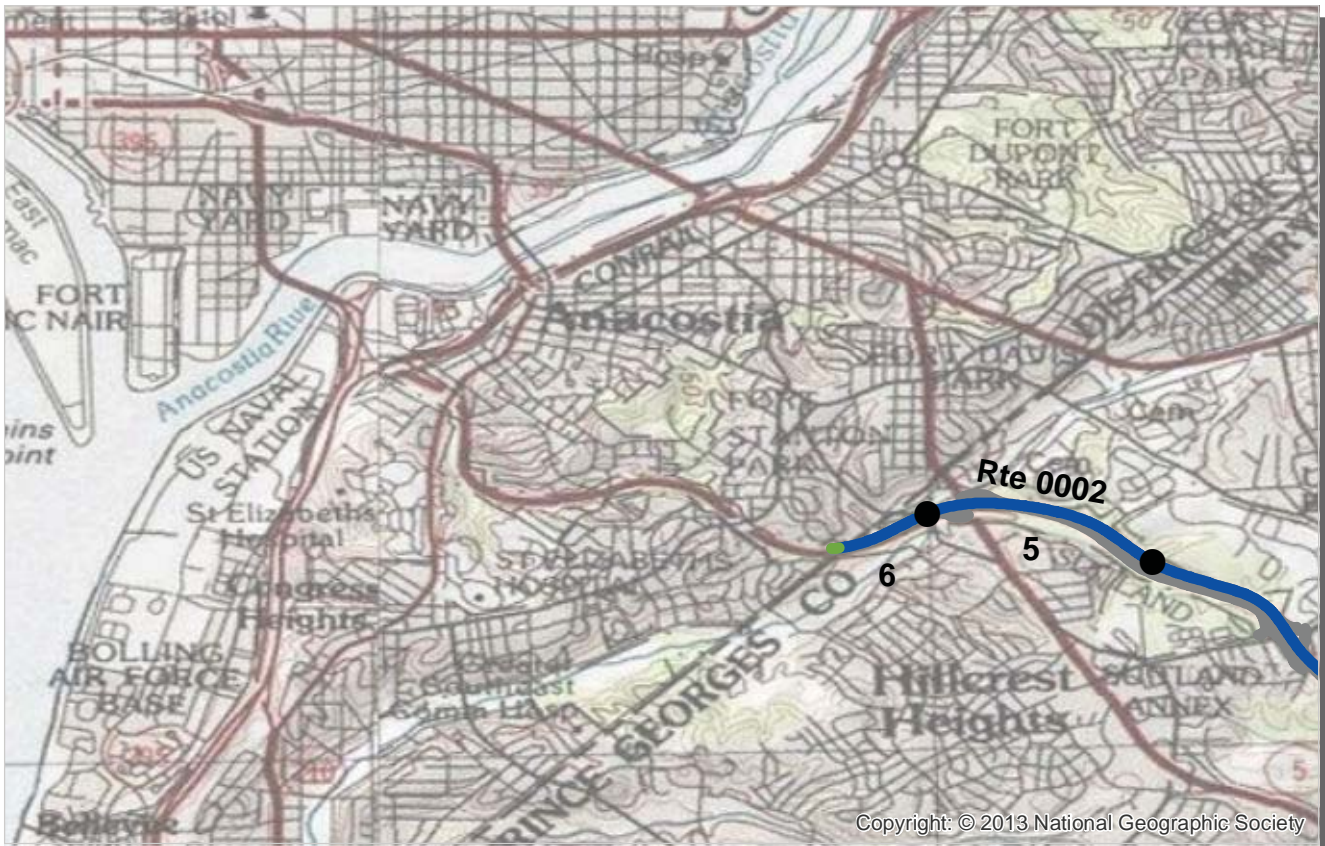
ROUTE: 0002 WESTBOUND SUITLAND PARKWAY

Section Number	5	6			
Section Length (mi)	1.00	0.43			
Cross Section Information					
Number of Lanes	2	2			
Paved Width (ft)	31	27			
Lane Width (ft)	13	12			
Roadway Condition Information					
SCR (Surface Condition Rating)	97	99			
PCR (Pavement Condition Rating)	98	99			
Distress Index Values					
Structural Crack Index	100	99			
Transverse Cracking Index	97	99			
Patching Index	100	100			
Rutting Index	100	99			
Roughness Condition Index (RCI)	100	100

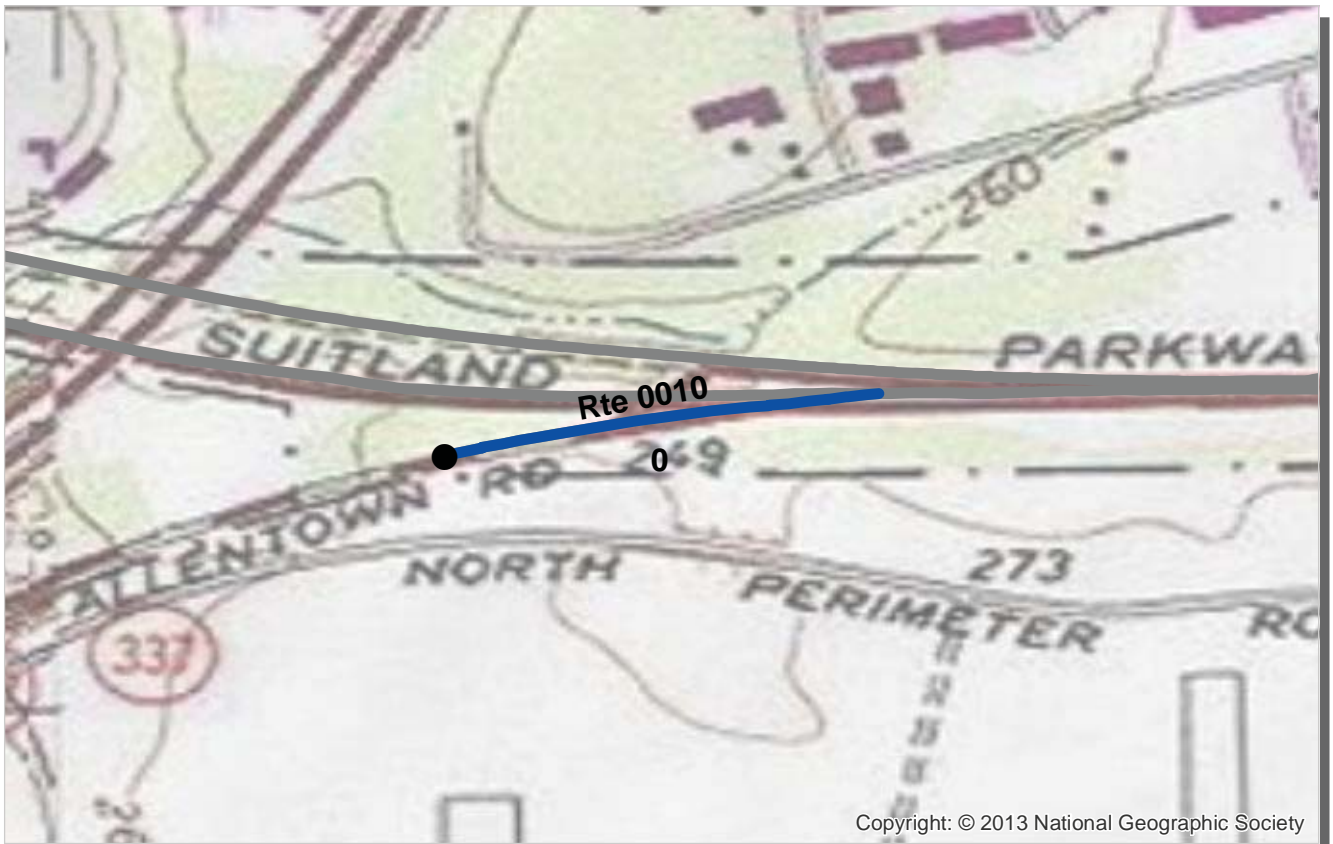
ROUTE: 0002 WESTBOUND SUTLAND PARKWAY

Section Number	0				
Section Length (mi)	0.22				
Cross Section Information					
Number of Lanes	1				
Paved Width (ft)	17				
Lane Width (ft)	16				
Roadway Condition Information					
SCR (Surface Condition Rating)	99				
PCR (Pavement Condition Rating)	99				
Distress Index Values					
Structural Crack Index	100				
Transverse Cracking Index	100				
Patching Index	100				
Rutting Index	99				
Roughness Condition Index (RCI)	NC

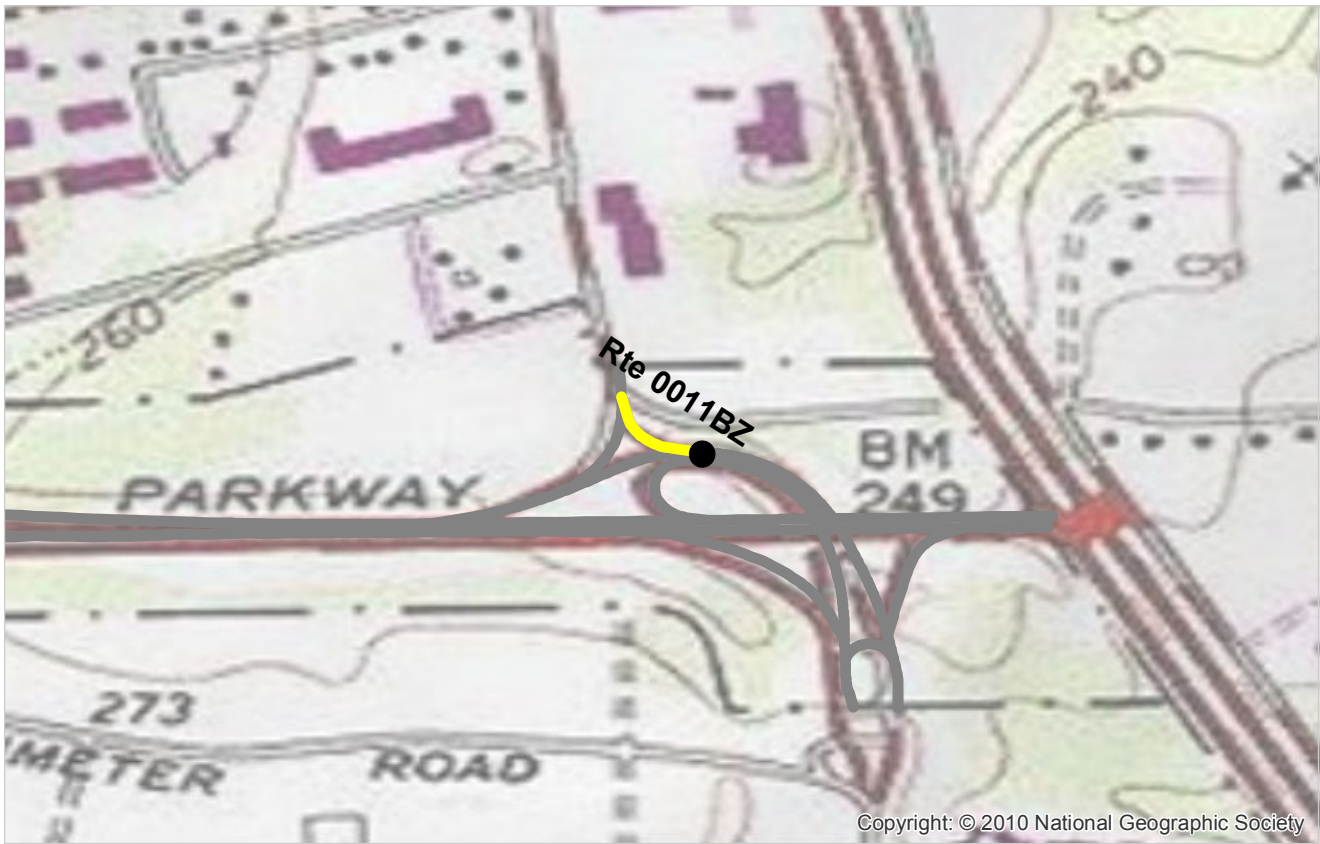
ROUTE: 0011ZZ OLD MARLBORO PIKE RAMPS

Section Number	0				
Section Length (mi)	0.03				
Cross Section Information					
Number of Lanes	1				
Paved Width (ft)	23				
Lane Width (ft)	21				
Roadway Condition Information					
SCR (Surface Condition Rating)	74				
PCR (Pavement Condition Rating)	74				
Distress Index Values					
Structural Crack Index	100				
Transverse Cracking Index	100				
Patching Index	74				
Rutting Index	98				
Roughness Condition Index (RCI)	NC
