Road Inventory and Condition Assessment

Vanderbilt Mansion National Historic Site VAMA

Cycle 5 Report

Prepared By: Federal Highway Administration
Road Inventory Program (RIP)
Data Collected: 04/2013
Report Date: 11/2013

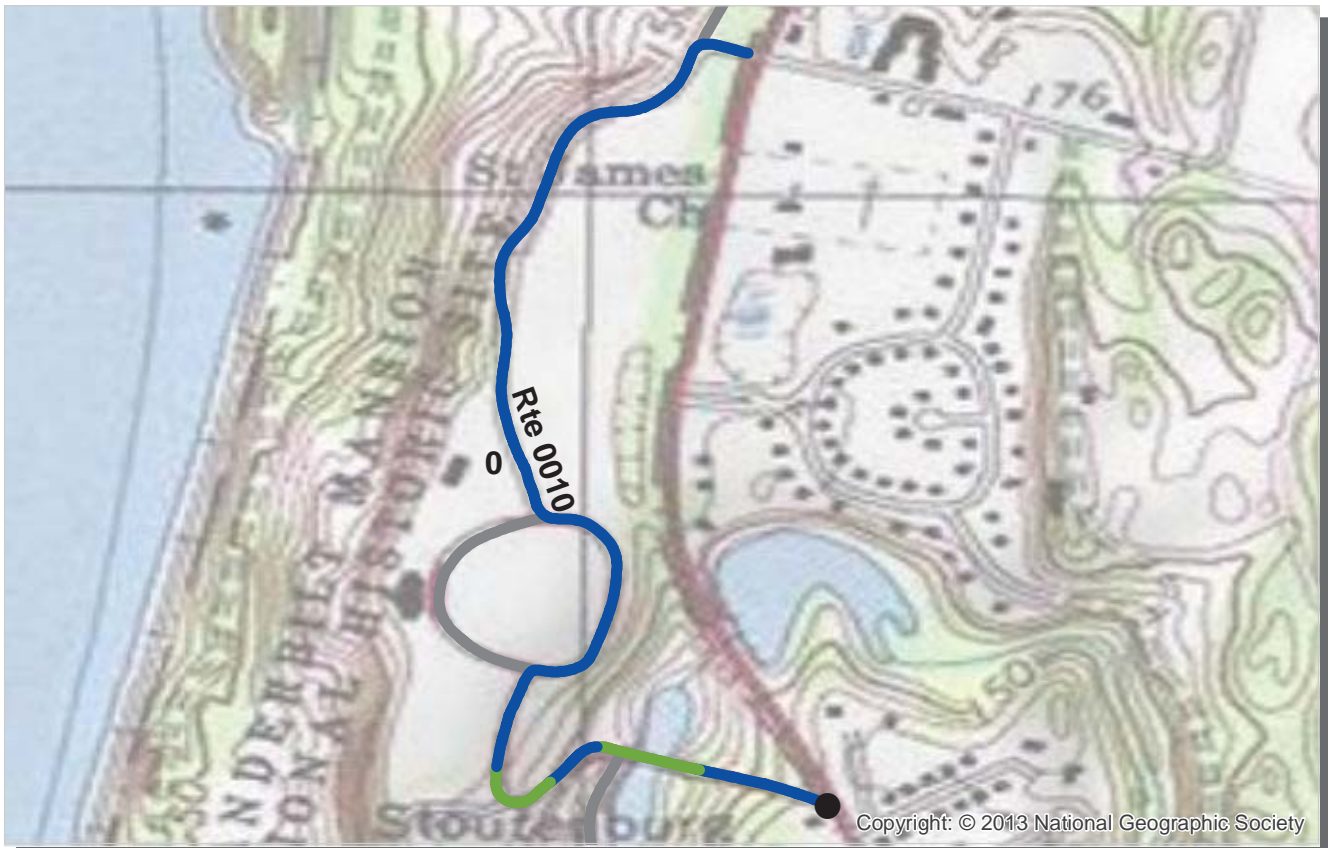
ROUTE: 0010 MAIN ENTRANCE ROAD

<i>Section Number</i>	0				
<i>Section Length (mi)</i>	0.95				
<i>Cross Section Information</i>					
Number of Lanes	2				
Paved Width (ft)	17				
Lane Width (ft)	9				
<i>Roadway Condition Information</i>					
SCR (Surface Condition Rating)	95				
PCR (Pavement Condition Rating)	95				
<i>Distress Index Values</i>					
Structural Crack Index	95				
Transverse Cracking Index	99				
Patching Index	100				
Rutting Index	97				
Roughness Condition Index (RCI)	NC

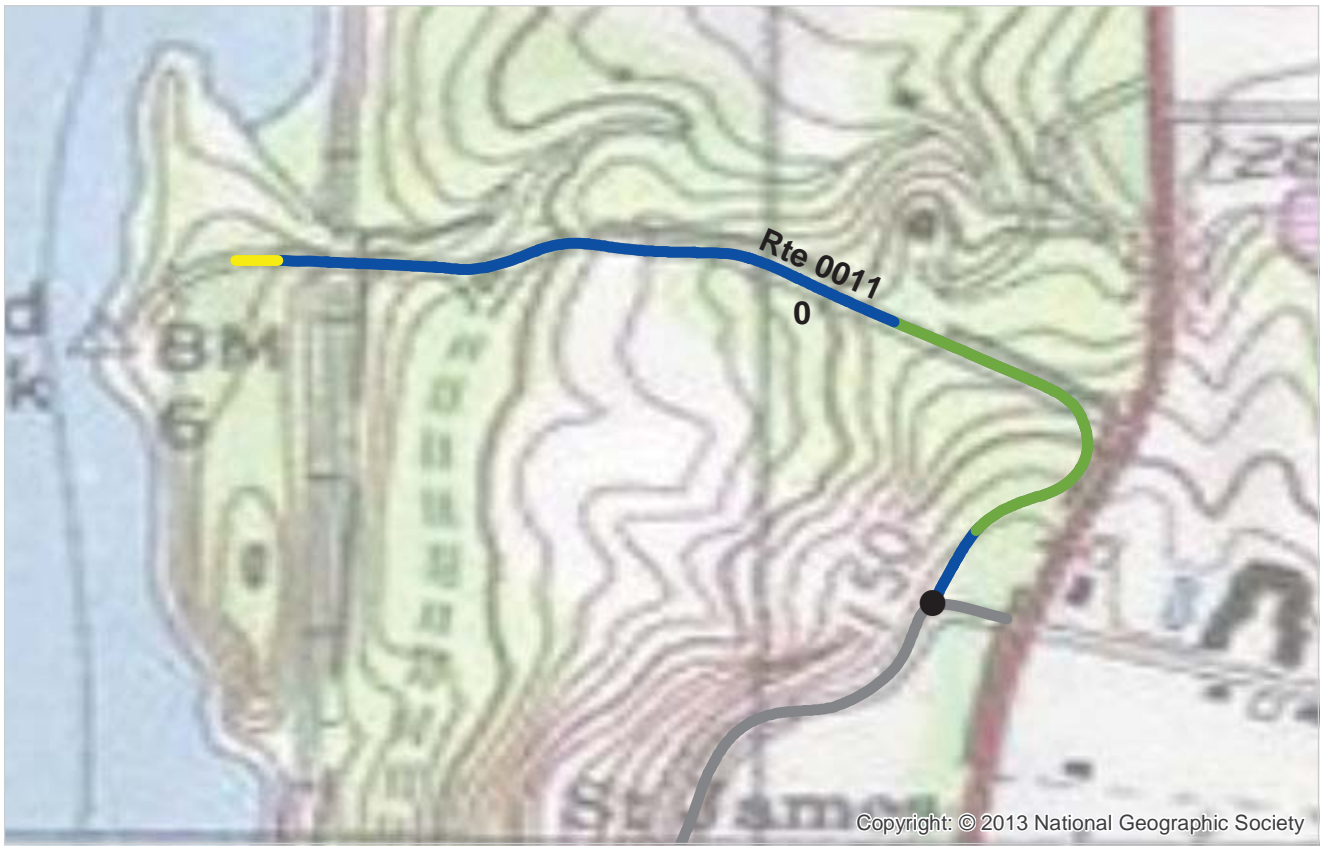
ROUTE: 0011 BARD ROCK ROAD

<i>Section Number</i>	0				
<i>Section Length (mi)</i>	0.45				
<i>Cross Section Information</i>					
Number of Lanes	2				
Paved Width (ft)	17				
Lane Width (ft)	9				
<i>Roadway Condition Information</i>					
SCR (Surface Condition Rating)	92				
PCR (Pavement Condition Rating)	92				
<i>Distress Index Values</i>					
Structural Crack Index	92				
Transverse Cracking Index	99				
Patching Index	100				
Rutting Index	100				
Roughness Condition Index (RCI)	NC

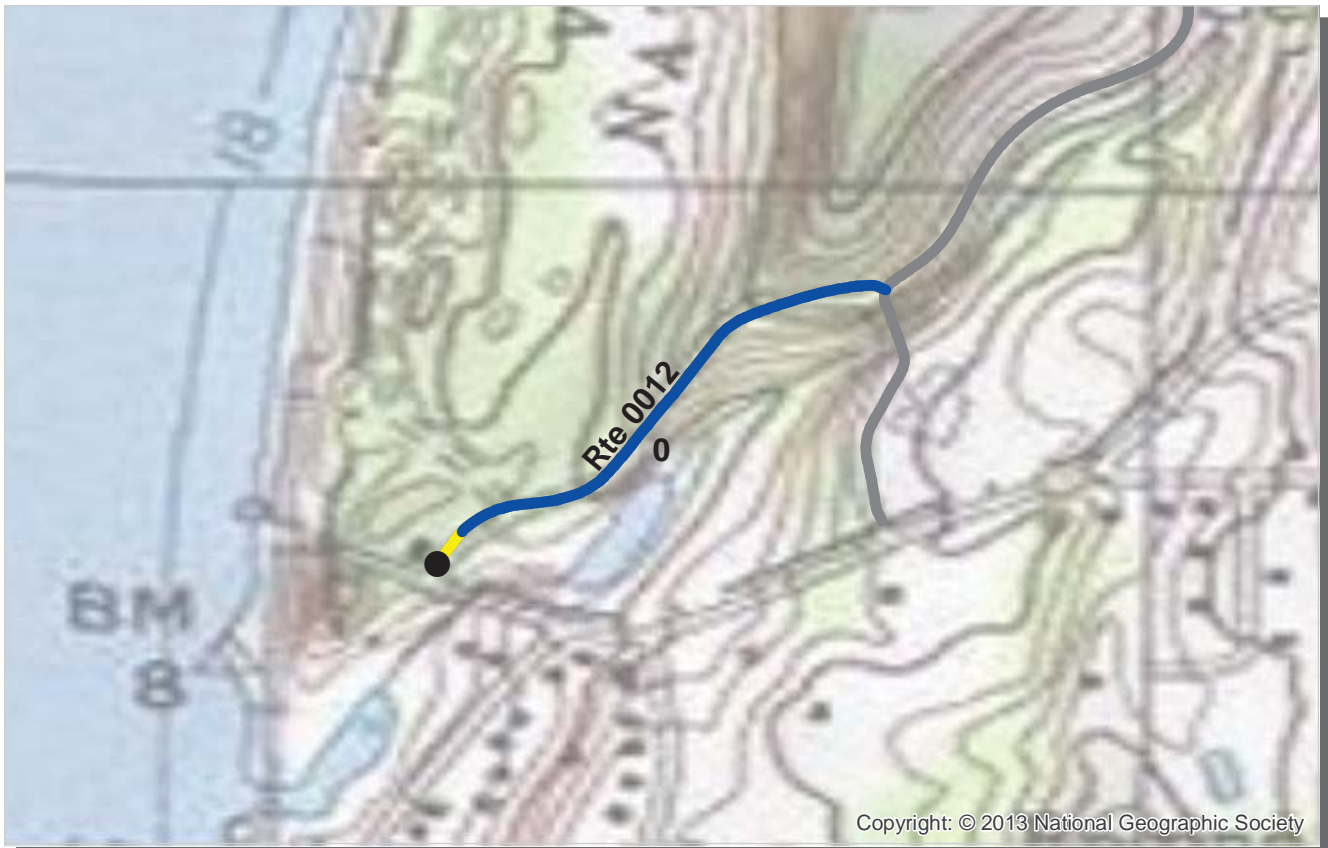
ROUTE: 0012 LOWER GATEHOUSE ROAD

Section Number	0				
Section Length (mi)	0.23				
Cross Section Information					
Number of Lanes	2				
Paved Width (ft)	15				
Lane Width (ft)	7				
Roadway Condition Information					
SCR (Surface Condition Rating)	96				
PCR (Pavement Condition Rating)	96				
Distress Index Values					
Structural Crack Index	96				
Transverse Cracking Index	99				
Patching Index	100				
Rutting Index	99				
Roughness Condition Index (RCI)	NC

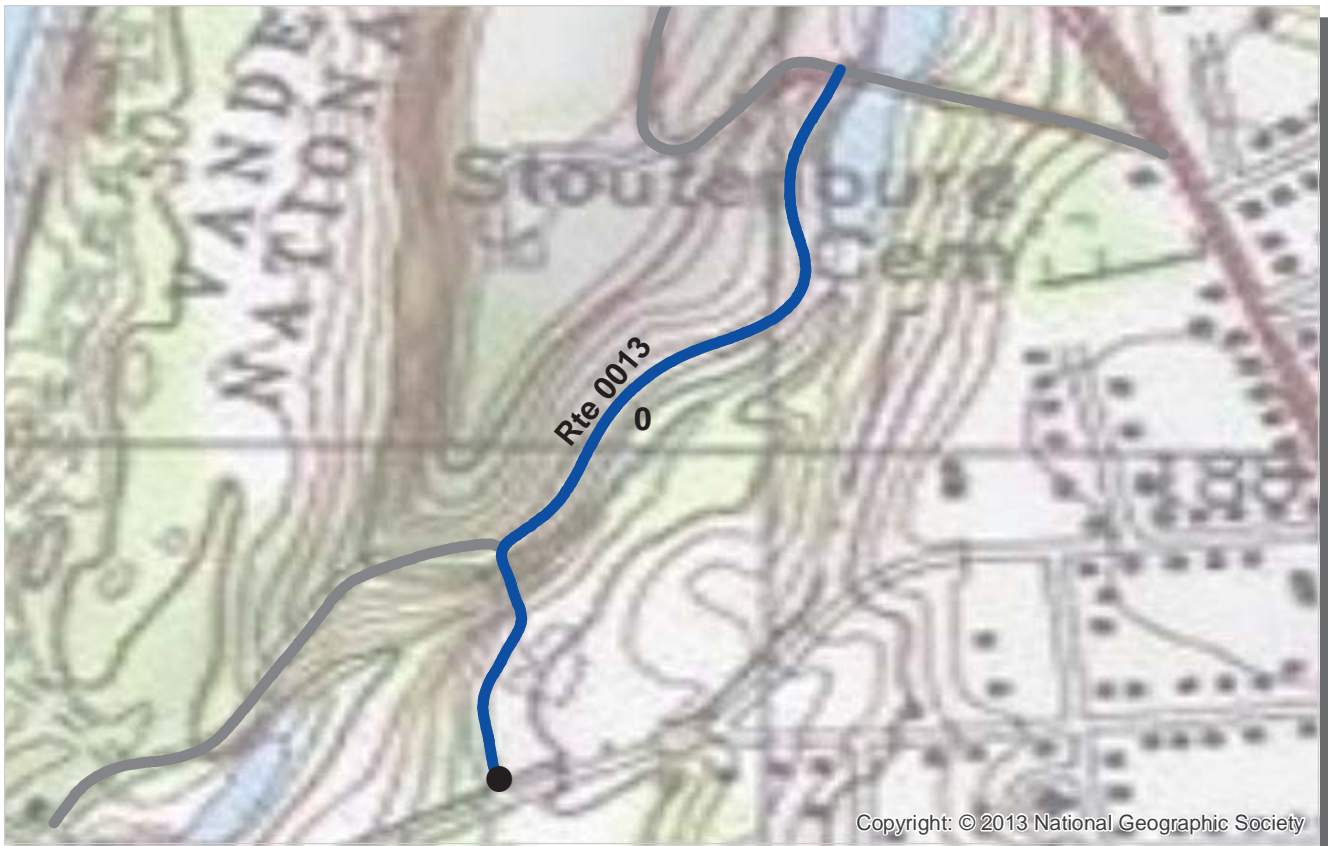
ROUTE: 0013 COACH HOUSE ROAD

Section Number	0				
Section Length (mi)	0.40				
Cross Section Information					
Number of Lanes	2				
Paved Width (ft)	17				
Lane Width (ft)	9				
Roadway Condition Information					
SCR (Surface Condition Rating)	99				
PCR (Pavement Condition Rating)	99				
Distress Index Values					
Structural Crack Index	99				
Transverse Cracking Index	99				
Patching Index	100				
Rutting Index	100				
Roughness Condition Index (RCI)	NC

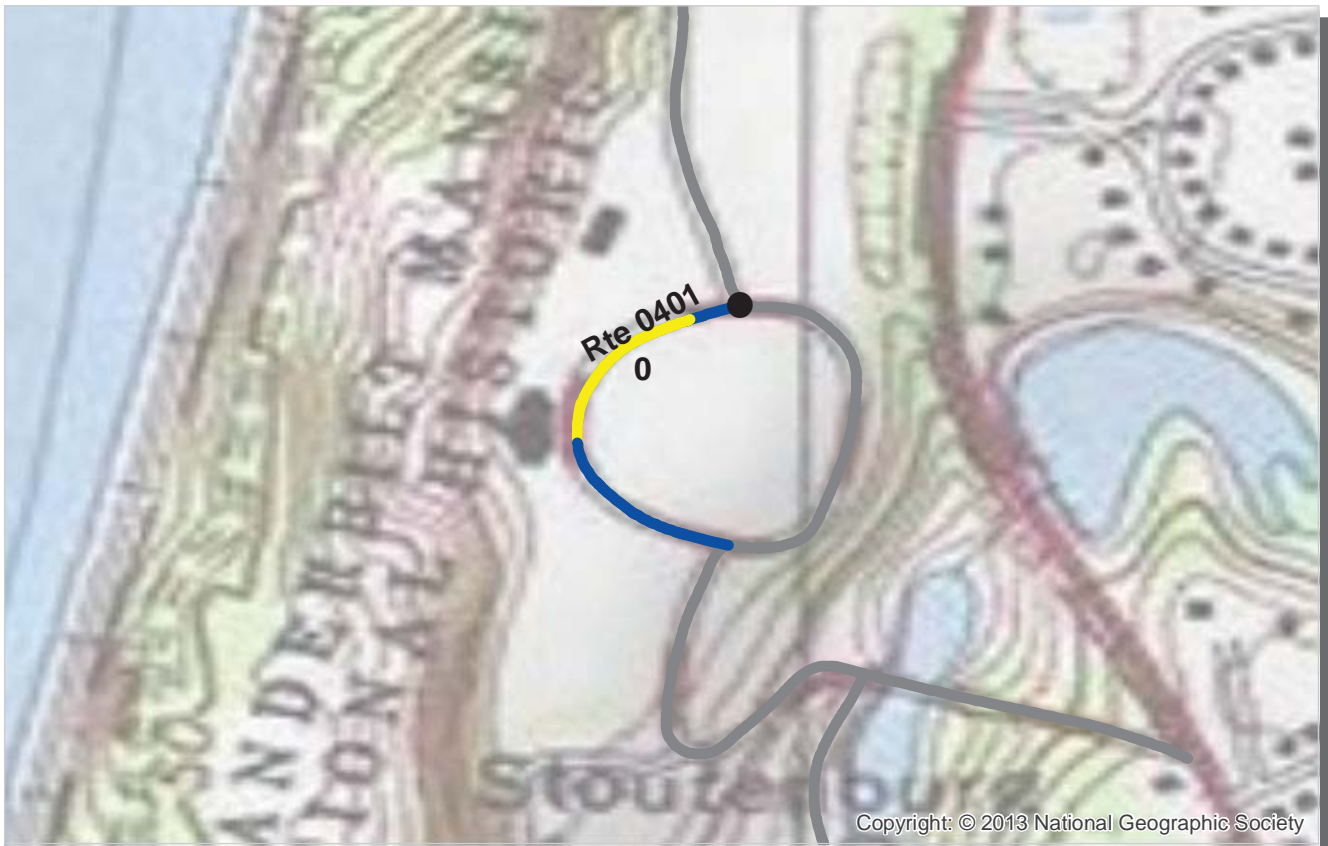
ROUTE: 0401 MANSION LOOP

Section Number	0				
Section Length (mi)	0.17				
Cross Section Information					
Number of Lanes	2				
Paved Width (ft)	17				
Lane Width (ft)	9				
Roadway Condition Information					
SCR (Surface Condition Rating)	94				
PCR (Pavement Condition Rating)	94				
Distress Index Values					
Structural Crack Index	97				
Transverse Cracking Index	94				
Patching Index	100				
Rutting Index	100				
Roughness Condition Index (RCI)	NC

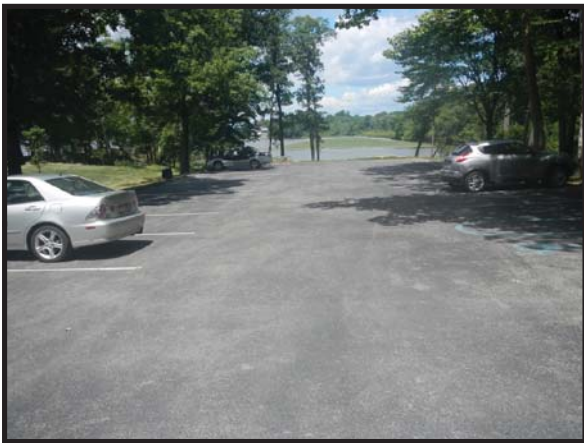
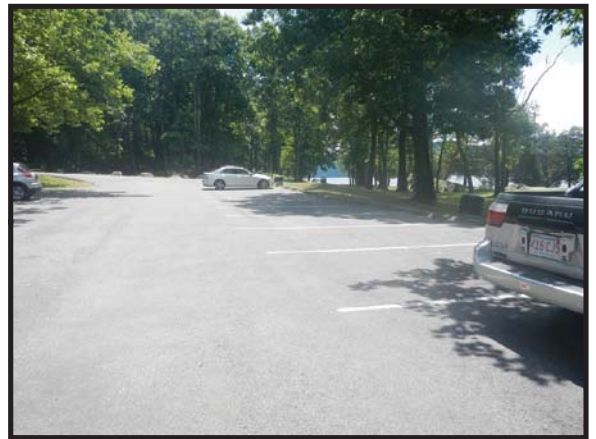
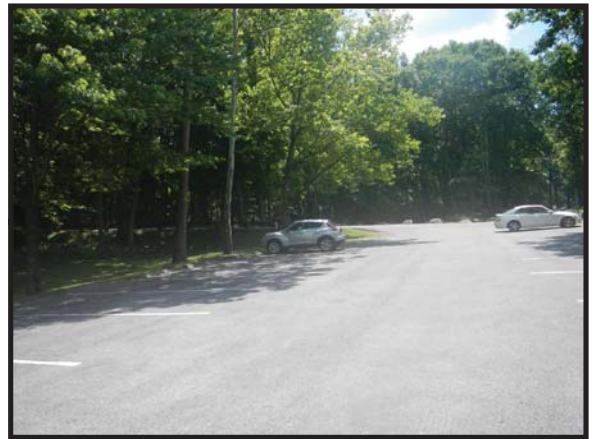
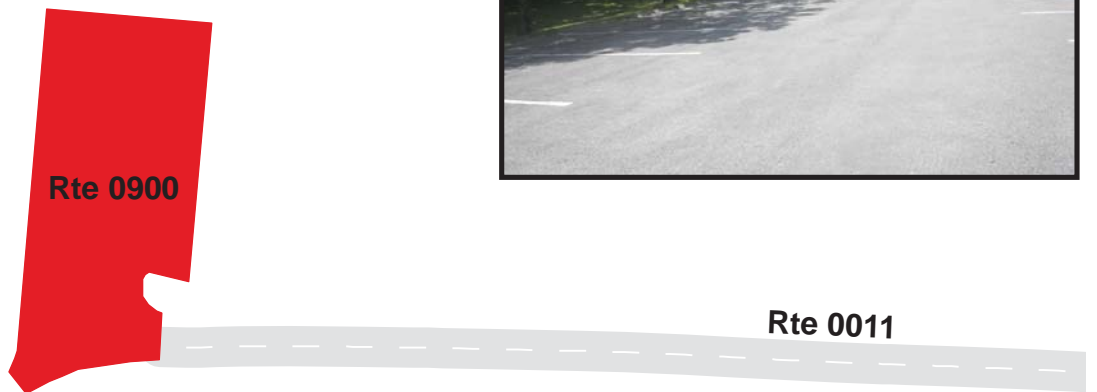
Route Number	Public / NonPublic	Date Visited	Area (sq ft)	Lane Miles *	Surface Type
0900	PUBLIC	7/2/2012	7,895	0.14	AS
Culverts	Drop Inlets	Gates	Curb & Gutter	Curb	PCR
0	0	1	NO CURB AND GUTTER	NO CURB	FAIR/73

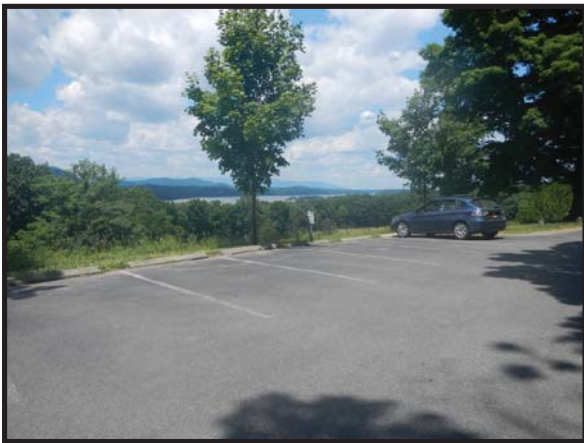
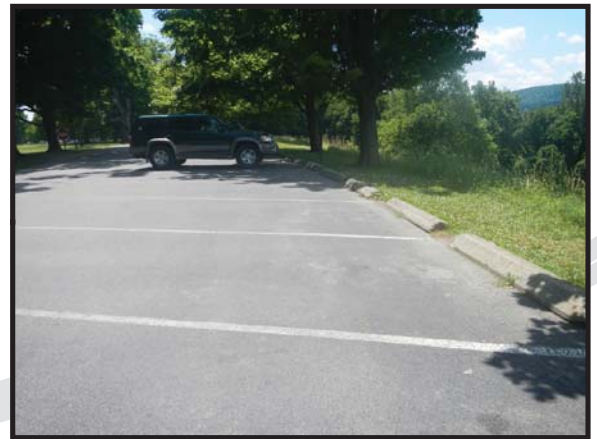
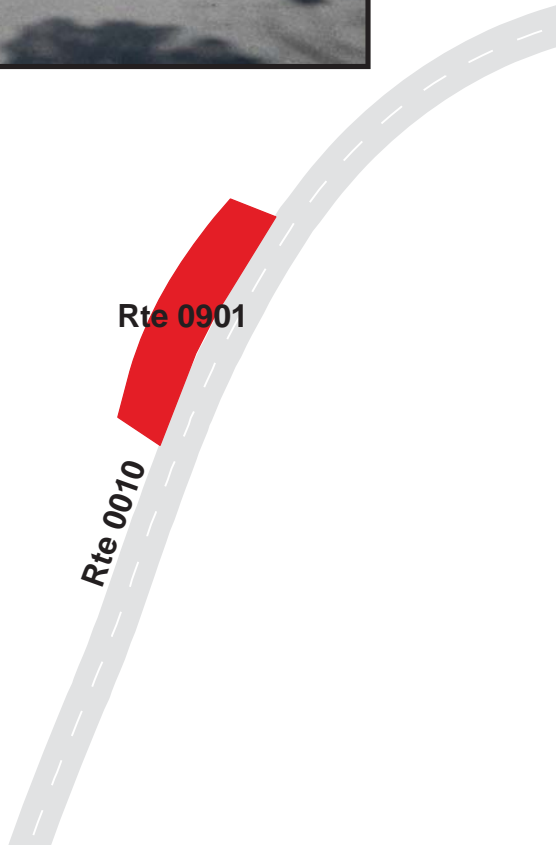
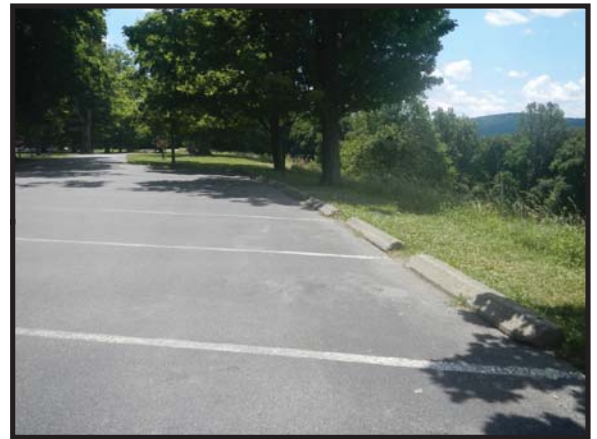
Route 0901

Route Number	Public / NonPublic	Date Visited	Area (sq ft)	Lane Miles *	Surface Type
0901	PUBLIC	7/2/2012	1,927	0.03	AS
Culverts	Drop Inlets	Gates	Curb & Gutter	Curb	PCR
0	0	0	NO CURB AND GUTTER	NO CURB	GOOD/90

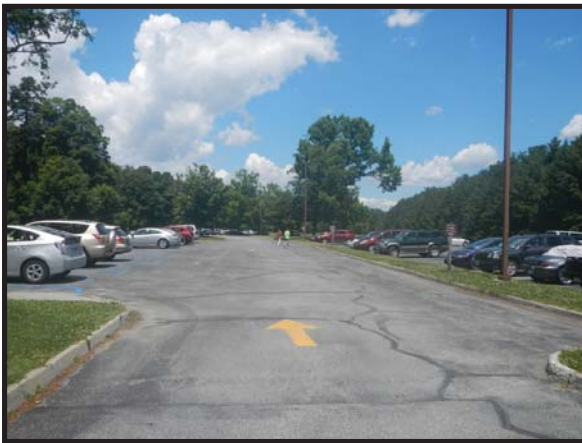
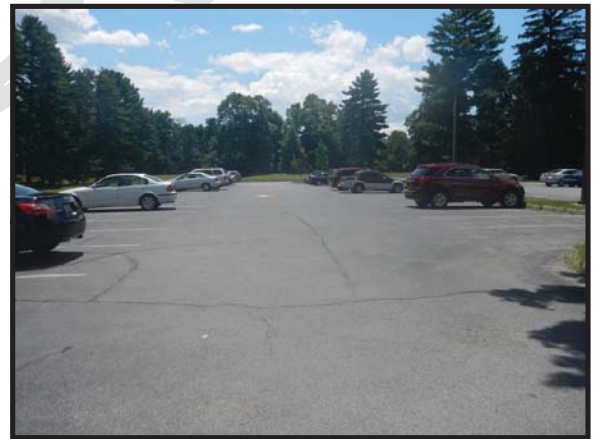
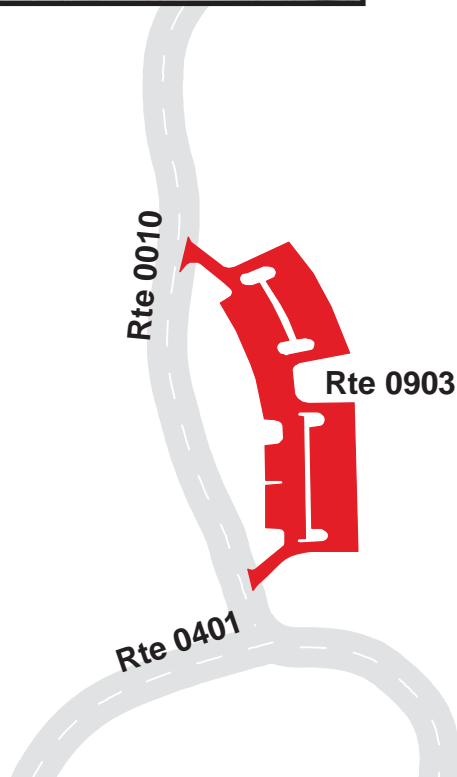
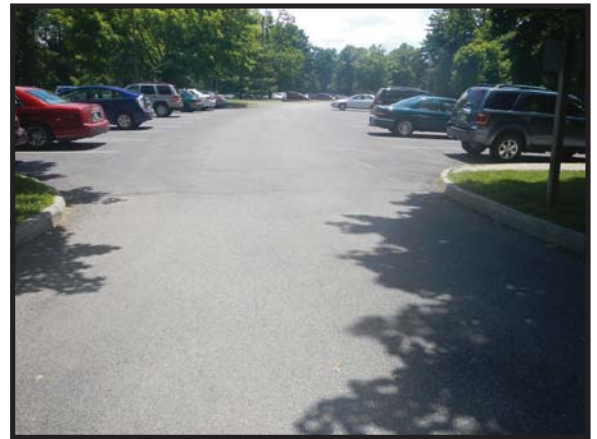
Route 0903

Route Number	Public / NonPublic	Date Visited	Area (sq ft)	Lane Miles *	Surface Type
0903	PUBLIC	7/2/2012	51,074	0.88	AS
Culverts	Drop Inlets	Gates	Curb & Gutter	Curb	PCR
0	9	0	NO CURB AND GUTTER	CONCRETE CURB	FAIR/73

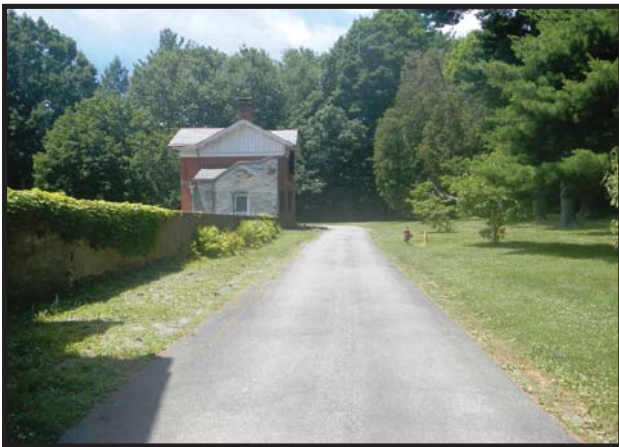
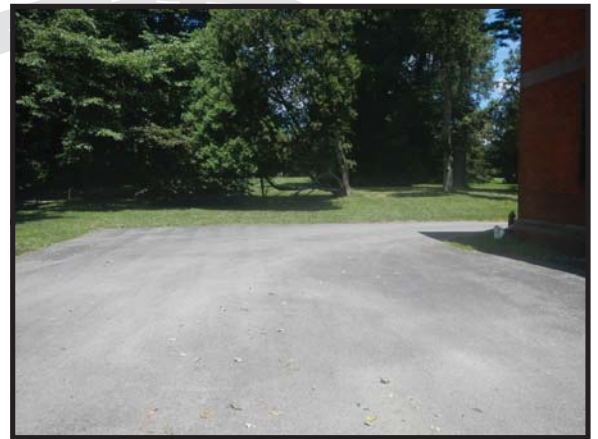
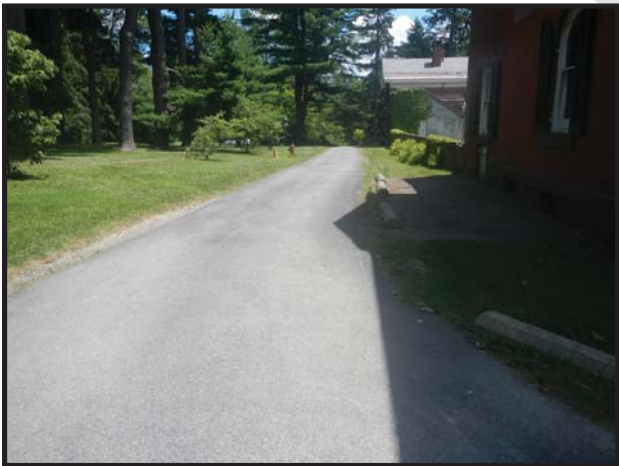
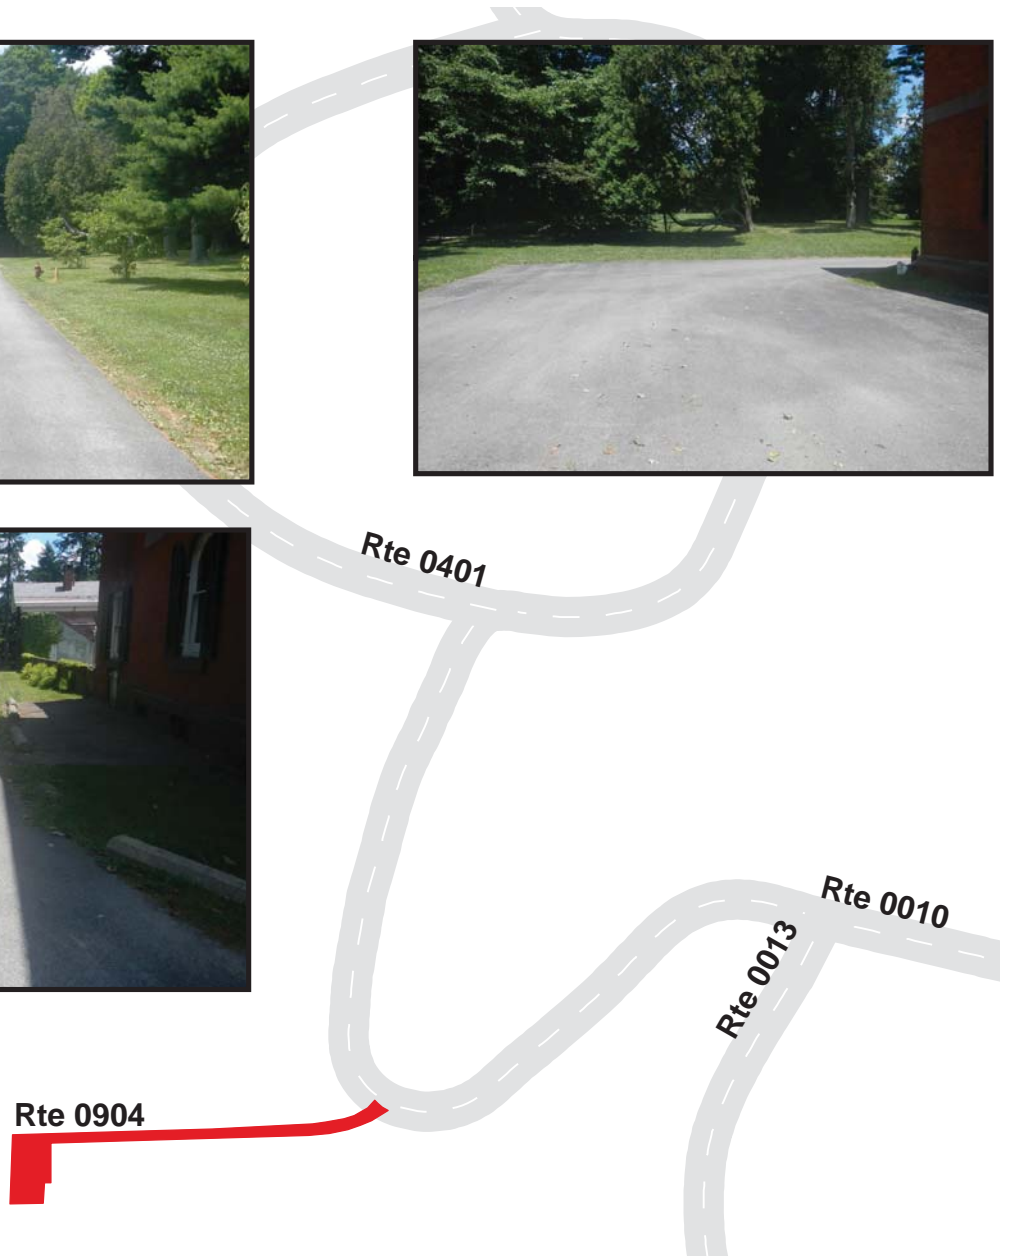
Route 0904

Route Number	Public / NonPublic	Date Visited	Area (sq ft)	Lane Miles *	Surface Type
0904	PUBLIC	7/2/2012	5,366	0.09	AS
Culverts	Drop Inlets	Gates	Curb & Gutter	Curb	PCR
0	0	0	NO CURB AND GUTTER	NO CURB	GOOD/90

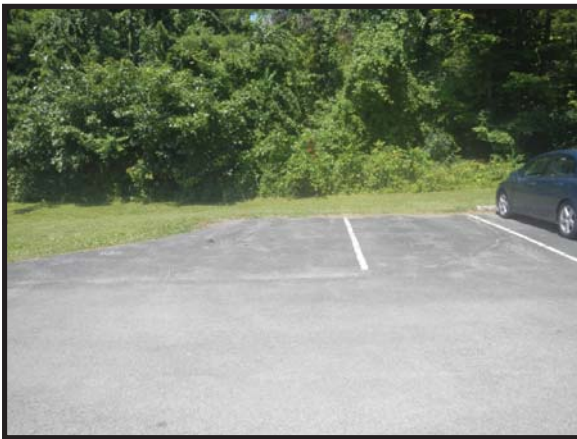
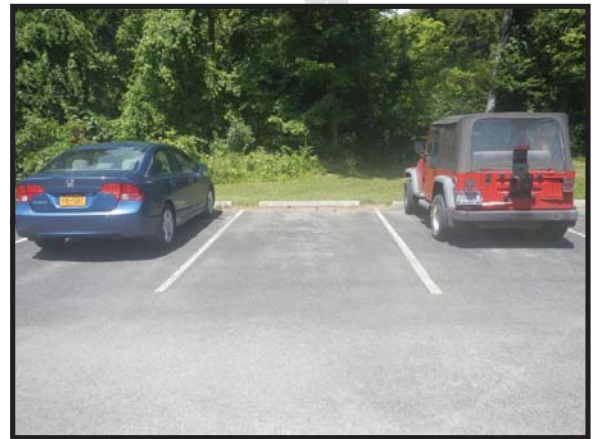
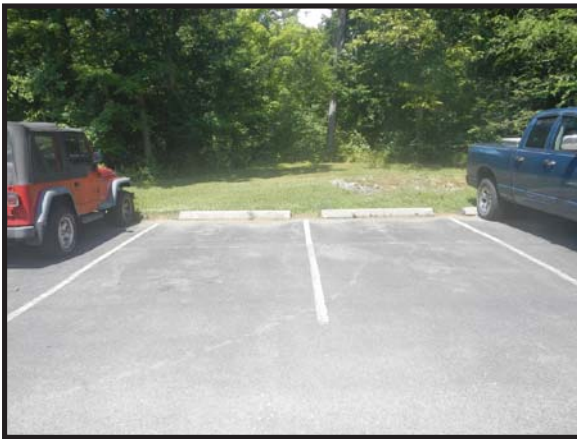
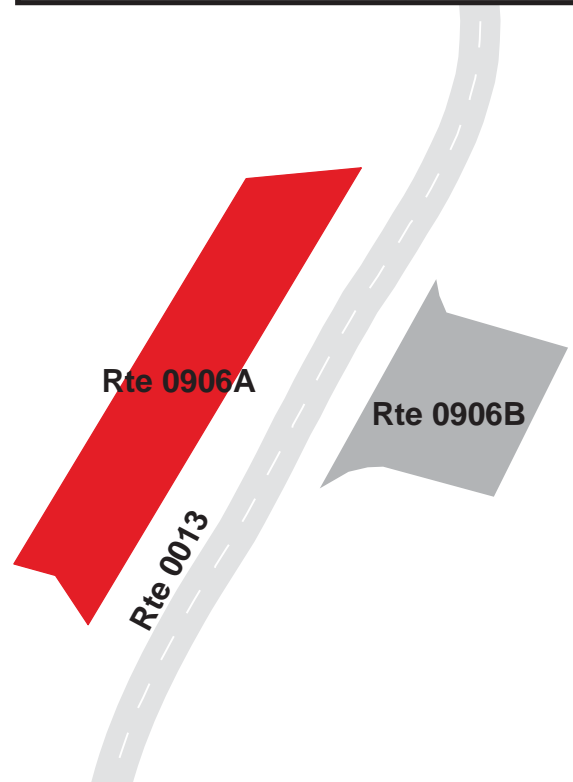
Route 0906A

Route Number	Public / NonPublic	Date Visited	Area (sq ft)	Lane Miles *	Surface Type
0906A	PUBLIC	7/2/2012	2,299	0.04	AS
Culverts	Drop Inlets	Gates	Curb & Gutter	Curb	PCR
0	0	0	NO CURB AND GUTTER	NO CURB	GOOD/90

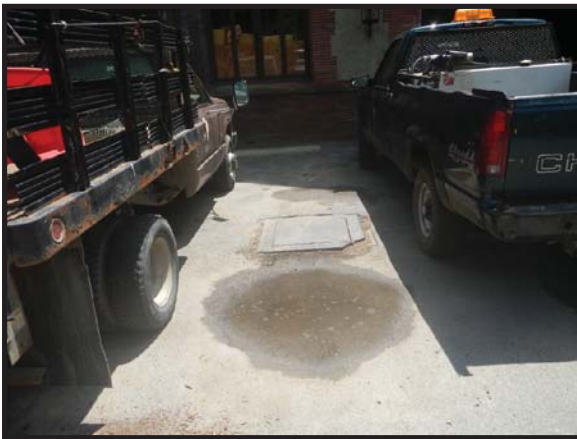
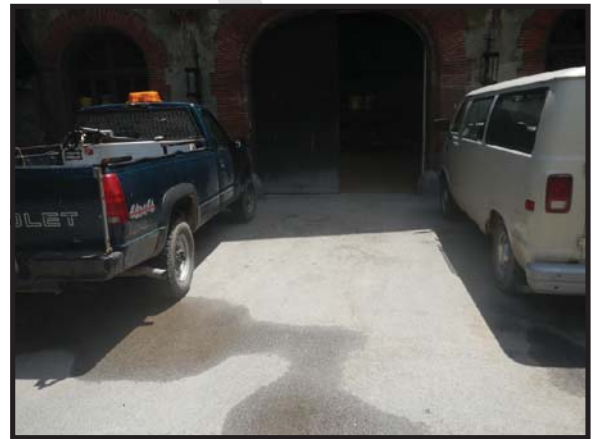
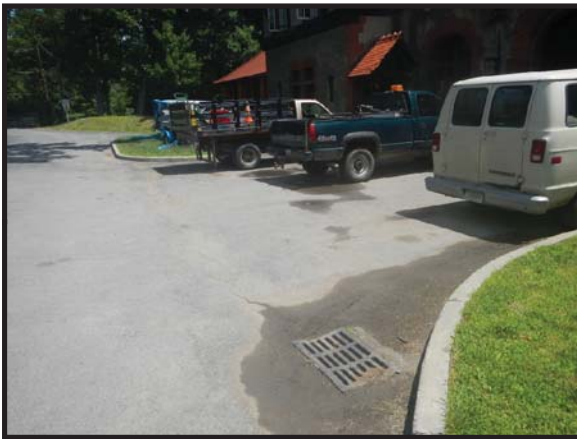
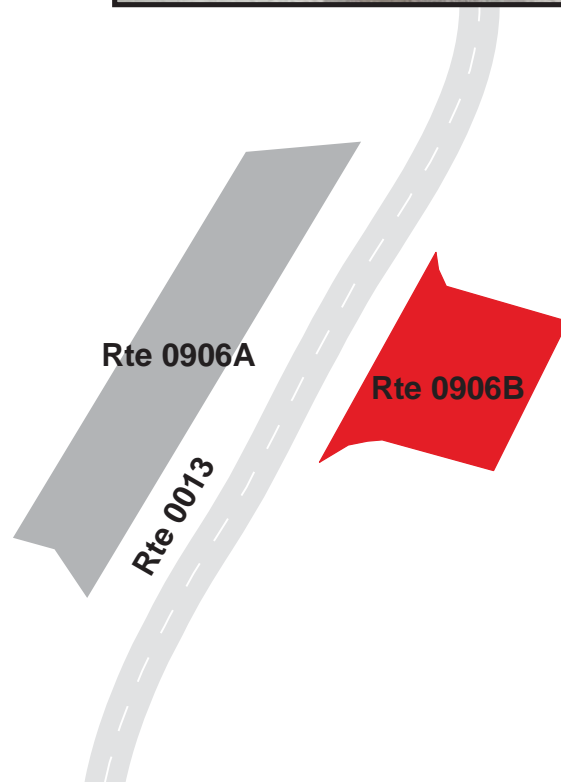
Route 0906B

Route Number	Public / NonPublic	Date Visited	Area (sq ft)	Lane Miles *	Surface Type
0906B	PUBLIC	7/2/2012	1,357	0.02	AS
Culverts	Drop Inlets	Gates	Curb & Gutter	Curb	PCR
0	1	0	NO CURB AND GUTTER	CONCRETE CURB	FAIR/73
