# Federal Lands Highway Road Inventory Program

Road Inventory and Condition Assessment

**Vicksburg National Military Park**  
**VICK - 5600**

**Cycle 5 Report**

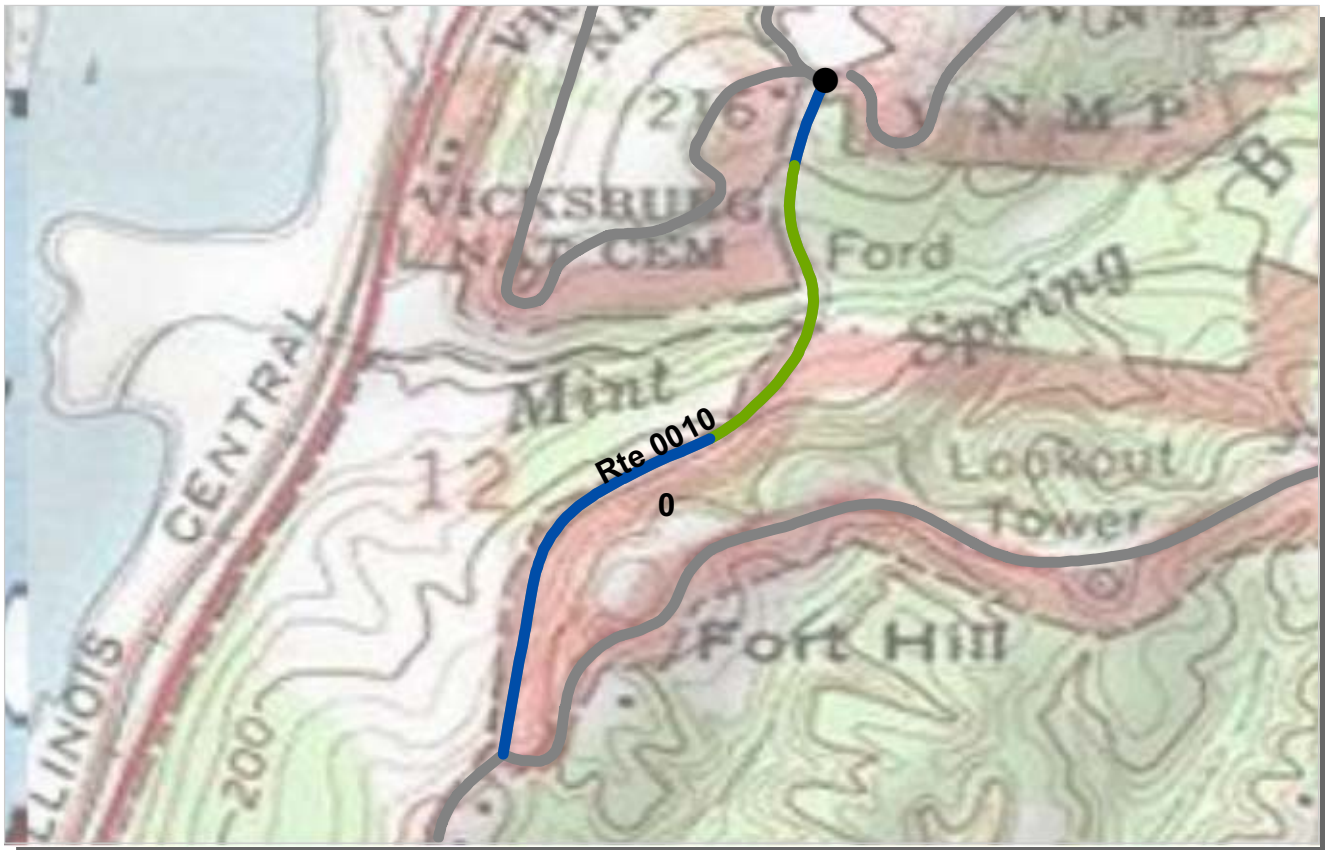
ROUTE: 0010 CONNECTING AVENUE

<b>Section Number</b>	0				
<b>Section Length (mi)</b>	0.52				
<b>Cross Section Information</b>					
Number of Lanes	2				
Paved Width (ft)	21				
Lane Width (ft)	10				
<b>Roadway Condition Information</b>					
SCR (Surface Condition Rating)	97				
PCR (Pavement Condition Rating)	93				
<b>Distress Index Values</b>					
Structural Crack Index	100				
Transverse Cracking Index	100				
Patching Index	100				
Rutting Index	97				
Roughness Condition Index (RCI)	86

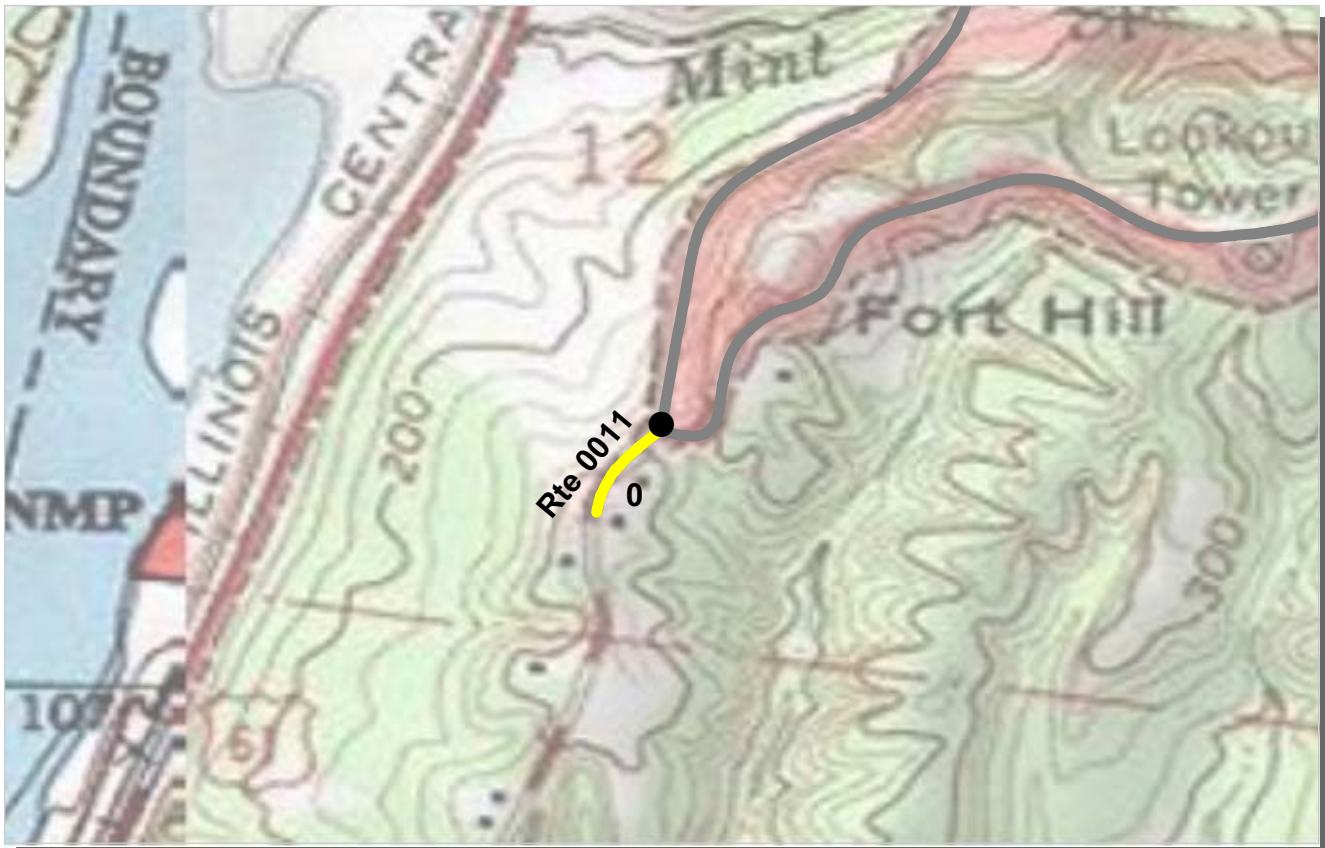
**ROUTE: 0011 FORT HILL DRIVE**

<b>Section Number</b>	0				
<b>Section Length (mi)</b>	0.07				
<b>Cross Section Information</b>					
Number of Lanes	2				
Paved Width (ft)	20				
Lane Width (ft)	10				
<b>Roadway Condition Information</b>					
SCR (Surface Condition Rating)	77				
PCR (Pavement Condition Rating)	77				
<b>Distress Index Values</b>					
Structural Crack Index	100				
Transverse Cracking Index	99				
Patching Index	100				
Rutting Index	77				
Roughness Condition Index (RCI)	NC

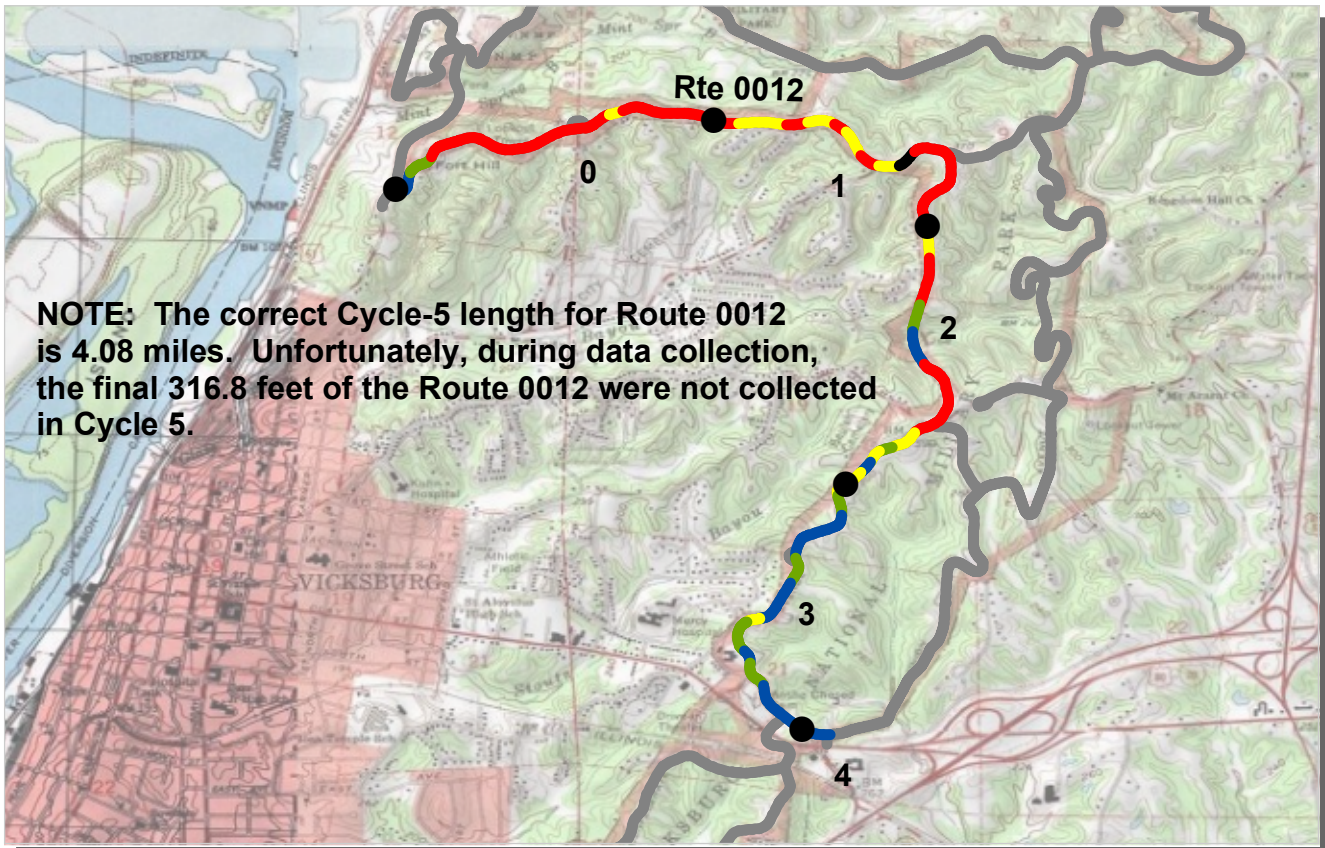
**ROUTE: 0012 CONFEDERATE AVENUE**

<i>Section Number</i>	0	1	2	3	4
<i>Section Length (mi)</i>	1.00	1.00	1.00	1.00	0.02
<i>Cross Section Information</i>					
Number of Lanes	1	1	1	1	1
Paved Width (ft)	20	20	19	19	21
Lane Width (ft)	19	20	19	18	21
<i>Roadway Condition Information</i>					
SCR (Surface Condition Rating)	NC	NC	NC	96	100
PCR (Pavement Condition Rating)	22	34	34	94	100
<i>Distress Index Values</i>					
Structural Crack Index	NC	NC	NC	96	100
Transverse Cracking Index	NC	NC	NC	96	100
Patching Index	NC	NC	NC	100	100
Rutting Index	NC	NC	NC	100	100
Roughness Condition Index (RCI)	22	34	34	91	100

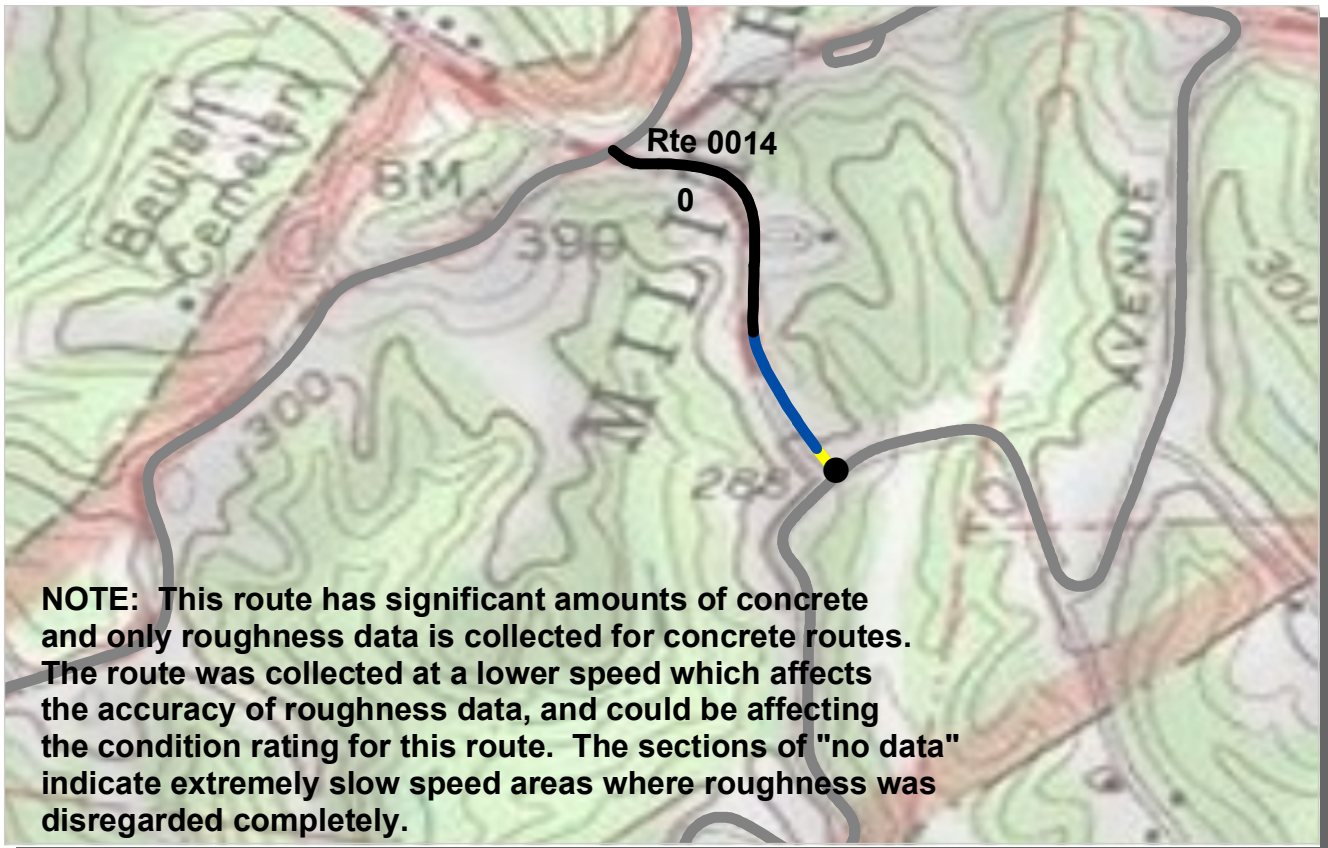
**ROUTE: 0014 PEMBERTON AVENUE**

**NOTE: This route has significant amounts of concrete and only roughness data is collected for concrete routes. The route was collected at a lower speed which affects the accuracy of roughness data, and could be affecting the condition rating for this route. The sections of "no data" indicate extremely slow speed areas where roughness was disregarded completely.**

<b>Section Number</b>	0				
<b>Section Length (mi)</b>	0.27				
<b>Cross Section Information</b>					
Number of Lanes	2				
Paved Width (ft)	18				
Lane Width (ft)	9				
<b>Roadway Condition Information</b>					
SCR (Surface Condition Rating)	NC				
PCR (Pavement Condition Rating)	NC				
<b>Distress Index Values</b>					
Structural Crack Index	NC				
Transverse Cracking Index	NC				
Patching Index	NC				
Rutting Index	NC				
Roughness Condition Index (RCI)	NC

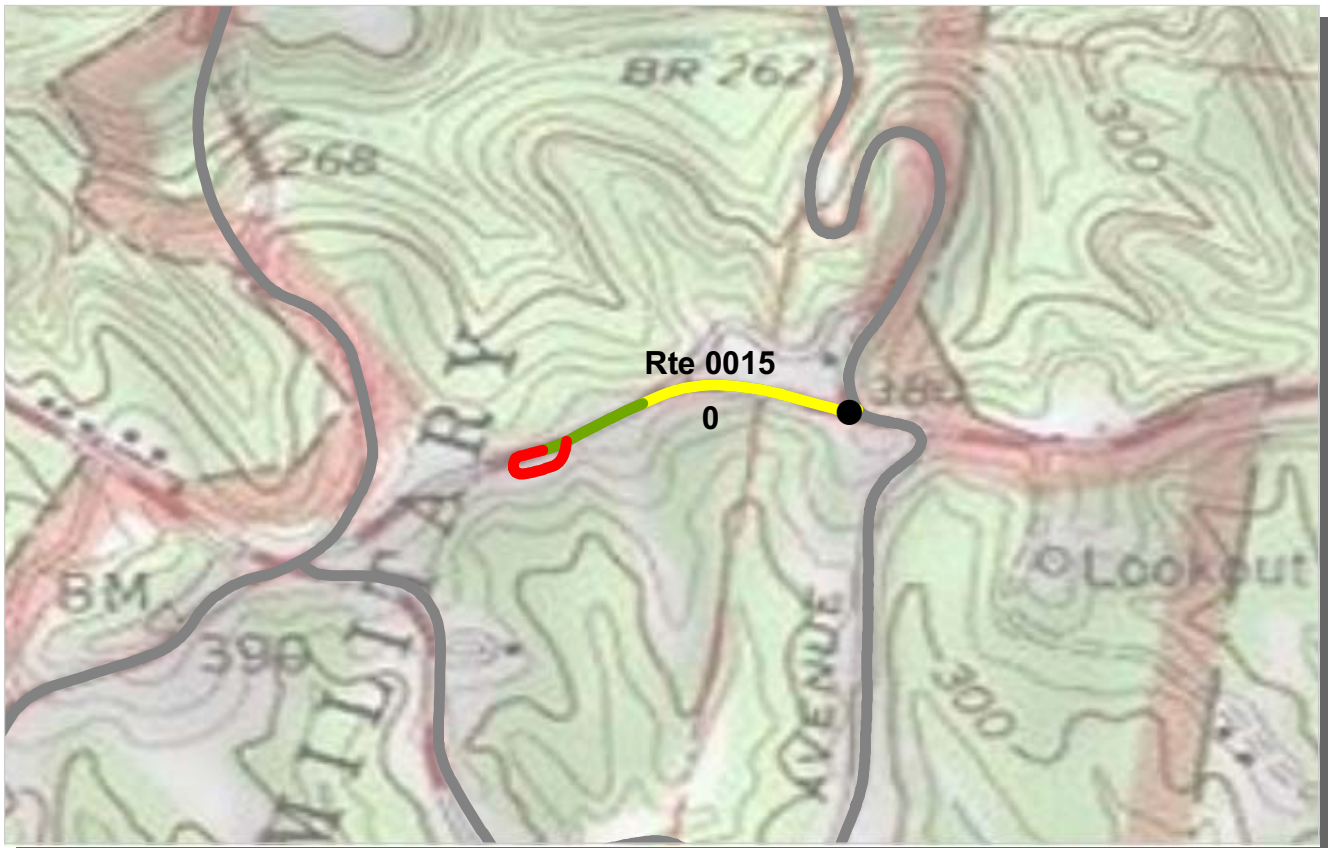
**ROUTE: 0015 SHIRLEY CIRCLE**

<b>Section Number</b>	0				
<b>Section Length (mi)</b>	0.24				
<b>Cross Section Information</b>					
Number of Lanes	1				
Paved Width (ft)	15				
Lane Width (ft)	13				
<b>Roadway Condition Information</b>					
SCR (Surface Condition Rating)	70				
PCR (Pavement Condition Rating)	70				
<b>Distress Index Values</b>					
Structural Crack Index	70				
Transverse Cracking Index	86				
Patching Index	100				
Rutting Index	97				
Roughness Condition Index (RCI)	NC

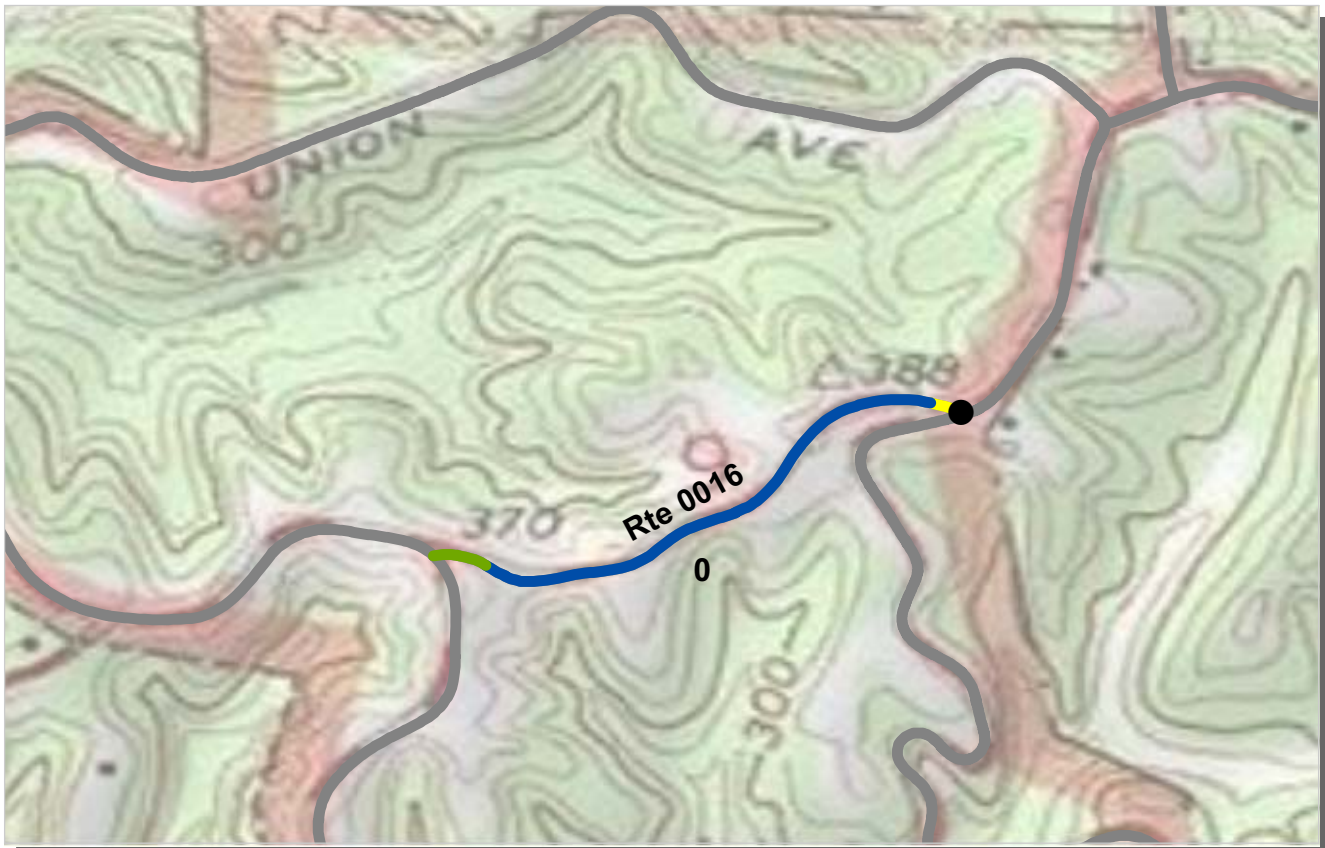
ROUTE: 0016 OLD GRAVEYARD ROAD

<b>Section Number</b>	0				
<b>Section Length (mi)</b>	0.33				
<b>Cross Section Information</b>					
Number of Lanes	2				
Paved Width (ft)	19				
Lane Width (ft)	9				
<b>Roadway Condition Information</b>					
SCR (Surface Condition Rating)	94				
PCR (Pavement Condition Rating)	94				
<b>Distress Index Values</b>					
Structural Crack Index	100				
Transverse Cracking Index	100				
Patching Index	100				
Rutting Index	94				
Roughness Condition Index (RCI)	NC

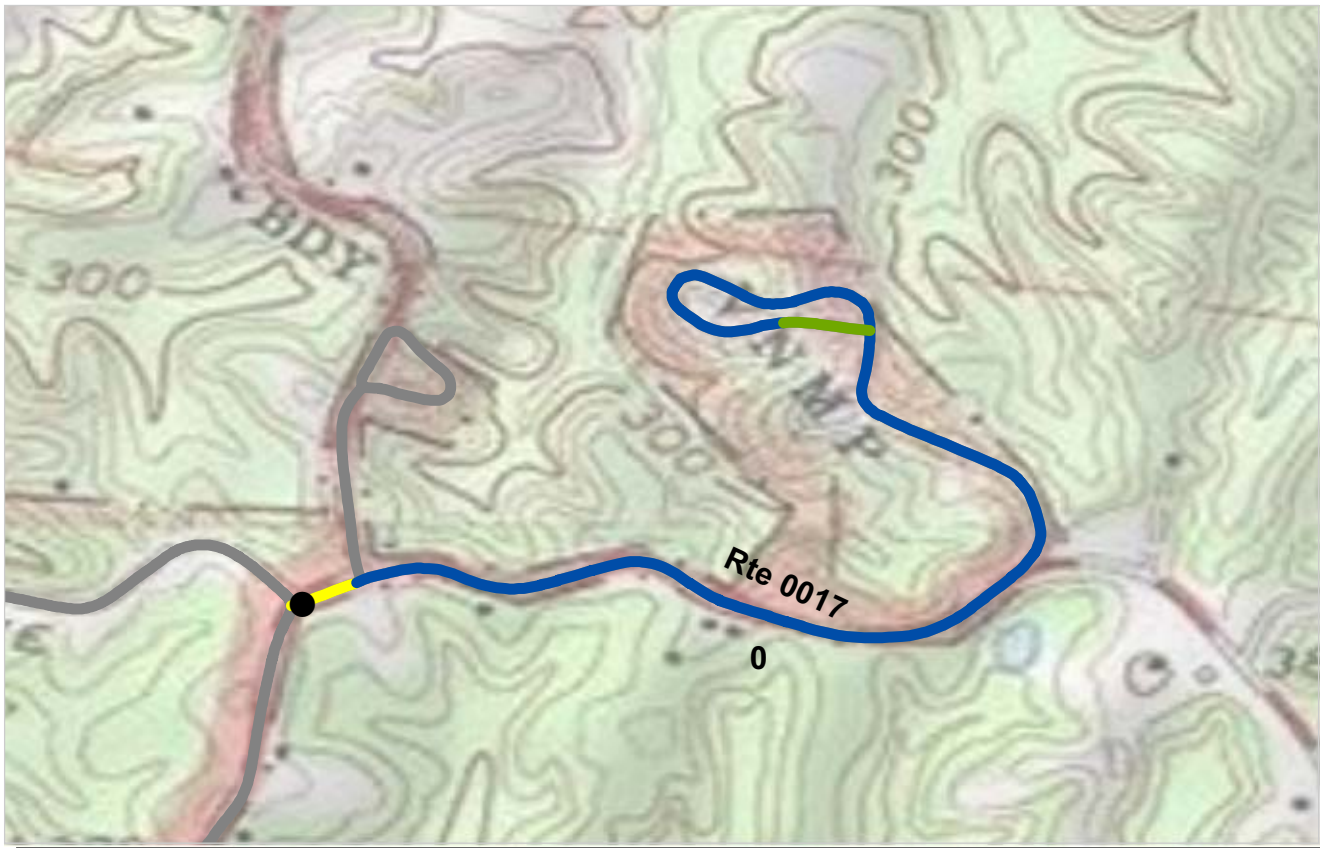
**ROUTE: 0017 GRANT AVENUE**

<b>Section Number</b>	0				
<b>Section Length (mi)</b>	0.91				
<b>Cross Section Information</b>					
Number of Lanes	2				
Paved Width (ft)	19				
Lane Width (ft)	11				
<b>Roadway Condition Information</b>					
SCR (Surface Condition Rating)	97				
PCR (Pavement Condition Rating)	97				
<b>Distress Index Values</b>					
Structural Crack Index	99				
Transverse Cracking Index	99				
Patching Index	100				
Rutting Index	97				
Roughness Condition Index (RCI)	NC

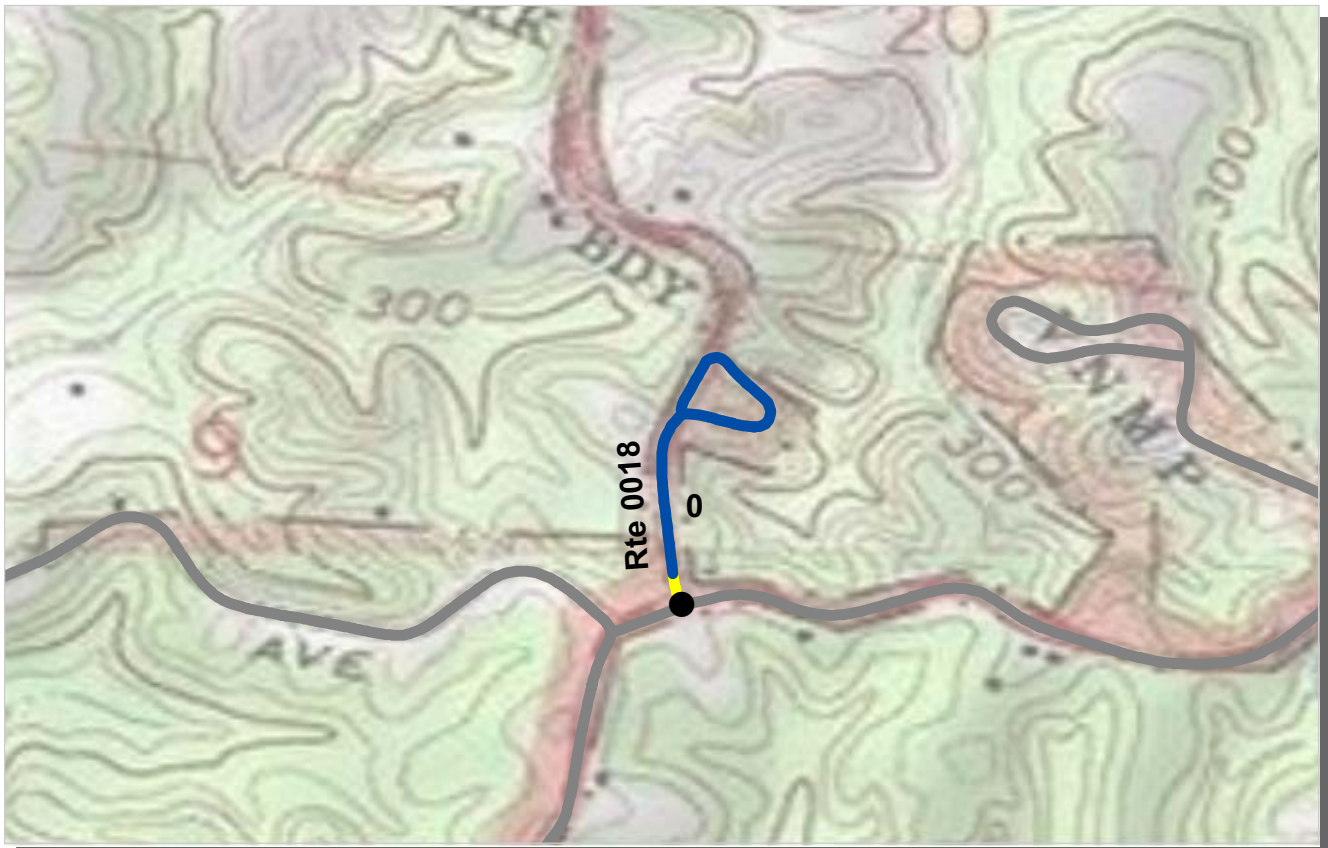
**ROUTE: 0018 SHERMAN'S CIRCLE**

<b>Section Number</b>	0				
<b>Section Length (mi)</b>	0.27				
<b>Cross Section Information</b>					
Number of Lanes	2				
Paved Width (ft)	13				
Lane Width (ft)	9				
<b>Roadway Condition Information</b>					
SCR (Surface Condition Rating)	96				
PCR (Pavement Condition Rating)	96				
<b>Distress Index Values</b>					
Structural Crack Index	100				
Transverse Cracking Index	100				
Patching Index	100				
Rutting Index	96				
Roughness Condition Index (RCI)	NC

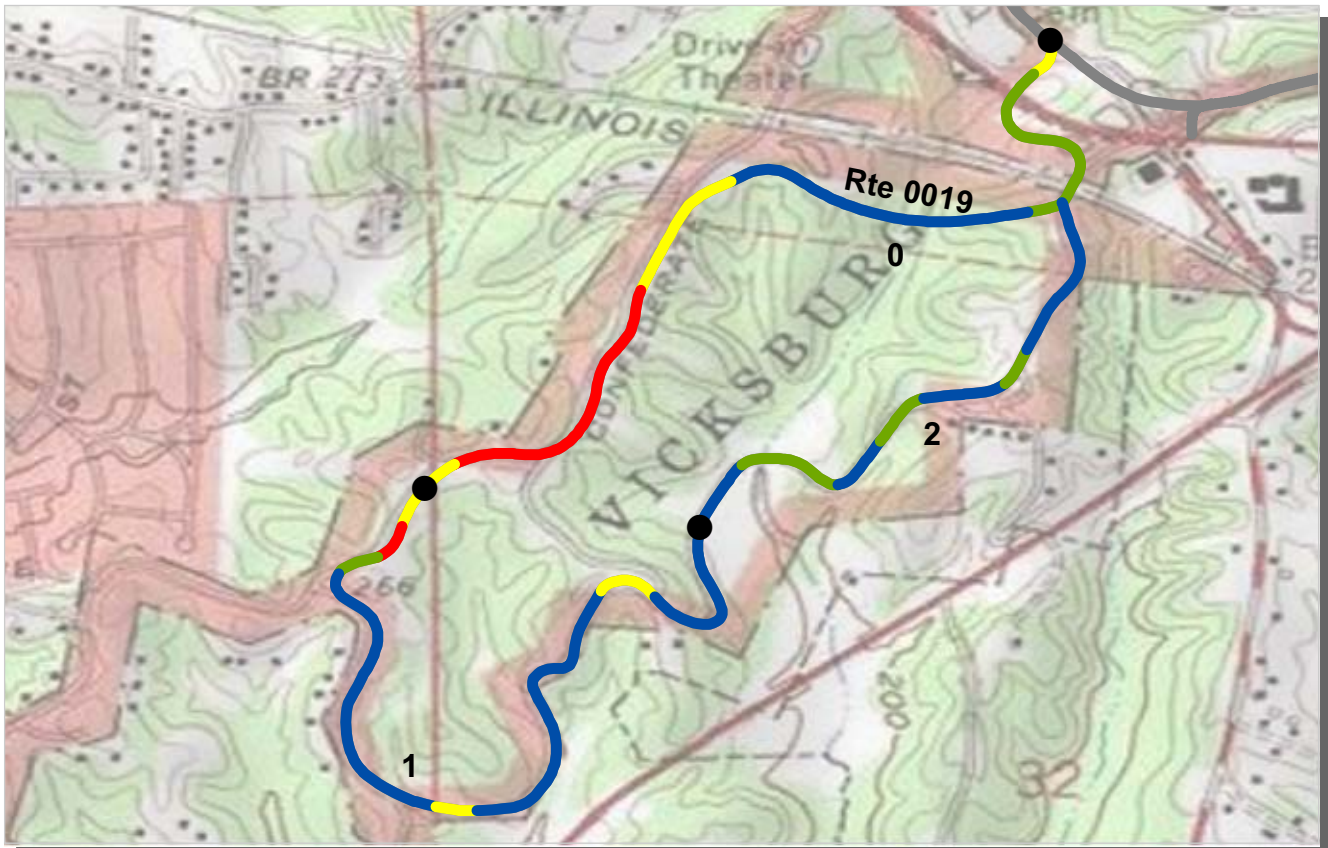
**ROUTE: 0019 SOUTH LOOP**

<i>Section Number</i>	0	1	2		
<i>Section Length (mi)</i>	1.00	1.00	0.58		
<i>Cross Section Information</i>					
Number of Lanes	1	1	1		
Paved Width (ft)	19	17	16		
Lane Width (ft)	15	13	13		
<i>Roadway Condition Information</i>					
SCR (Surface Condition Rating)	100	98	100		
PCR (Pavement Condition Rating)	90	94	94		
<i>Distress Index Values</i>					
Structural Crack Index	100	100	100		
Transverse Cracking Index	100	100	100		
Patching Index	100	100	100		
Rutting Index	100	98	100		
Roughness Condition Index (RCI)	75	88	85

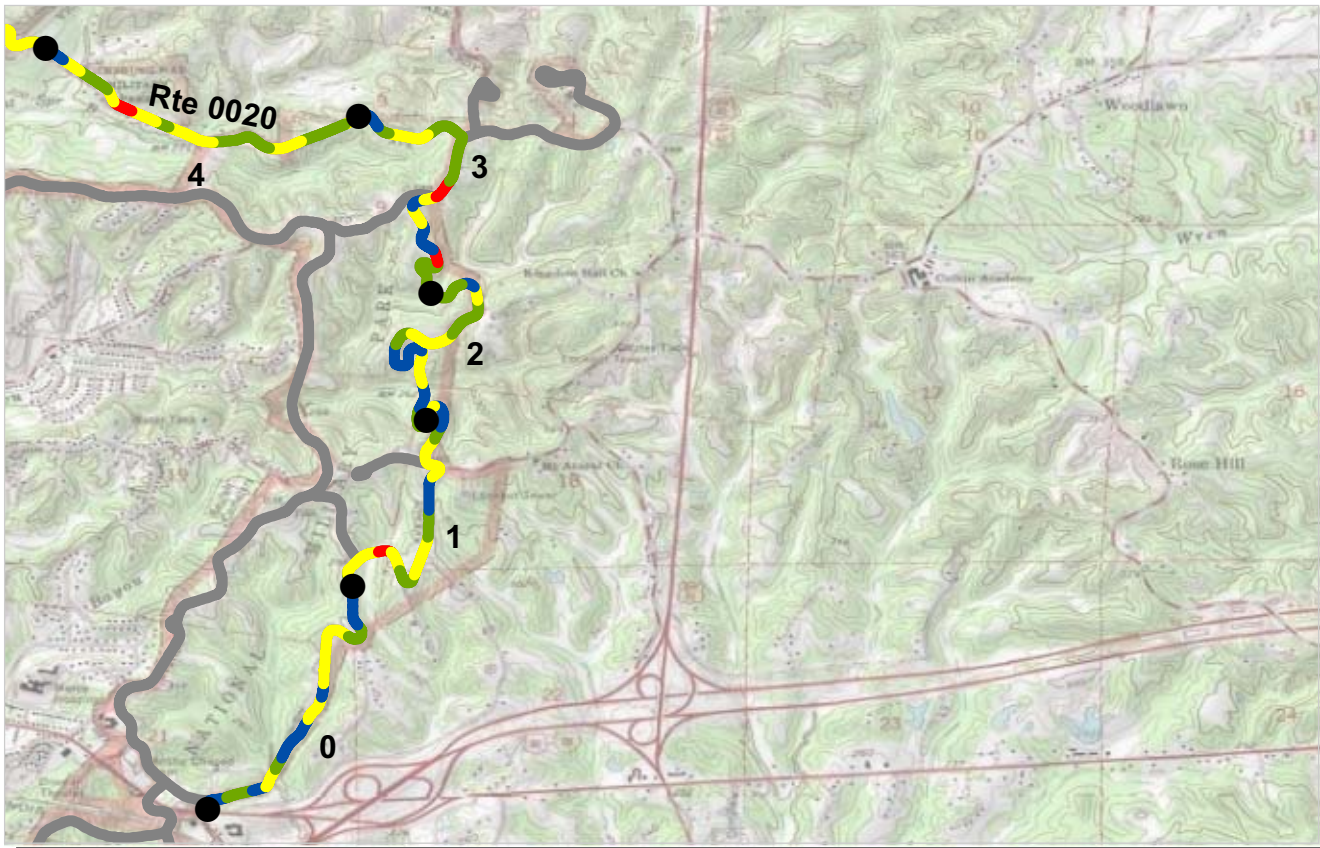
**ROUTE: 0020 UNION AVENUE**

<i>Section Number</i>	0	1	2	3	4
<i>Section Length (mi)</i>	1.00	1.00	1.00	1.00	1.00
<i>Cross Section Information</i>					
Number of Lanes	1	1	1	1	1
Paved Width (ft)	20	17	18	17	18
Lane Width (ft)	15	14	18	17	18
<i>Roadway Condition Information</i>					
SCR (Surface Condition Rating)	94	86	95	80	81
PCR (Pavement Condition Rating)	88	82	87	81	76
<i>Distress Index Values</i>					
Structural Crack Index	94	86	95	80	81
Transverse Cracking Index	98	92	97	94	95
Patching Index	100	100	99	100	98
Rutting Index	99	99	99	98	99
Roughness Condition Index (RCI)	79	76	76	83	68

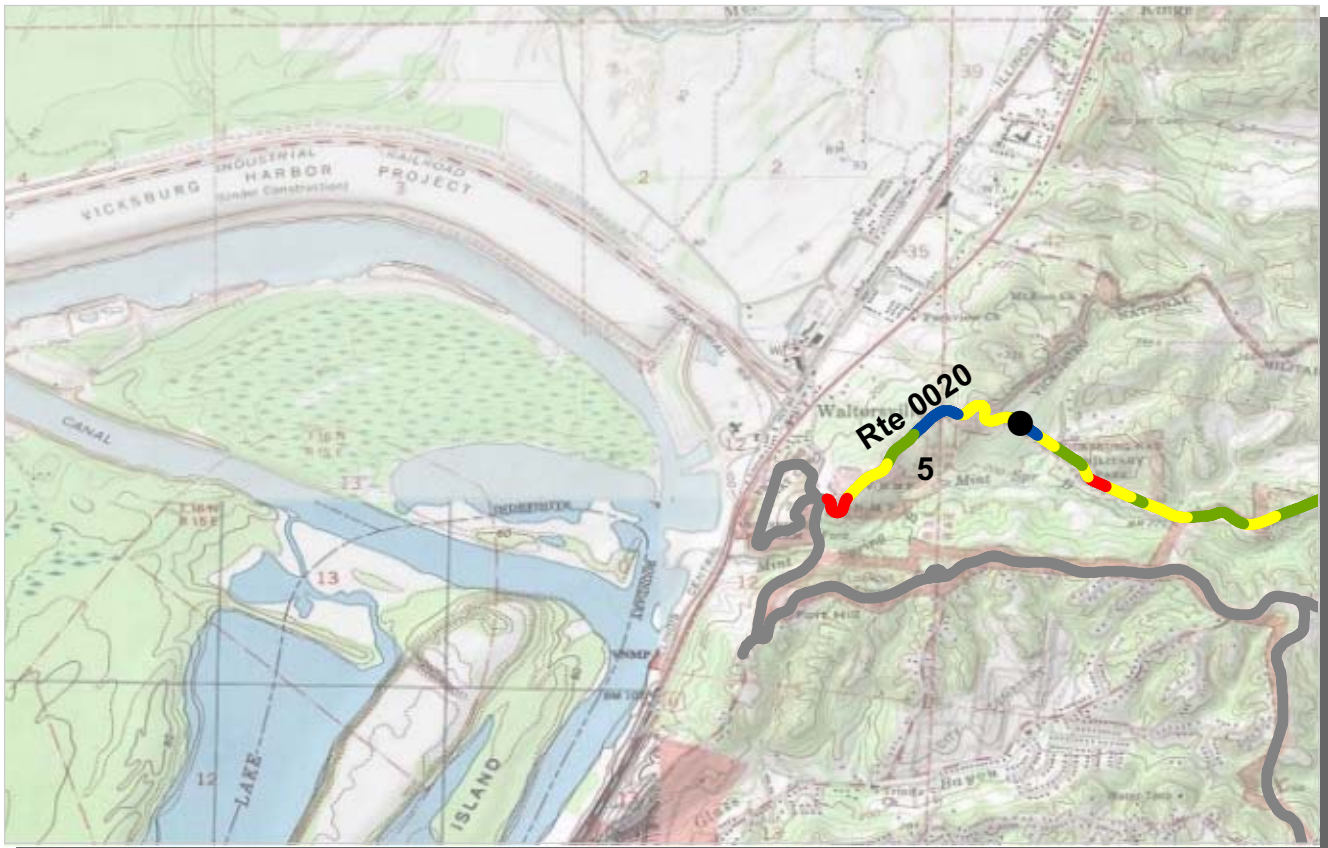
**ROUTE: 0020 UNION AVENUE**

<b>Section Number</b>	5				
<b>Section Length (mi)</b>	0.77				
<b>Cross Section Information</b>					
Number of Lanes	2				
Paved Width (ft)	18				
Lane Width (ft)	14				
<b>Roadway Condition Information</b>					
SCR (Surface Condition Rating)	80				
PCR (Pavement Condition Rating)	79				
<b>Distress Index Values</b>					
Structural Crack Index	80				
Transverse Cracking Index	92				
Patching Index	100				
Rutting Index	99				
Roughness Condition Index (RCI)	78

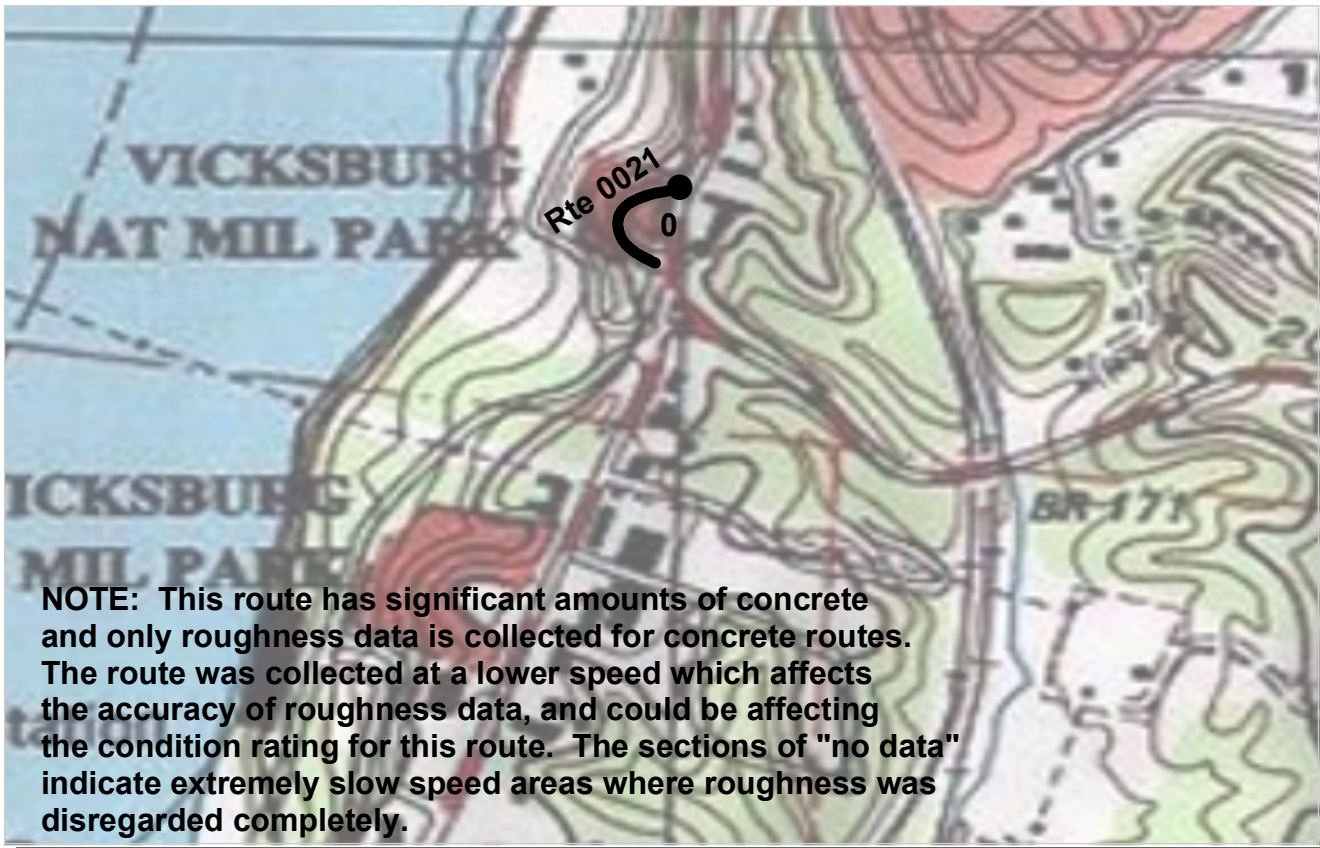
**ROUTE: 0021 LOUISIANA CIRCLE**

<b>Section Number</b>	0				
<b>Section Length (mi)</b>	0.08				
<b>Cross Section Information</b>					
Number of Lanes	2				
Paved Width (ft)	23				
Lane Width (ft)	11				
<b>Roadway Condition Information</b>					
SCR (Surface Condition Rating)	NC				
PCR (Pavement Condition Rating)	NC				
<b>Distress Index Values</b>					
Structural Crack Index	NC				
Transverse Cracking Index	NC				
Patching Index	NC				
Rutting Index	NC				
Roughness Condition Index (RCI)	NC

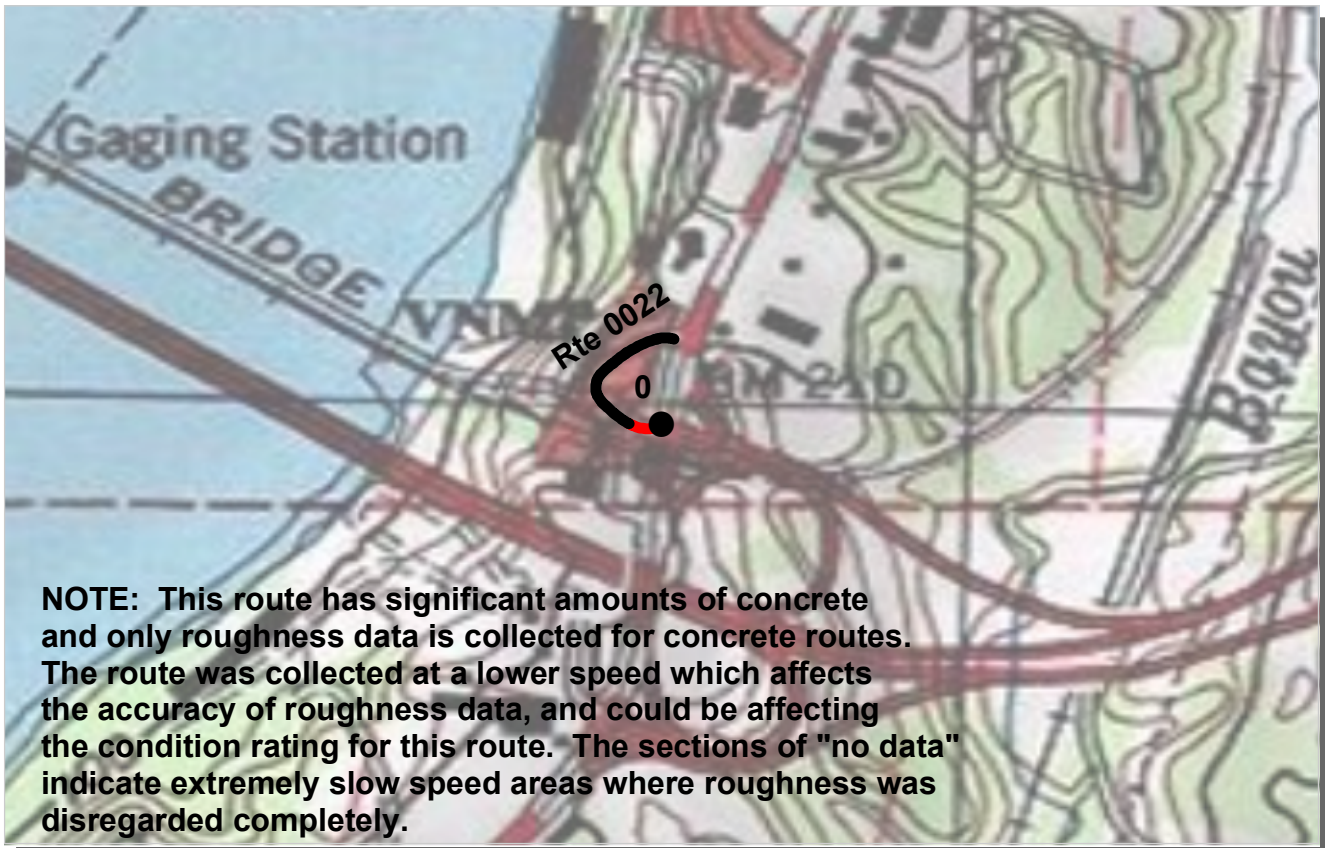
**ROUTE: 0022 NAVY CIRCLE**

<b>Section Number</b>	0				
<b>Section Length (mi)</b>	0.11				
<b>Cross Section Information</b>					
Number of Lanes	1				
Paved Width (ft)	16				
Lane Width (ft)	16				
<b>Roadway Condition Information</b>					
SCR (Surface Condition Rating)	NC				
PCR (Pavement Condition Rating)	NC				
<b>Distress Index Values</b>					
Structural Crack Index	NC				
Transverse Cracking Index	NC				
Patching Index	NC				
Rutting Index	NC				
Roughness Condition Index (RCI)	NC

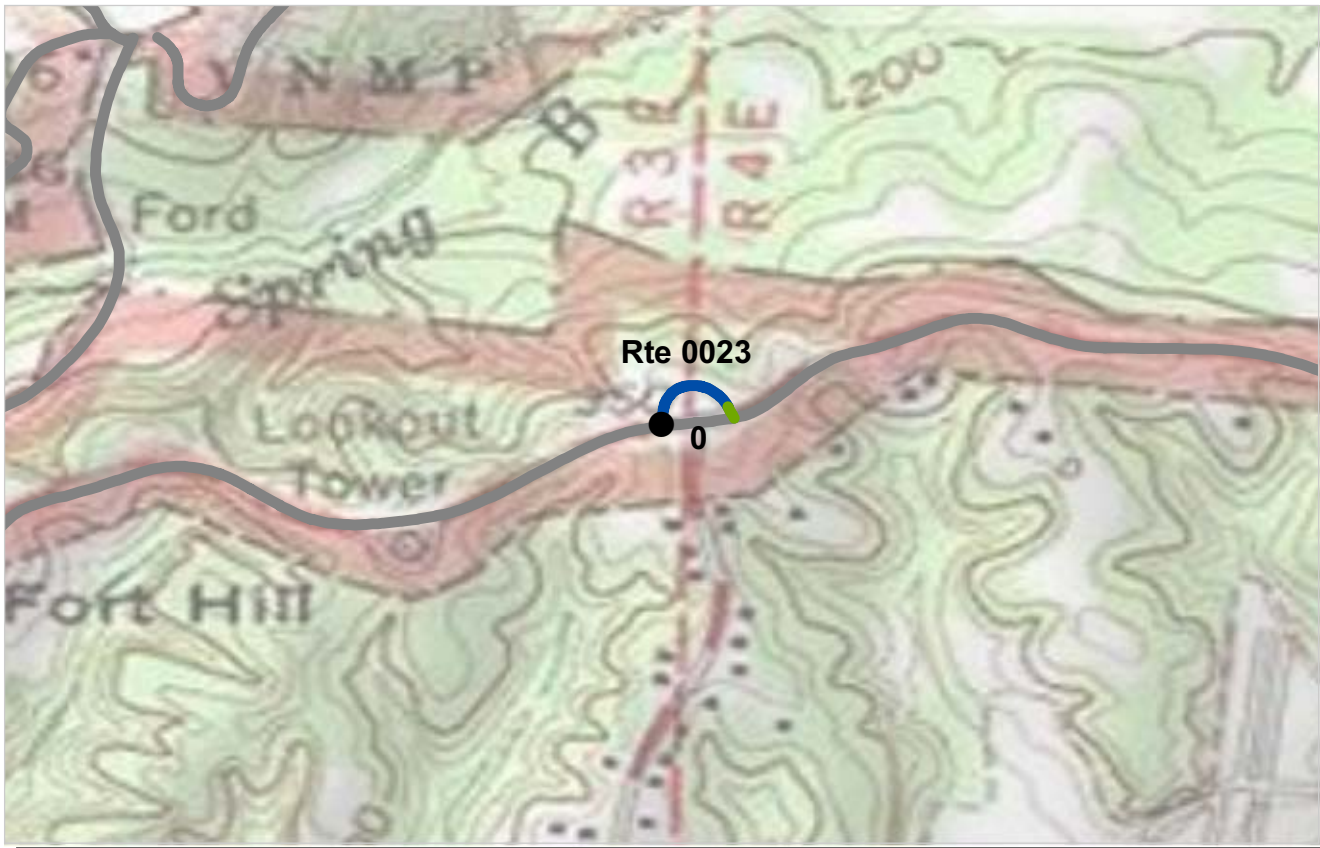
ROUTE: 0023 TENNESSEE CIRCLE

<b>Section Number</b>	0				
<b>Section Length (mi)</b>	0.07				
<b>Cross Section Information</b>					
Number of Lanes	1				
Paved Width (ft)	13				
Lane Width (ft)	13				
<b>Roadway Condition Information</b>					
SCR (Surface Condition Rating)	98				
PCR (Pavement Condition Rating)	98				
<b>Distress Index Values</b>					
Structural Crack Index	99				
Transverse Cracking Index	98				
Patching Index	100				
Rutting Index	99				
Roughness Condition Index (RCI)	NC

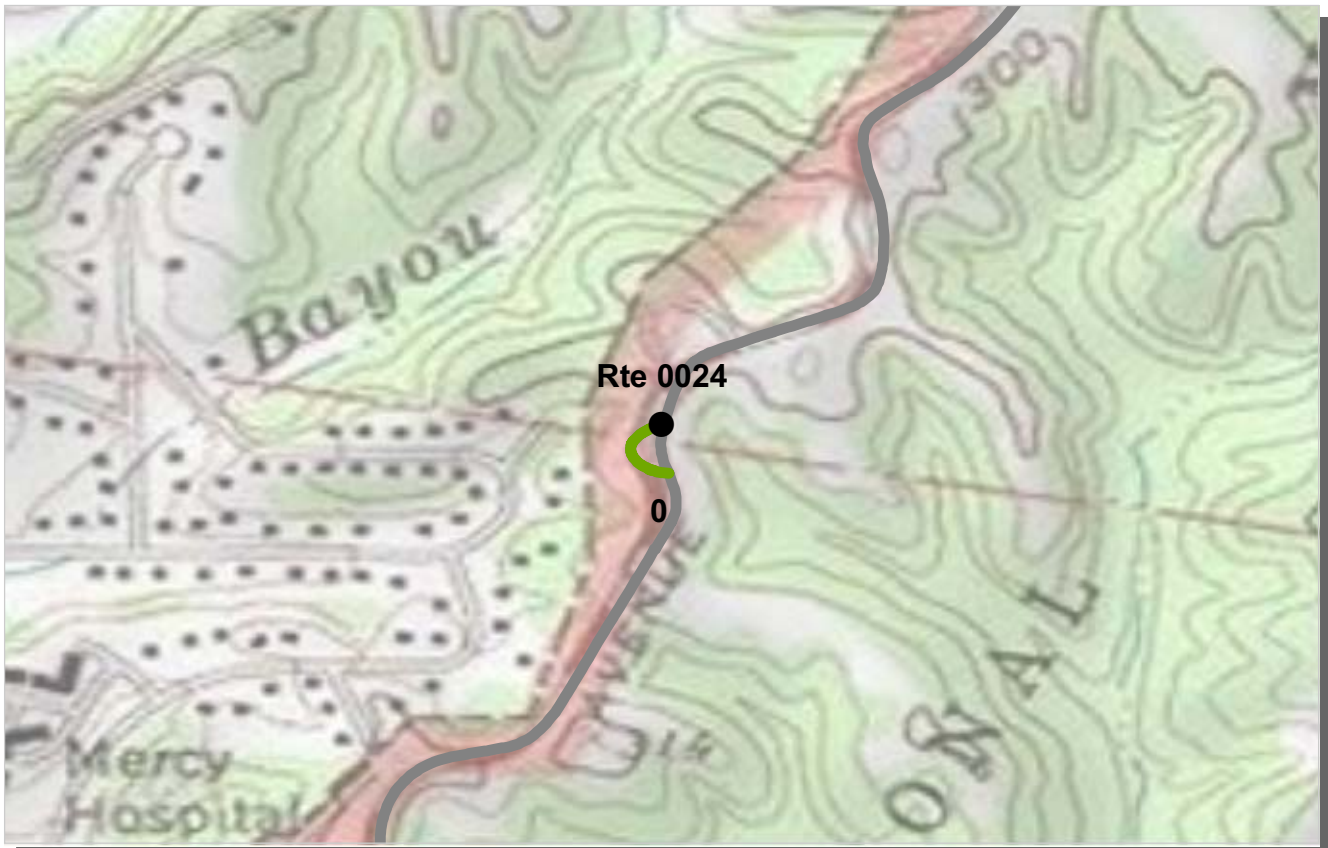
**ROUTE: 0024 PEMBERTON CIRCLE**

<b>Section Number</b>	0				
<b>Section Length (mi)</b>	0.05				
<b>Cross Section Information</b>					
Number of Lanes	1				
Paved Width (ft)	13				
Lane Width (ft)	13				
<b>Roadway Condition Information</b>					
SCR (Surface Condition Rating)	91				
PCR (Pavement Condition Rating)	91				
<b>Distress Index Values</b>					
Structural Crack Index	100				
Transverse Cracking Index	91				
Patching Index	100				
Rutting Index	94				
Roughness Condition Index (RCI)	NC

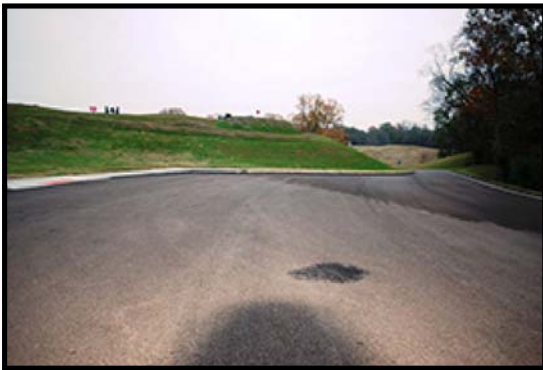
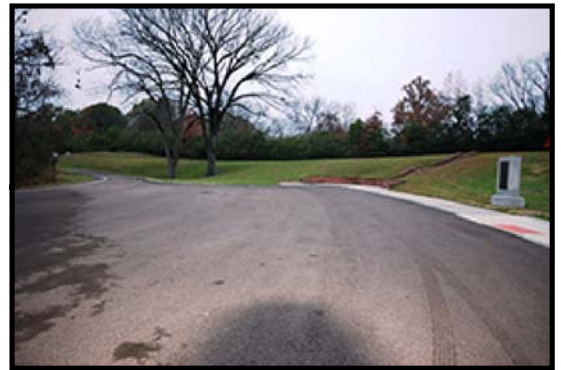
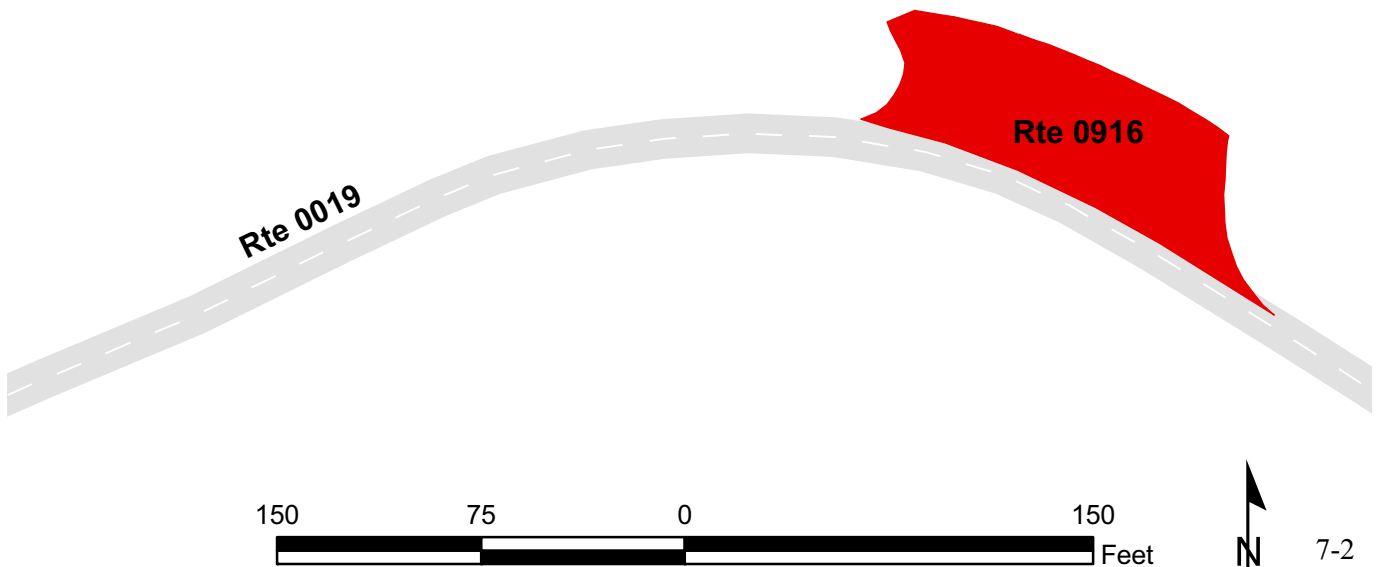
## Route 0916

Route Number	Public / NonPublic	Date Visited	Area (sq ft)	Lane Miles *	Surface Type
0916	PUBLIC	12/13/2011	5,391	0.09	AS
Culverts	Drop Inlets	Gates	Curb & Gutter	Curb	PCR
0	0	0	NO CURB AND GUTTER	CONCRETE CURB	GOOD/90

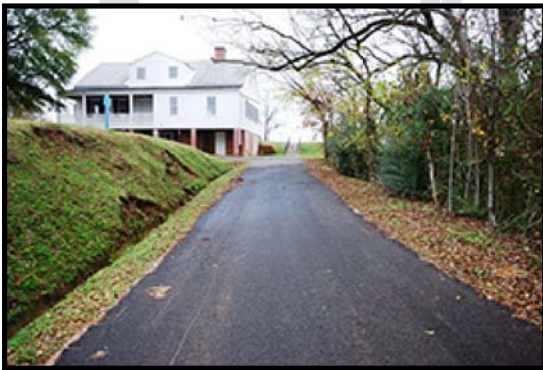
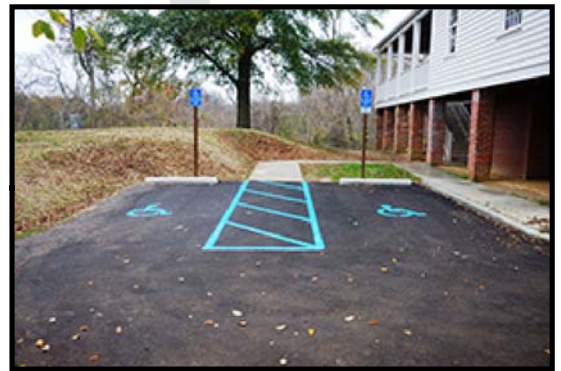
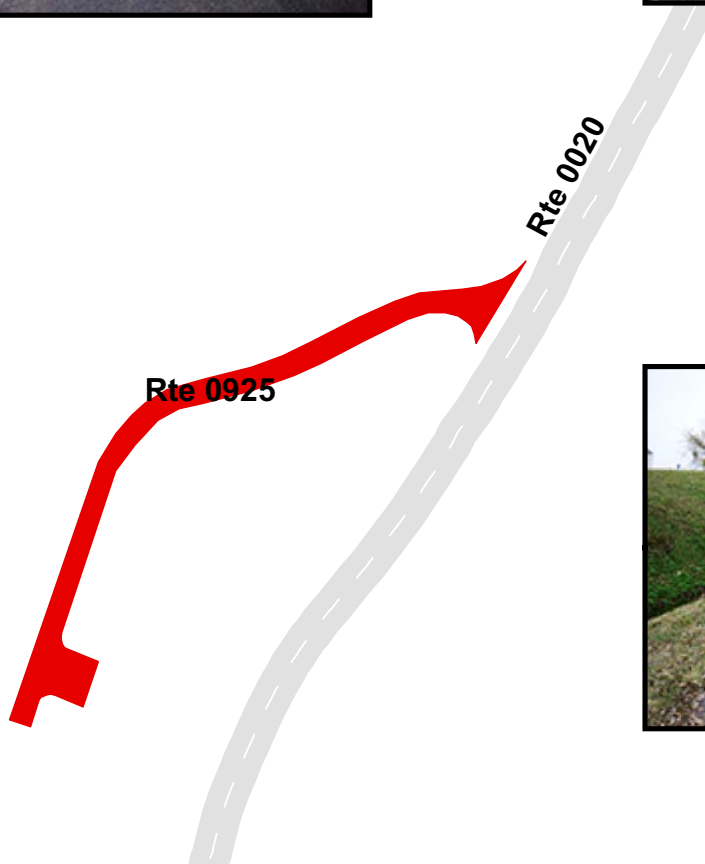
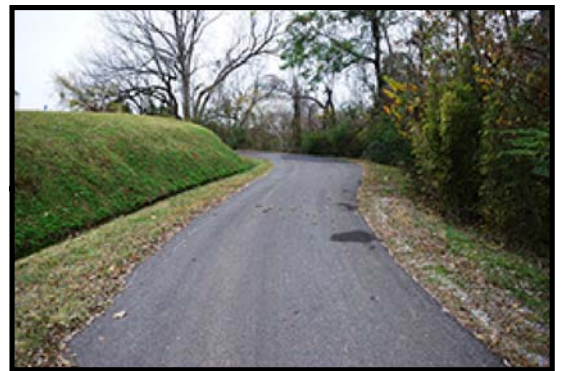
## Route 0925

Route Number	Public / NonPublic	Date Visited	Area (sq ft)	Lane Miles *	Surface Type
0925	PUBLIC	12/13/2011	4,139	0.07	AS
Culverts	Drop Inlets	Gates	Curb & Gutter	Curb	PCR
2	0	1	NO CURB AND GUTTER	CONCRETE CURB	GOOD/90

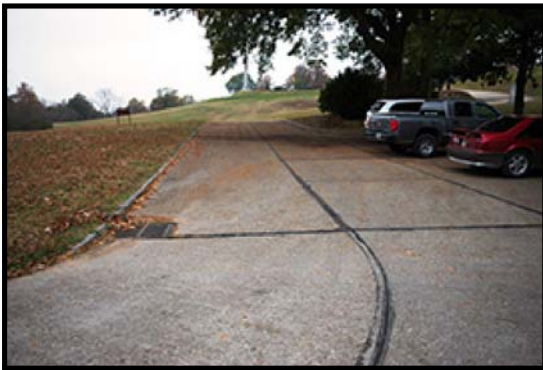
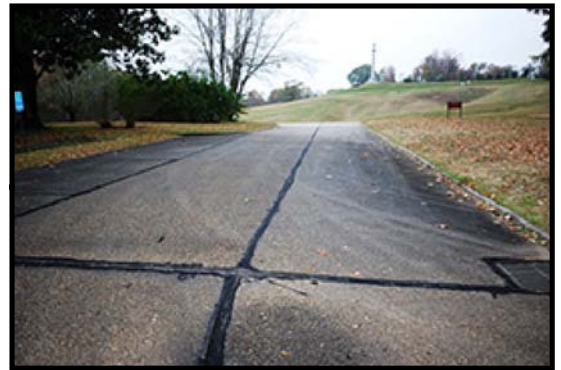
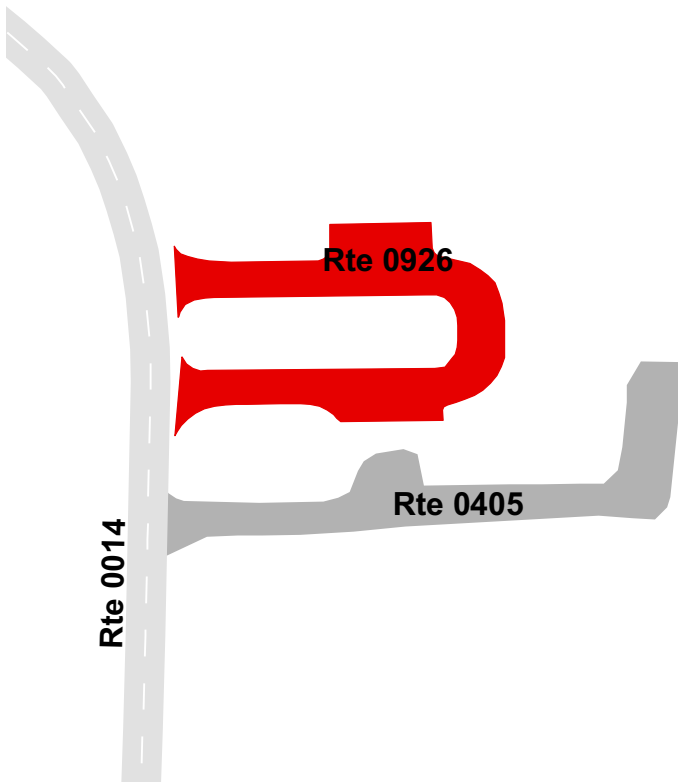
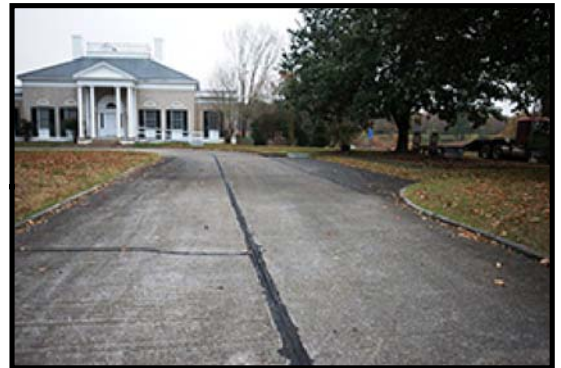
## Route 0926

Route Number	Public / NonPublic	Date Visited	Area (sq ft)	Lane Miles *	Surface Type
0926	PUBLIC	12/13/2011	8,131	0.14	CO
Culverts	Drop Inlets	Gates	Curb & Gutter	Curb	PCR
0	2	0	NO CURB AND GUTTER	CONCRETE CURB	POOR/45
