Federal Lands Highway Road Inventory Program

Road Inventory and Condition Assessment

Voyageurs National Park
VOYA

Cycle 5 Report

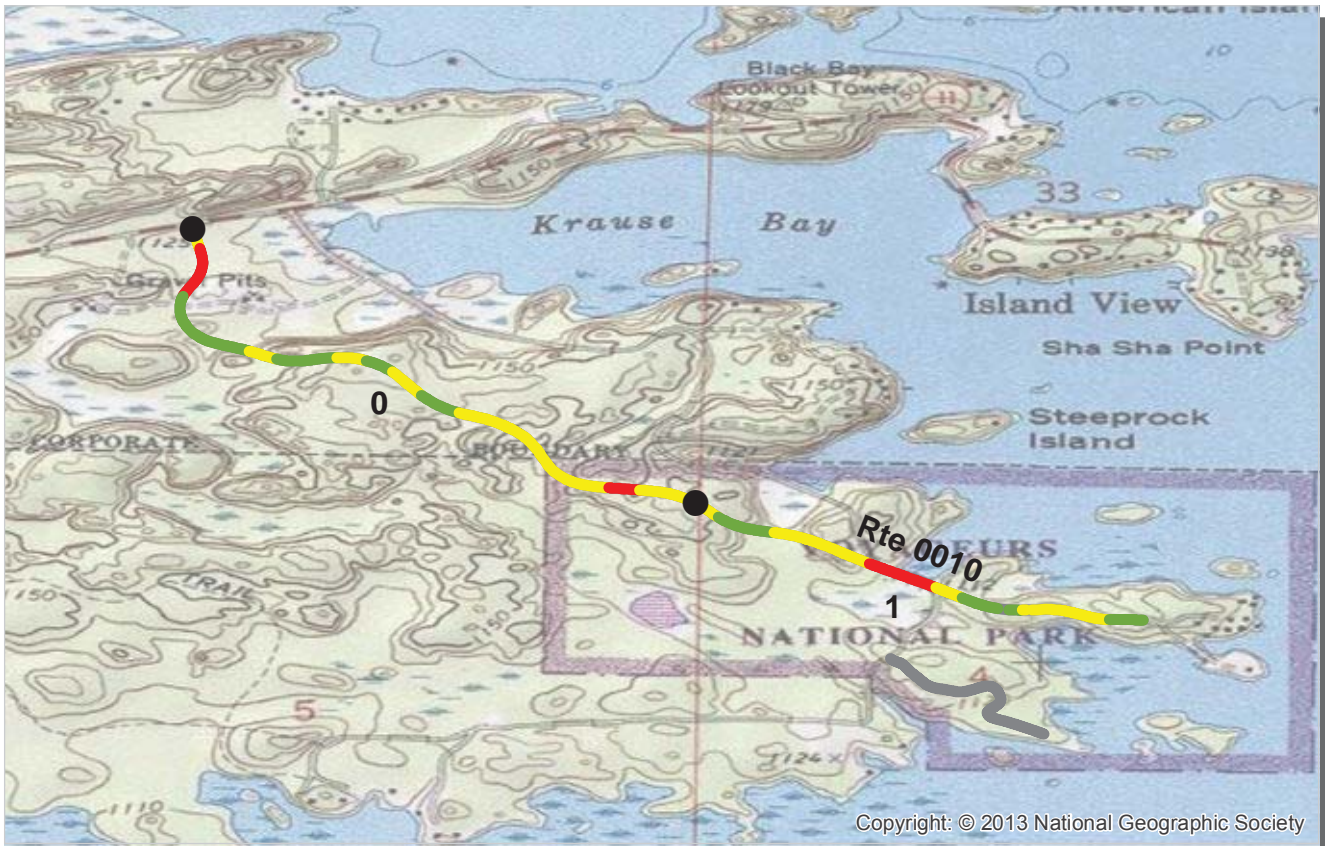
ROUTE: 0010 RAINY LAKE VISITOR CENTER ACCESS ROAD

Section Number	0	1			
Section Length (mi)	1.00	0.64			
Cross Section Information					
Number of Lanes	2	2			
Paved Width (ft)	25	26			
Lane Width (ft)	11	11			
Roadway Condition Information					
SCR (Surface Condition Rating)	82	89			
PCR (Pavement Condition Rating)	80	80			
Distress Index Values					
Structural Crack Index	90	91			
Transverse Cracking Index	82	89			
Patching Index	100	100			
Rutting Index	96	92			
Roughness Condition Index (RCI)	77	66

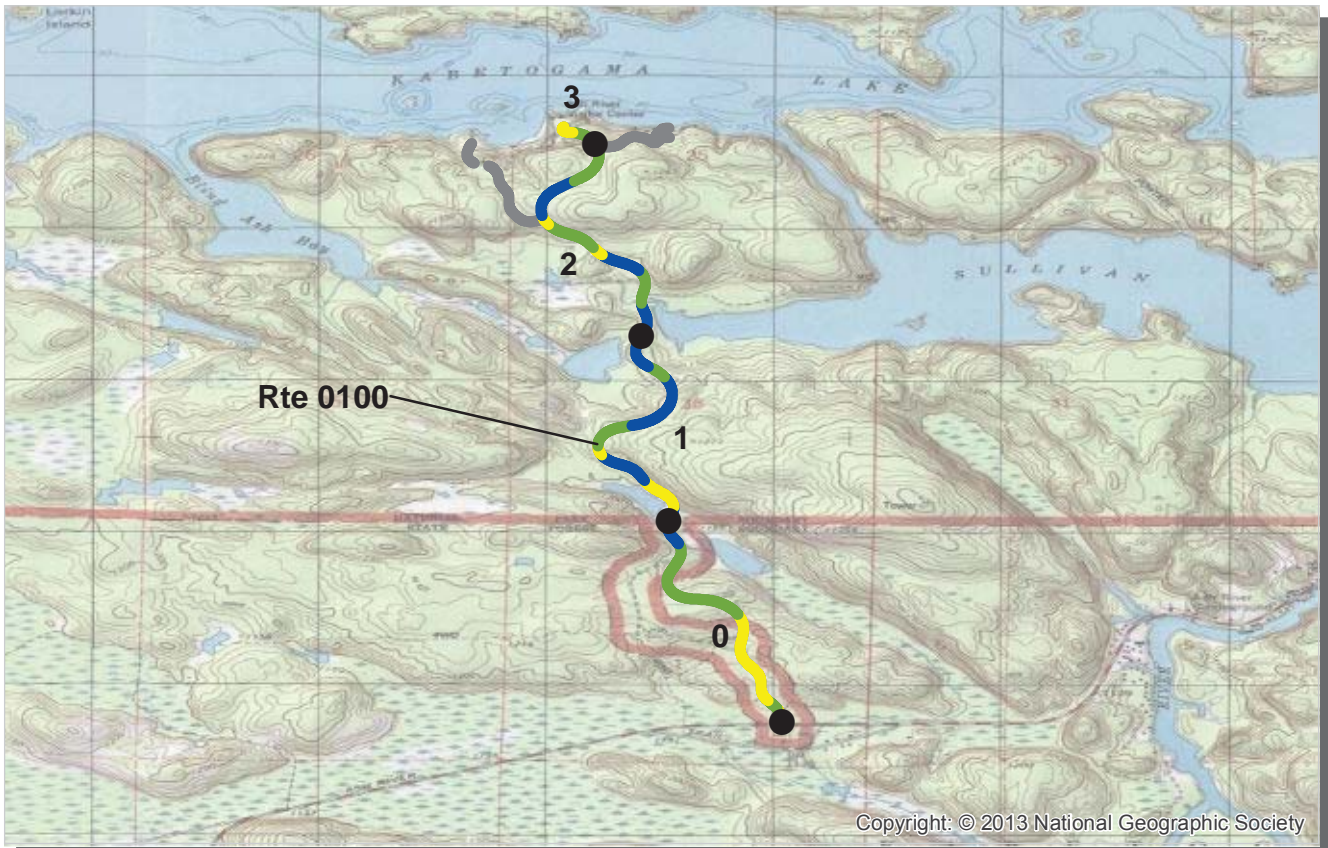
ROUTE: 0100 ASH RIVER VISITOR CENTER ACCESS ROAD

<i>Section Number</i>	0	1	2	3	
<i>Section Length (mi)</i>	1.00	1.00	1.00	0.13	
<i>Cross Section Information</i>					
Number of Lanes	2	2	2	2	
Paved Width (ft)	25	25	25	24	
Lane Width (ft)	11	11	11	11	
<i>Roadway Condition Information</i>					
SCR (Surface Condition Rating)	88	92	92	89	
PCR (Pavement Condition Rating)	85	90	92	84	
<i>Distress Index Values</i>					
Structural Crack Index	99	100	100	99	
Transverse Cracking Index	88	92	92	89	
Patching Index	100	100	100	100	
Rutting Index	94	97	96	97	
Roughness Condition Index (RCI)	80	88	91	76

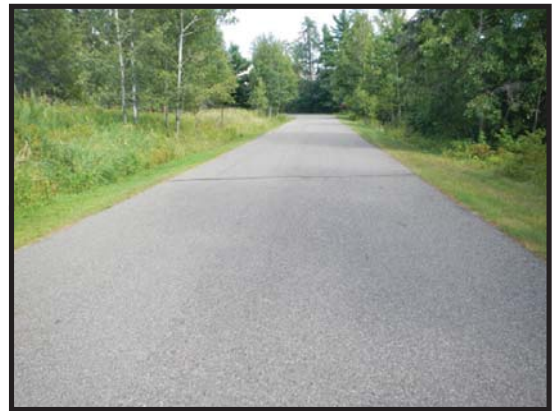
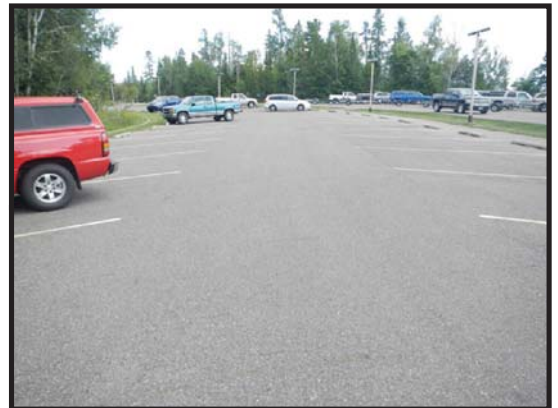
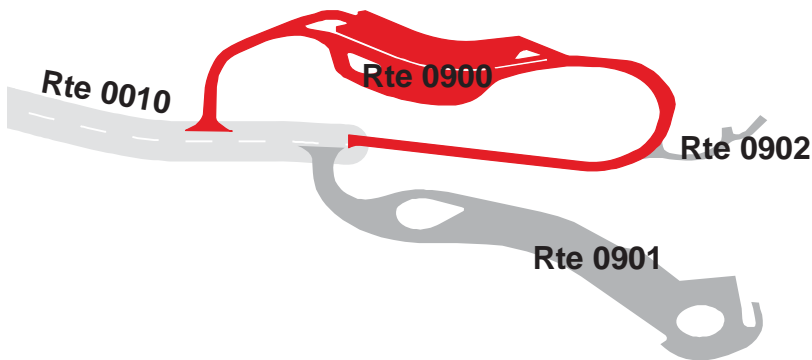
Route 0901

Route Number	Public / NonPublic	Date Visited	Area (sq ft)	Lane Miles *	Surface Type
0901	PUBLIC	8/13/2012	65,686	1.13	AS
Culverts	Drop Inlets	Gates	Curb & Gutter	Curb	PCR
0	0	0	NO CURB AND GUTTER	WOOD CURB	POOR/45

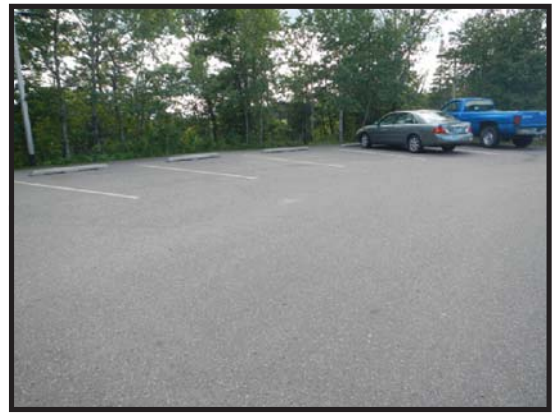
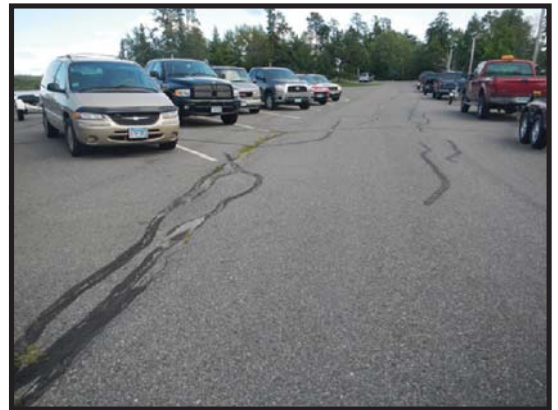
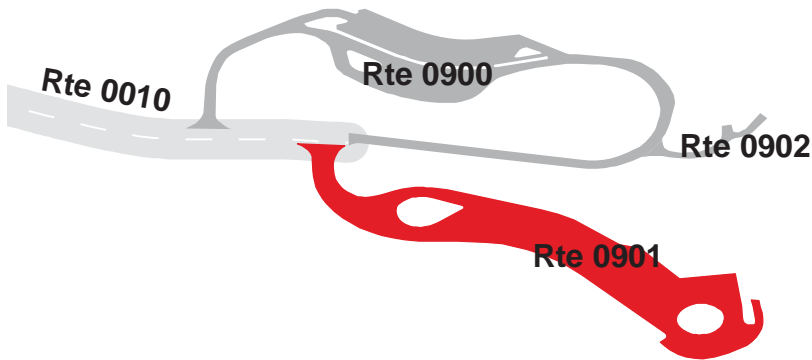
Route 0902

Route Number	Public / NonPublic	Date Visited	Area (sq ft)	Lane Miles *	Surface Type
0902	NONPUBLIC	8/13/2012	3,253	0.06	AS
Culverts	Drop Inlets	Gates	Curb & Gutter	Curb	PCR
1	1	0	NO CURB AND GUTTER	NO CURB	FAIR/73

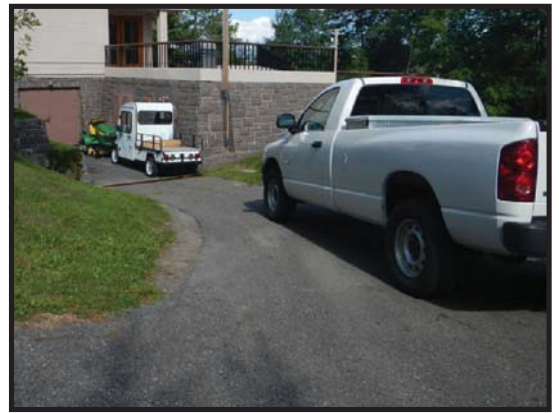
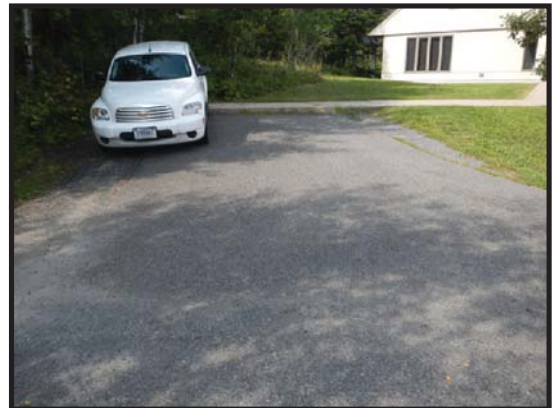
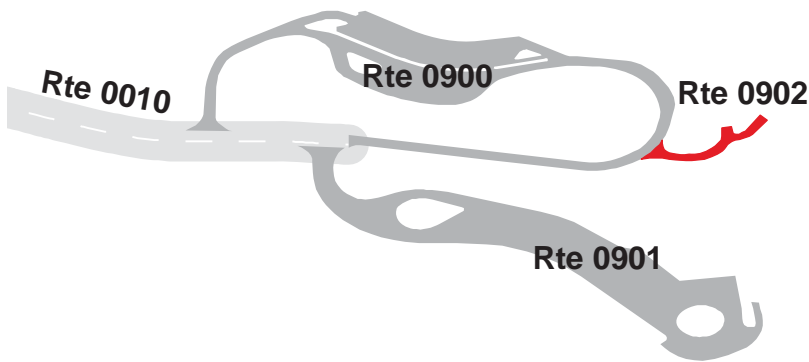
Route 0903

Route Number	Public / NonPublic	Date Visited	Area (sq ft)	Lane Miles *	Surface Type
0903	NONPUBLIC	8/13/2012	3,432	0.06	AS
Culverts	Drop Inlets	Gates	Curb & Gutter	Curb	PCR
0	0	0	NO CURB AND GUTTER	NO CURB	GOOD/90

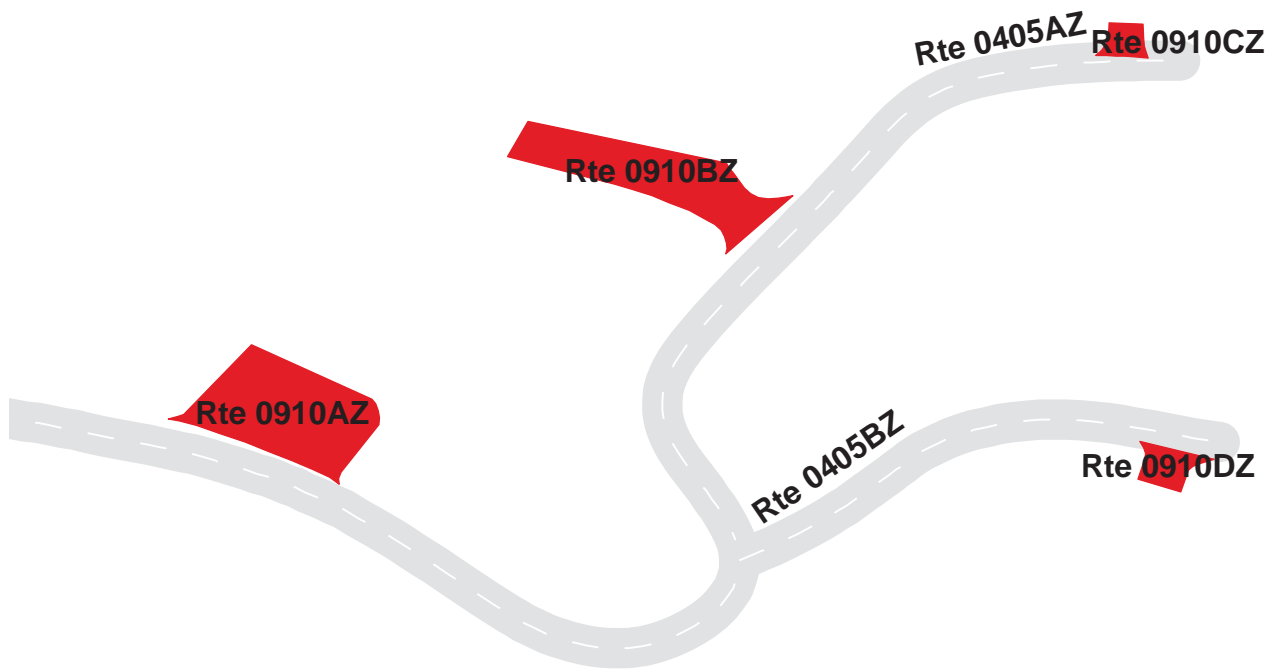
Route 0910AZ

Route Number	Public / NonPublic	Date Visited	Area (sq ft)	Lane Miles *	Surface Type
0910AZ	NONPUBLIC	8/13/2012	2,839	0.05	AS
Culverts	Drop Inlets	Gates	Curb & Gutter	Curb	PCR
0	0	0	NO CURB AND GUTTER	NO CURB	GOOD/90

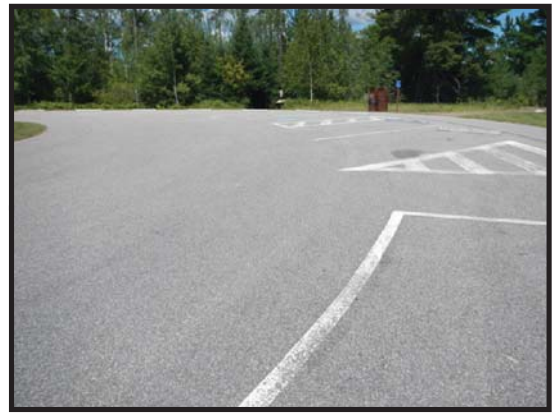
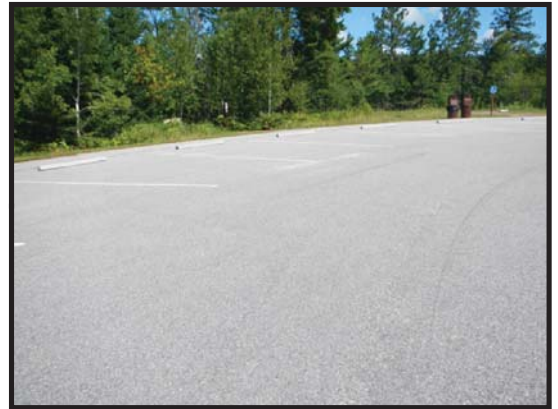
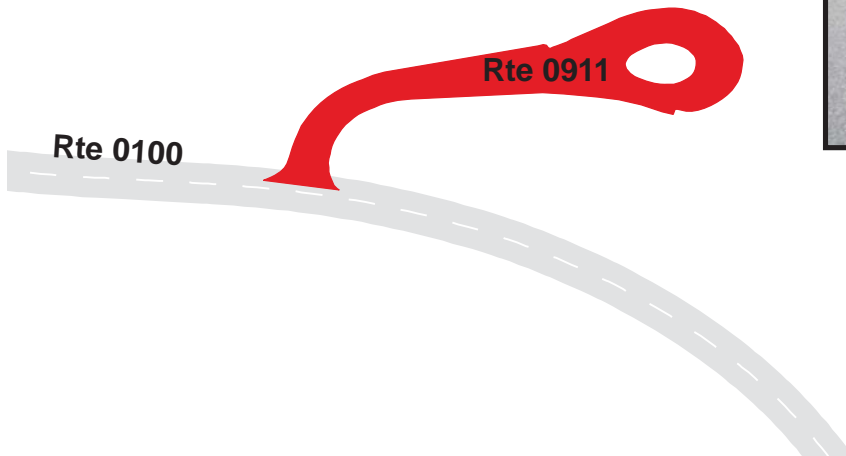
Route 0912

Route Number	Public / NonPublic	Date Visited	Area (sq ft)	Lane Miles *	Surface Type
0912	PUBLIC	8/13/2012	11,448	0.20	AS
Culverts	Drop Inlets	Gates	Curb & Gutter	Curb	PCR
0	0	0	NO CURB AND GUTTER	NO CURB	GOOD/90
