# AMIS Cycle 6

## Final Report

### Road Inventory and Condition Assessment of Paved Routes Amistad National Recreation Area

**Report Date: September 2017**

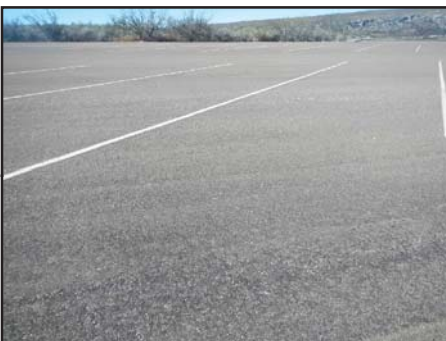
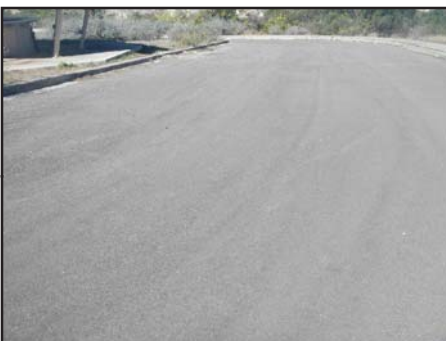
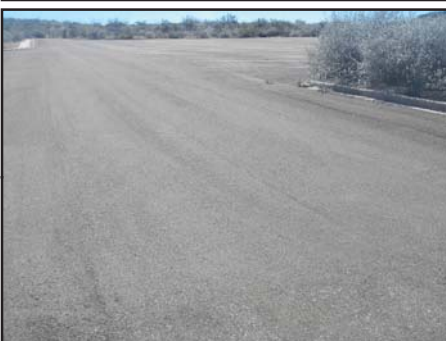
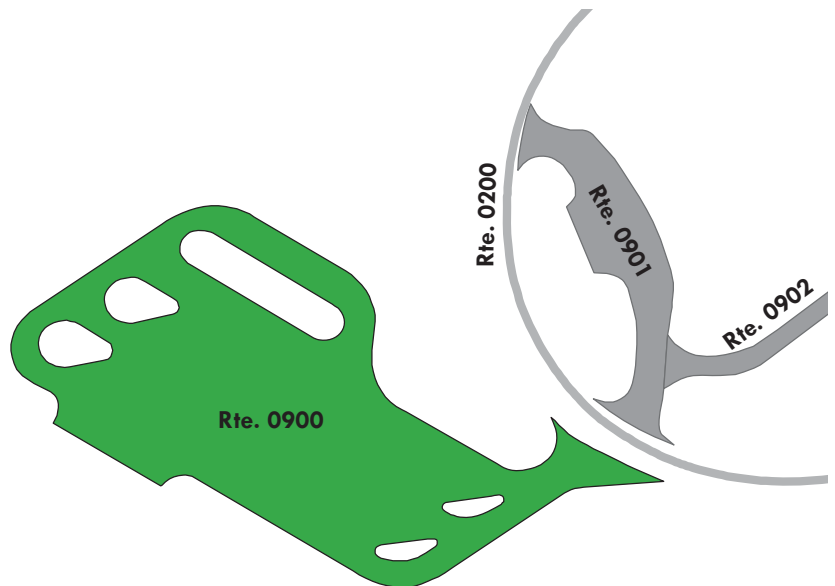
Inspection Date	FMSS Number	User Access	Surface Type
2/22/2017	21976	PUBLIC	ASPHALT
Area (Sq. Ft.)	Lane Miles (11' Widths)	Curb Reveal (Inches)	Curb Recommendation
59,334	1.022	NOT APPLICABLE	DO NOTHING
Curb Type		Curb & Gutter Type	
NO CURB		CONCRETE	
Pavement Recommendation		Condition Rating / PCR	
PREVENTIVE MAINTENANCE		GOOD / 90

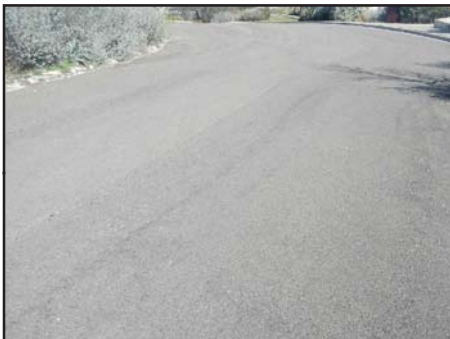
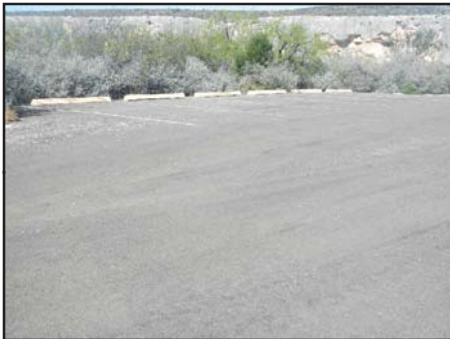
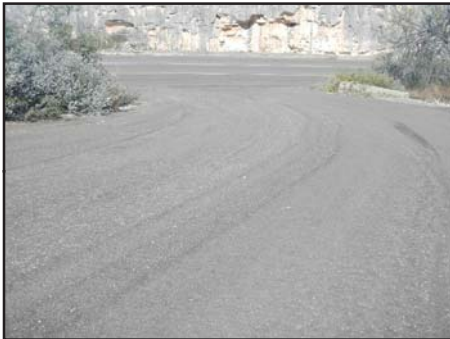
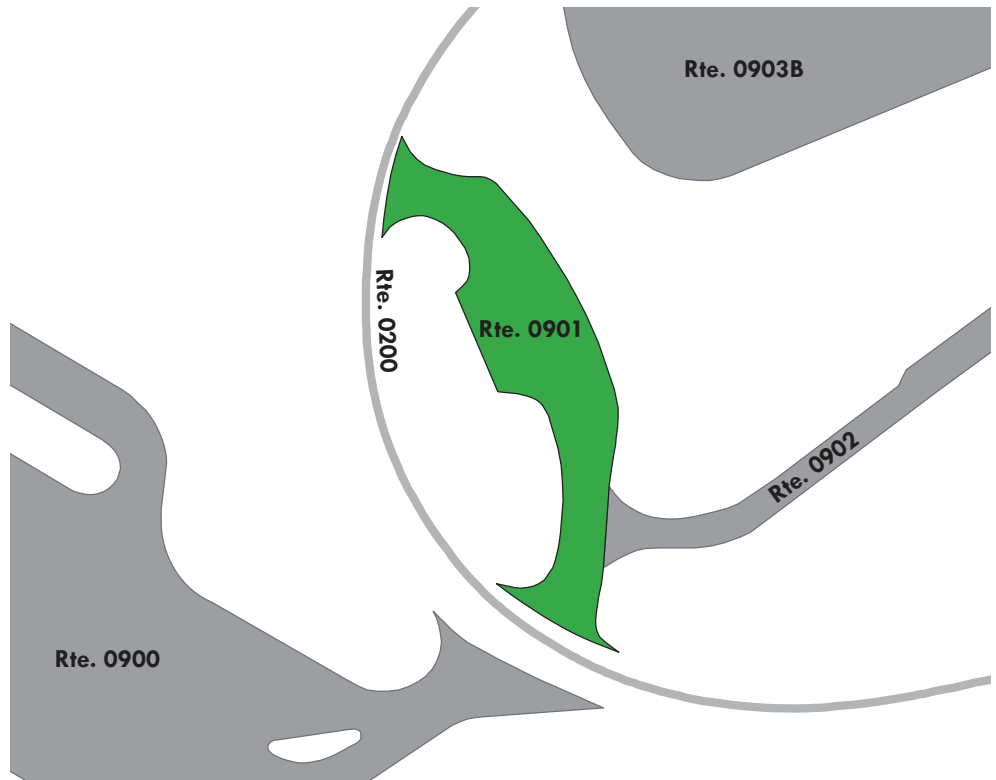
## ROUTE 0901: PECOS COMFORT STATION PARKING LOT

Inspection Date	FMSS Number	User Access	Surface Type
2/22/2017	21977	PUBLIC	ASPHALT
Area (Sq. Ft.)	Lane Miles (11' Widths)	Curb Reveal (Inches)	Curb Recommendation
10,520	0.181	NOT APPLICABLE	DO NOTHING
Curb Type		Curb & Gutter Type	
NO CURB		CONCRETE	
Pavement Recommendation		Condition Rating / PCR	
PREVENTIVE MAINTENANCE		GOOD / 90

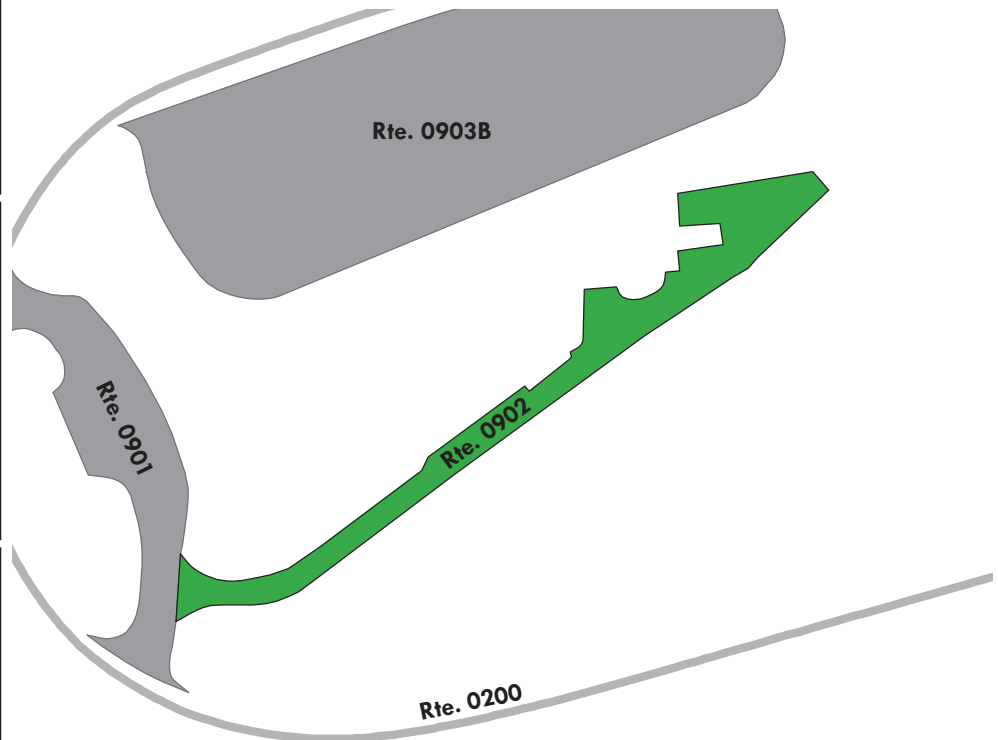
Inspection Date	FMSS Number	User Access	Surface Type
2/22/2017	52923	NONPUBLIC	ASPHALT
Area (Sq. Ft.)	Lane Miles (11' Widths)	Curb Reveal (Inches)	Curb Recommendation
11,213	0.193	NOT APPLICABLE	NOT APPLICABLE
Curb Type		Curb & Gutter Type	
NO CURB		NO CURB AND GUTTER	
Pavement Recommendation		Condition Rating / PCR	
PREVENTIVE MAINTENANCE		GOOD / 90

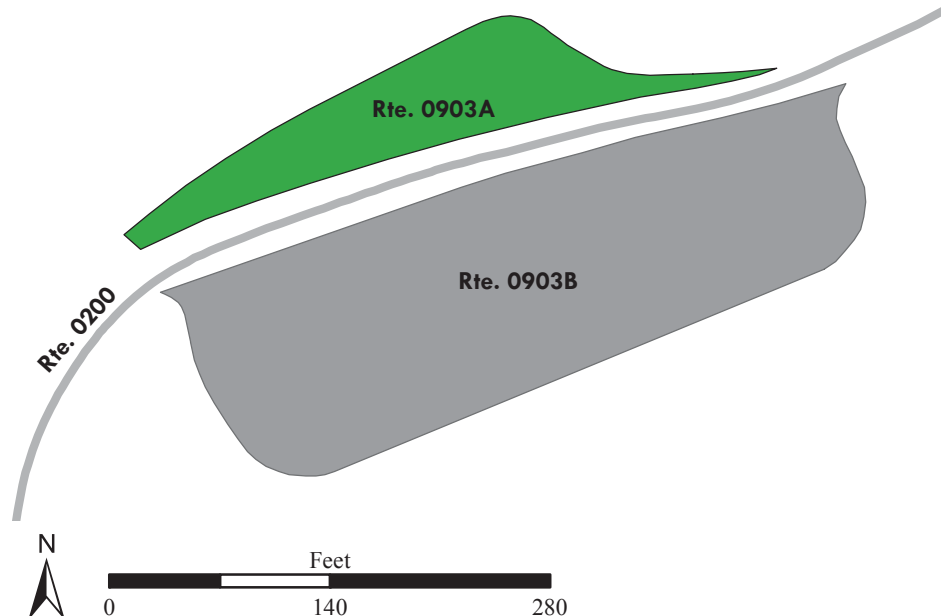
Inspection Date	FMSS Number	User Access	Surface Type
2/22/2017	52941	PUBLIC	ASPHALT
Area (Sq. Ft.)	Lane Miles (11' Widths)	Curb Reveal (Inches)	Curb Recommendation
13,353	0.23	NOT APPLICABLE	NOT APPLICABLE
Curb Type		Curb & Gutter Type	
NO CURB		NO CURB AND GUTTER	
Pavement Recommendation		Condition Rating / PCR	
PREVENTIVE MAINTENANCE		GOOD / 90
