AMME Cycle 6

Final Report

Road Inventory and Condition Assessments for American Memorial Park

**Federal Highway Administration
Eastern Federal Lands Highway Division
Road Inventory Program (RIP)**

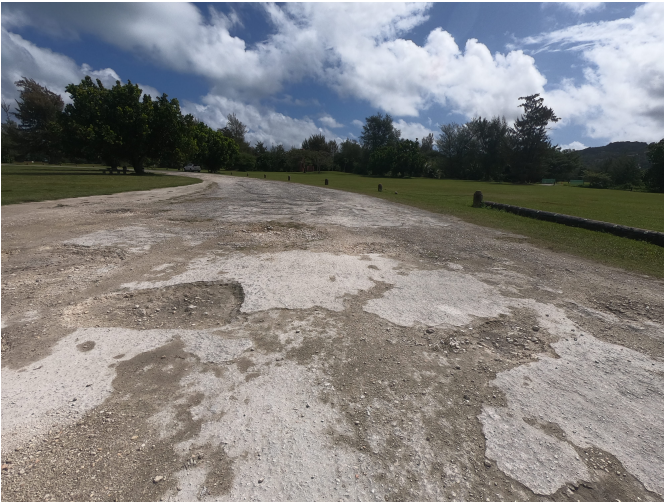
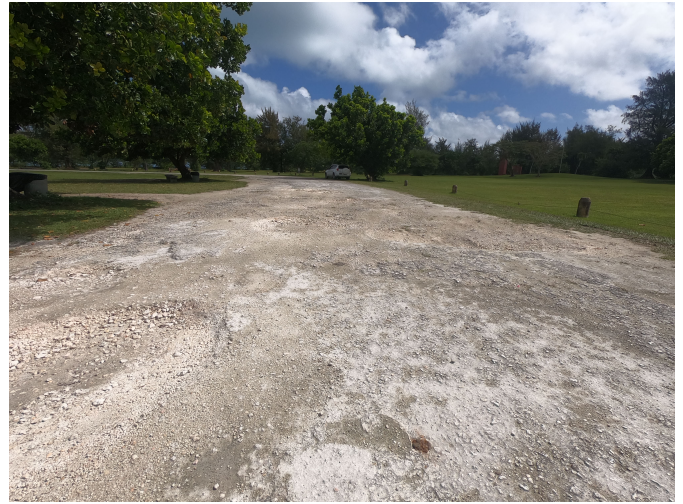
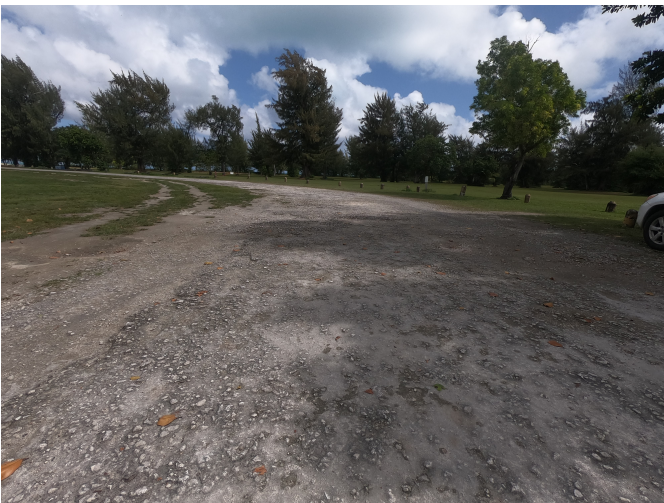
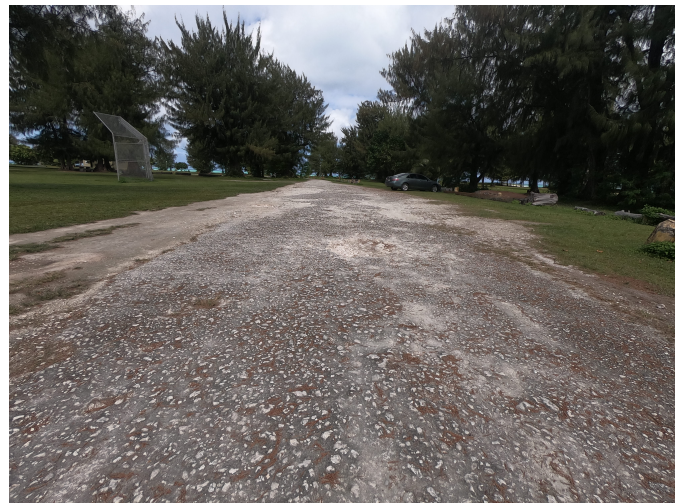
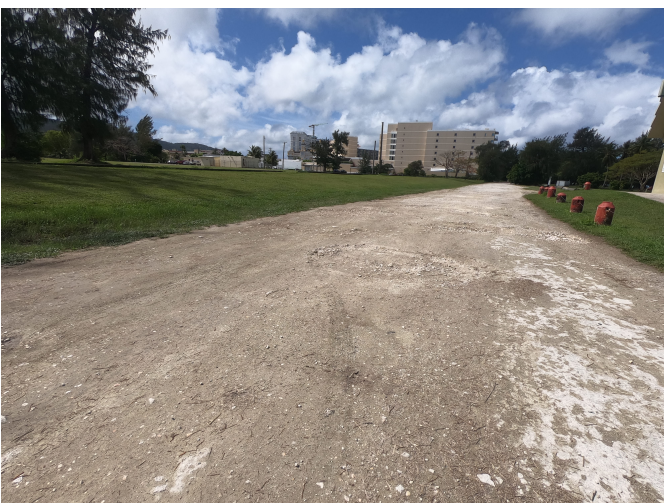
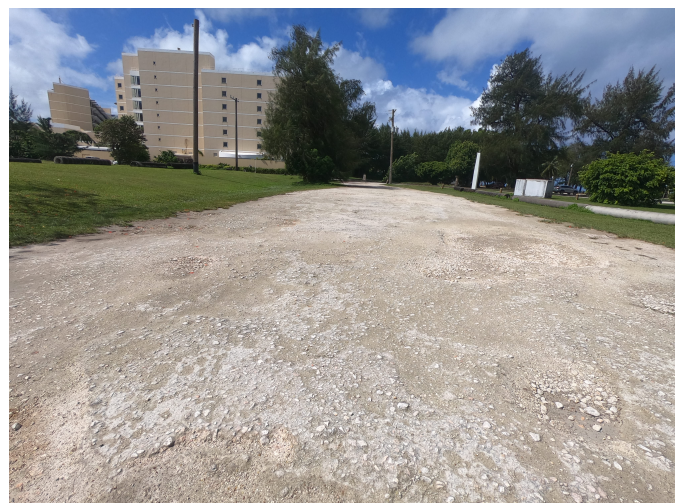
ROUTE 0010: MICRO BEACH LOOP ROAD

Route Condition Legend					
Poor (1)	Poor (2)	Fair (3)	Good (4)	Excellent (5)	Not Rated
See Appendix for definitions and formulas					
Inspection Date: 3/21/2022		Unpaved Length (Miles): 0.331		Surface Type: GRAVEL

Begin MP	End MP	Section Length	# of Lanes	Lane Width	Road Width	Treatment Recommendation	Treatment Cost	Unpaved Rating (Paser +)	Crown Severity	Drainage Severity	Rutting, Washboard Severity	Potholes / Loose Aggregate Severity
0.00	0.308	0.308	2	8.0	16.0	Heavy Rehabilitation	\$49,280	2	Med	Med	Low	High
Route Level Data:		0.308	2	8.0	16.0	Heavy Rehabilitation	\$49,280	2	Med	Med	Low	High

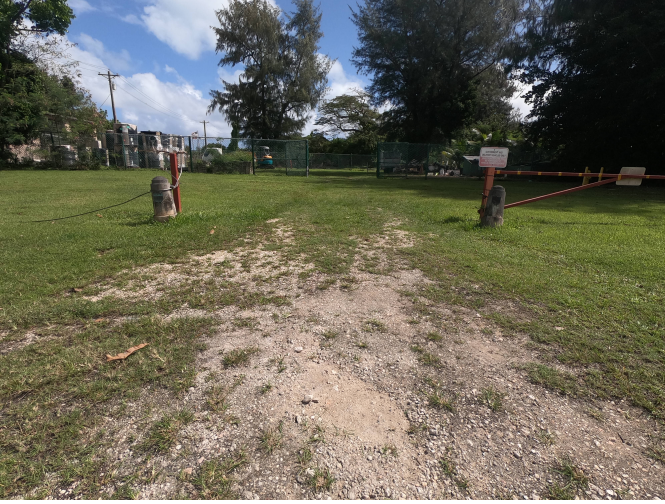
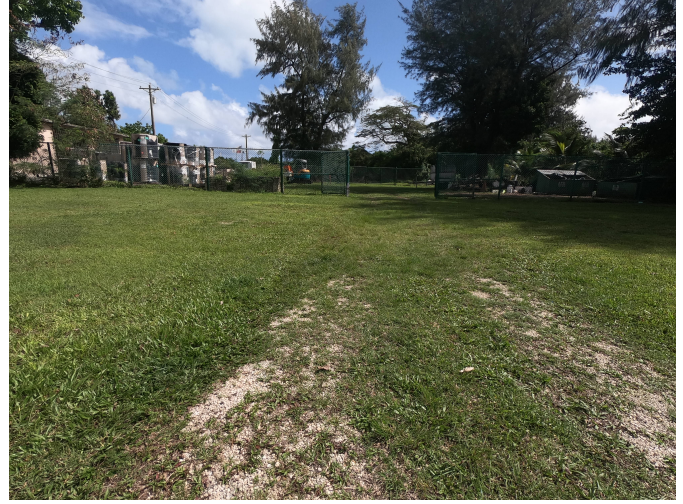
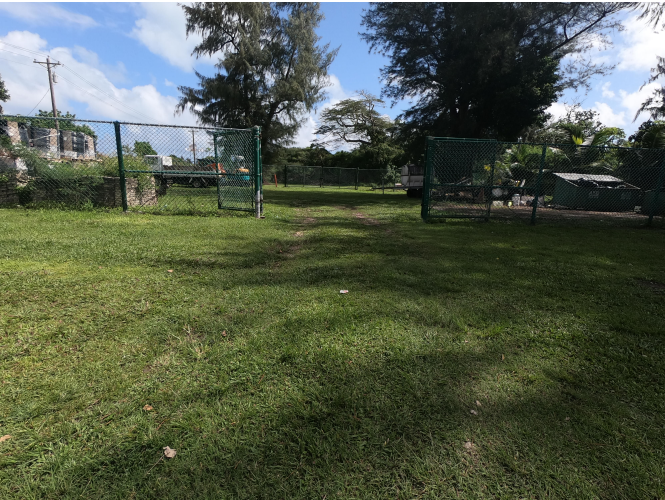
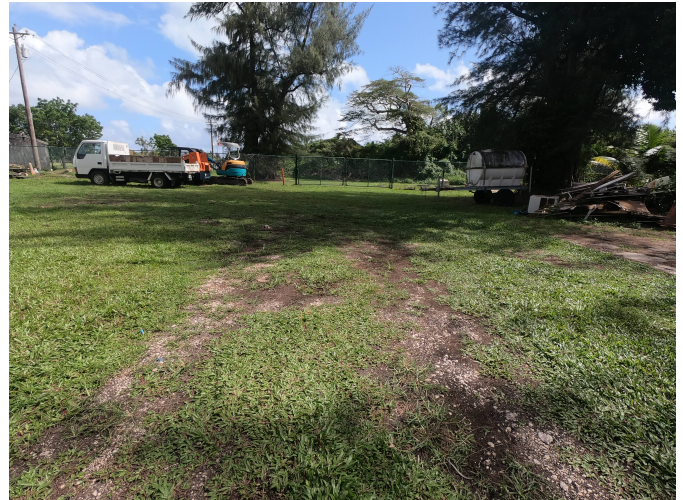
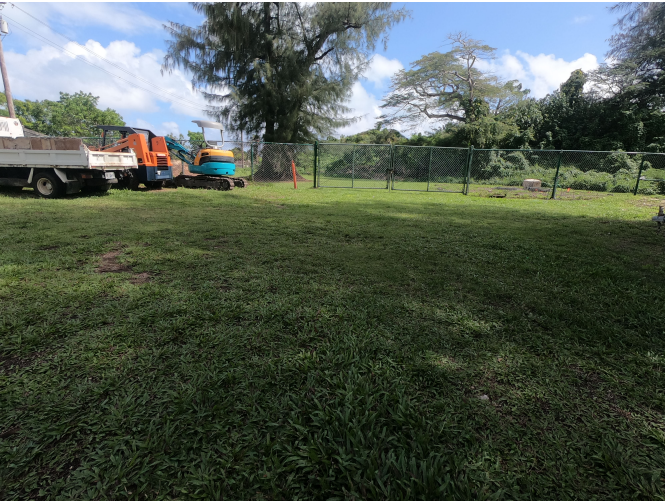
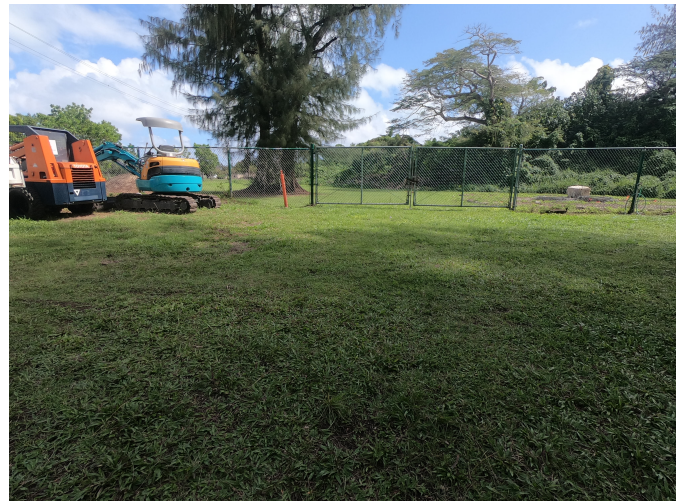
ROUTE 0400: WETLANDS UNPAVED MAINTENANCE ROAD

Begin MP	End MP	Section Length	# of Lanes	Lane Width	Road Width	Treatment Recommendation	Treatment Cost	Unpaved Rating (Paser +)	Crown Severity	Drainage Severity	Rutting, Washboard Severity	Potholes / Loose Aggregate Severity	
0.00	0.036	0.036	1	12.0	12.0	Heavy Rehabilitation	\$5,760	2	Med	Med	Low	High	
Route Level Data:			0.036	1	12.0	12.0	Heavy Rehabilitation	\$5,760	2	Med	Med	Low	High

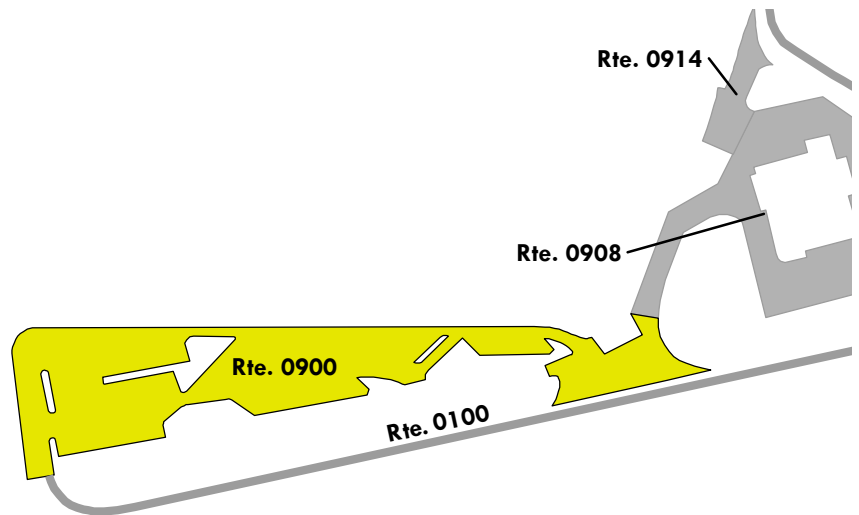
Inspection Date	FMSS Number	User Access	Surface Type
3/21/2022	70423	PUBLIC	ASPHALT
Area (Sq. Ft.)	Lane Miles (11' Widths)	Curb Reveal (Inches)	Curb Recommendation
48,109	0.828	5	LIGHT REPAIR
Curb Type		Curb & Gutter Type	
CONCRETE		NO CURB AND GUTTER	
Pavement Recommendation		Condition Rating / PCR	
LIGHT 3R TREATMENTS		FAIR / 73

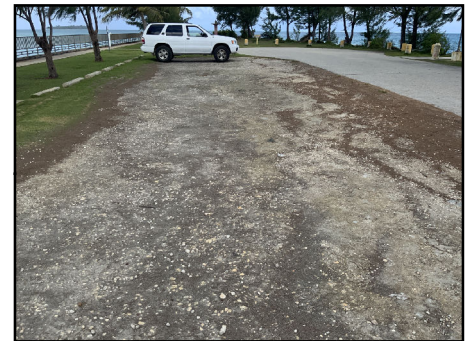
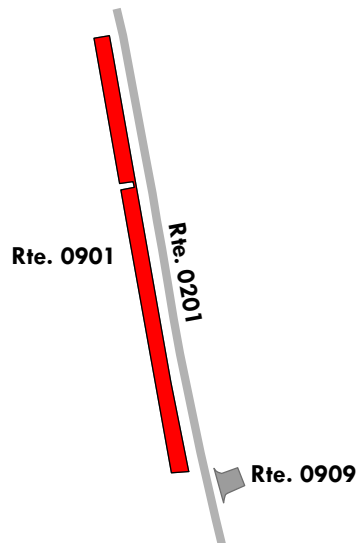
ROUTE 0901: MARINA COVE PARKING - OUTER COVE (UNPAVED)

Inspection Date	FMSS Number	User Access	Surface Type
3/21/2022	104678	PUBLIC	GRAVEL
Area (Sq. Ft.)	Lane Miles (11' Widths)	Curb Reveal (Inches)	Curb Recommendation
10,814	0.186	NOT APPLICABLE	NOT APPLICABLE
Curb Type		Curb & Gutter Type	
NO CURB		NO CURB AND GUTTER	
Treatment Recommendation		Condition Rating	
RECONSTRUCTION		1

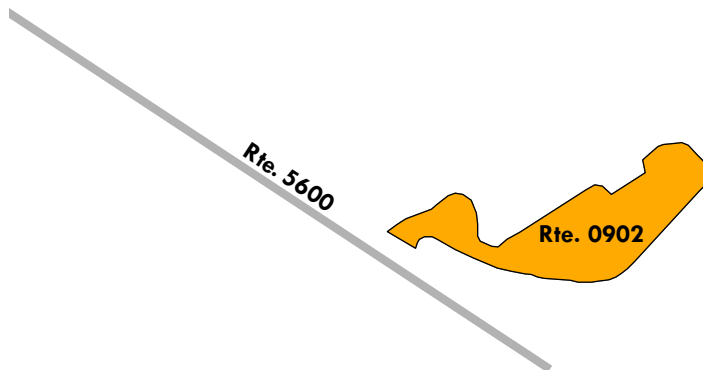
ROUTE 0902: UNPAVED TENNIS COURT PARKING

Inspection Date	FMSS Number	User Access	Surface Type
3/21/2022	70440	PUBLIC	GRAVEL
Area (Sq. Ft.)	Lane Miles (11' Widths)	Curb Reveal (Inches)	Curb Recommendation
28,437	0.490	NOT APPLICABLE	NOT APPLICABLE
Curb Type		Curb & Gutter Type	
NO CURB		NO CURB AND GUTTER	
Treatment Recommendation		Condition Rating	
HEAVY REHABILITATION		2

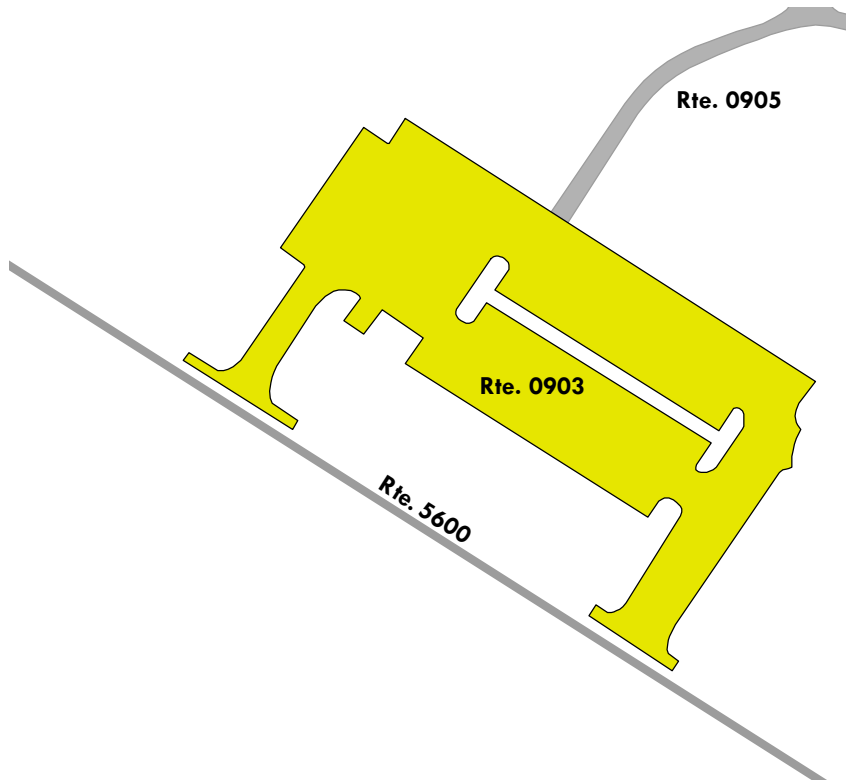
ROUTE 0903: VISITOR CENTER / AMPHITHEATER PARKING

Inspection Date	FMSS Number	User Access	Surface Type
3/21/2022	70451	PUBLIC	CONCRETE
Area (Sq. Ft.)	Lane Miles (11' Widths)	Curb Reveal (Inches)	Curb Recommendation
49,064	0.845	5	MODERATE REPAIR
Curb Type		Curb & Gutter Type	
CONCRETE		NO CURB AND GUTTER	
Pavement Recommendation		Condition Rating / PCR	
LIGHT 3R TREATMENTS		FAIR / 73

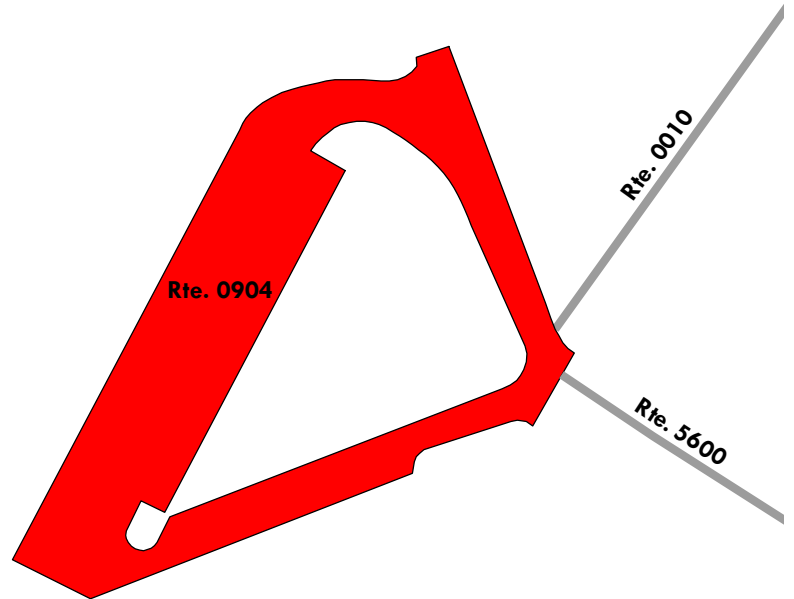
ROUTE 0904: MICRO BEACH PAVILION PARKING

Inspection Date	FMSS Number	User Access	Surface Type
3/21/2022	70461	PUBLIC	ASPHALT
Area (Sq. Ft.)	Lane Miles (11' Widths)	Curb Reveal (Inches)	Curb Recommendation
27,390	0.472	8	REPLACE
Curb Type		Curb & Gutter Type	
CONCRETE		NO CURB AND GUTTER	
Pavement Recommendation		Condition Rating / PCR	
HEAVY 3R TREATMENTS		POOR / 53

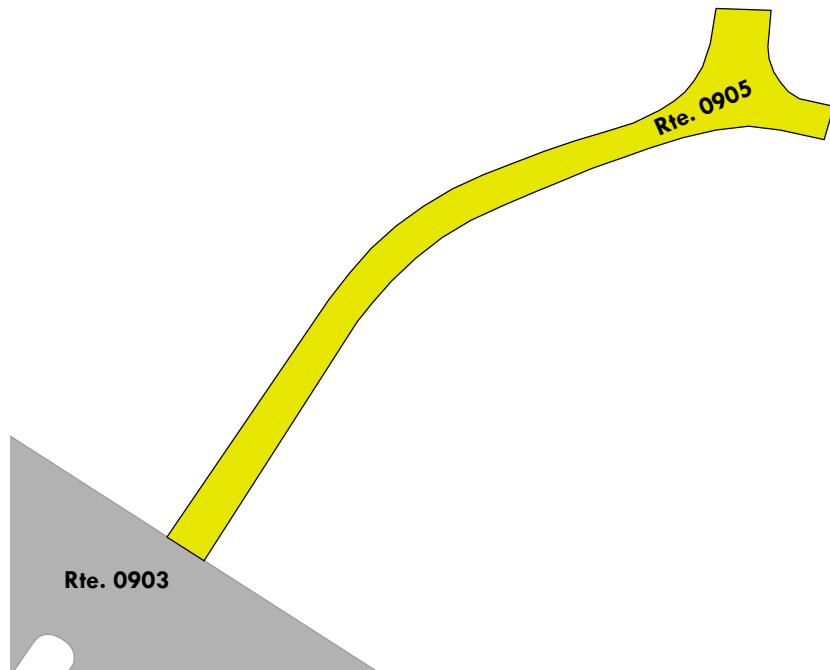
ROUTE 0905: ADMINISTRATIVE OFFICES PARKING

Inspection Date	FMSS Number	User Access	Surface Type
3/21/2022	104802	NONPUBLIC	CONCRETE
Area (Sq. Ft.)	Lane Miles (11' Widths)	Curb Reveal (Inches)	Curb Recommendation
3,351	0.058	NOT APPLICABLE	NOT APPLICABLE
Curb Type		Curb & Gutter Type	
NO CURB		NO CURB AND GUTTER	
Pavement Recommendation		Condition Rating / PCR	
LIGHT 3R TREATMENTS		FAIR / 73

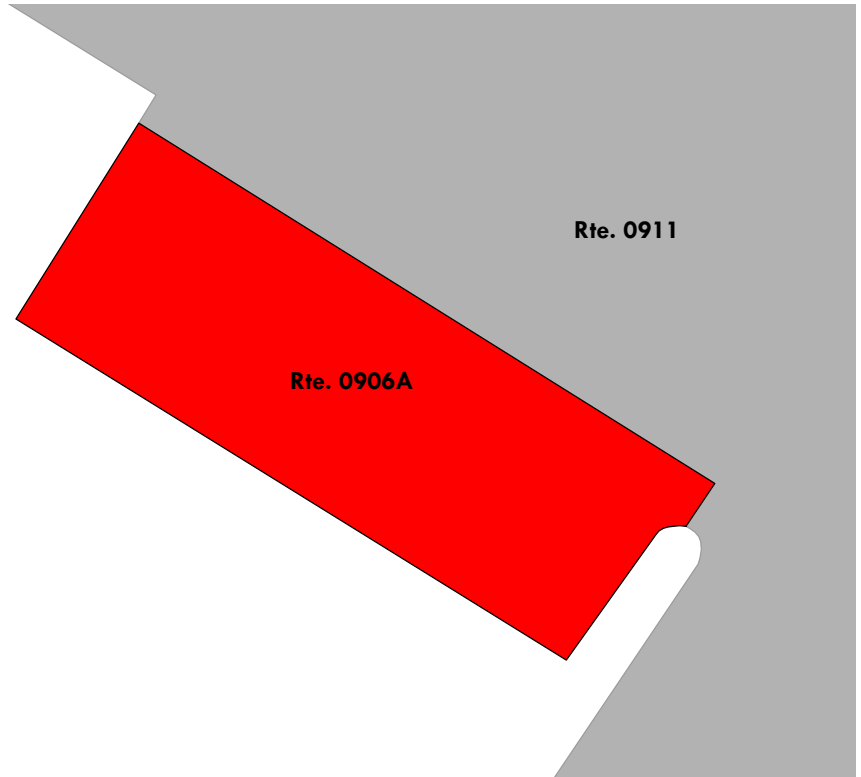
ROUTE 0906A: MAINTENANCE EMPLOYEE PARKING

Inspection Date	FMSS Number	User Access	Surface Type
3/21/2022	104814	PUBLIC	CONCRETE
Area (Sq. Ft.)	Lane Miles (11' Widths)	Curb Reveal (Inches)	Curb Recommendation
1,839	0.032	6	LIGHT REPAIR
Curb Type		Curb & Gutter Type	
CONCRETE		NO CURB AND GUTTER	
Pavement Recommendation		Condition Rating / PCR	
HEAVY 3R TREATMENTS		POOR / 53

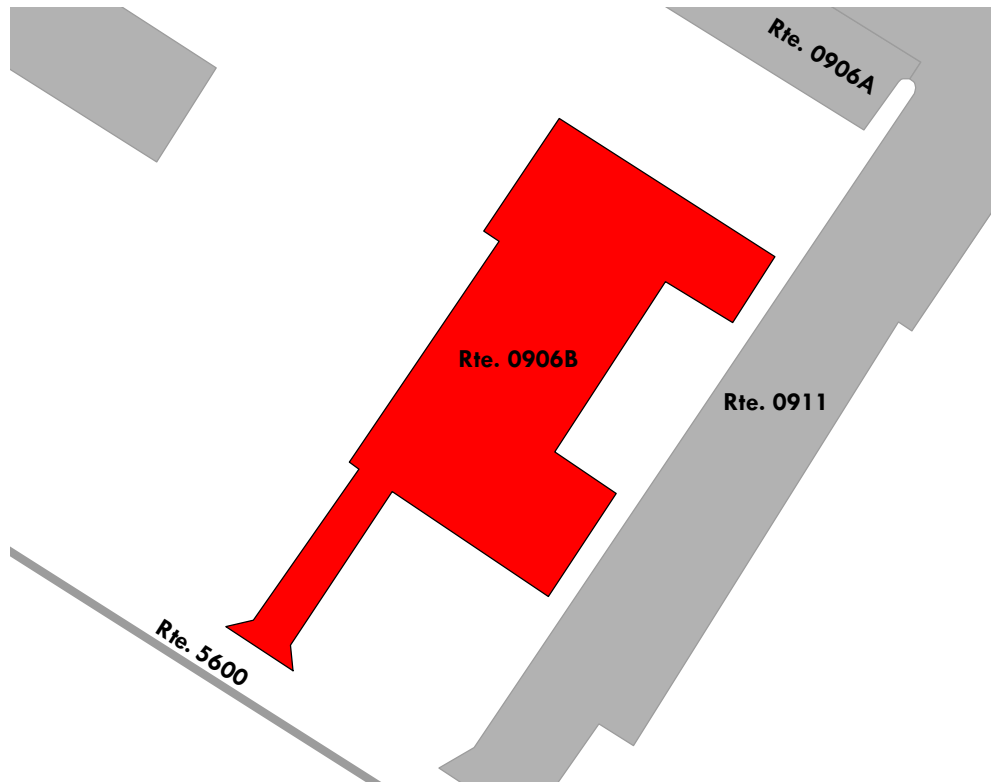
ROUTE 0906B: MAINTENANCE YARD

Inspection Date	FMSS Number	User Access	Surface Type
3/21/2022	104818	NONPUBLIC	CONCRETE
Area (Sq. Ft.)	Lane Miles (11' Widths)	Curb Reveal (Inches)	Curb Recommendation
7,744	0.133	5	DO NOTHING
Curb Type		Curb & Gutter Type	
CONCRETE		NO CURB AND GUTTER	
Pavement Recommendation		Condition Rating / PCR	
HEAVY 3R TREATMENTS		POOR / 53

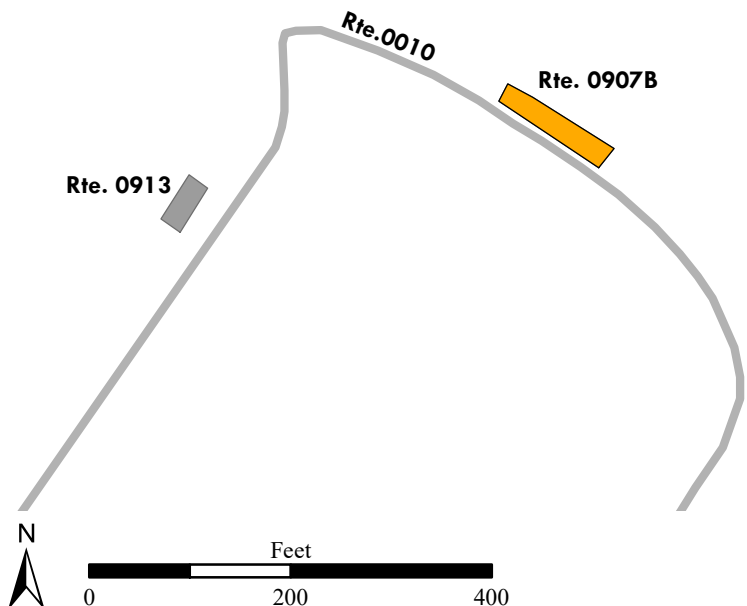
ROUTE 0907B: MICRO BEACH PARKING

Inspection Date	FMSS Number	User Access	Surface Type
3/21/2022	104839	PUBLIC	GRAVEL
Area (Sq. Ft.)	Lane Miles (11' Widths)	Curb Reveal (Inches)	Curb Recommendation
2,566	0.044	NOT APPLICABLE	NOT APPLICABLE
Curb Type		Curb & Gutter Type	
NO CURB		NO CURB AND GUTTER	
Treatment Recommendation		Condition Rating	
HEAVY REHABILITATION		2
