BADL Cycle 6

Final Report

Road Inventory and Condition Assessment of Paved Routes Badlands National Park

Federal Highway Administration
Eastern Federal Lands Highway Division
Road Inventory Program (RIP)

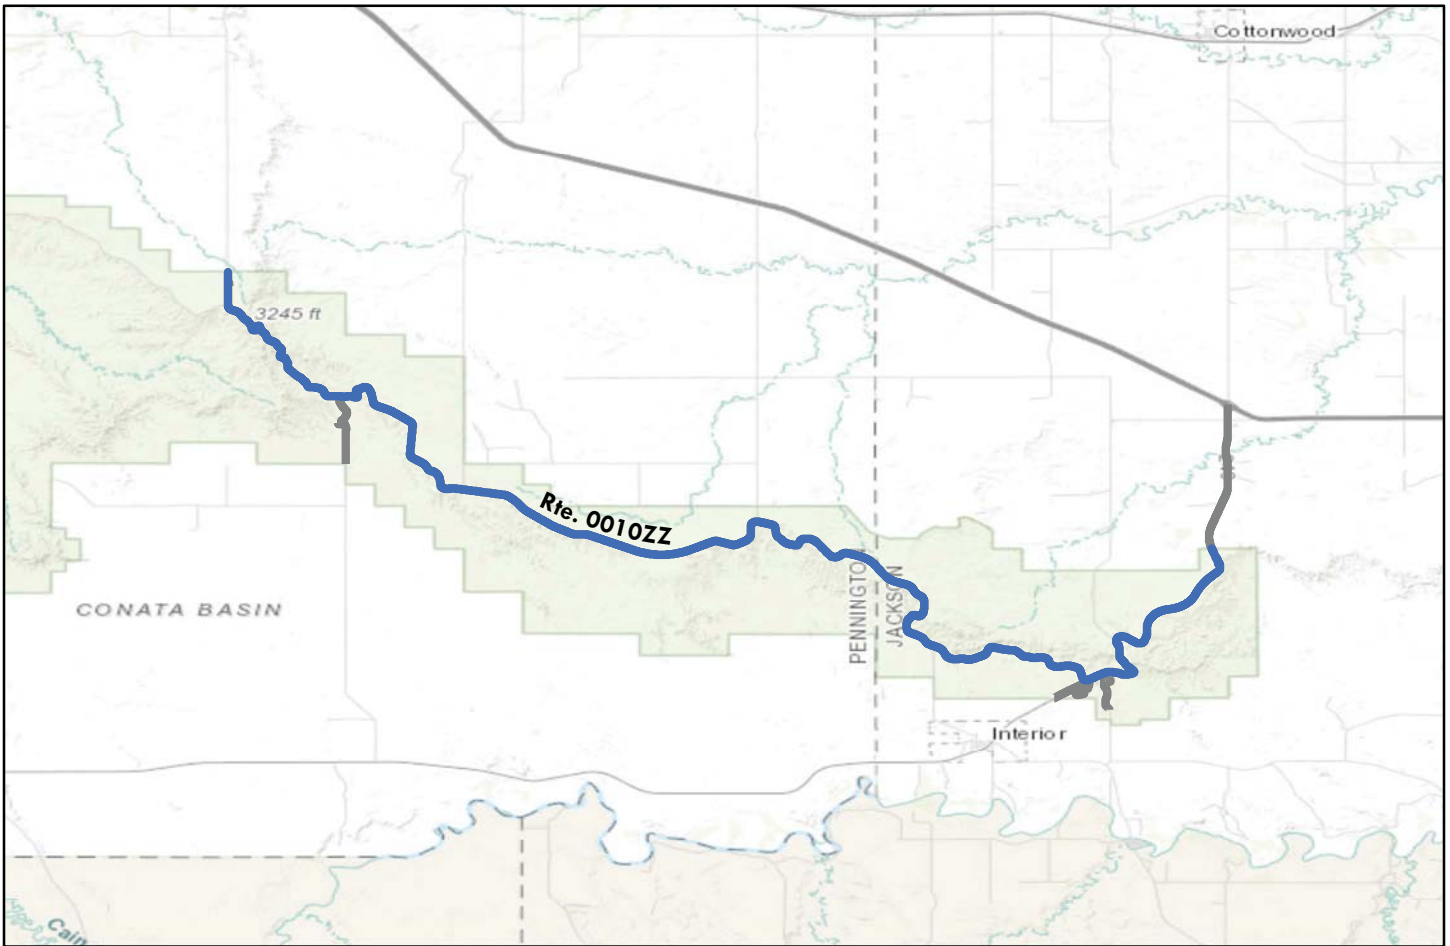
Summary Route

Route Condition Legend – Pavement Condition Rating (PCR)						
Poor (0 - 60)	Fair (61- 84)	Good (85 - 94)	Excellent (95 - 100)	Not Rated		
See Appendix for definitions and formulas						
Inspection Date:	7/18/2017					
Paved Length (Miles):	27.98					
Surface Type:	ASPHALT	Route Summary				
Roadway Condition Information						
Pavement Condition Rating (PCR)	97					
Lane & Width Information						
Number of Lanes	2					
Paved Width (ft)	25.2					
Lane Width (ft)	10.2

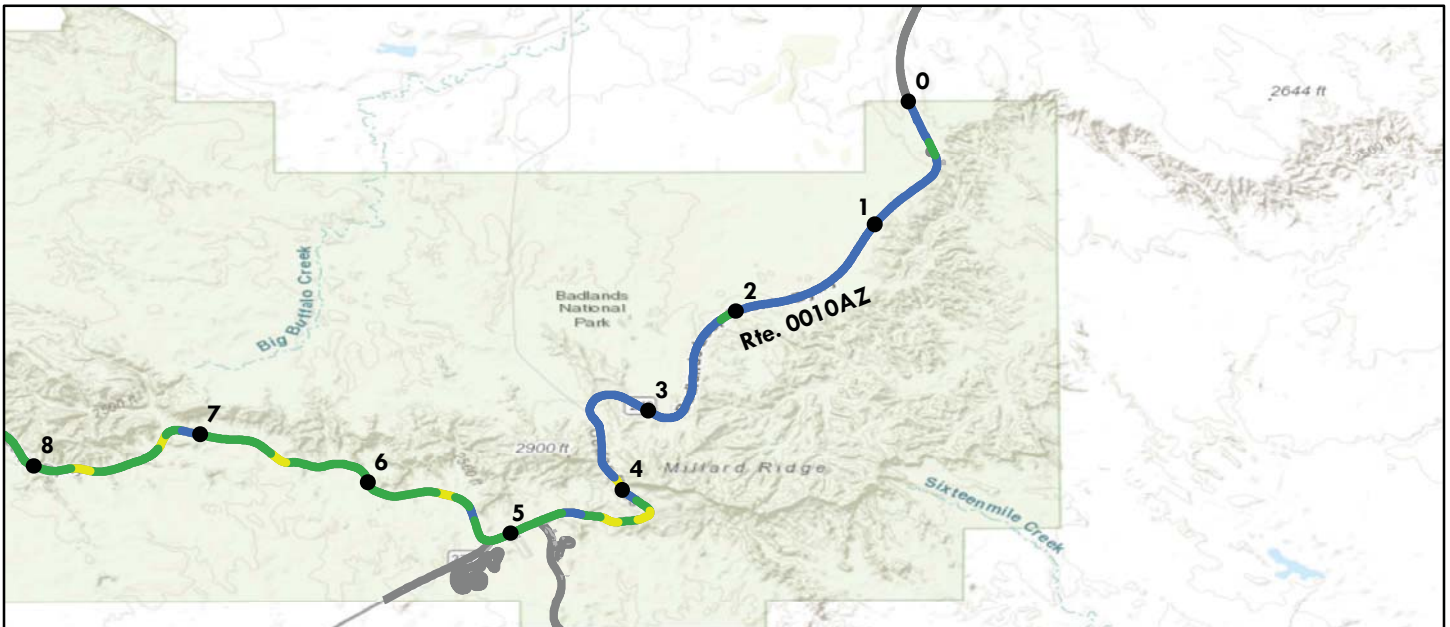
Subcomponent of Route BADL-0010ZZ
Data Collection Vehicle (DCV) Rating

Route Condition Legend – Pavement Condition Rating (PCR)						
Poor (0 - 60)	Fair (61- 84)	Good (85 - 94)	Excellent (95 - 100)	Not Rated		
See Appendix for definitions and formulas						
Inspection Date: 7/18/2017	Beginning Section MP	0	1	2	3	4
Paved Length (Miles): 27.92	Section Length (MI)	1	1	1	1	1
Surface Type: ASPHALT	Route Summary					
Roadway Condition Information						
Pavement Condition Rating (PCR)	97	99	100	100	99	85
Surface Condition Rating (SCR)	99	98	100	100	100	97
Roughness Condition Index (RCI)	95	100	100	100	97	68
Distress Index Values						
Structural Crack Index	100	100	100	100	100	99
Alligator Crack Index	100	100	100	100	100	100
Longitudinal Crack Index	100	100	100	100	100	99
Transverse Cracking Index	99	100	100	100	100	99
Patching Index	100	100	100	100	100	100
Rutting Index	99	98	100	100	100	97
International Roughness Index (IRI)	127	106	79	89	123	208
Lane & Width Information						
Number of Lanes	2	2	2	2	2	2

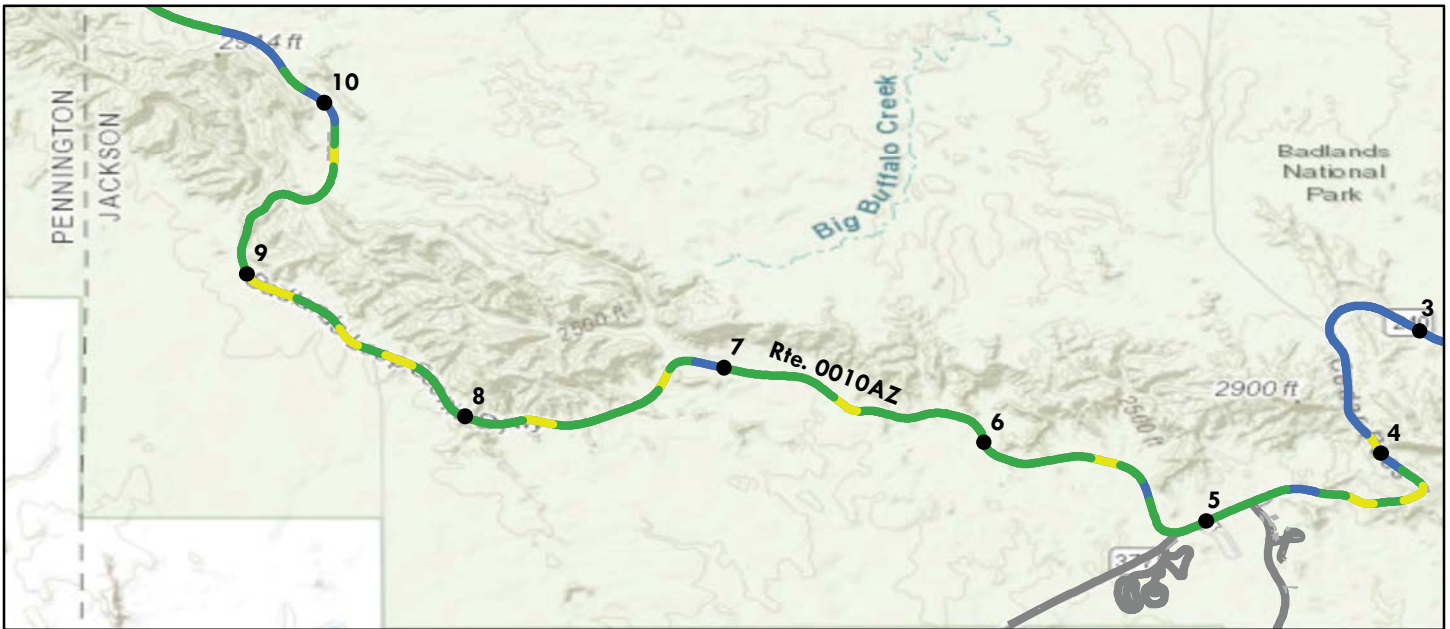
Subcomponent of Route BADL-0010ZZ
Data Collection Vehicle (DCV) Rating

Route Condition Legend – Pavement Condition Rating (PCR)						
Poor (0 - 60)	Fair (61- 84)	Good (85 - 94)	Excellent (95 - 100)	Not Rated		
See Appendix for definitions and formulas						
Inspection Date: 7/18/2017	Beginning Section MP	5	6	7	8	9
Paved Length (Miles): 27.92	Section Length (MI)	1	1	1	1	1
Surface Type: ASPHALT	Route Summary					
Roadway Condition Information						
Pavement Condition Rating (PCR)	97	90	88	88	85	89
Surface Condition Rating (SCR)	99	98	99	98	98	96
Roughness Condition Index (RCI)	95	78	72	72	66	78
Distress Index Values						
Structural Crack Index	100	100	100	100	100	100
Alligator Crack Index	100	100	100	100	100	100
Longitudinal Crack Index	100	100	100	100	100	100
Transverse Cracking Index	99	99	99	98	98	99
Patching Index	100	100	100	100	100	100
Rutting Index	99	98	99	99	98	96
International Roughness Index (IRI)	127	174	194	195	217	174
Lane & Width Information						
Number of Lanes	2	2	2	2	2	2

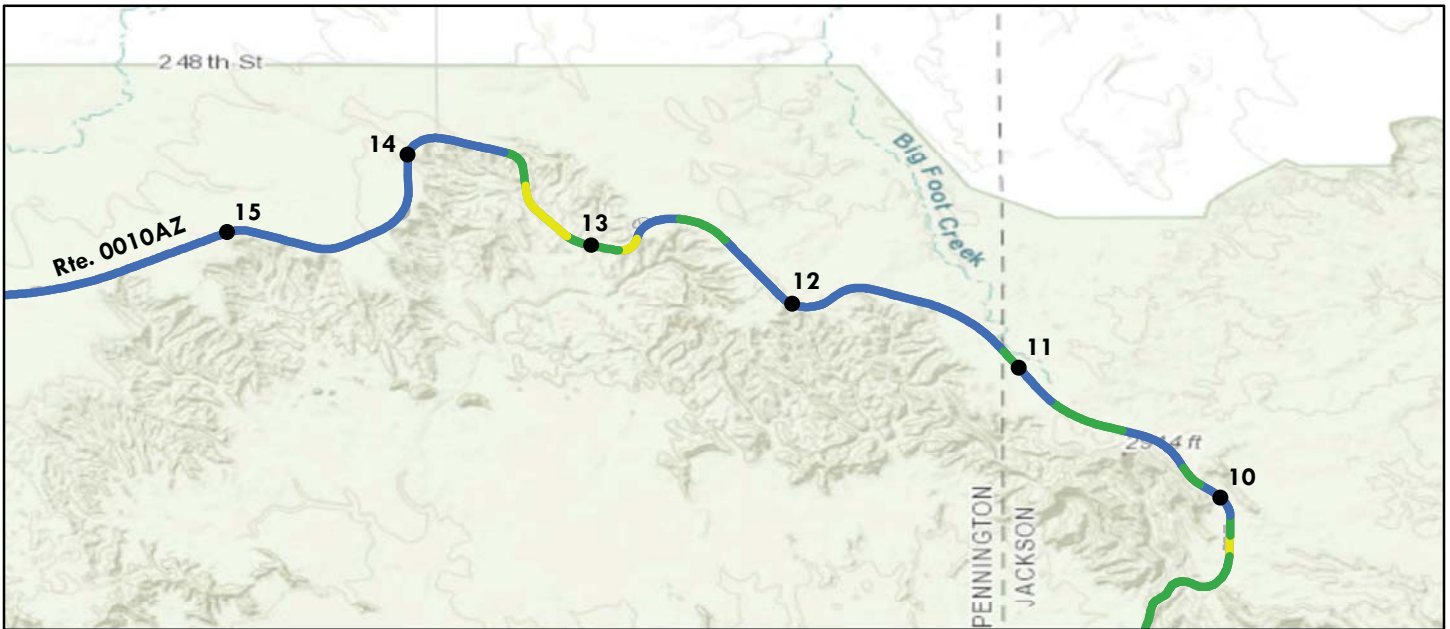
Subcomponent of Route BADL-0010ZZ
Data Collection Vehicle (DCV) Rating

Route Condition Legend – Pavement Condition Rating (PCR)						
Poor (0 - 60)	Fair (61- 84)	Good (85 - 94)	Excellent (95 - 100)	Not Rated		
See Appendix for definitions and formulas						
Inspection Date: 7/18/2017	Beginning Section MP	10	11	12	13	14
Paved Length (Miles): 27.92	Section Length (MI)	1	1	1	1	1
Surface Type: ASPHALT	Route Summary					
Roadway Condition Information						
Pavement Condition Rating (PCR)	97	94	99	96	90	99
Surface Condition Rating (SCR)	99	98	98	98	97	99
Roughness Condition Index (RCI)	95	87	100	93	79	100
Distress Index Values						
Structural Crack Index	100	100	100	100	99	100
Alligator Crack Index	100	100	100	100	100	100
Longitudinal Crack Index	100	100	100	100	99	100
Transverse Cracking Index	99	100	100	98	99	99
Patching Index	100	100	100	100	100	100
Rutting Index	99	98	98	99	97	100
International Roughness Index (IRI)	127	148	92	133	173	89
Lane & Width Information						
Number of Lanes	2	2	2	2	2	2

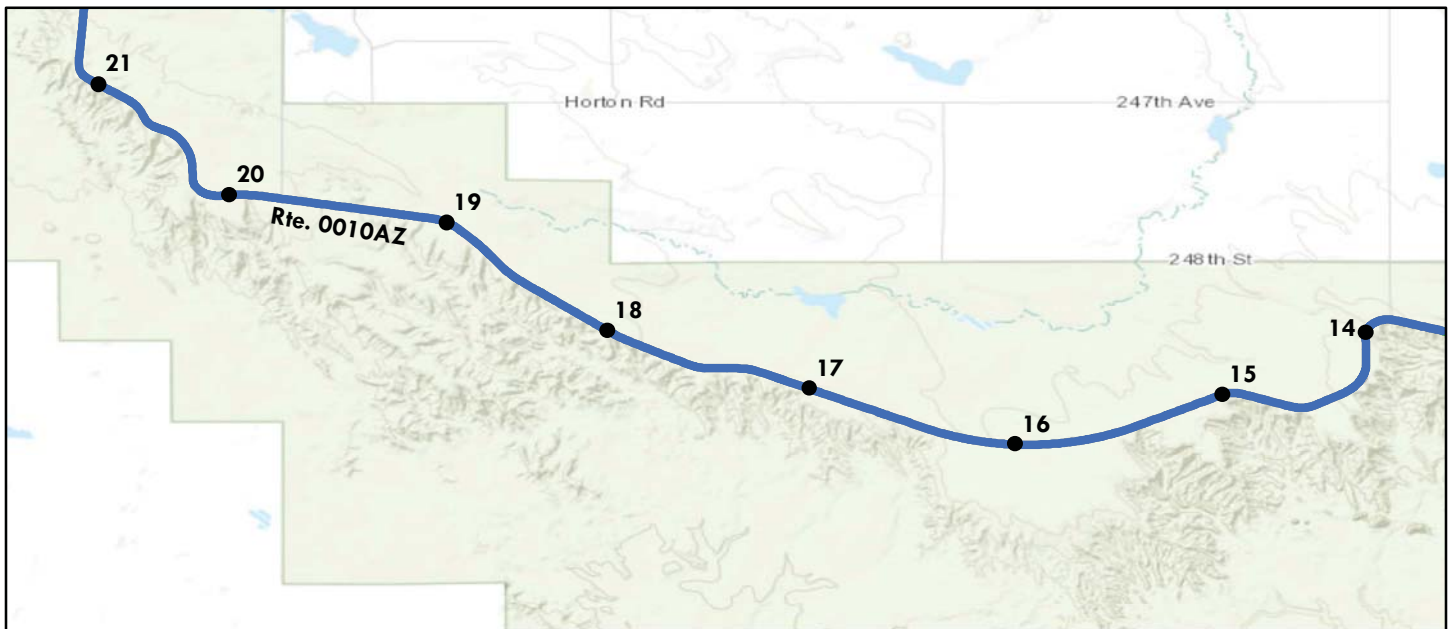
Subcomponent of Route BADL-0010ZZ
Data Collection Vehicle (DCV) Rating

Beginning Section MP	15	16	17	18	19
Inspection Date:	7/18/2017	Section Length (MI)	1	1	1	1	1
Paved Length (Miles):	27.92	Route Summary					
Surface Type:	ASPHALT						
Roadway Condition Information							
Pavement Condition Rating (PCR)	97	100	99	99	100	100	
Surface Condition Rating (SCR)	99	100	99	99	100	100	
Roughness Condition Index (RCI)	95	100	100	100	100	100	
Distress Index Values							
Structural Crack Index	100	100	100	100	100	100	
Alligator Crack Index	100	100	100	100	100	100	
Longitudinal Crack Index	100	100	100	100	100	100	
Transverse Cracking Index	99	100	99	99	100	100	
Patching Index	100	100	100	100	100	100	
Rutting Index	99	100	99	100	100	100	
International Roughness Index (IRI)	127	81	76	84	65	71	
Lane & Width Information							
Number of Lanes	2	2	2	2	2	2	
Paved Width (ft)	25.2	22	22.2	20.3	21.1	21.9	
Lane Width (ft)	10.2	9.4	9.3	8.9	8.7	9

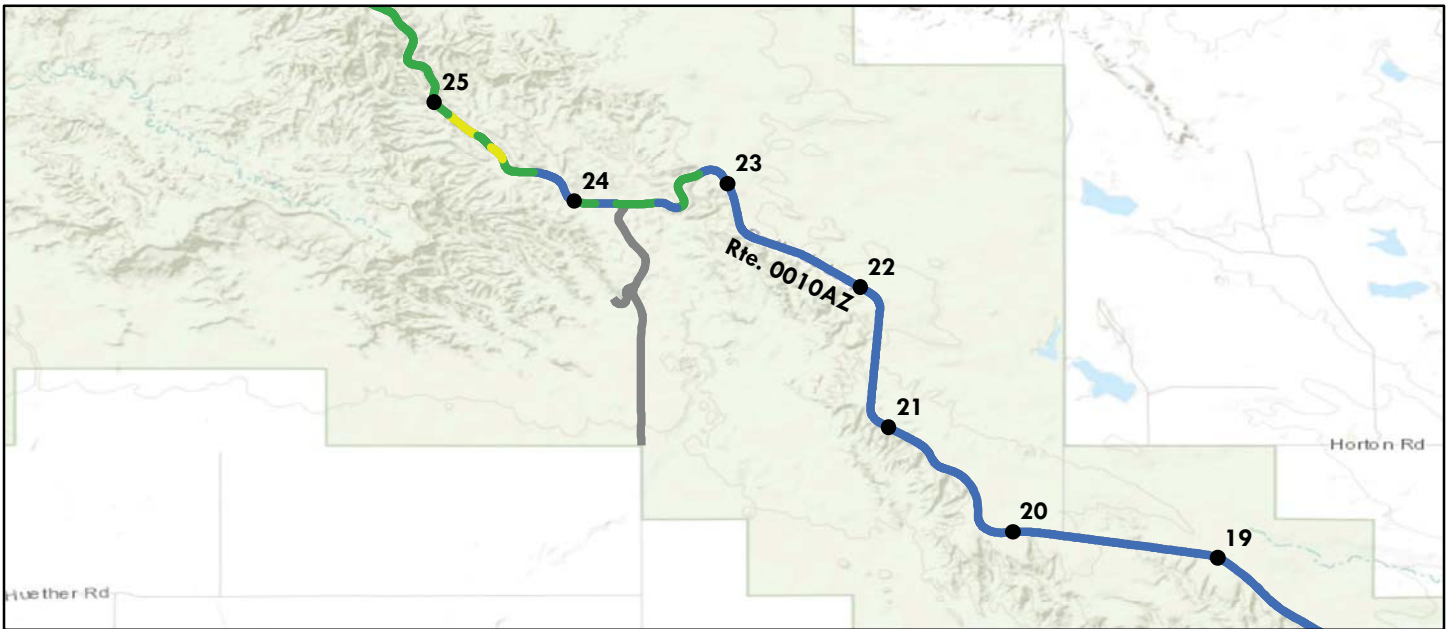
Subcomponent of Route BADL-0010ZZ
Data Collection Vehicle (DCV) Rating

Route Condition Legend – Pavement Condition Rating (PCR)						
Poor (0 - 60)	Fair (61- 84)	Good (85 - 94)	Excellent (95 - 100)	Not Rated		
See Appendix for definitions and formulas						
Inspection Date: 7/18/2017	Beginning Section MP	20	21	22	23	24
Paved Length (Miles): 27.92	Section Length (MI)	1	1	1	1	1
Surface Type: ASPHALT	Route Summary					
Roadway Condition Information						
Pavement Condition Rating (PCR)	97	99	100	99	93	90
Surface Condition Rating (SCR)	99	99	100	99	99	99
Roughness Condition Index (RCI)	95	100	100	100	83	76
Distress Index Values						
Structural Crack Index	100	100	100	100	100	100
Alligator Crack Index	100	100	100	100	100	100
Longitudinal Crack Index	100	100	100	100	100	100
Transverse Cracking Index	99	99	100	99	99	99
Patching Index	100	100	100	100	100	100
Rutting Index	99	100	100	100	100	100
International Roughness Index (IRI)	127	62	78	89	159	180
Lane & Width Information						
Number of Lanes	2	2	2	2	2	2

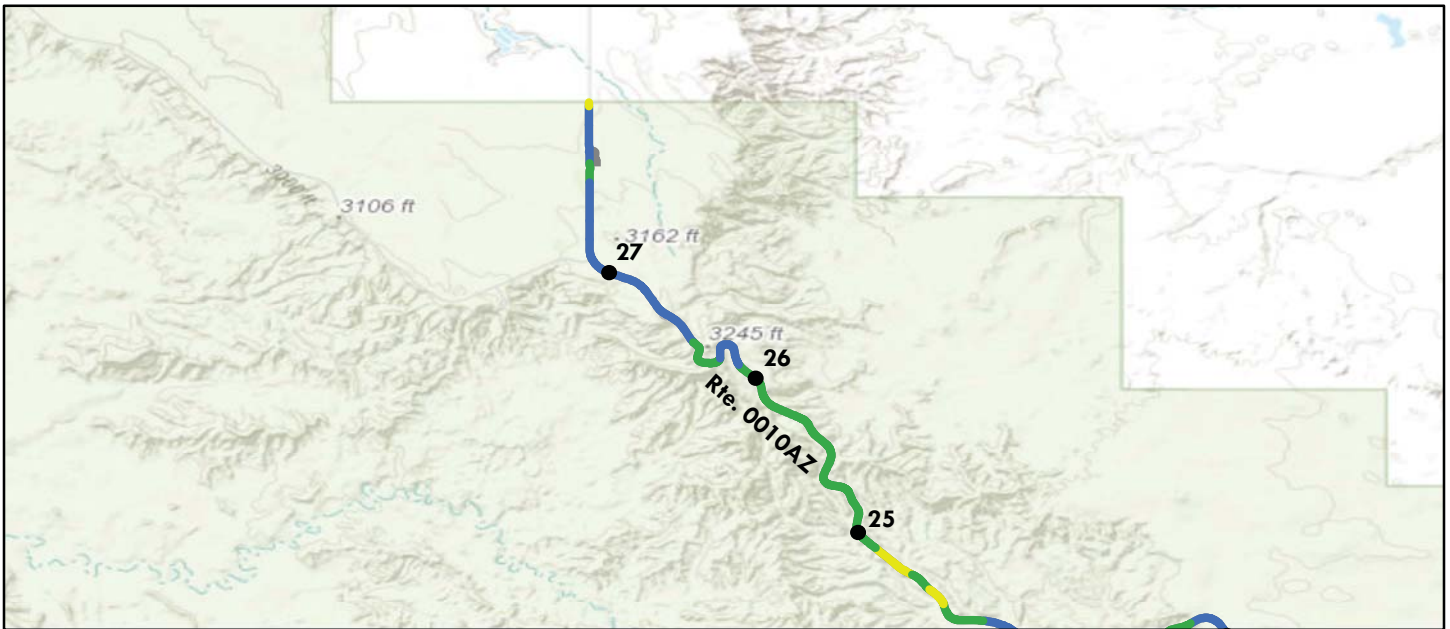
Subcomponent of Route BADL-0010ZZ
Data Collection Vehicle (DCV) Rating

Beginning Section MP	25	26	27		
Inspection Date:	7/18/2017	Section Length (MI)	1	1	0.92		
Paved Length (Miles):	27.92	Route Summary					
Surface Type:	ASPHALT						
Roadway Condition Information							
Pavement Condition Rating (PCR)	97	89	97	99			
Surface Condition Rating (SCR)	99	99	98	99			
Roughness Condition Index (RCI)	95	75	96	98			
Distress Index Values							
Structural Crack Index	100	100	98	100			
Alligator Crack Index	100	100	100	100			
Longitudinal Crack Index	100	100	98	100			
Transverse Cracking Index	99	99	99	99			
Patching Index	100	100	100	100			
Rutting Index	99	100	99	99			
International Roughness Index (IRI)	127	186	125	120			
Lane & Width Information							
Number of Lanes	2	2	2	2			
Paved Width (ft)	25.2	27.8	26.9	33.1			
Lane Width (ft)	10.2	11.3	11.4	10.5

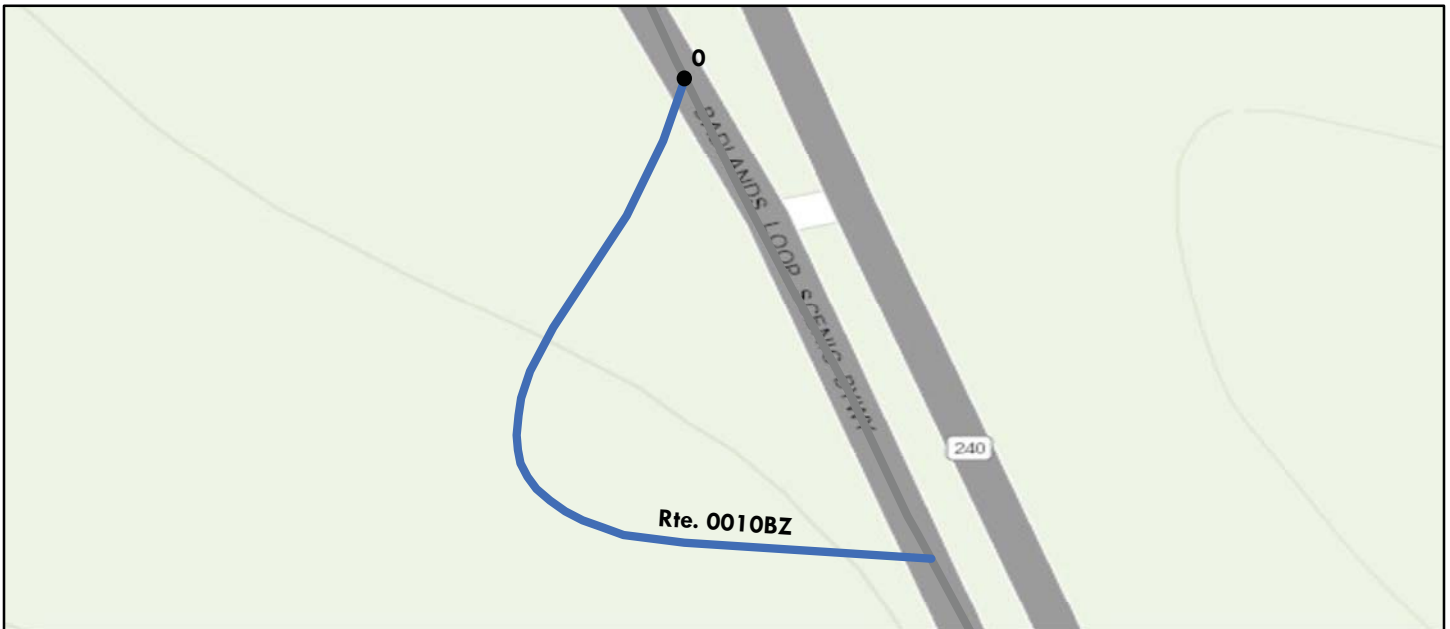
Manual Rating

Inspection Date: 4/27/2017	Beginning Section MP	0.00				
Paved Length (Miles): 0.06	Section Length (MI)	0.06				
Surface Type: ASPHALT	Route Summary					
Roadway Condition Information						
Pavement Condition Rating (PCR)	100	100				
Surface Condition Rating (SCR)	100	100				
Roughness Condition Index (RCI)	N/A	N/A				
Distress Index Values						
Structural Crack Index	100	100				
Alligator Crack Index	100	100				
Longitudinal Crack Index	100	100				
Transverse Cracking Index	100	100				
Patching Index	100	100				
Rutting Index	100	100				
International Roughness Index (IRI)	N/A	N/A				
Lane & Width Information						
Number of Lanes	2	2				
Paved Width (ft)	30	30				
Lane Width (ft)	15	15

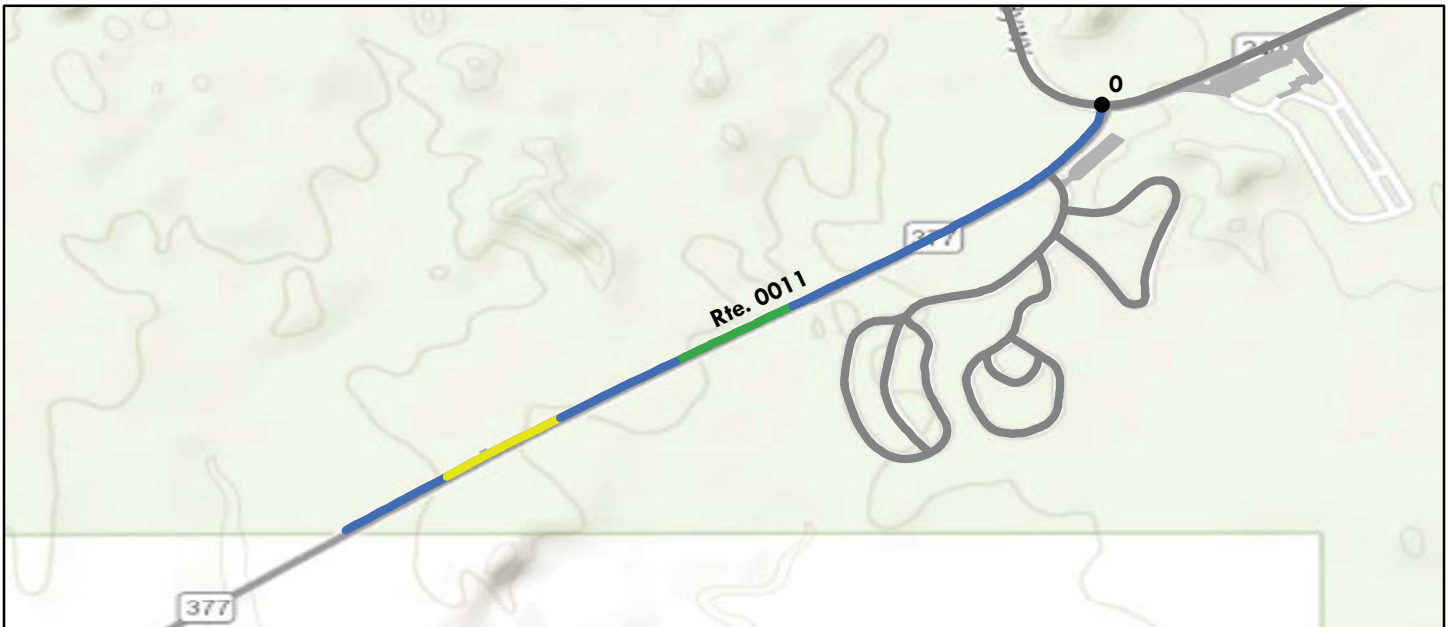
Data Collection Vehicle (DCV) Rating

Route Condition Legend – Pavement Condition Rating (PCR)						
Poor (0 - 60)	Fair (61- 84)	Good (85 - 94)	Excellent (95 - 100)	Not Rated		
See Appendix for definitions and formulas						
Inspection Date: 7/18/2017	Beginning Section MP	0				
Paved Length (Miles): 0.69	Section Length (MI)	0.69				
Surface Type: ASPHALT	Route Summary					
Roadway Condition Information						
Pavement Condition Rating (PCR)	96	96				
Surface Condition Rating (SCR)	97	97				
Roughness Condition Index (RCI)	94	94				
Distress Index Values						
Structural Crack Index	97	97				
Alligator Crack Index	100	100				
Longitudinal Crack Index	97	97				
Transverse Cracking Index	100	100				
Patching Index	99	99				
Rutting Index	100	100				
International Roughness Index (IRI)	130	130				
Lane & Width Information						
Number of Lanes	2	2				
Paved Width (ft)	28.3	28.3				
Lane Width (ft)	11.1	11.1

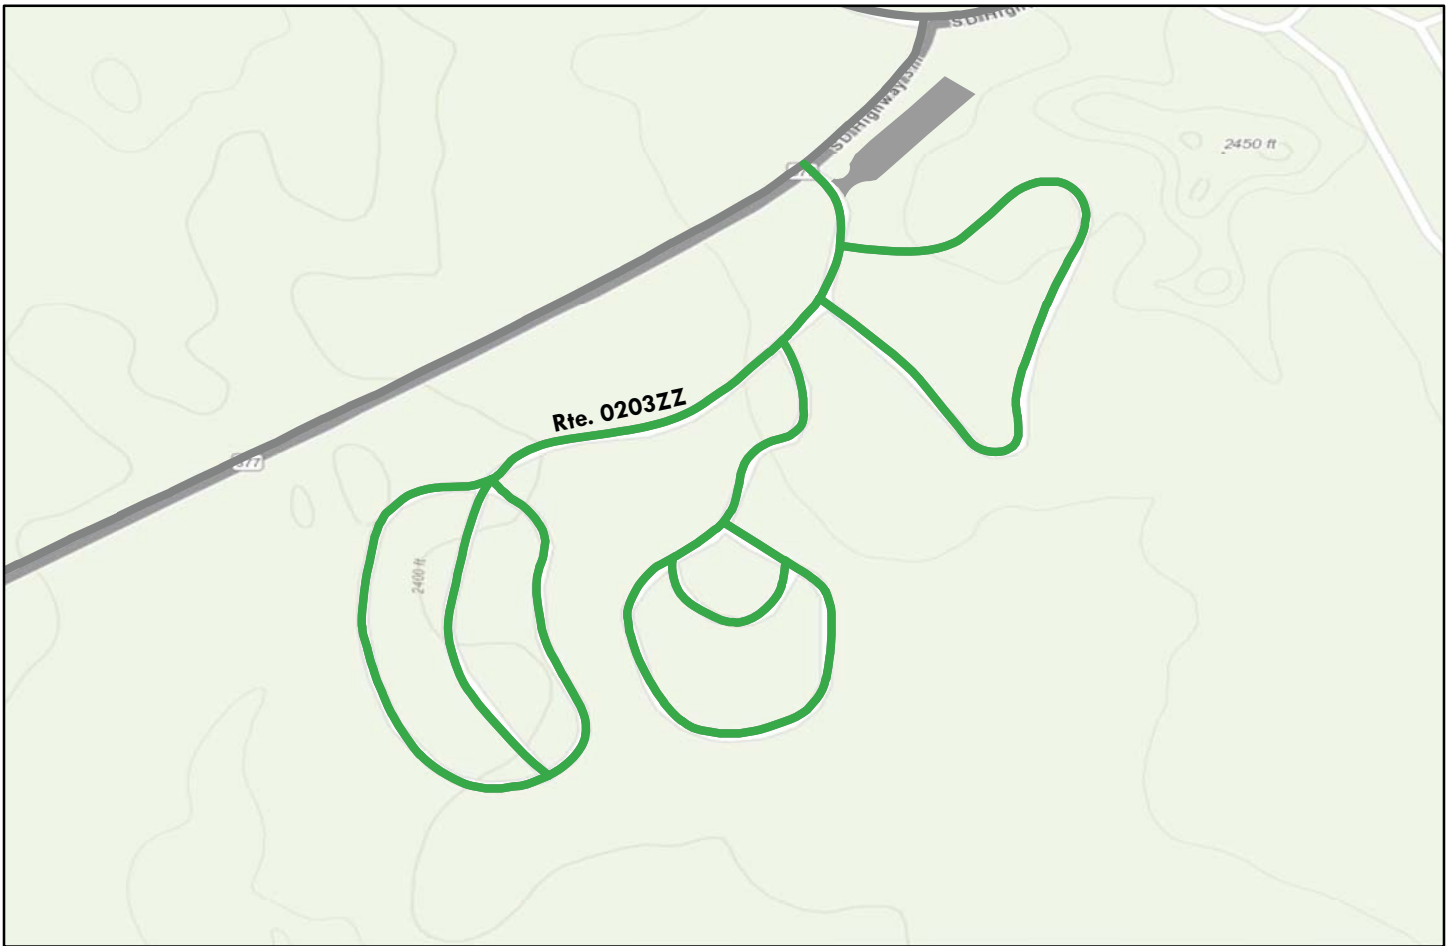
Summary Route

Route Condition Legend – Pavement Condition Rating (PCR)						
Poor (0 - 60)	Fair (61- 84)	Good (85 - 94)	Excellent (95 - 100)	Not Rated		
See Appendix for definitions and formulas						
Inspection Date:	7/18/2017					
Paved Length (Miles):	1.37					
Surface Type:	ASPHALT	Route Summary				
Roadway Condition Information						
Pavement Condition Rating (PCR)	92					
Lane & Width Information						
Number of Lanes	1					
Paved Width (ft)	19.7					
Lane Width (ft)	15.9
