# BAND Cycle 6

## Final Report

# Road Inventory and Condition Assessment of Paved Routes Bandelier National Monument

Federal Highway Administration  
Eastern Federal Lands Highway Division  
Road Inventory Program (RIP)

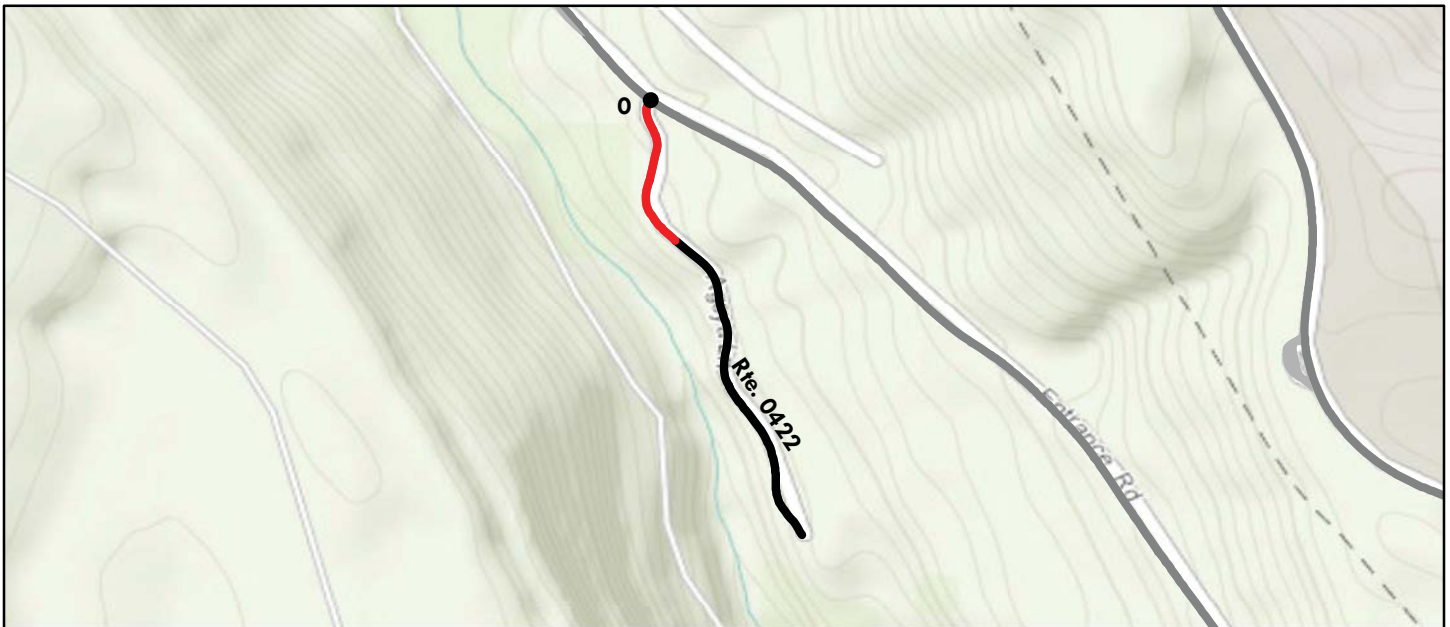
### Data Collection Vehicle (DCV) Rating

Route Condition Legend – Pavement Condition Rating (PCR)						
Poor (0 - 60)	Fair (61- 84)	Good (85 - 94)	Excellent (95 - 100)	Not Rated		
See Appendix for definitions and formulas						
<b>Inspection Date:</b> 6/1/2017	<b>Beginning Section MP</b>	0				
<b>Paved Length (Miles):</b> 0.3	<b>Section Length (MI)</b>	0.3				
<b>Surface Type:</b> ASPHALT	<b>Route Summary</b>					
<b>Roadway Condition Information</b>						
Pavement Condition Rating (PCR)	N/A	N/A				
Surface Condition Rating (SCR)	N/A	N/A				
Roughness Condition Index (RCI)	N/A	N/A				
<b>Distress Index Values</b>						
Structural Crack Index	N/A	N/A				
Alligator Crack Index	N/A	N/A				
Longitudinal Crack Index	N/A	N/A				
Transverse Cracking Index	N/A	N/A				
Patching Index	N/A	N/A				
Rutting Index	N/A	N/A				
International Roughness Index (IRI)	N/A	N/A				
<b>Lane &amp; Width Information</b>						
Number of Lanes	1	1				
Paved Width (ft)	12.2	12.2

Note: The majority of the route was not rated due to badly degraded asphalt.

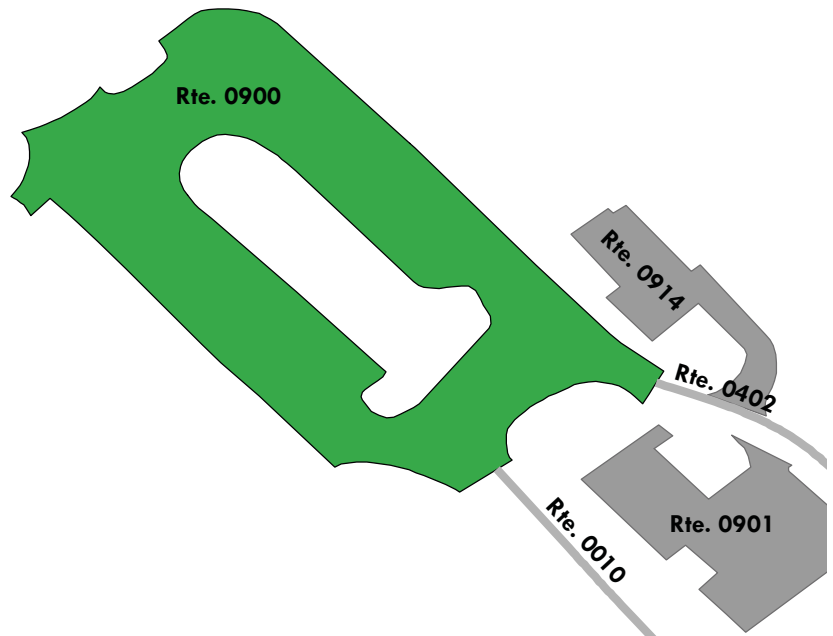
Inspection Date	FMSS Number	User Access	Surface Type
6/1/2017	31666	PUBLIC	ASPHALT
Area (Sq. Ft.)	Lane Miles (11' Widths)	Curb Reveal (Inches)	Curb Recommendation
37,030	0.638	6	LIGHT REPAIR
Curb Type		Curb & Gutter Type	
STONE		NO CURB AND GUTTER	
Pavement Recommendation		Condition Rating / PCR	
PREVENTIVE MAINTENANCE		GOOD / 90

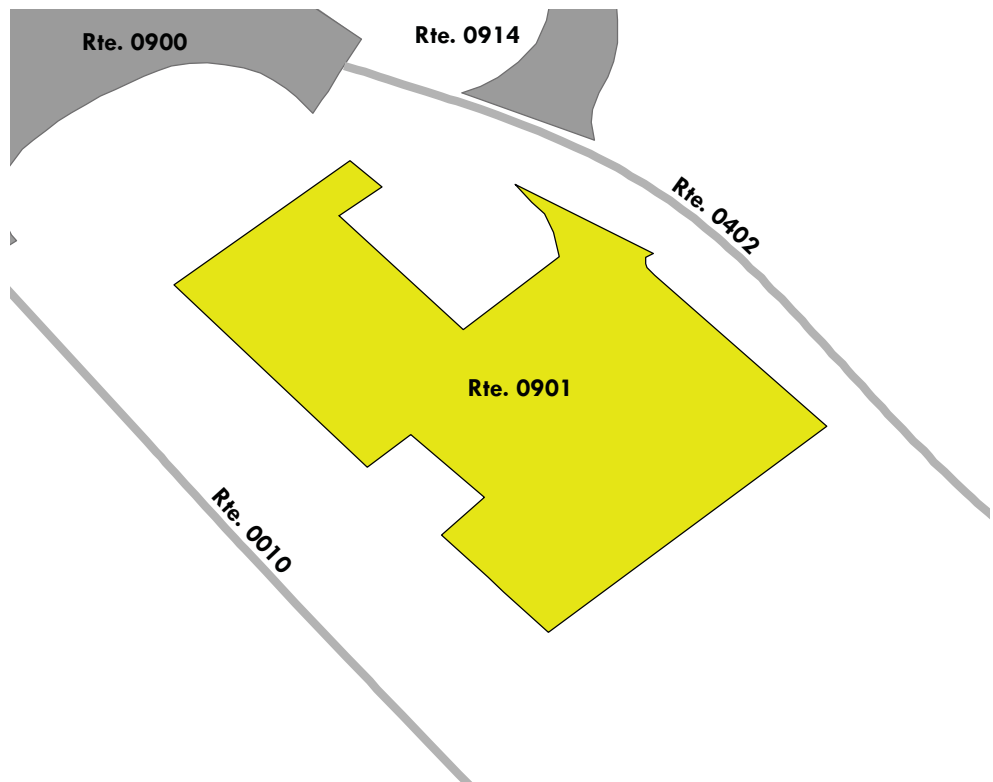
## ROUTE 0901: FRIJOLES CANYON MAINTENANCE AREA PARKING

Inspection Date	FMSS Number	User Access	Surface Type
6/1/2017	31670	NONPUBLIC	ASPHALT
Area (Sq. Ft.)	Lane Miles (11' Widths)	Curb Reveal (Inches)	Curb Recommendation
8,709	0.15	NOT APPLICABLE	NOT APPLICABLE
Curb Type		Curb & Gutter Type	
NO CURB		NO CURB AND GUTTER	
Pavement Recommendation		Condition Rating / PCR	
LIGHT 3R TREATMENTS		FAIR / 73

Note: Parking area consists of multiple surface types: 1 part Asphalt at 8,005 square feet; 1 part Concrete at 704 square feet.
