Road Inventory and Condition Assessment of Paved Routes Black Canyon of the Gunnison National Park

Prepared By: Federal Highway Administration Eastern Federal Lands Highway Division Road Inventory Program (RIP)

Report Date: November 2015

Black Canyon of the Gunnison National Park in Colorado

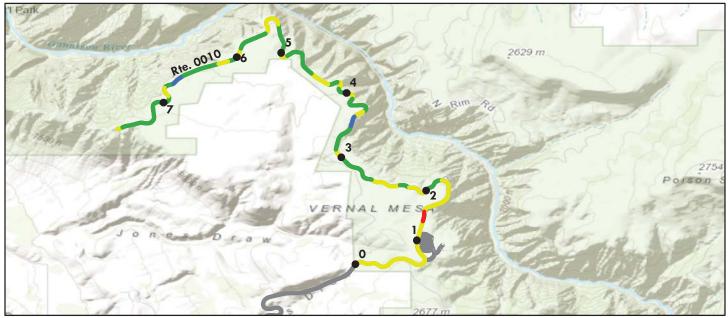
Black Canyon of the Gunnison National Park ROUTE 0010: SOUTH RIM DRIVE

| Route Condition Legend – Pavement Condition Rating (PCR) | | | | | | | | | | |
|--|---|---|---|---|---|---|--|--|--|--|
| Pavement Condition Rating (PCR) | 81 | 70 | 69 | 83 | 86 | 84 | | | | |
| Surface Condition Rating (SCR) | 90 | 82 | 75 | 94 | 96 | 95 | | | | |
| Roughness Condition Index (RCI) | 68 | 53 | 61 | 67 | 71 | 67 | | | | |

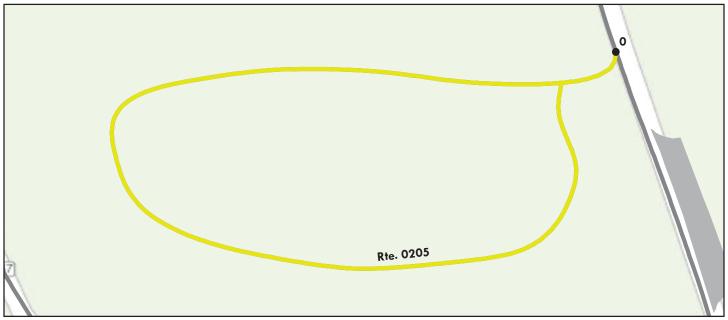
ROUTE 0205: CAMPGROUND LOOPA

| Route | Condition Legend – Pav | ement Condi | tion Rating (PCR) | |
|---|---|---|---|---|
| Pavement Condition Rating (PCR) | 77 | 77 | | |
| Surface Condition Rating (SCR) | 77 | 77 | | |

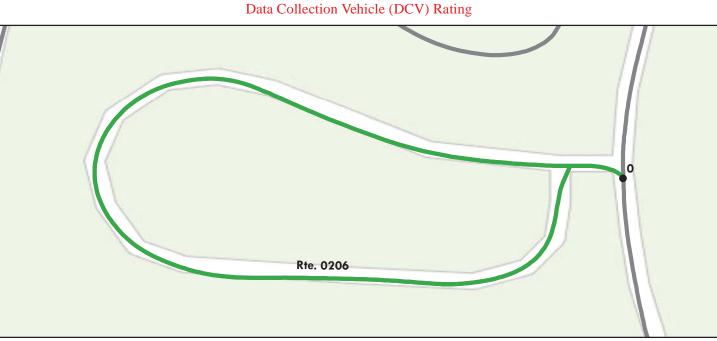
ROUTE 0206: CAMPGROUND LOOP B

| Route | Condition Legend – Pav | ement Cond | ition Rating (PCR) | |
|---|---|---|---|---|
| Pavement Condition Rating (PCR) | 90 | 90 | | |
| Surface Condition Rating (SCR) | 90 | 90 | | |

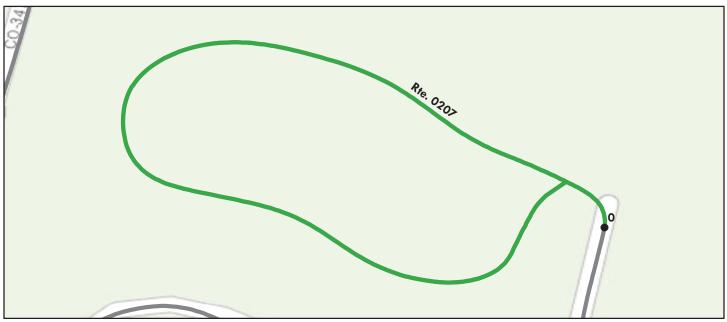
ROUTE 0207: CAMPGROUND LOOP C

| Route C | Condition Legend – Pav | ement Condi | tion Rating (PCR) | |
|---|---|---|---|---|
| Pavement Condition Rating (PCR) | 88 | 88 | | |
| Surface Condition Rating (SCR) | 88 | 88 | | |

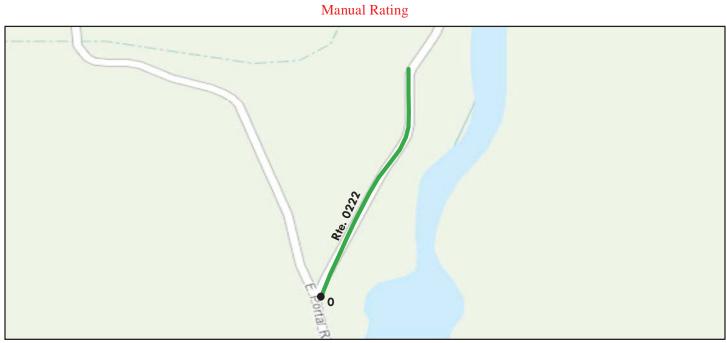
ROUTE 0222: EAST PORTAL CAMPGROUND ACCESS ROAD

| Rout | e Condition Legend – Pav | ement Condi | tion Rating (PCR) | |
|---|---|---|---|---|
| Pavement Condition Rating (PCR) | 90 | 90 | | |
| Surface Condition Rating (SCR) | 90 | 90 | | |

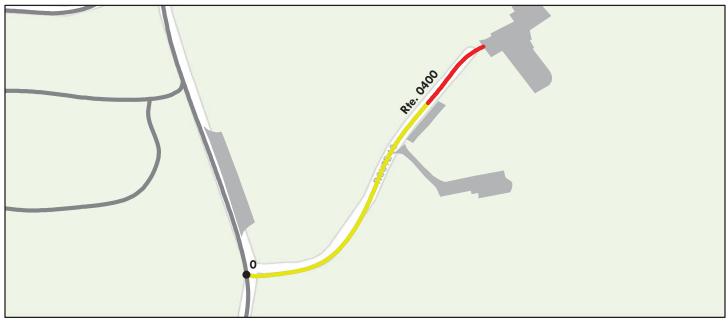
ROUTE 0400: SOUTH RIM RESIDENCE ROAD

| Route | Condition Legend – Pav | ement Cond | ition Rating (PCR) | |
|---|---|---|---|---|
| Pavement Condition Rating (PCR) | 77 | 77 | | |
| Surface Condition Rating (SCR) | 77 | 77 | | |
| Structural Crack Index | 77 | 77 | | |
