BRCA Cycle 6

Final Report

Road Inventory and Condition Assessment of Paved Routes Bryce Canyon National Park

Federal Highway Administration
Eastern Federal Lands Highway Division
Road Inventory Program (RIP)

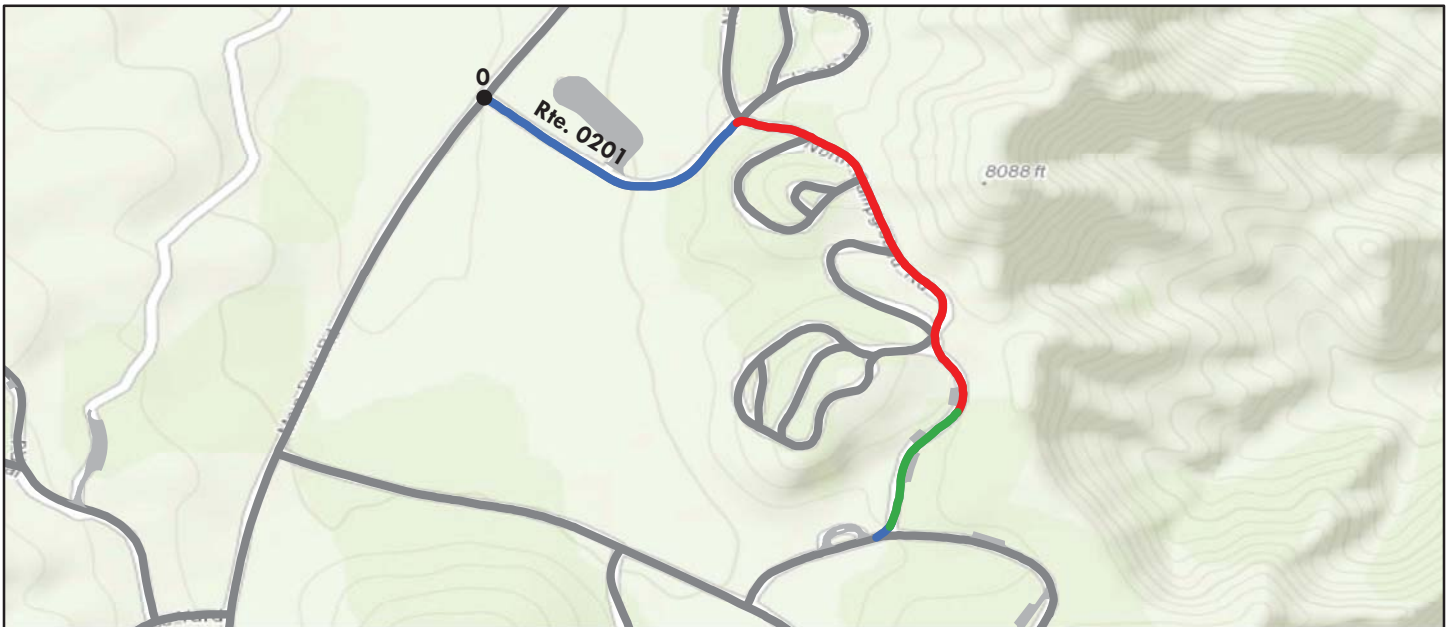
Route Condition Legend – Pavement Condition Rating (PCR)						
Poor (0 - 60)	Fair (61- 84)	Good (85 - 94)	Excellent (95 - 100)	Not Rated		
See Appendix for definitions and formulas						
Inspection Date: 11/6/2016	Beginning Section MP	0				
Paved Length (Miles): 0.61	Section Length (MI)	0.61				
Surface Type: ASPHALT	Route Summary					
Roadway Condition Information						
Pavement Condition Rating (PCR)	56	56				
Surface Condition Rating (SCR)	79	79				
Roughness Condition Index (RCI)	N/A	N/A				
Distress Index Values						
Structural Crack Index	79	79				
Alligator Crack Index	89	89				
Longitudinal Crack Index	90	90				
Transverse Cracking Index	93	93				
Patching Index	96	96				
Rutting Index	93	93				
International Roughness Index (IRI)	N/A	N/A				
Lane & Width Information						
Number of Lanes	2	2				
Paved Width (ft)	21.3	21.3				
Lane Width (ft)	10.1	10.1

Badly degraded Asphalt from MP 0.30 to MP 0.48.
