CABR Cycle 6

Final Report

Road Inventory and Condition Assessment of Paved Routes Cabrillo National Monument

Report Date: November 2015

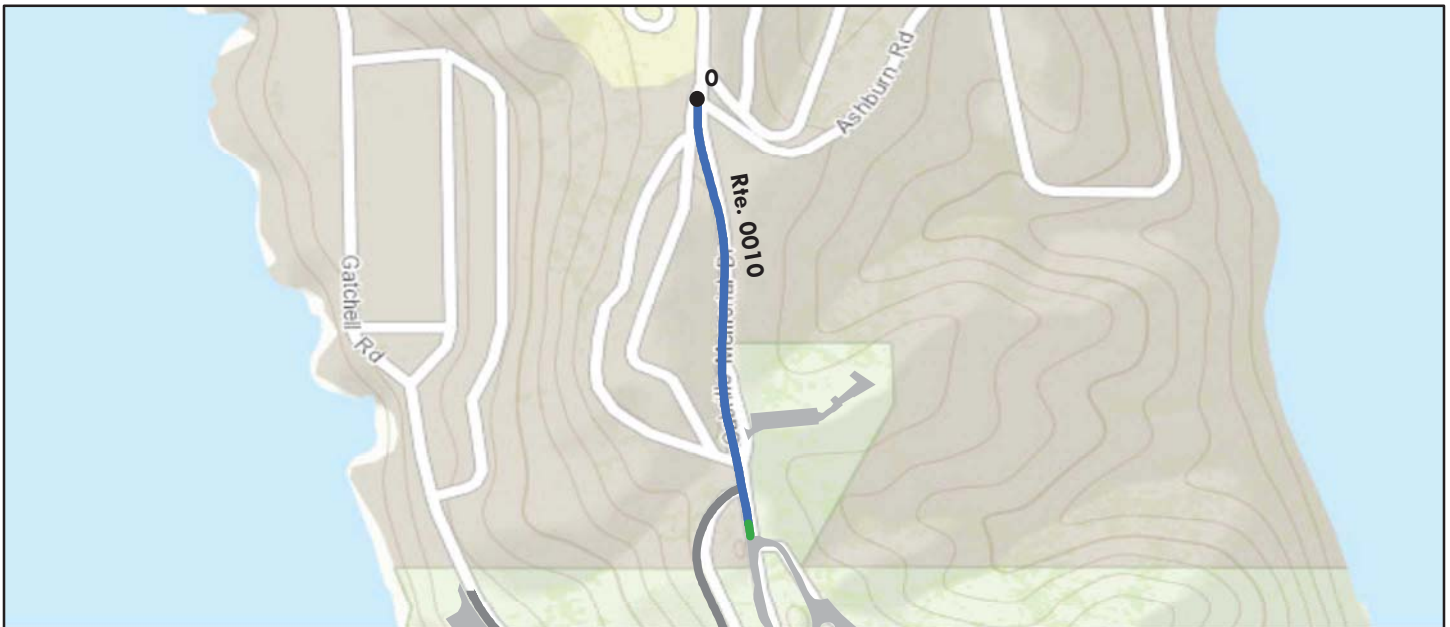
ROUTE 0010: CABRILLO MEMORIAL DRIVE

| Route Condition Legend – Pavement Condition Rating (PCR) | | | | | | |
|---|---|---|---|---|--|--|
| Pavement Condition Rating (PCR) | 96 | 96 | | | | |
| Surface Condition Rating (SCR) | 96 | 96 | | | | |

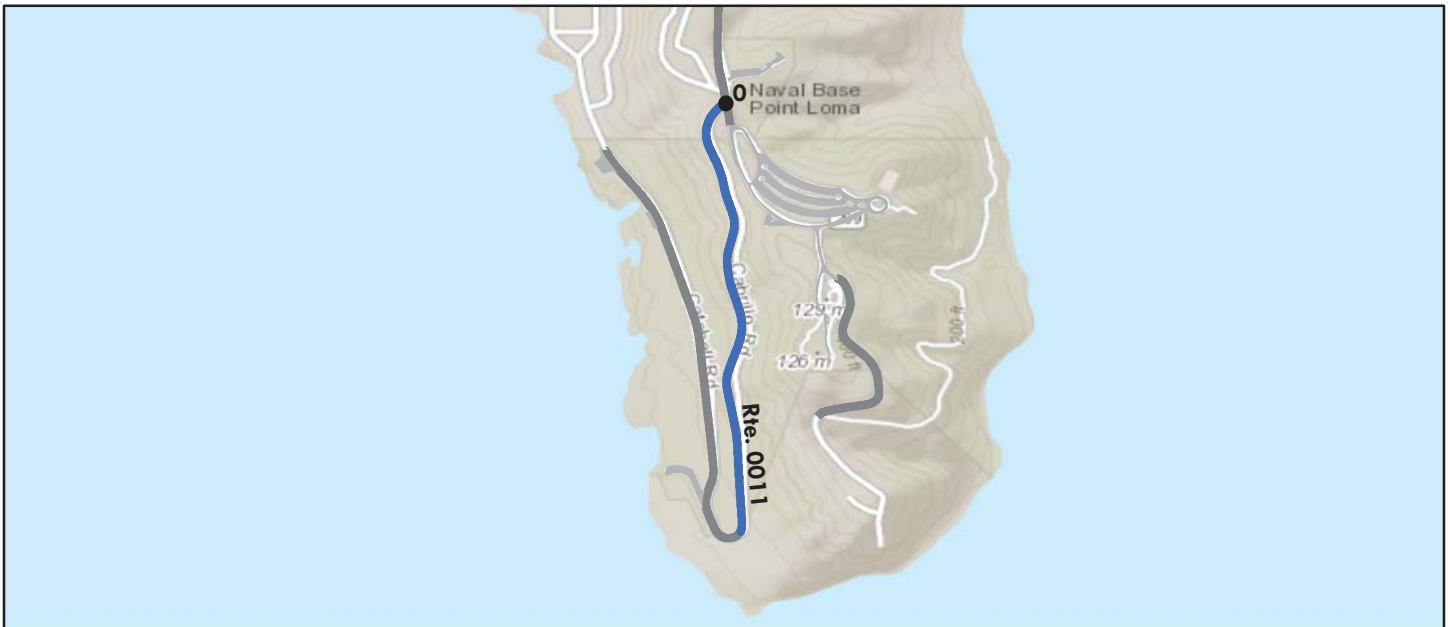
ROUTE 0011: CABRILLO ROAD

| Route Condition Legend – Pavement Condition Rating (PCR) | | | | | | |
|---|---|---|---|---|--|--|
| Pavement Condition Rating (PCR) | 100 | 100 | | | | |
| Surface Condition Rating (SCR) | 100 | 100 | | | | |

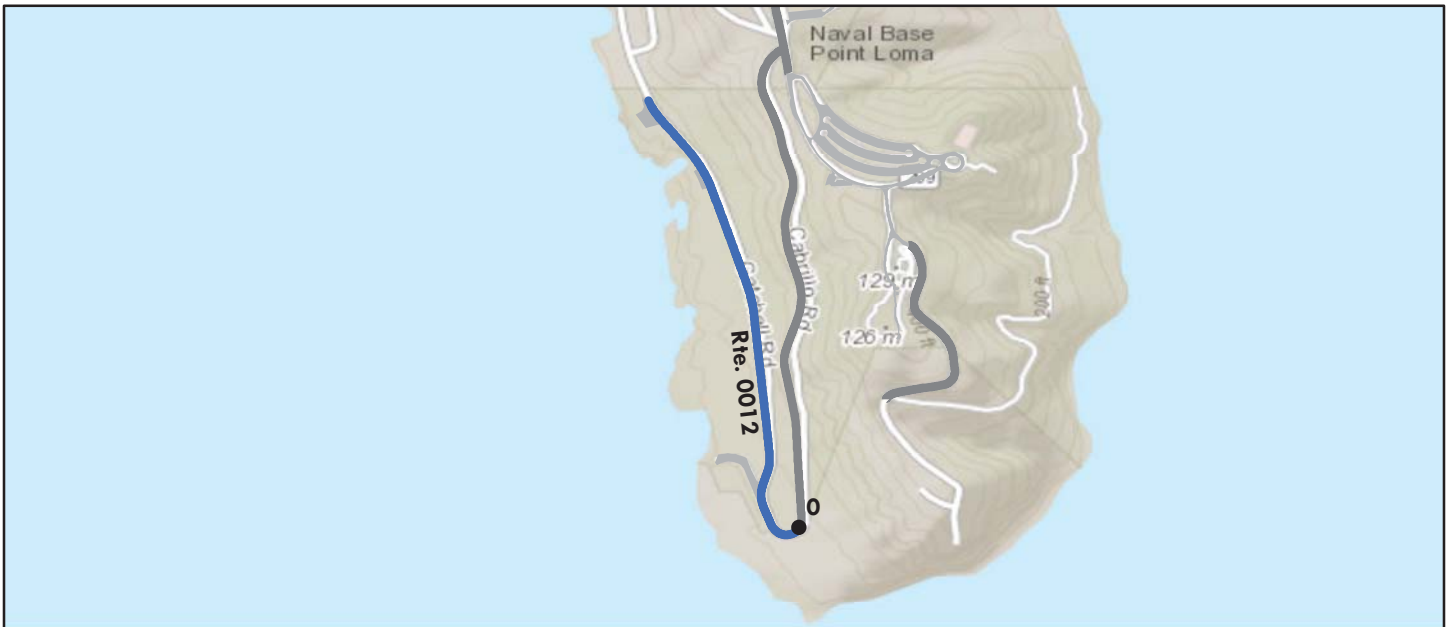
ROUTE 0012: GATCHELL ROAD

| Route Condition Legend – Pavement Condition Rating (PCR) | | | | | | |
|---|---|---|---|---|--|--|
| Pavement Condition Rating (PCR) | 100 | 100 | | | | |
| Surface Condition Rating (SCR) | 100 | 100 | | | | |

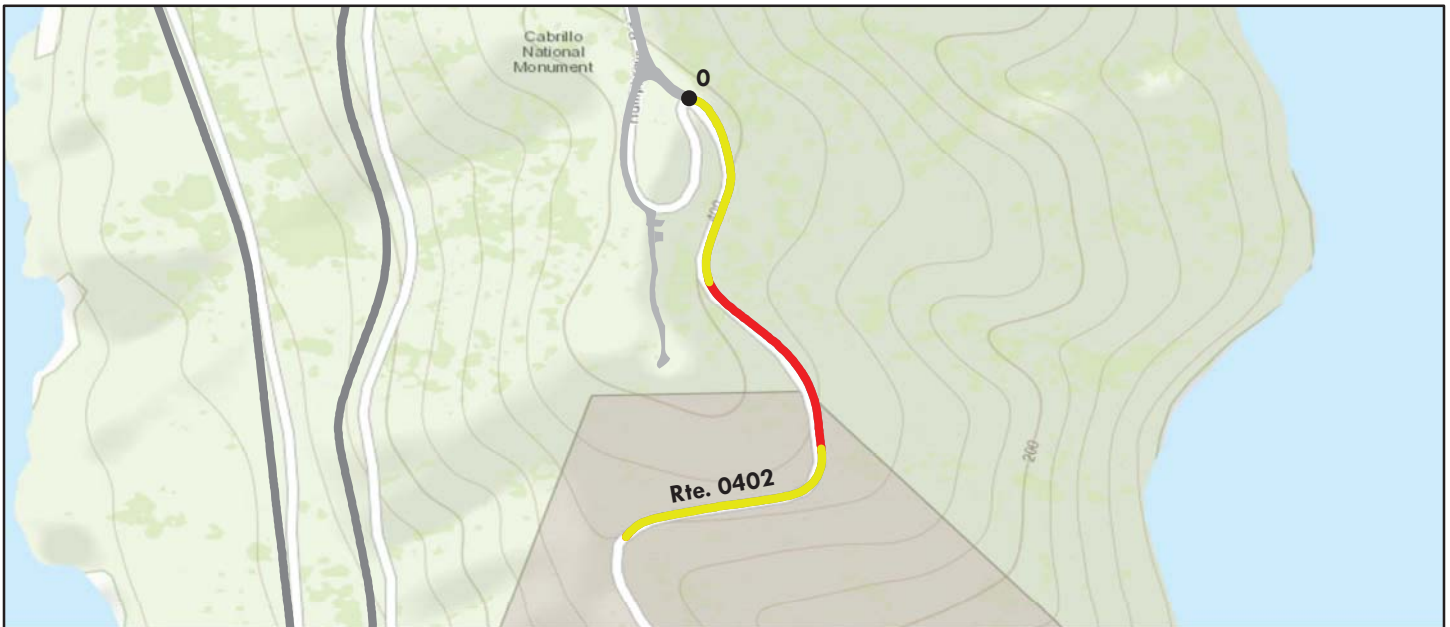
ROUTE 0402: BATTERY HUMPHREYS ROAD

| Route Condition Legend – Pavement Condition Rating (PCR) | | | | | | |
|---|---|---|---|---|--|--|
| Pavement Condition Rating (PCR) | 68 | 68 | | | | |
| Surface Condition Rating (SCR) | 68 | 68 | | | | |
| Structural Crack Index | 68 | 68 | | | | |
| Longitudinal Crack Index | 68 | 68 | | | | |
| Transverse Cracking Index | 97 | 97 | | | | |

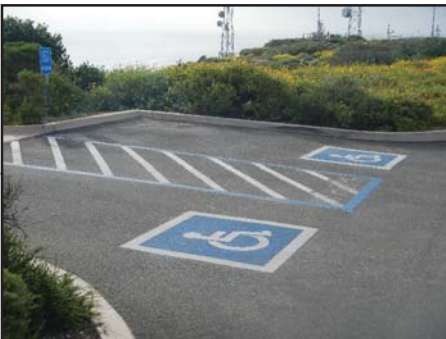
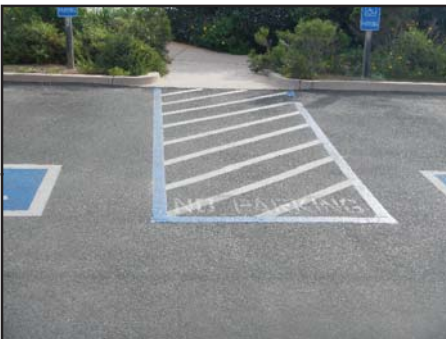
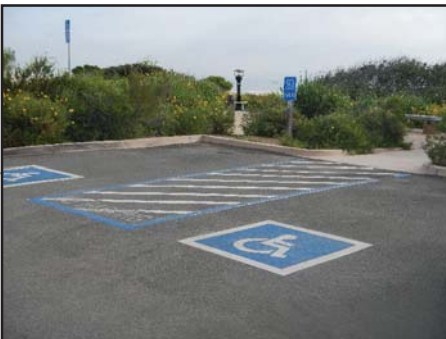
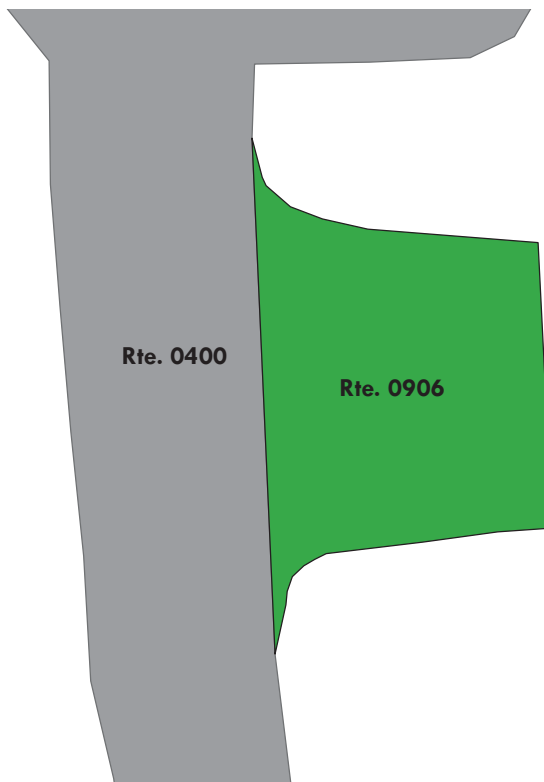
ROUTE 0906: LIGHTHOUSE PARKING AREA

| Route No. | FMSS No. | Route Name | User Access | Surf. Type | Area (Sq. Ft.) | Pavement Condition Rating (PCR) | <u>Asphalt Surface Distresses</u> | | | | | <u>Concrete Surface Distresses</u> | | | | | | |
|---|---|---|---|---|---|---|---|---|---|---|---|---|---|---|---|---|---|--|
| CABR-0906 | 234528 | LIGHTHOUSE PARKING AREA | PUBLIC | AS | 508 | 90 | 97 | 97 | 97 | 97 | 97 | 90 | | | | | | |
