CACH Cycle 6

Final Report

Road Inventory and Condition Assessment of Paved Routes Canyon de Chelly National Monument

Report Date: March 2017

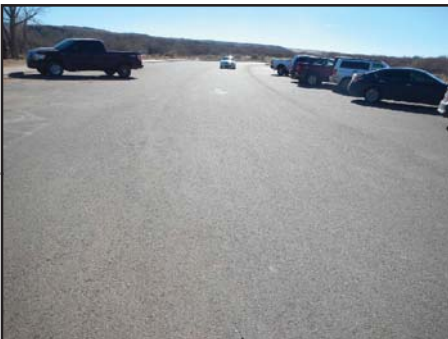
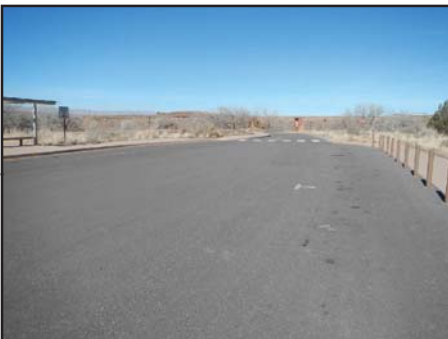
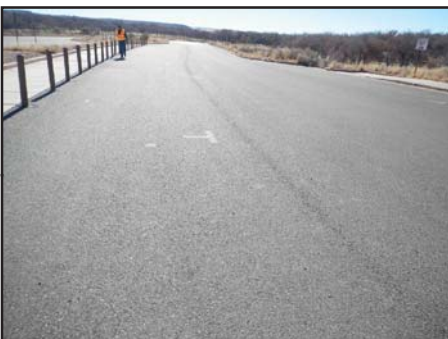
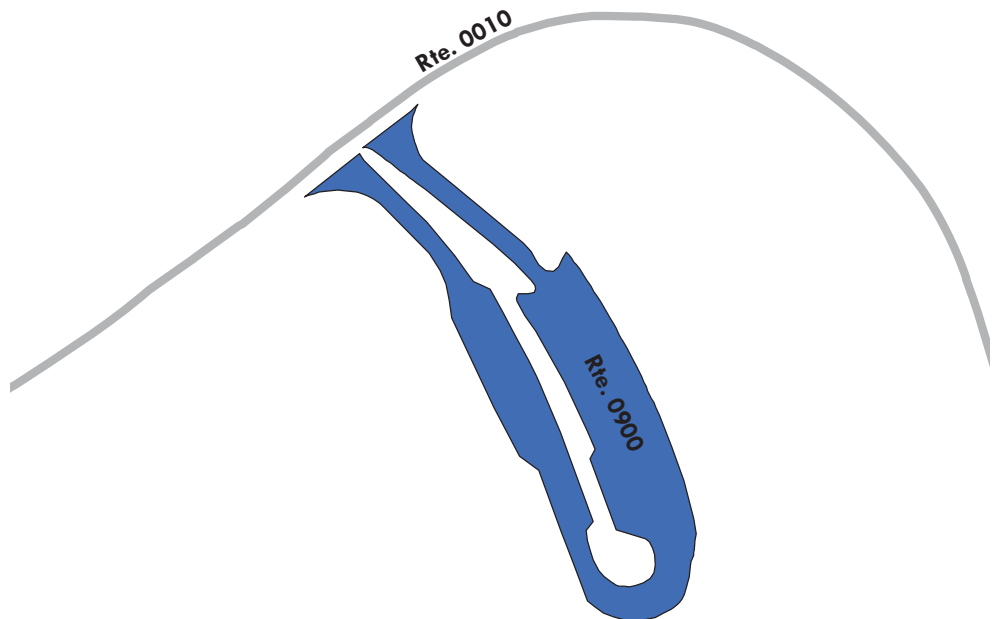
Inspection Date	FMSS Number	User Access	Surface Type
1/13/2016	68952	PUBLIC	ASPHALT
Area (Sq. Ft.)	Lane Miles (11' Widths)	Curb Reveal (Inches)	Curb Recommendation
44,710	0.77	NOT APPLICABLE	DO NOTHING
Curb Type		Curb & Gutter Type	
NO CURB		CONCRETE	
Pavement Recommendation		Condition Rating / PCR	
DO NOTHING		EXCELLENT / 97

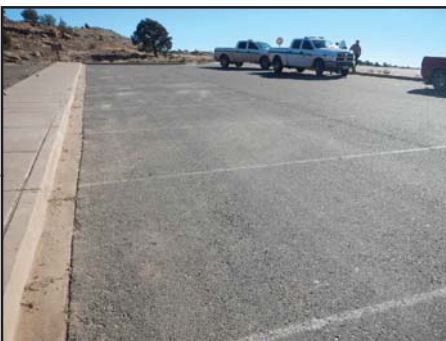
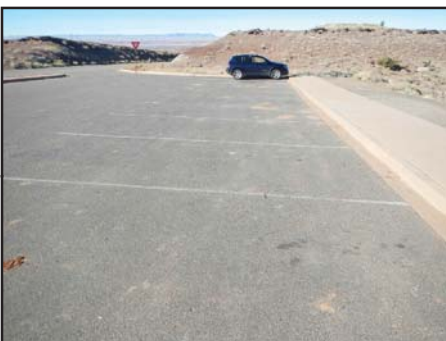
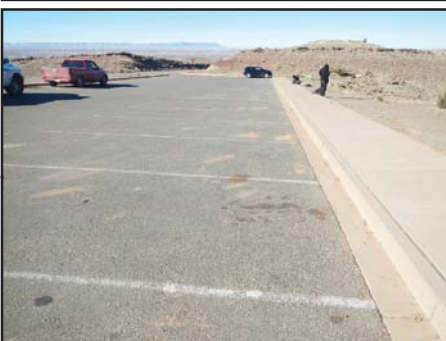
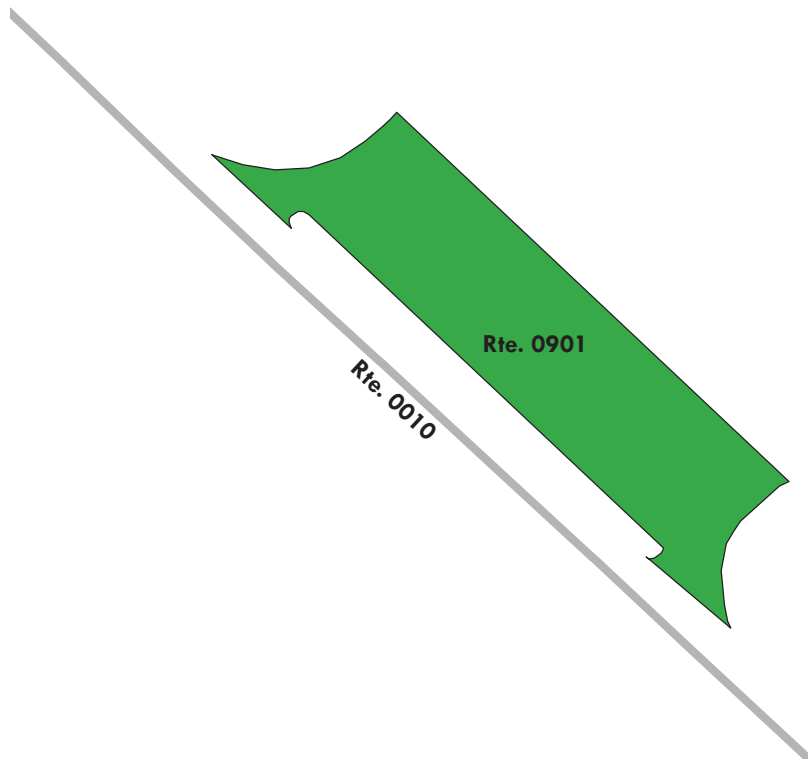
Inspection Date	FMSS Number	User Access	Surface Type
1/13/2016	68856	PUBLIC	ASPHALT
Area (Sq. Ft.)	Lane Miles (11' Widths)	Curb Reveal (Inches)	Curb Recommendation
10,172	0.175	NOT APPLICABLE	DO NOTHING
Curb Type		Curb & Gutter Type	
NO CURB		CONCRETE	
Pavement Recommendation		Condition Rating / PCR	
PREVENTIVE MAINTENANCE		GOOD / 90

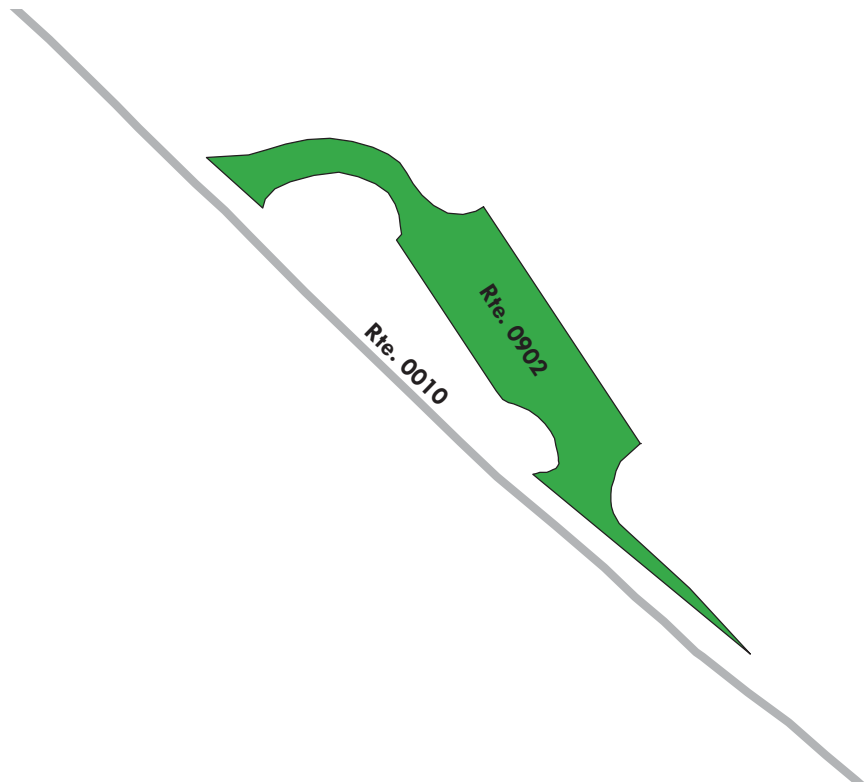
Inspection Date	FMSS Number	User Access	Surface Type
1/13/2016	68858	PUBLIC	ASPHALT
Area (Sq. Ft.)	Lane Miles (11' Widths)	Curb Reveal (Inches)	Curb Recommendation
13,396	0.231	6	DO NOTHING
Curb Type		Curb & Gutter Type	
CONCRETE		CONCRETE	
Pavement Recommendation		Condition Rating / PCR	
PREVENTIVE MAINTENANCE		GOOD / 90

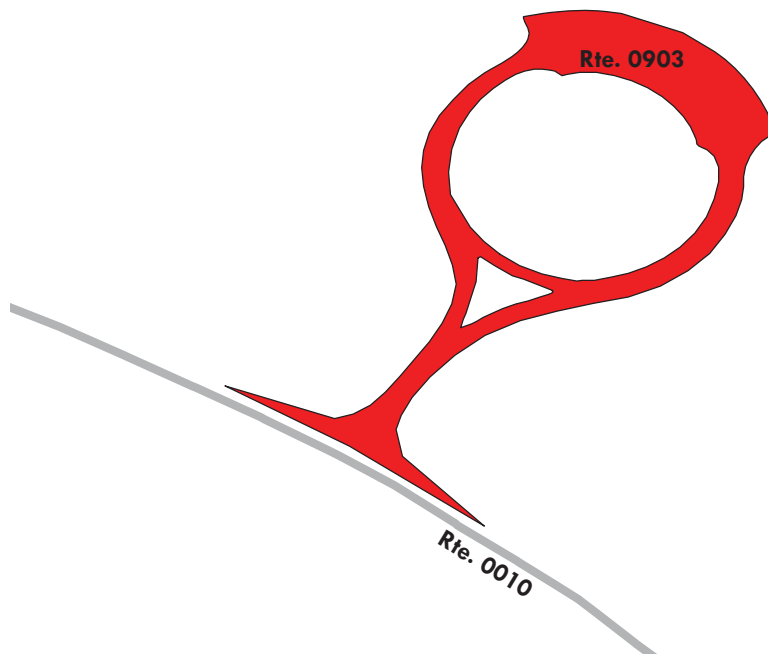
Inspection Date	FMSS Number	User Access	Surface Type
1/13/2016	68861	PUBLIC	ASPHALT
Area (Sq. Ft.)	Lane Miles (11' Widths)	Curb Reveal (Inches)	Curb Recommendation
21,498	0.37	4	DO NOTHING
Curb Type		Curb & Gutter Type	
CONCRETE		CONCRETE	
Pavement Recommendation		Condition Rating / PCR	
HEAVY 3R TREATMENTS		POOR / 53

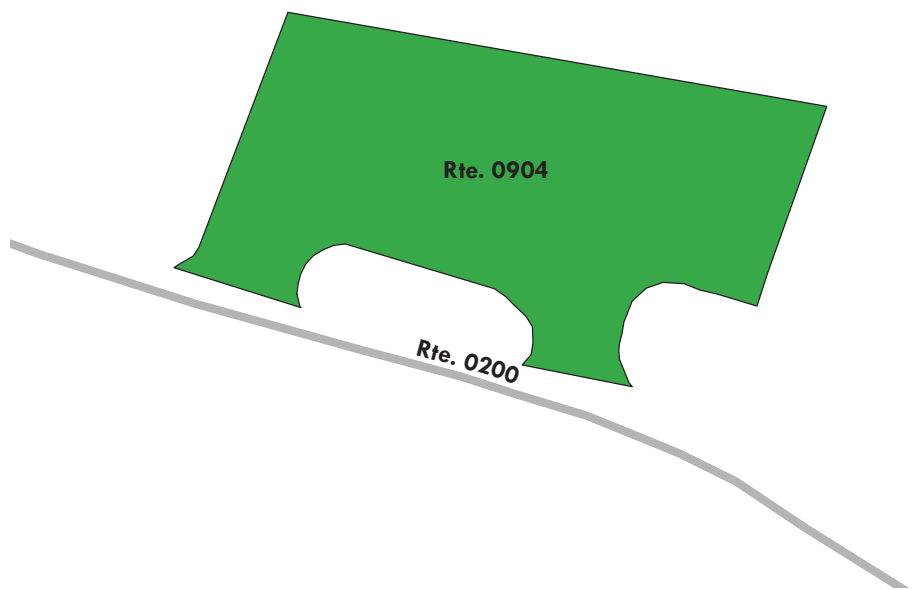
Inspection Date	FMSS Number	User Access	Surface Type
1/13/2016	79403	PUBLIC	ASPHALT
Area (Sq. Ft.)	Lane Miles (11' Widths)	Curb Reveal (Inches)	Curb Recommendation
16,282	0.28	NOT APPLICABLE	NOT APPLICABLE
Curb Type		Curb & Gutter Type	
NO CURB		NO CURB AND GUTTER	
Pavement Recommendation		Condition Rating / PCR	
PREVENTIVE MAINTENANCE		GOOD / 90

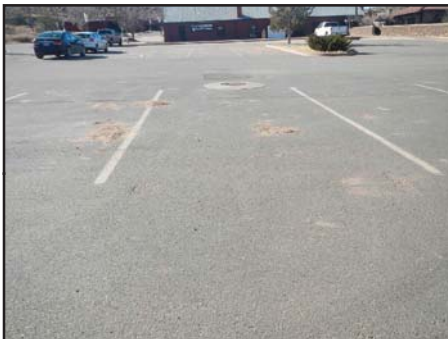
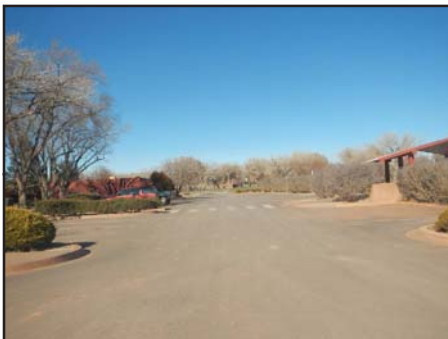
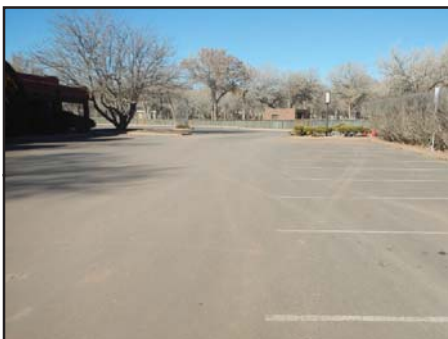
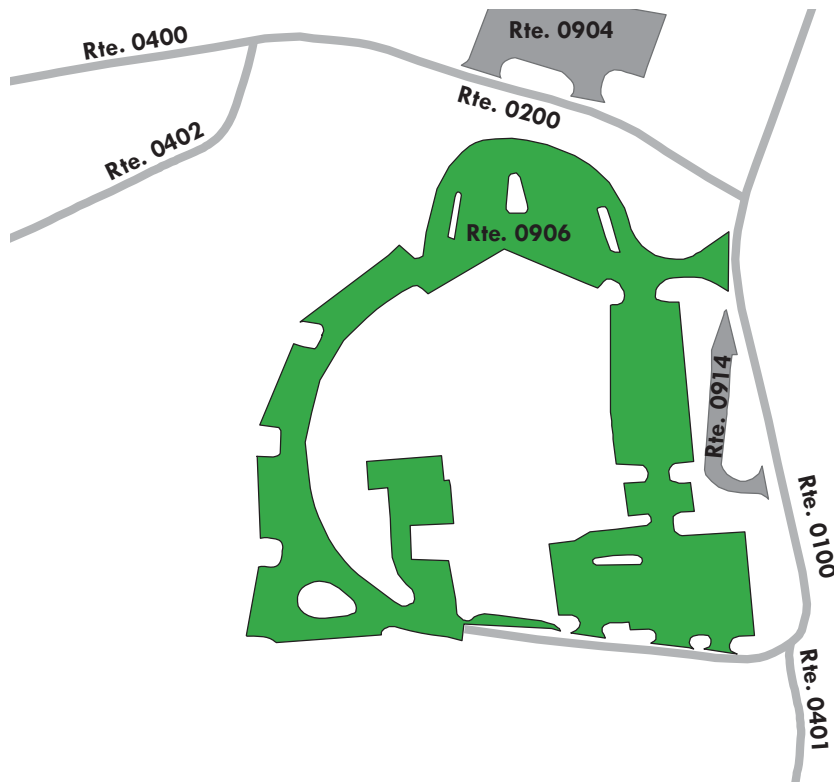
Inspection Date	FMSS Number	User Access	Surface Type
1/13/2016	68955	PUBLIC	ASPHALT
Area (Sq. Ft.)	Lane Miles (11' Widths)	Curb Reveal (Inches)	Curb Recommendation
108,750	1.872	NOT APPLICABLE	DO NOTHING
Curb Type		Curb & Gutter Type	
NO CURB		CONCRETE	
Pavement Recommendation		Condition Rating / PCR	
PREVENTIVE MAINTENANCE		GOOD / 90

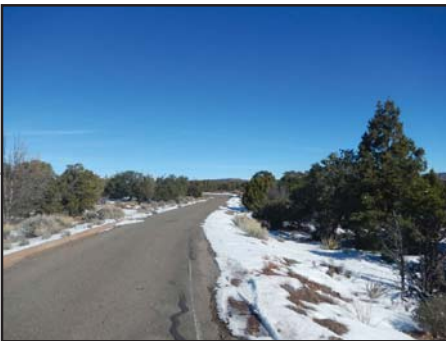
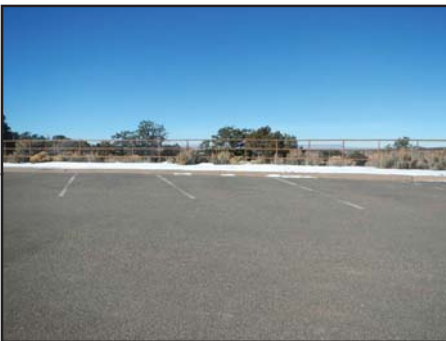
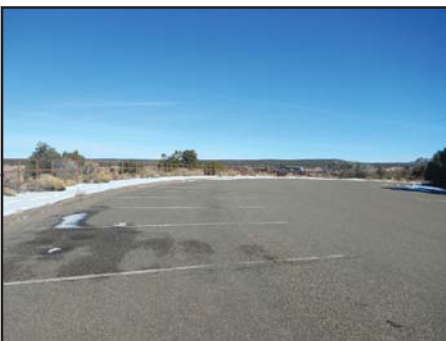
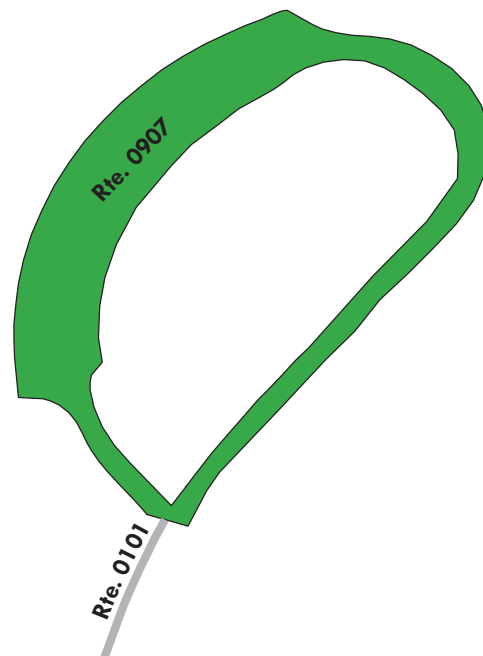
Inspection Date	FMSS Number	User Access	Surface Type
1/13/2016	68869	PUBLIC	ASPHALT
Area (Sq. Ft.)	Lane Miles (11' Widths)	Curb Reveal (Inches)	Curb Recommendation
25,536	0.44	6	DO NOTHING
Curb Type		Curb & Gutter Type	
CONCRETE		CONCRETE	
Pavement Recommendation		Condition Rating / PCR	
PREVENTIVE MAINTENANCE		GOOD / 90

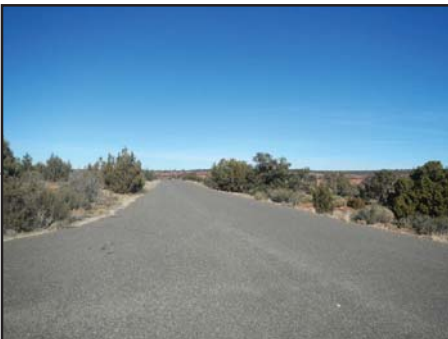
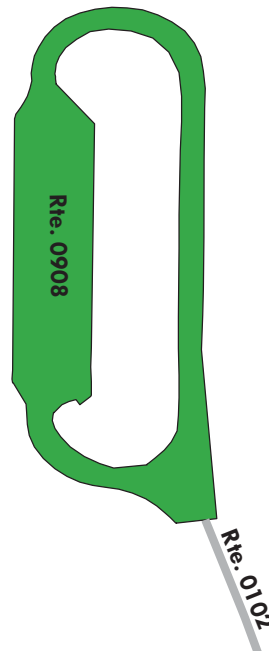
Inspection Date	FMSS Number	User Access	Surface Type
1/13/2016	68865	PUBLIC	ASPHALT
Area (Sq. Ft.)	Lane Miles (11' Widths)	Curb Reveal (Inches)	Curb Recommendation
25,508	0.439	NOT APPLICABLE	NOT APPLICABLE
Curb Type		Curb & Gutter Type	
NO CURB		CONCRETE	
Pavement Recommendation		Condition Rating / PCR	
PREVENTIVE MAINTENANCE		GOOD / 90

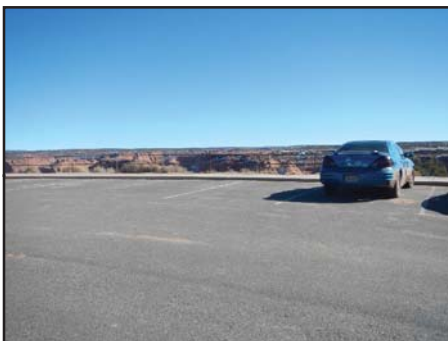
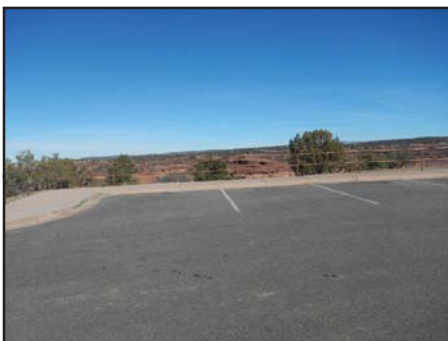
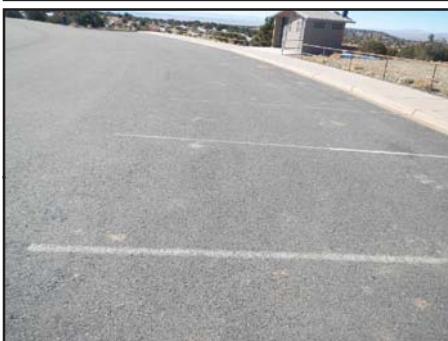
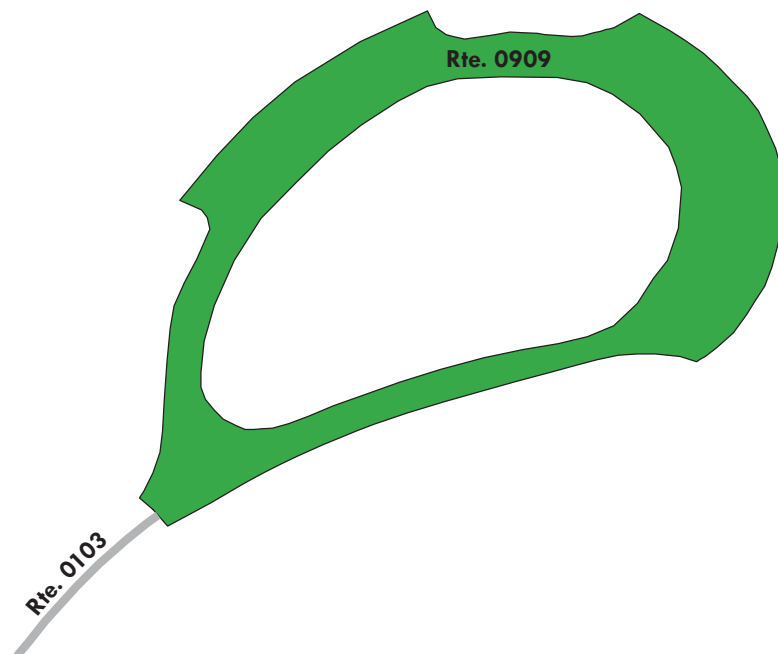
Inspection Date	FMSS Number	User Access	Surface Type
1/13/2016	68862	PUBLIC	ASPHALT
Area (Sq. Ft.)	Lane Miles (11' Widths)	Curb Reveal (Inches)	Curb Recommendation
31,064	0.535	4	DO NOTHING
Curb Type		Curb & Gutter Type	
CONCRETE		CONCRETE	
Pavement Recommendation		Condition Rating / PCR	
PREVENTIVE MAINTENANCE		GOOD / 90

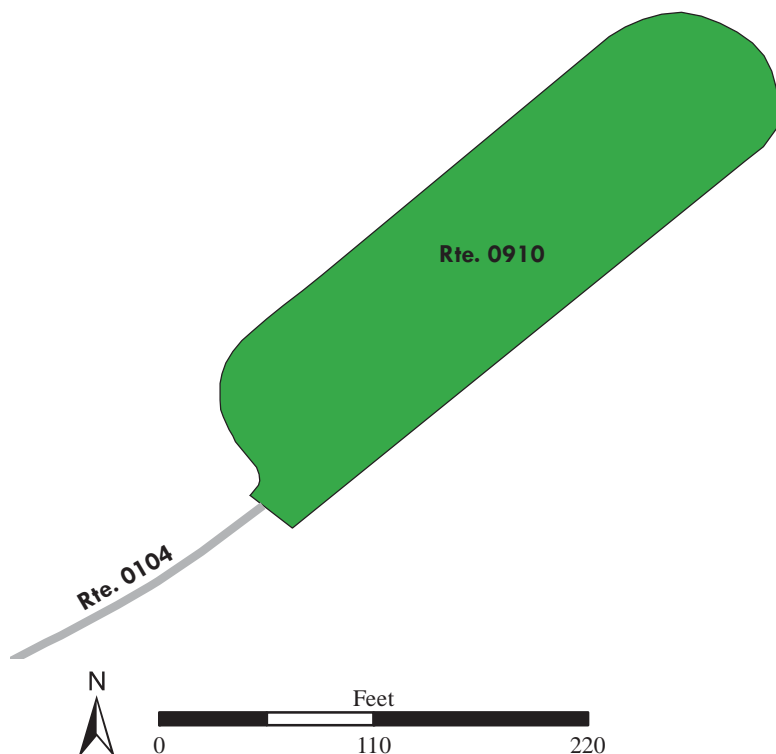
Inspection Date	FMSS Number	User Access	Surface Type
1/13/2016	68877	PUBLIC	ASPHALT
Area (Sq. Ft.)	Lane Miles (11' Widths)	Curb Reveal (Inches)	Curb Recommendation
24,161	0.416	6	DO NOTHING
Curb Type		Curb & Gutter Type	
CONCRETE		CONCRETE	
Pavement Recommendation		Condition Rating / PCR	
PREVENTIVE MAINTENANCE		GOOD / 90
