CACO Cycle 6

Final Report

Road Inventory and Condition Assessment of Paved Routes Cape Cod National Seashore

Cape Cod National Seashore in Massachusetts

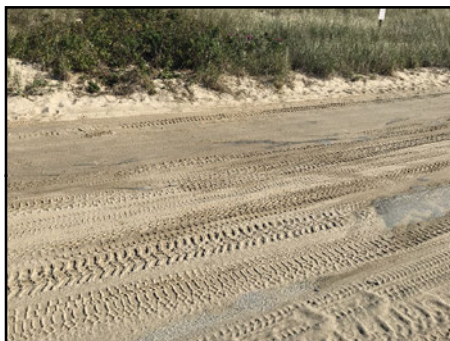
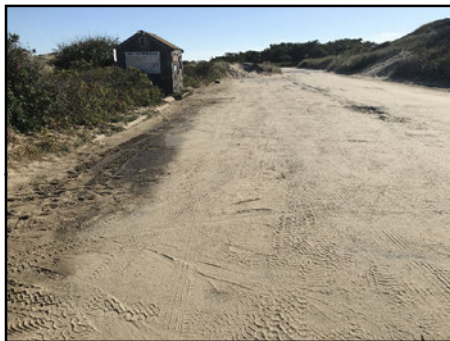
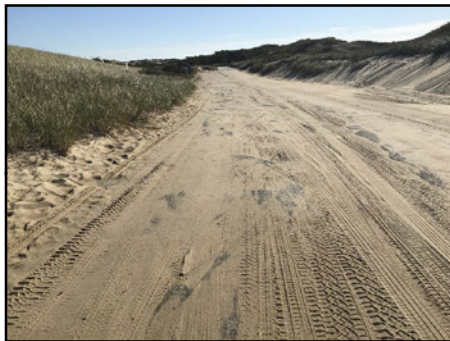
PARKING LOT WAS COVERED WITH SAND AND WAS NOT RATED.
CRACKING/DISTORTION VISIBLE IN AREAS WHERE PAVEMENT WAS OBSERVED.
