**CANA
Cycle 6**

**Road Inventory and Condition Assessment of Paved Routes
Canaveral National Seashore**

**Federal Lands Highway
Road Inventory Program**

Report Date: April 2020

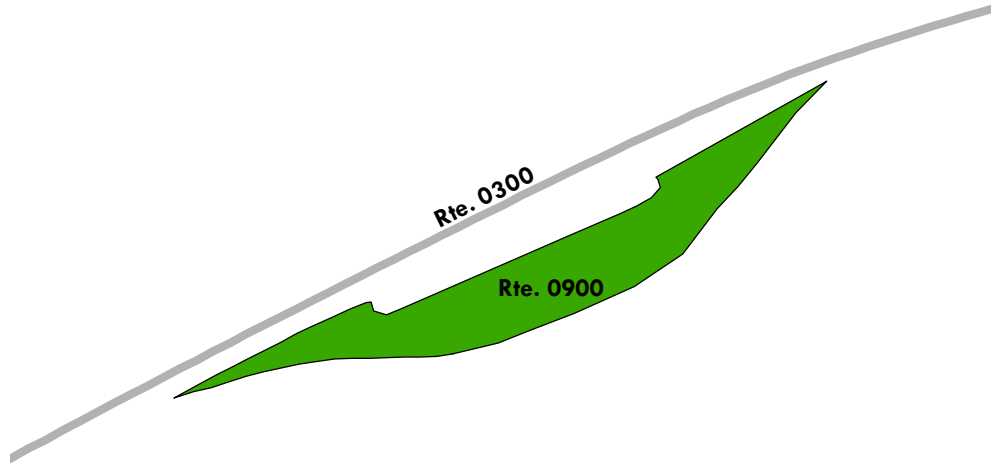
Inspection Date	FMSS Number	User Access	Surface Type
3/11/2019	60799	PUBLIC	ASPHALT
Area (Sq. Ft.)	Lane Miles (11' Widths)	Curb Reveal (Inches)	Curb Recommendation
3,810	0.066	NOT APPLICABLE	NOT APPLICABLE
Curb Type		Curb & Gutter Type	
NO CURB		NO CURB AND GUTTER	
Pavement Recommendation		Condition Rating / PCR	
PREVENTIVE MAINTENANCE		GOOD / 90

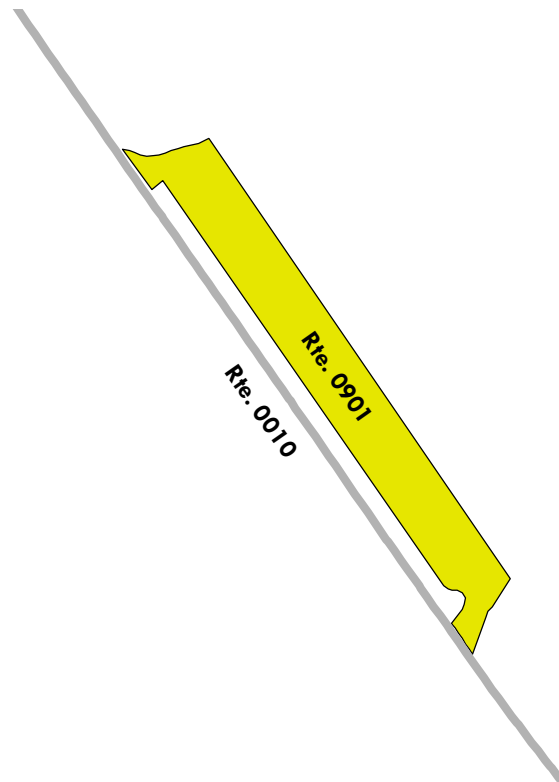
ROUTE 0901: PD PARKING #1

Inspection Date	FMSS Number	User Access	Surface Type
3/11/2019	60815	PUBLIC	ASPHALT
Area (Sq. Ft.)	Lane Miles (11' Widths)	Curb Reveal (Inches)	Curb Recommendation
28,772	0.495	NOT APPLICABLE	NOT APPLICABLE
Curb Type		Curb & Gutter Type	
NO CURB		NO CURB AND GUTTER	
Pavement Recommendation		Condition Rating / PCR	
LIGHT 3R TREATMENTS		FAIR / 73

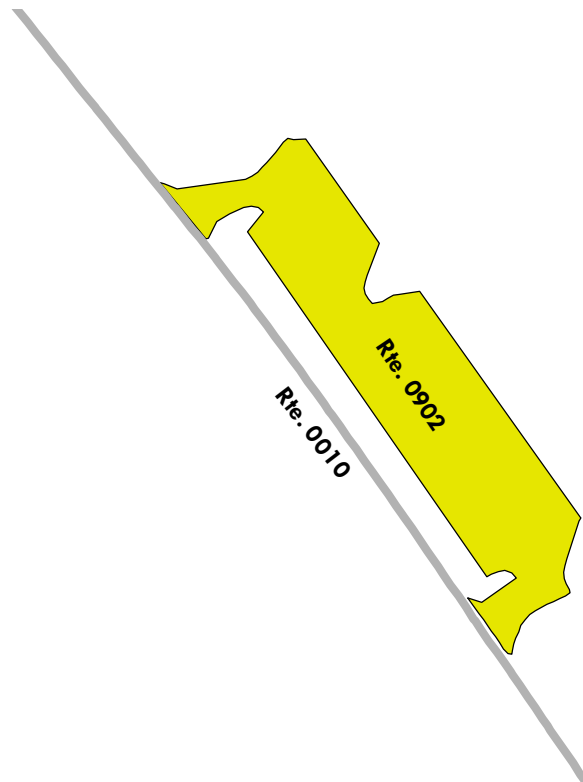
ROUTE 0902: PD PARKING #2

Inspection Date	FMSS Number	User Access	Surface Type
3/11/2019	60817	PUBLIC	ASPHALT
Area (Sq. Ft.)	Lane Miles (11' Widths)	Curb Reveal (Inches)	Curb Recommendation
36,304	0.625	NOT APPLICABLE	NOT APPLICABLE
Curb Type		Curb & Gutter Type	
NO CURB		NO CURB AND GUTTER	
Pavement Recommendation		Condition Rating / PCR	
LIGHT 3R TREATMENTS		FAIR / 73

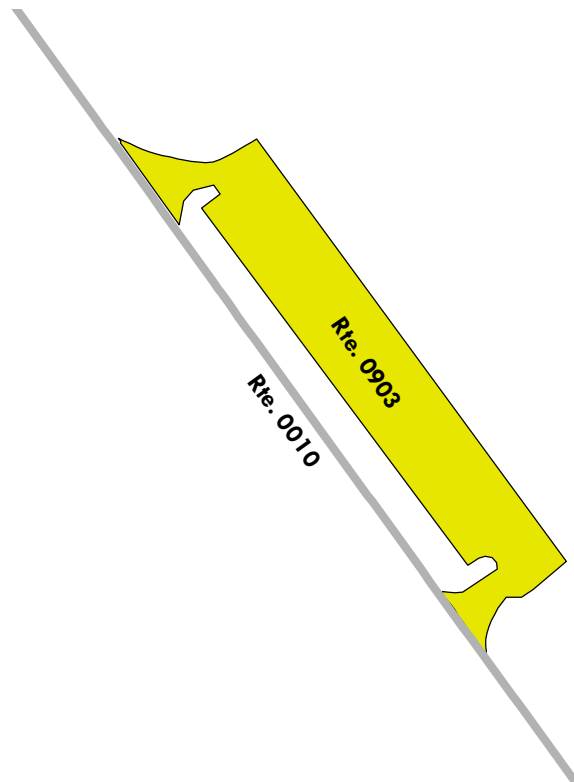
ROUTE 0903: PD PARKING #3

Inspection Date	FMSS Number	User Access	Surface Type
3/11/2019	60818	PUBLIC	ASPHALT
Area (Sq. Ft.)	Lane Miles (11' Widths)	Curb Reveal (Inches)	Curb Recommendation
31,067	0.535	NOT APPLICABLE	NOT APPLICABLE
Curb Type		Curb & Gutter Type	
NO CURB		NO CURB AND GUTTER	
Pavement Recommendation		Condition Rating / PCR	
LIGHT 3R TREATMENTS		FAIR / 73

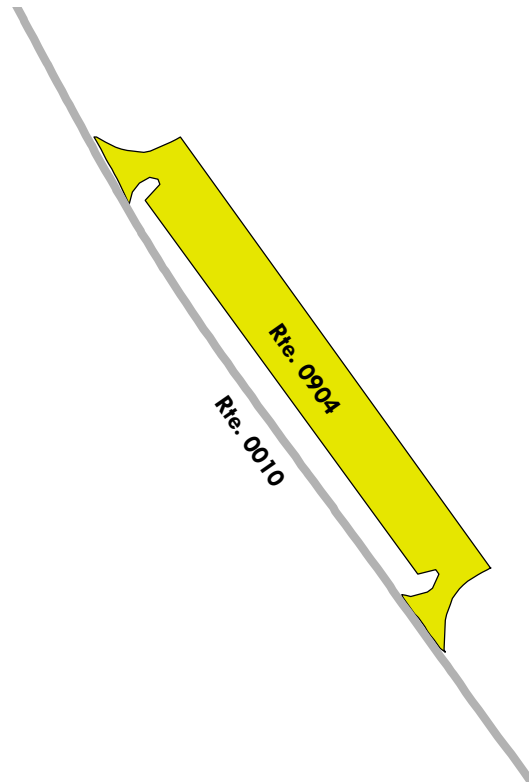
ROUTE 0904: PD PARKING #4

Inspection Date	FMSS Number	User Access	Surface Type
3/11/2019	60819	PUBLIC	ASPHALT
Area (Sq. Ft.)	Lane Miles (11' Widths)	Curb Reveal (Inches)	Curb Recommendation
39,969	0.688	NOT APPLICABLE	NOT APPLICABLE
Curb Type		Curb & Gutter Type	
NO CURB		NO CURB AND GUTTER	
Pavement Recommendation		Condition Rating / PCR	
LIGHT 3R TREATMENTS		FAIR / 73

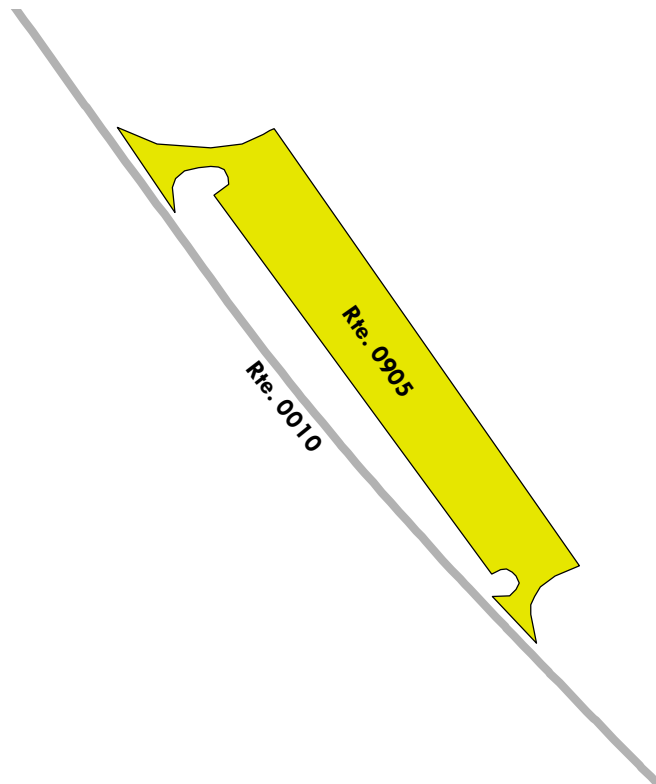
ROUTE 0905: PD PARKING #5

Inspection Date	FMSS Number	User Access	Surface Type
3/11/2019	60820	PUBLIC	ASPHALT
Area (Sq. Ft.)	Lane Miles (11' Widths)	Curb Reveal (Inches)	Curb Recommendation
33,407	0.575	NOT APPLICABLE	NOT APPLICABLE
Curb Type		Curb & Gutter Type	
NO CURB		NO CURB AND GUTTER	
Pavement Recommendation		Condition Rating / PCR	
LIGHT 3R TREATMENTS		FAIR / 73

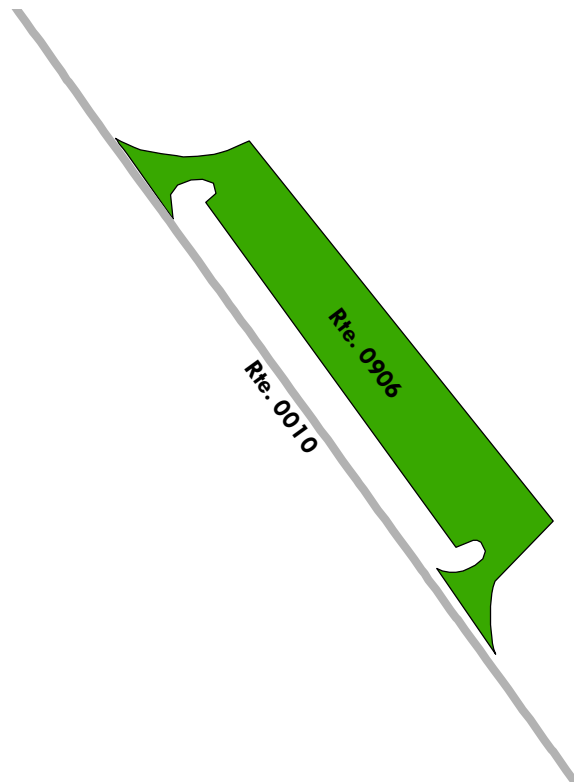
ROUTE 0906: PD PARKING #6

Inspection Date	FMSS Number	User Access	Surface Type
3/11/2019	60827	PUBLIC	ASPHALT
Area (Sq. Ft.)	Lane Miles (11' Widths)	Curb Reveal (Inches)	Curb Recommendation
38,741	0.667	NOT APPLICABLE	NOT APPLICABLE
Curb Type		Curb & Gutter Type	
NO CURB		NO CURB AND GUTTER	
Pavement Recommendation		Condition Rating / PCR	
PREVENTIVE MAINTENANCE		GOOD / 90

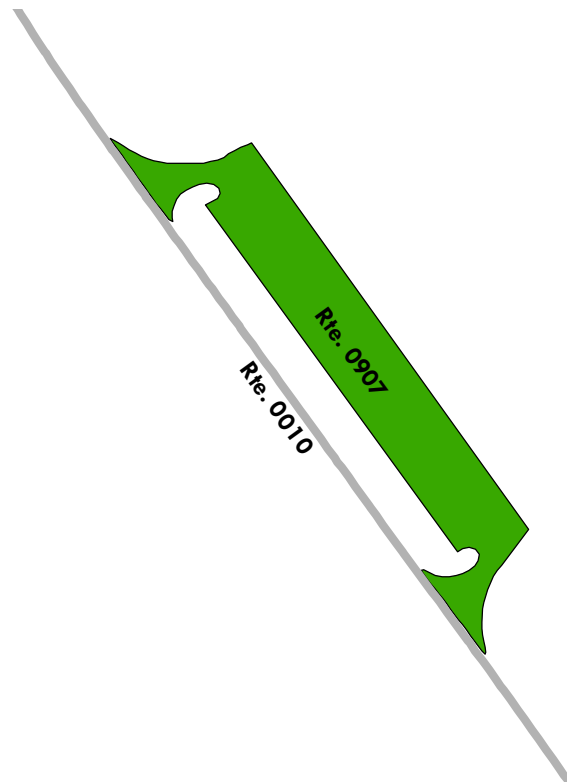
ROUTE 0907: PD PARKING #7

Inspection Date	FMSS Number	User Access	Surface Type
3/11/2019	60826	PUBLIC	ASPHALT
Area (Sq. Ft.)	Lane Miles (11' Widths)	Curb Reveal (Inches)	Curb Recommendation
34,681	0.597	NOT APPLICABLE	NOT APPLICABLE
Curb Type		Curb & Gutter Type	
NO CURB		NO CURB AND GUTTER	
Pavement Recommendation		Condition Rating / PCR	
PREVENTIVE MAINTENANCE		GOOD / 90

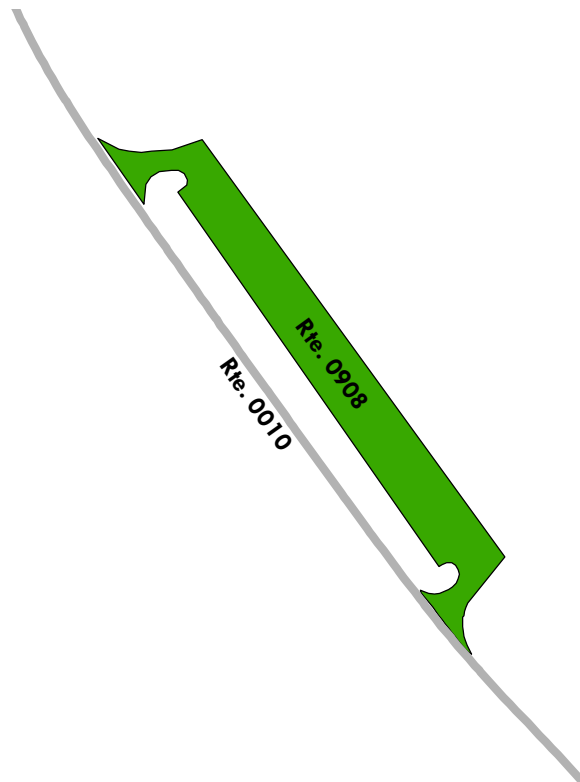
ROUTE 0908: PD PARKING #8

Inspection Date	FMSS Number	User Access	Surface Type
3/11/2019	60829	PUBLIC	ASPHALT
Area (Sq. Ft.)	Lane Miles (11' Widths)	Curb Reveal (Inches)	Curb Recommendation
43,430	0.748	NOT APPLICABLE	NOT APPLICABLE
Curb Type		Curb & Gutter Type	
NO CURB		NO CURB AND GUTTER	
Pavement Recommendation		Condition Rating / PCR	
PREVENTIVE MAINTENANCE		GOOD / 90

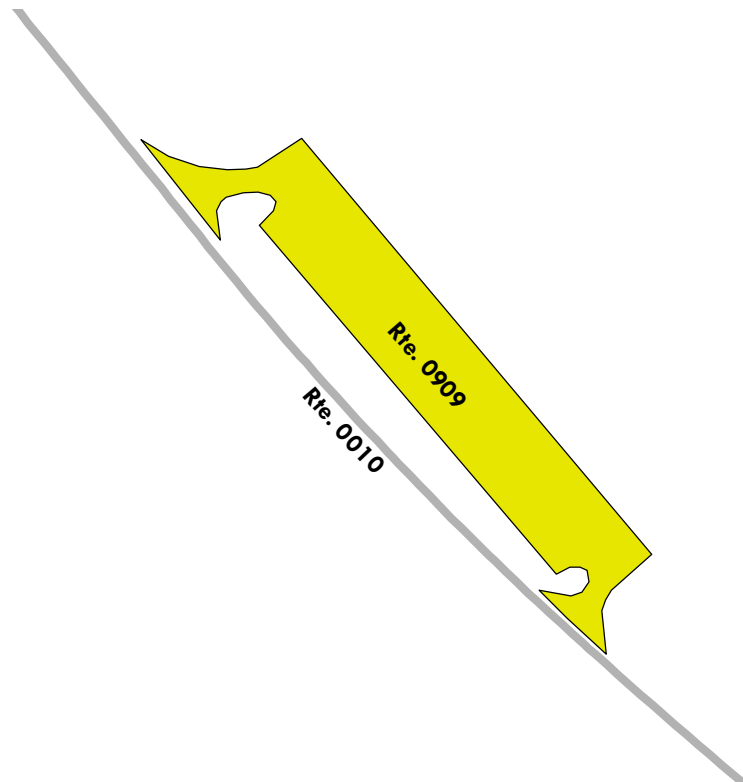
ROUTE 0909: PD PARKING #9

Inspection Date	FMSS Number	User Access	Surface Type
3/11/2019	60831	PUBLIC	ASPHALT
Area (Sq. Ft.)	Lane Miles (11' Widths)	Curb Reveal (Inches)	Curb Recommendation
29,732	0.512	NOT APPLICABLE	NOT APPLICABLE
Curb Type		Curb & Gutter Type	
NO CURB		NO CURB AND GUTTER	
Pavement Recommendation		Condition Rating / PCR	
LIGHT 3R TREATMENTS		FAIR / 73

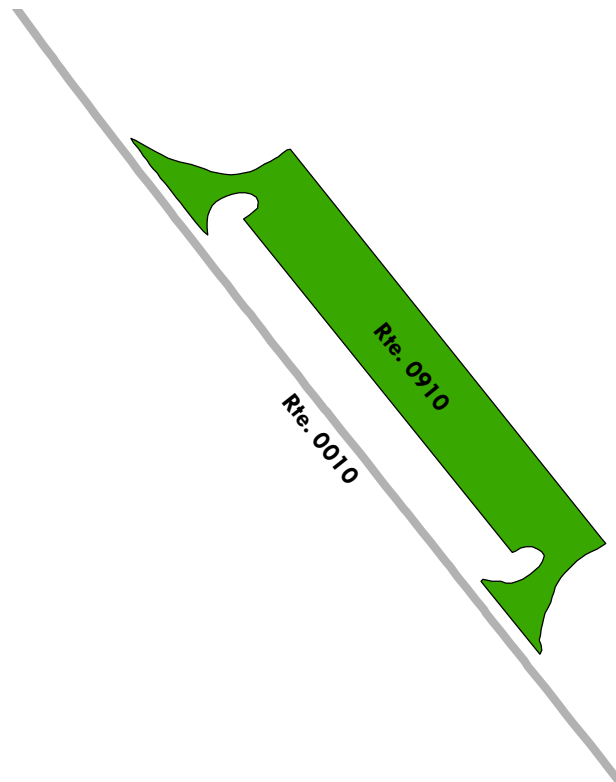
ROUTE 0910: PD PARKING #10

Inspection Date	FMSS Number	User Access	Surface Type
3/11/2019	60832	PUBLIC	ASPHALT
Area (Sq. Ft.)	Lane Miles (11' Widths)	Curb Reveal (Inches)	Curb Recommendation
30,054	0.517	NOT APPLICABLE	NOT APPLICABLE
Curb Type		Curb & Gutter Type	
NO CURB		NO CURB AND GUTTER	
Pavement Recommendation		Condition Rating / PCR	
PREVENTIVE MAINTENANCE		GOOD / 90
