CASA Cycle 6

Final Report

Road Inventory and Condition Assessment of Paved Routes Castillo de San Marcos National Monument

Report Date: April 2020

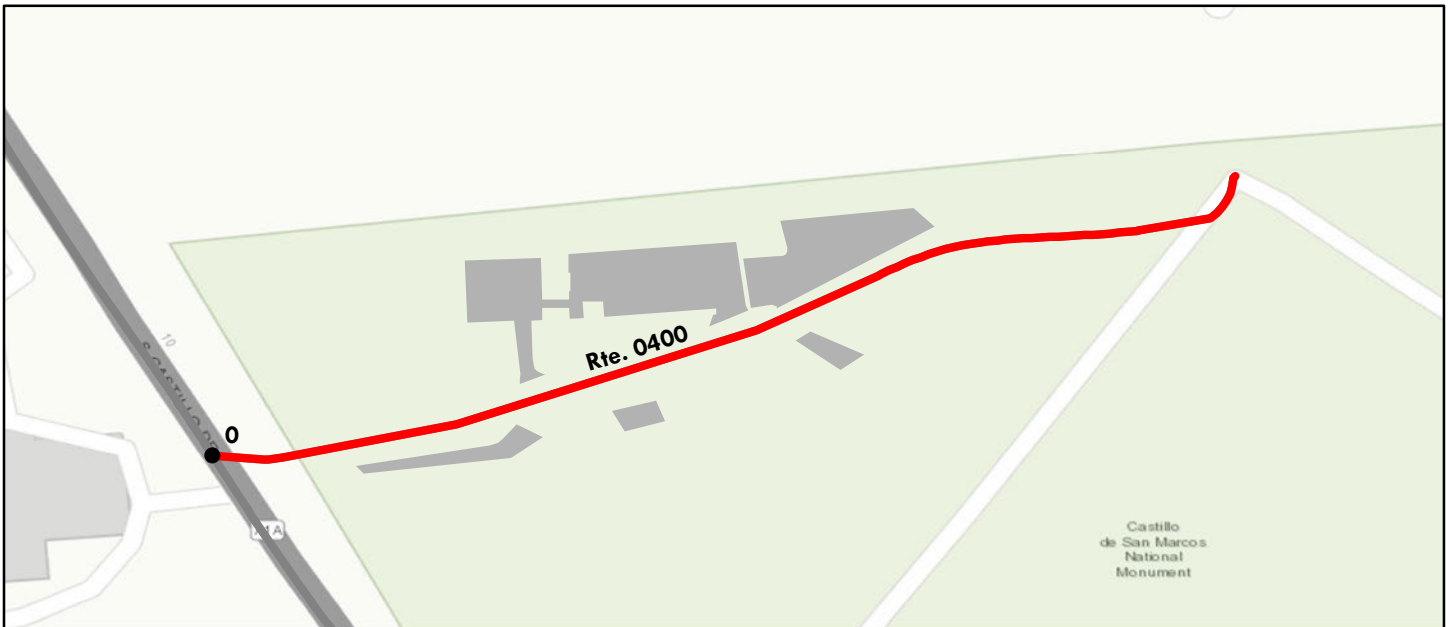
ROUTE 0400: SERVICE ACCESS ROAD

Inspection Date: 4/4/2019	Beginning Section MP	0				
Paved Length (Miles): 0.11	Section Length (MI)	0.11				
Surface Type: ASPHALT	Route Summary					
Roadway Condition Information						
Pavement Condition Rating (PCR)	47	47				
Surface Condition Rating (SCR)	47	47				
Roughness Condition Index (RCI)	N/A	N/A				
Distress Index Values						
Structural Crack Index	49	49				
Alligator Crack Index	100	100				
Longitudinal Crack Index	49	49				
Transverse Cracking Index	47	47				
Patching Index	100	100				
Rutting Index	93	93				
International Roughness Index (IRI)	N/A	N/A				
Lane & Width Information						
Number of Lanes	2	2				
Paved Width (ft)	17.4	17.4				
Lane Width (ft)	9.4	9.4

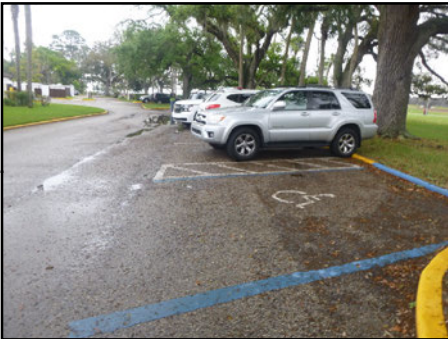
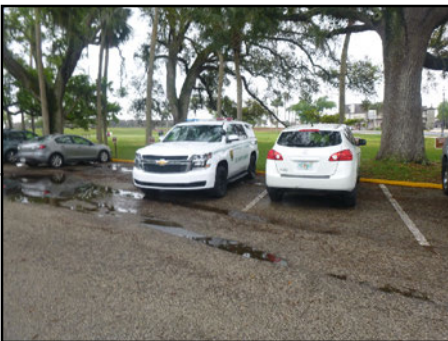
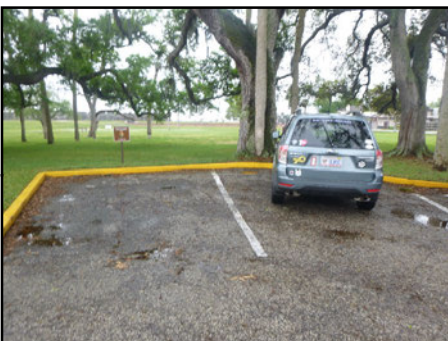
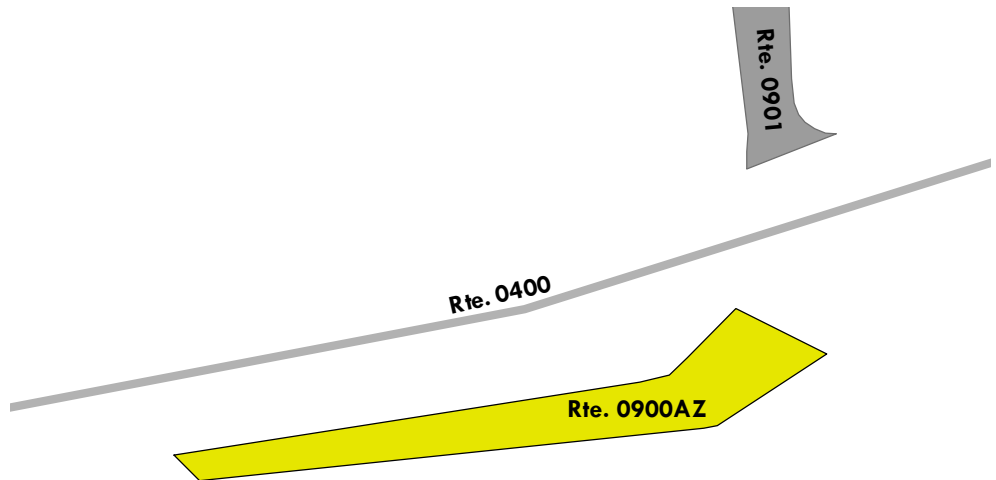
ROUTE 0900AZ: ADMINISTRATIVE AREA A

Inspection Date	FMSS Number	User Access	Surface Type
4/4/2019	37033	NONPUBLIC	ASPHALT
Area (Sq. Ft.)	Lane Miles (11' Widths)	Curb Reveal (Inches)	Curb Recommendation
919	0.016	3	DO NOTHING
Curb Type		Curb & Gutter Type	
CONCRETE		NO CURB AND GUTTER	
Pavement Recommendation		Condition Rating / PCR	
LIGHT 3R TREATMENTS		FAIR / 73

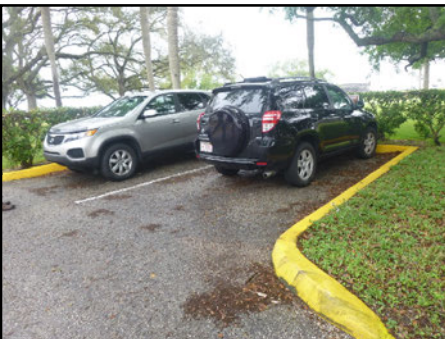
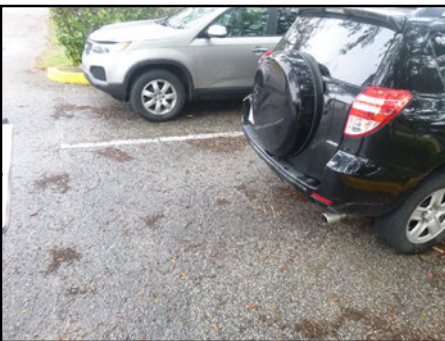
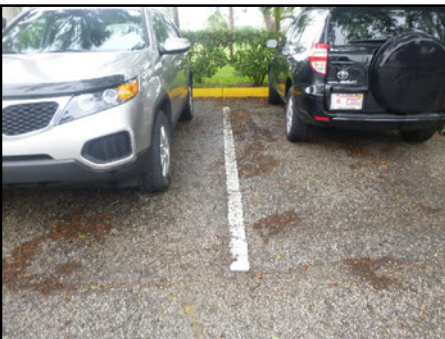
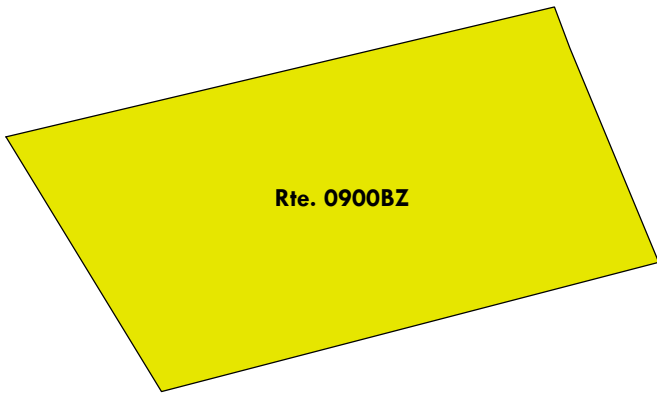
ROUTE 0900BZ: ADMINISTRATIVE AREA B

Inspection Date	FMISS Number	User Access	Surface Type
4/4/2019	37033	NONPUBLIC	ASPHALT
Area (Sq. Ft.)	Lane Miles (11' Widths)	Curb Reveal (Inches)	Curb Recommendation
362	0.006	4	DO NOTHING
Curb Type		Curb & Gutter Type	
CONCRETE		NO CURB AND GUTTER	
Pavement Recommendation		Condition Rating / PCR	
LIGHT 3R TREATMENTS		FAIR / 73

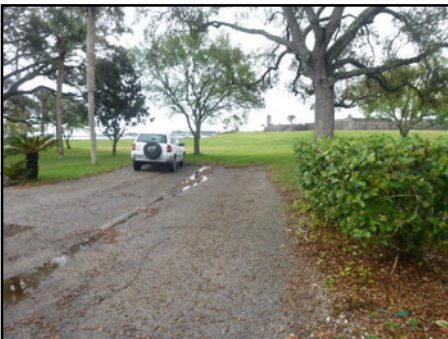
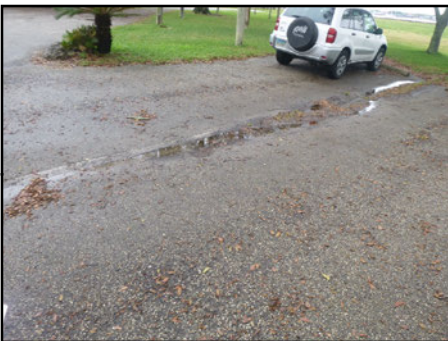
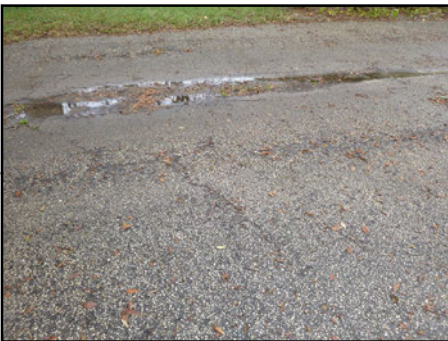
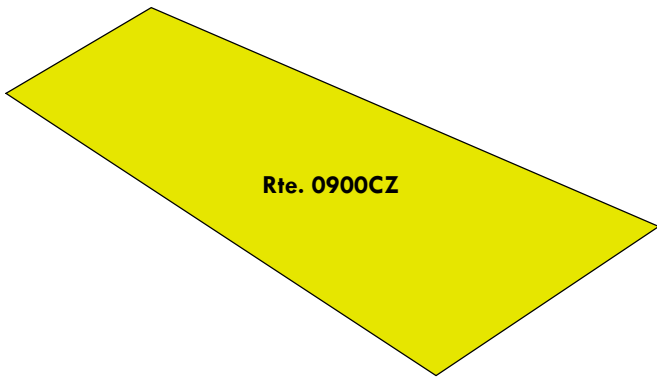
ROUTE 0900CZ: ADMINISTRATIVE AREA C

Inspection Date	FMSS Number	User Access	Surface Type
4/4/2019	37033	NONPUBLIC	ASPHALT
Area (Sq. Ft.)	Lane Miles (11' Widths)	Curb Reveal (Inches)	Curb Recommendation
407	0.007	NOT APPLICABLE	NOT APPLICABLE
Curb Type		Curb & Gutter Type	
NO CURB		NO CURB AND GUTTER	
Pavement Recommendation		Condition Rating / PCR	
LIGHT 3R TREATMENTS		FAIR / 73

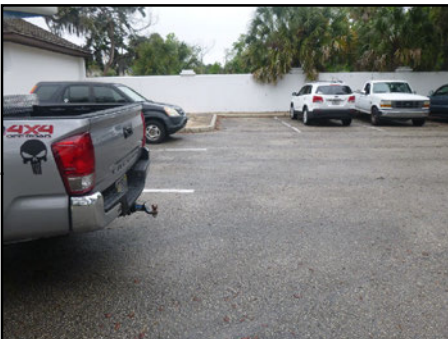
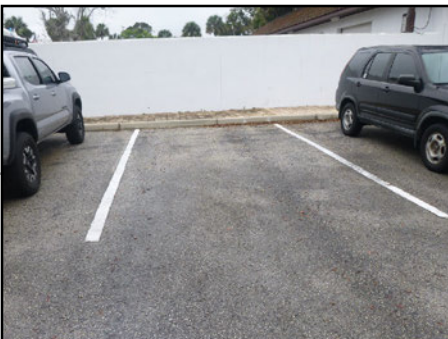
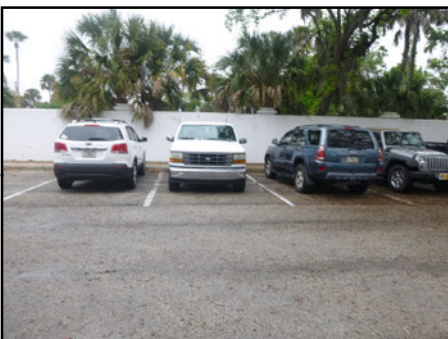
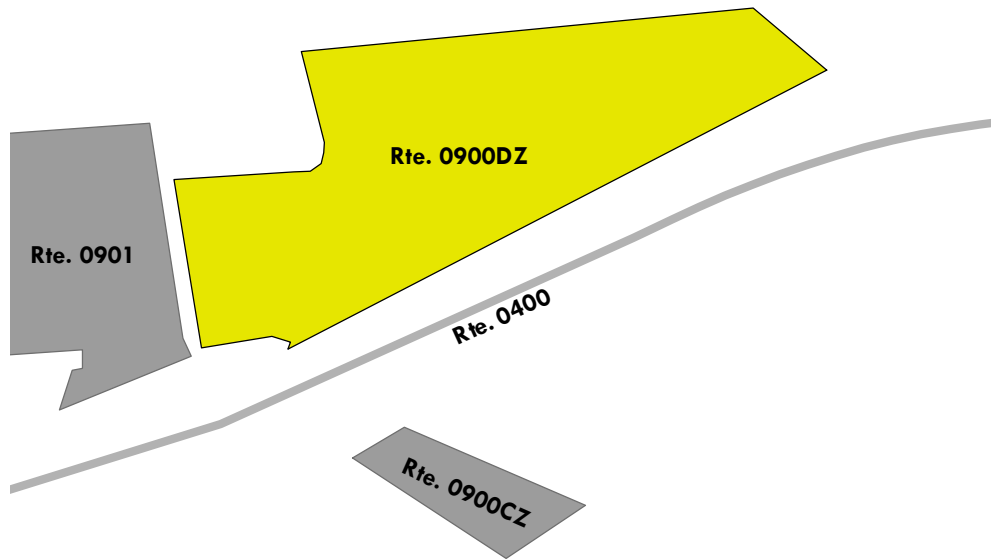
ROUTE 0900DZ: ADMINISTRATIVE AREA D

Inspection Date	FMSS Number	User Access	Surface Type
4/4/2019	37033	NONPUBLIC	ASPHALT
Area (Sq. Ft.)	Lane Miles (11' Widths)	Curb Reveal (Inches)	Curb Recommendation
3,468	0.06	4	LIGHT REPAIR
Curb Type		Curb & Gutter Type	
CONCRETE		NO CURB AND GUTTER	
Pavement Recommendation		Condition Rating / PCR	
LIGHT 3R TREATMENTS		FAIR / 73

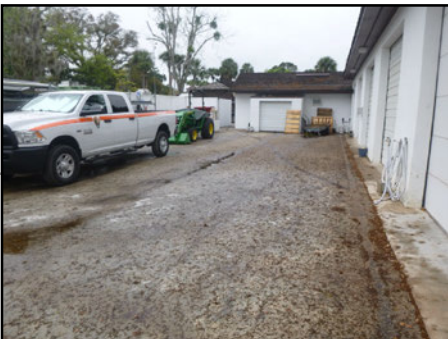
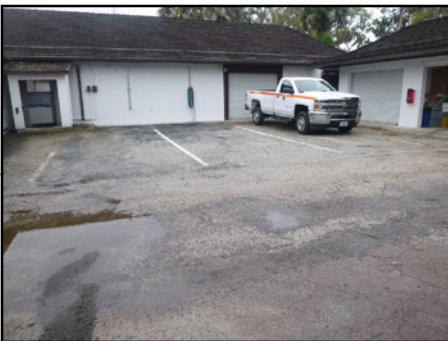
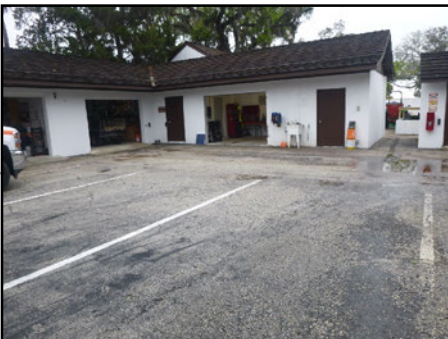
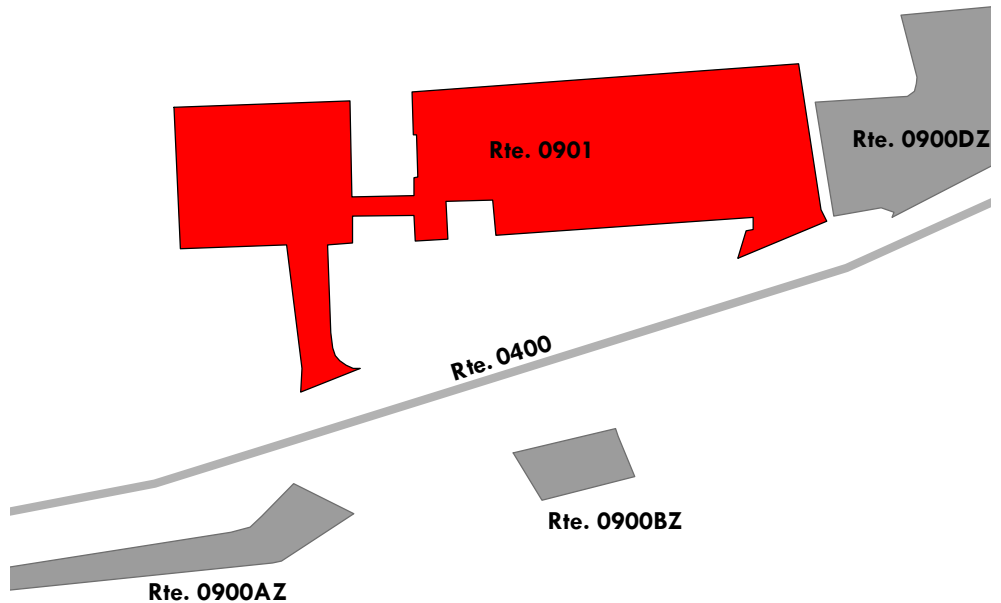
ROUTE 0901: MAINTENANCE AREA

Inspection Date	FMSS Number	User Access	Surface Type
4/4/2019	37034	NONPUBLIC	ASPHALT
Area (Sq. Ft.)	Lane Miles (11' Widths)	Curb Reveal (Inches)	Curb Recommendation
6,257	0.108	4	DO NOTHING
Curb Type		Curb & Gutter Type	
CONCRETE		NO CURB AND GUTTER	
Pavement Recommendation		Condition Rating / PCR	
HEAVY 3R TREATMENTS		POOR / 53

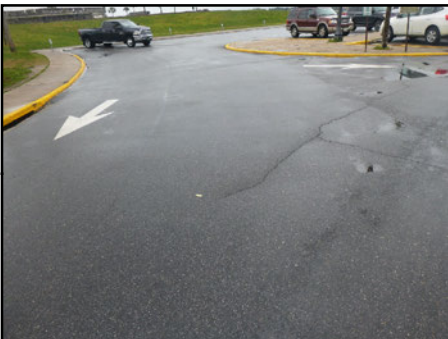
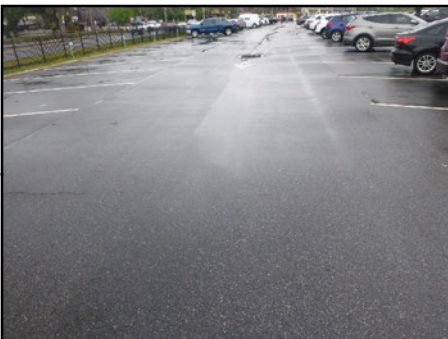
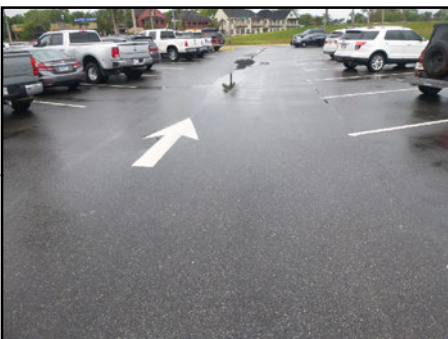
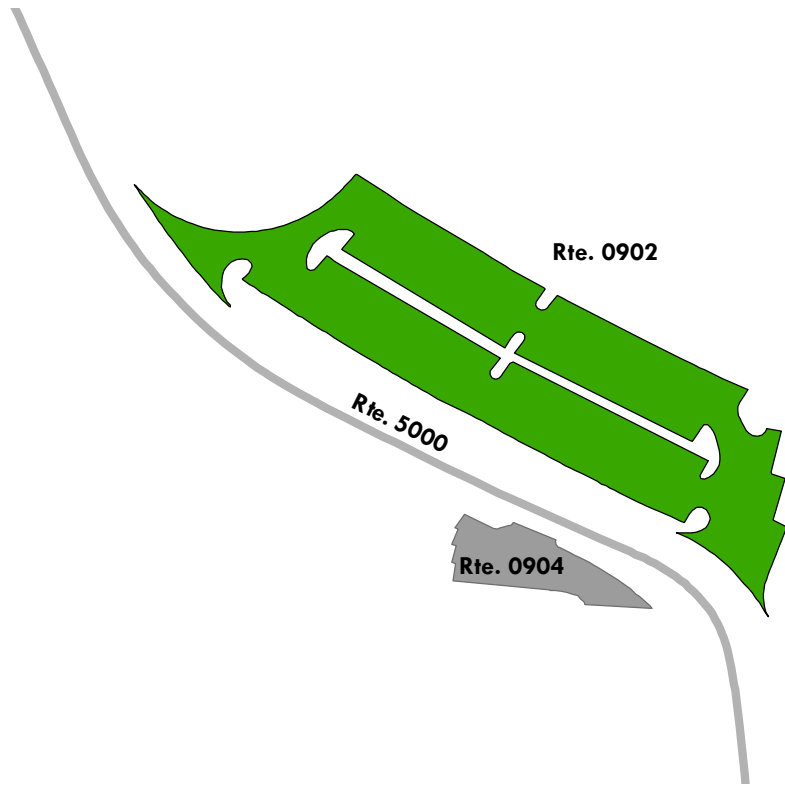
ROUTE 0902: VISITOR PARKING

Inspection Date	FMSS Number	User Access	Surface Type
4/4/2019	37031	PUBLIC	ASPHALT
Area (Sq. Ft.)	Lane Miles (11' Widths)	Curb Reveal (Inches)	Curb Recommendation
54,440	0.937	2	DO NOTHING
Curb Type		Curb & Gutter Type	
CONCRETE		CONCRETE	
Pavement Recommendation		Condition Rating / PCR	
PREVENTIVE MAINTENANCE		GOOD / 90

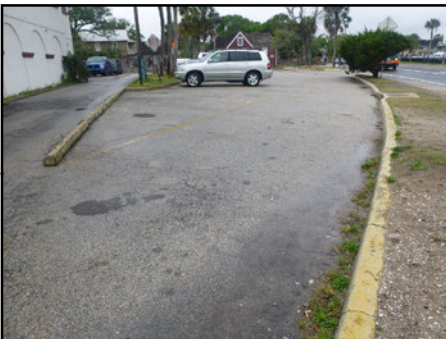
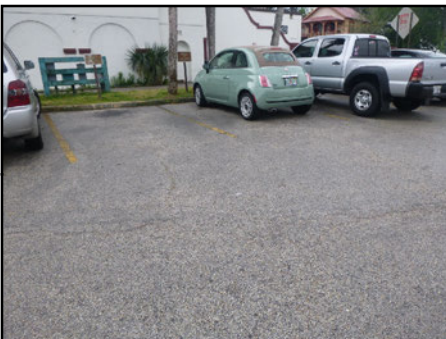
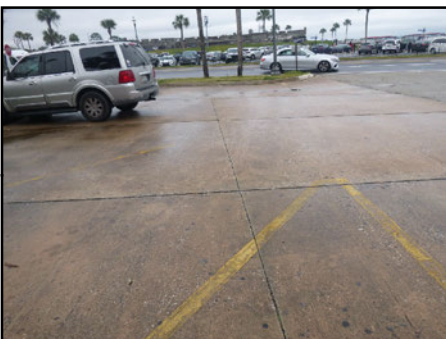
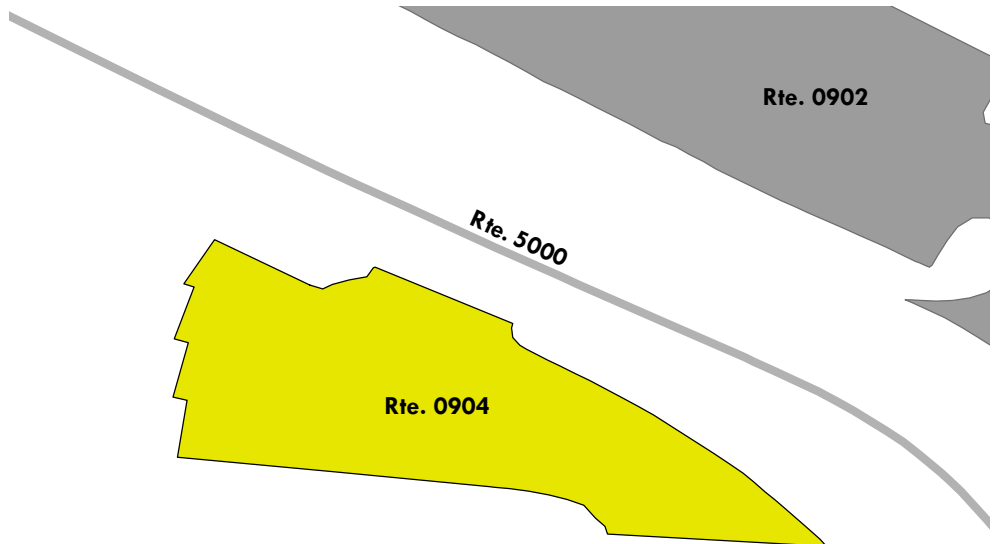
ROUTE 0904: EMPLOYEE PARKING

Inspection Date	FMSS Number	User Access	Surface Type
4/4/2019	37032	NONPUBLIC	ASPHALT
Area (Sq. Ft.)	Lane Miles (11' Widths)	Curb Reveal (Inches)	Curb Recommendation
6,162	0.106	4	LIGHT REPAIR
Curb Type		Curb & Gutter Type	
CONCRETE		NO CURB AND GUTTER	
Pavement Recommendation		Condition Rating / PCR	
LIGHT 3R TREATMENTS		FAIR / 73

Note: Parking area consists of multiple surface types: 1 part Asphalt at 4,046 square feet; 1 part Concrete at 2,116 square feet.
