CATO Cycle 6

Final Report

Road Inventory and Condition Assessment of Paved Routes Catoctin Mountain Park

**Federal Highway Administration
Eastern Federal Lands Highway Division
Road Inventory Program (RIP)**

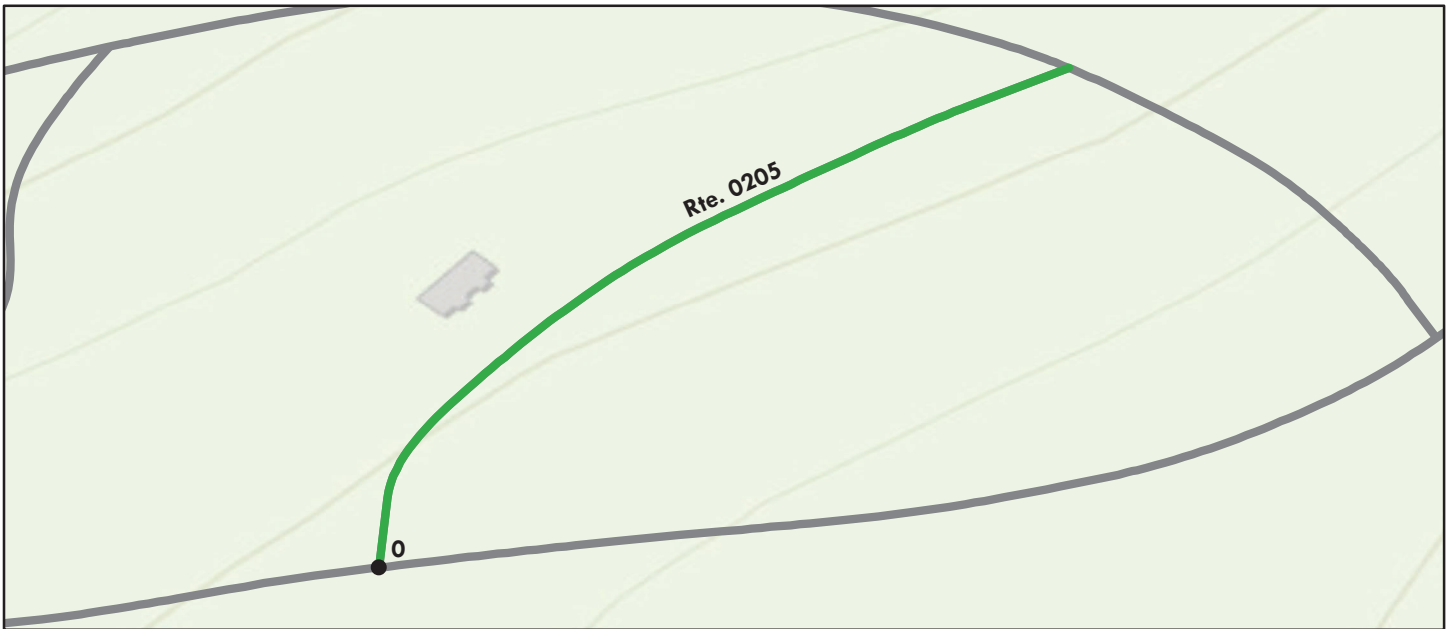
Inspection Date:	7/30/2018	Beginning Section MP	0				
Paved Length (Miles):	0.08	Section Length (MI)	0.08				
Surface Type:	ASPHALT	Route Summary					
Roadway Condition Information							
Pavement Condition Rating (PCR)	88	88					
Surface Condition Rating (SCR)	88	88					
Roughness Condition Index (RCI)	N/A	N/A					
Distress Index Values							
Structural Crack Index	95	95					
Alligator Crack Index	100	100					
Longitudinal Crack Index	95	95					
Transverse Cracking Index	100	100					
Patching Index	100	100					
Rutting Index	88	88					
International Roughness Index (IRI)	N/A	N/A					
Lane & Width Information							
Number of Lanes	1	1					
Paved Width (ft)	12.3	12.3					
Lane Width (ft)	12.3	12.3

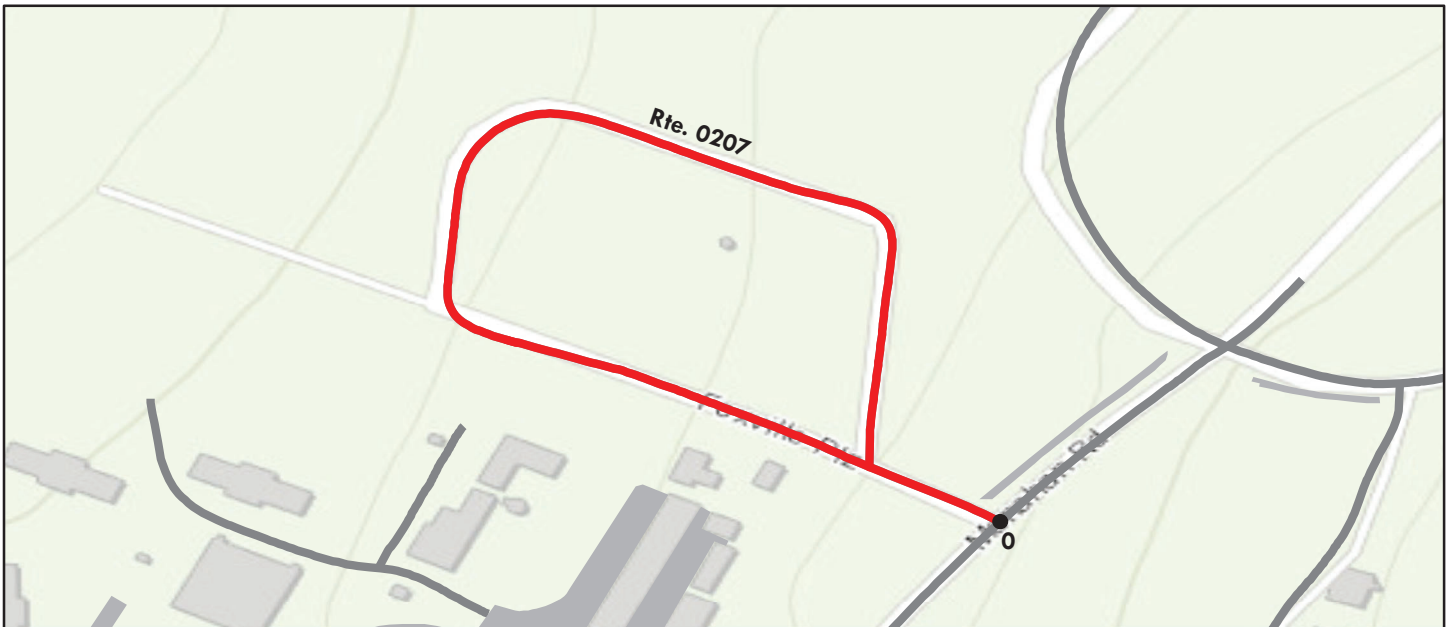
Inspection Date: 7/30/2018	Beginning Section MP	0				
Paved Length (Miles): 0.30	Section Length (MI)	0.30				
Surface Type: ASPHALT	Route Summary					
Roadway Condition Information						
Pavement Condition Rating (PCR)	0	0				
Surface Condition Rating (SCR)	0	0				
Roughness Condition Index (RCI)	N/A	N/A				
Distress Index Values						
Structural Crack Index	0	0				
Alligator Crack Index	86	86				
Longitudinal Crack Index	12	12				
Transverse Cracking Index	70	70				
Patching Index	97	97				
Rutting Index	85	85				
International Roughness Index (IRI)	N/A	N/A				
Lane & Width Information						
Number of Lanes	1	1				
Paved Width (ft)	20.2	20.2				
Lane Width (ft)	20.2	20.2

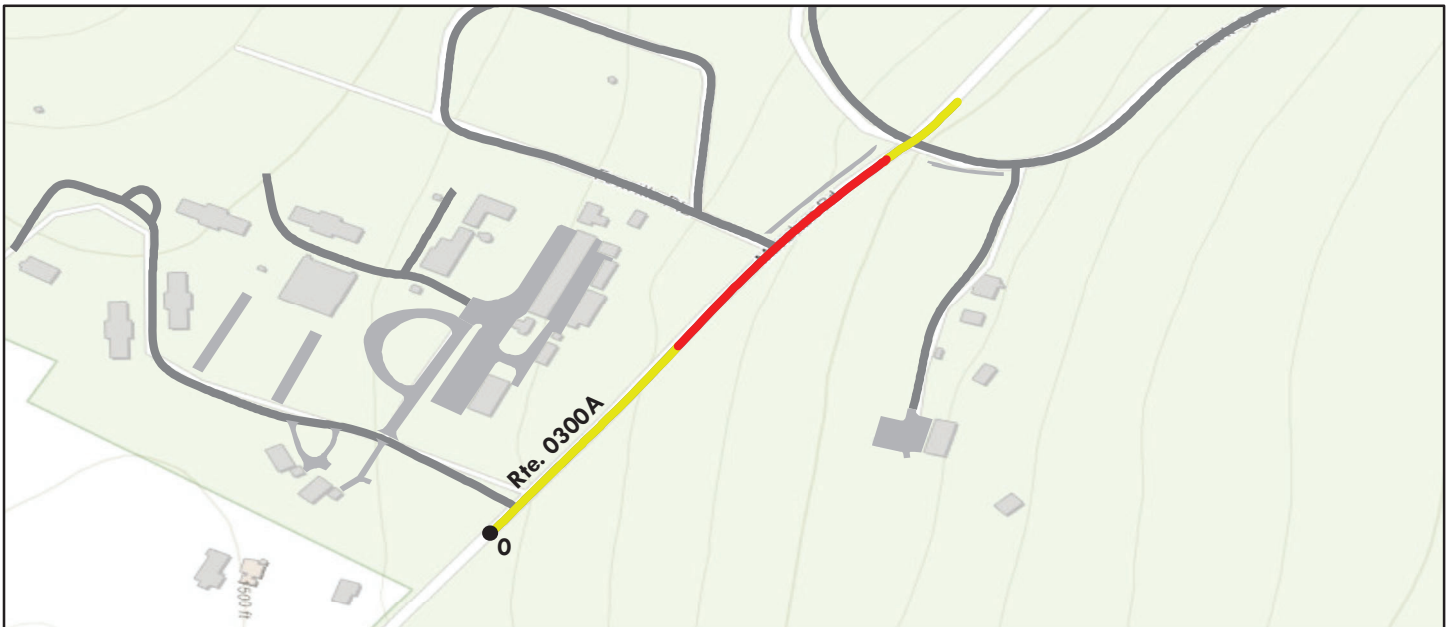
Inspection Date: 7/30/2018	Beginning Section MP	0				
Paved Length (Miles): 0.23	Section Length (MI)	0.23				
Surface Type: ASPHALT	Route Summary					
Roadway Condition Information						
Pavement Condition Rating (PCR)	45	45				
Surface Condition Rating (SCR)	45	45				
Roughness Condition Index (RCI)	N/A	N/A				
Distress Index Values						
Structural Crack Index	45	45				
Alligator Crack Index	95	95				
Longitudinal Crack Index	50	50				
Transverse Cracking Index	82	82				
Patching Index	100	100				
Rutting Index	95	95				
International Roughness Index (IRI)	N/A	N/A				
Lane & Width Information						
Number of Lanes	2	2				
Paved Width (ft)	19	19				
Lane Width (ft)	8.8	8.8

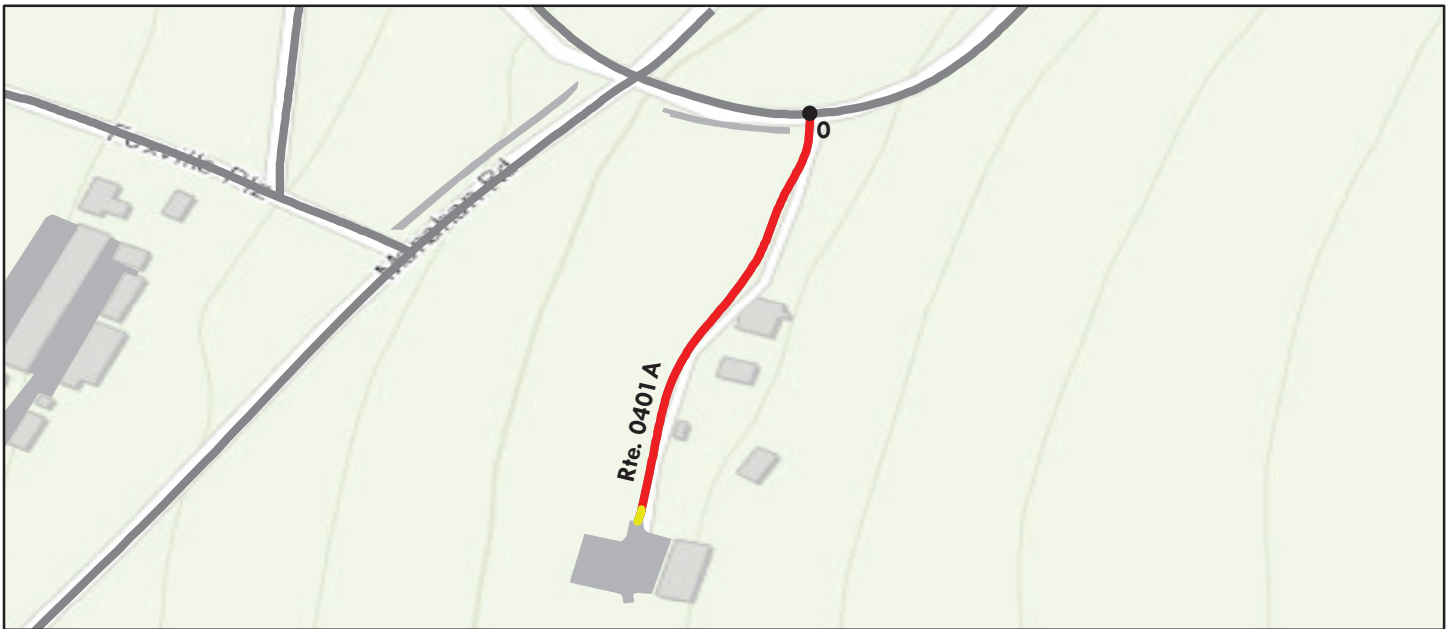
Inspection Date: 7/30/2018	Beginning Section MP	0				
Paved Length (Miles): 0.10	Section Length (MI)	0.10				
Surface Type: ASPHALT	Route Summary					
Roadway Condition Information						
Pavement Condition Rating (PCR)	38	38				
Surface Condition Rating (SCR)	38	38				
Roughness Condition Index (RCI)	N/A	N/A				
Distress Index Values						
Structural Crack Index	38	38				
Alligator Crack Index	68	68				
Longitudinal Crack Index	70	70				
Transverse Cracking Index	94	94				
Patching Index	100	100				
Rutting Index	90	90				
International Roughness Index (IRI)	N/A	N/A				
Lane & Width Information						
Number of Lanes	1	1				
Paved Width (ft)	11	11				
Lane Width (ft)	11	11

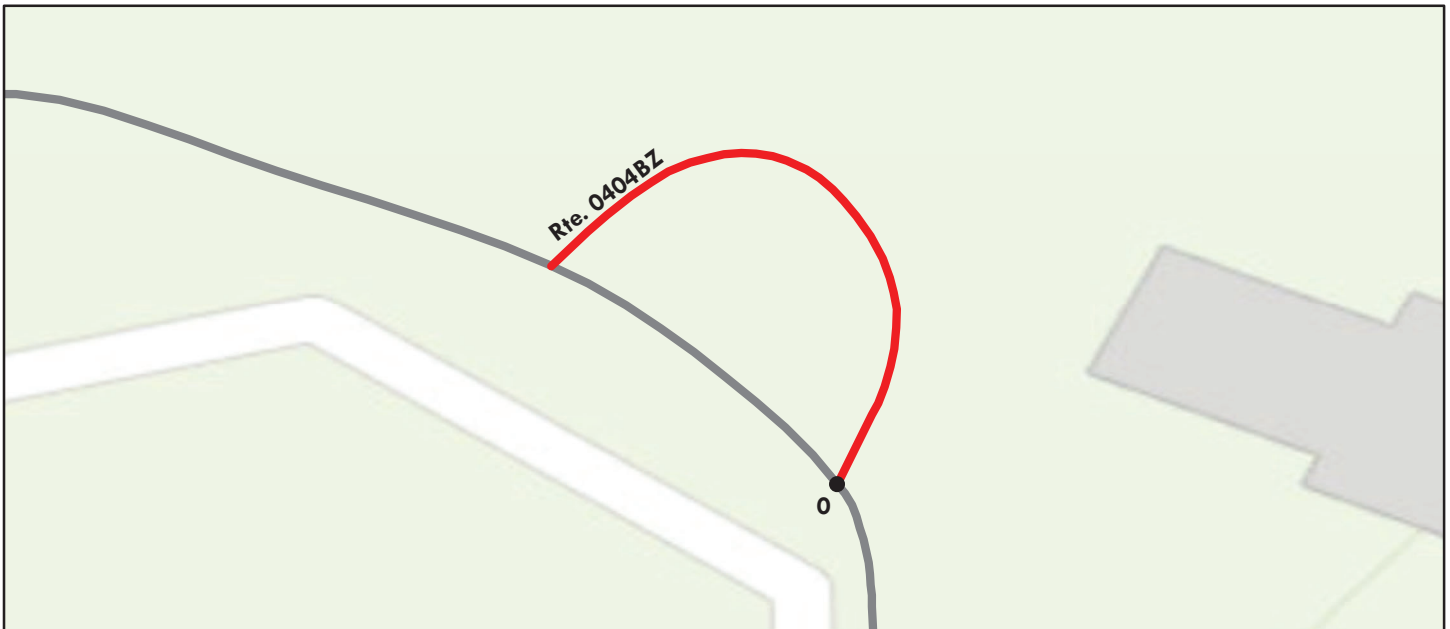
Manual Rating

Inspection Date: 8/9/2018	Beginning Section MP	0.00				
Paved Length (Miles): 0.02	Section Length (MI)	0.02				
Surface Type: ASPHALT	Route Summary					
Roadway Condition Information						
Pavement Condition Rating (PCR)	30	30				
Surface Condition Rating (SCR)	30	30				
Roughness Condition Index (RCI)	N/A	N/A				
Distress Index Values						
Structural Crack Index	N/A	N/A				
Alligator Crack Index	30	30				
Longitudinal Crack Index	73	73				
Transverse Cracking Index	90	90				
Patching Index	90	90				
Rutting Index	73	73				
International Roughness Index (IRI)	N/A	N/A				
Lane & Width Information						
Number of Lanes	1	1				
Paved Width (ft)	12	12				
Lane Width (ft)	12	12
