CEBR Cycle 6

Final Report

Road Inventory and Condition Assessment of Paved Routes Cedar Breaks National Monument

Report Date: December 2016

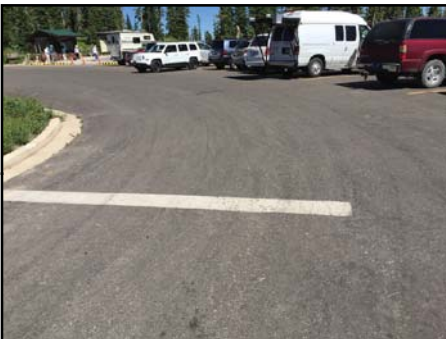
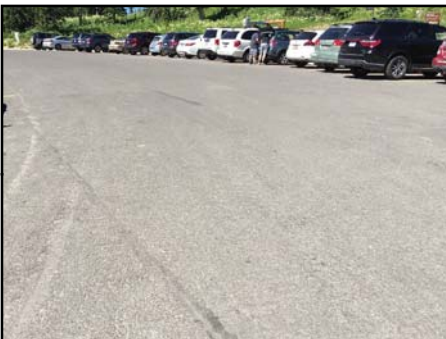
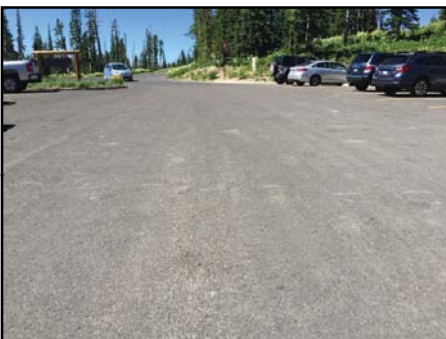
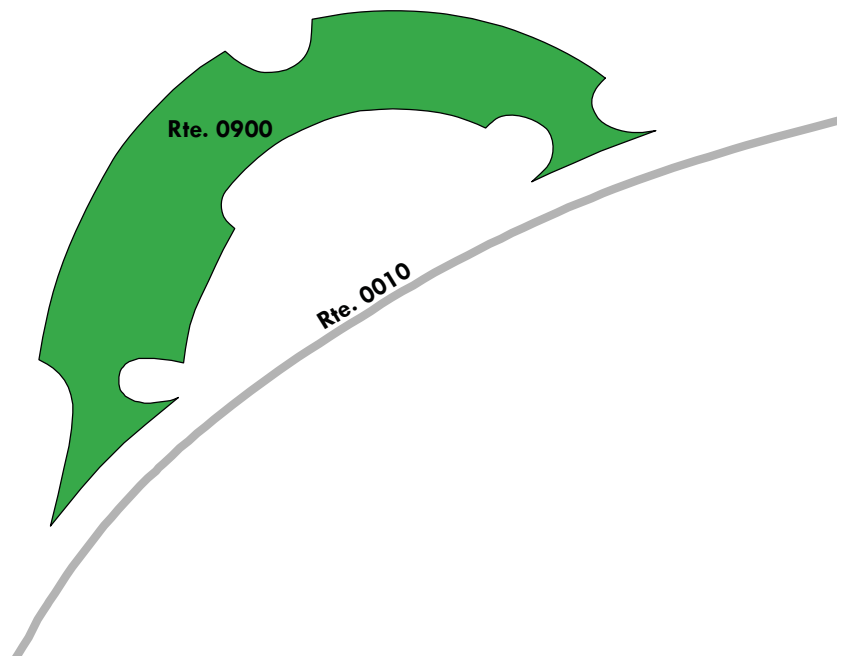
Inspection Date	FMSS Number	User Access	Surface Type
7/12/2016	46922	PUBLIC	ASPHALT
Area (Sq. Ft.)	Lane Miles (11' Widths)	Curb Reveal (Inches)	Curb Recommendation
27,194	0.468	NOT APPLICABLE	LIGHT REPAIR
Curb Type		Curb & Gutter Type	
NO CURB		CONCRETE	
Pavement Recommendation		Condition Rating / PCR	
PREVENTIVE MAINTENANCE		GOOD / 90

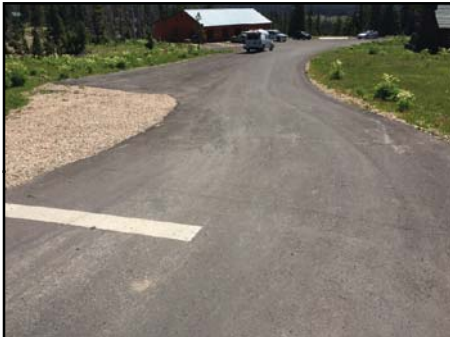
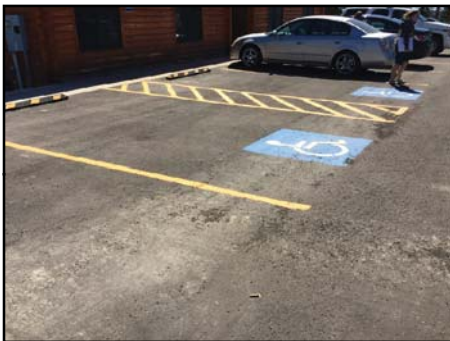
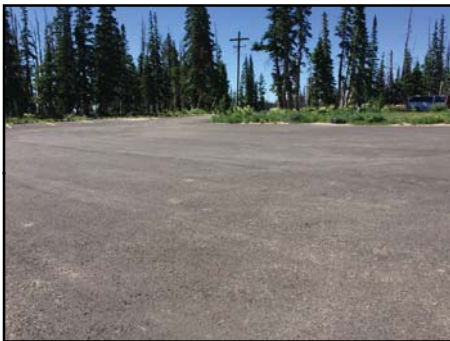
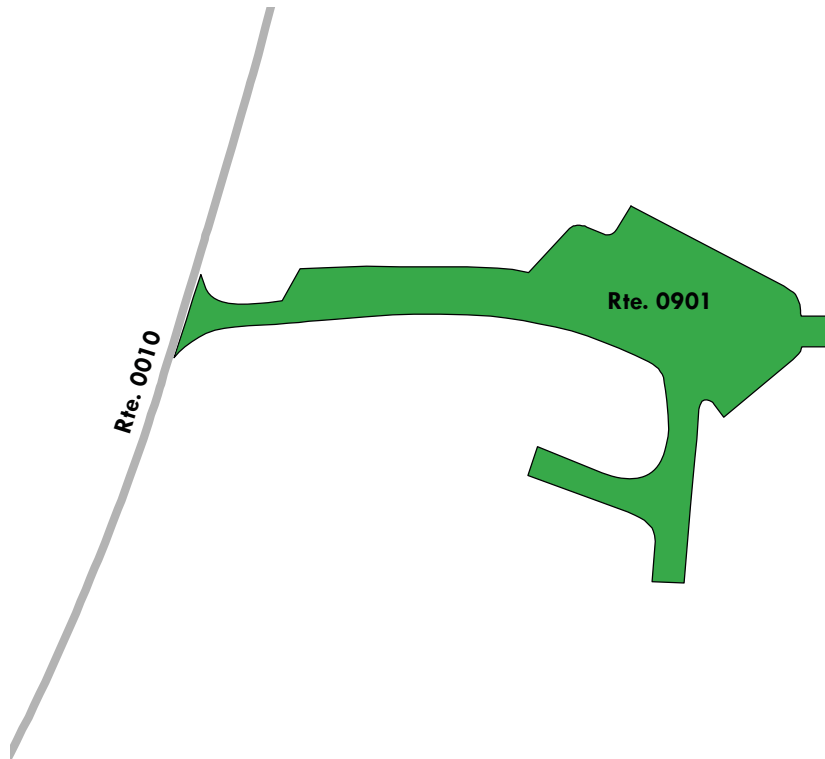
ROUTE 0901: RANGER STATION ACCESS AND PARKING AREA

Inspection Date	FMSS Number	User Access	Surface Type
7/12/2016	52353	NONPUBLIC	ASPHALT
Area (Sq. Ft.)	Lane Miles (11' Widths)	Curb Reveal (Inches)	Curb Recommendation
21,104	0.363	NOT APPLICABLE	NOT APPLICABLE
Curb Type		Curb & Gutter Type	
NO CURB		NO CURB AND GUTTER	
Pavement Recommendation		Condition Rating / PCR	
PREVENTIVE MAINTENANCE		GOOD / 90

Parking area consists of multiple surface types: 1 part Asphalt at 20,826 square feet; 1 part Concrete at 278 square feet.

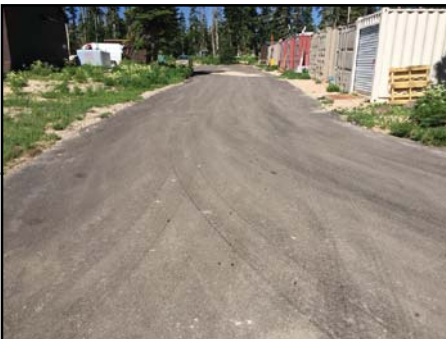
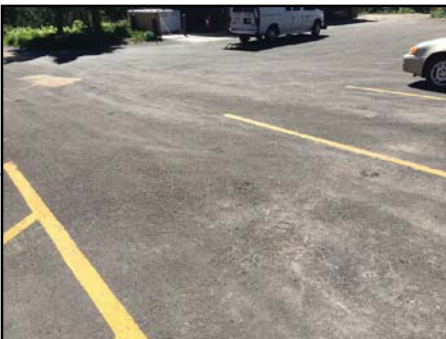
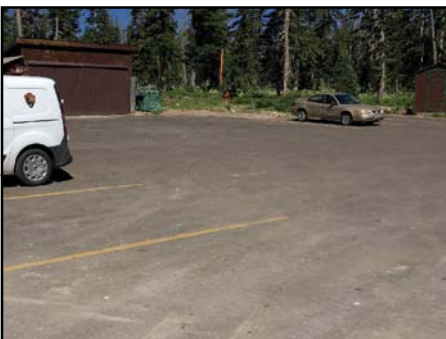
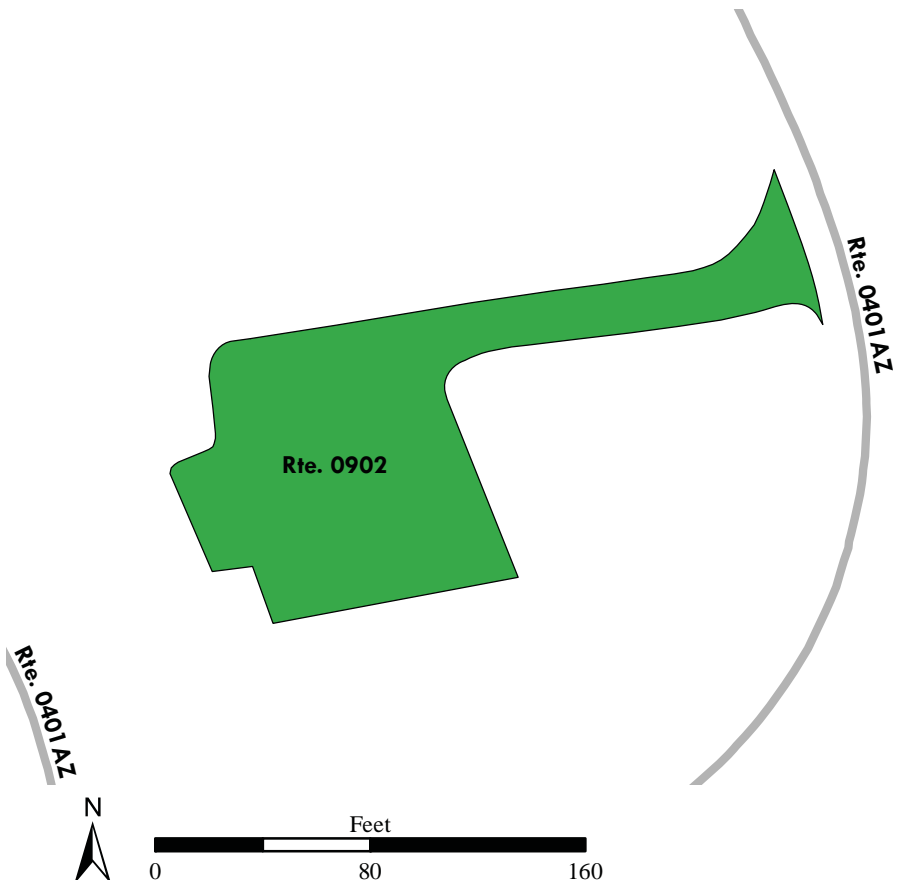
ROUTE 0902: MAINTENANCE AREA PARKING

Inspection Date	FMSS Number	User Access	Surface Type
7/12/2016	47023	NONPUBLIC	ASPHALT
Area (Sq. Ft.)	Lane Miles (11' Widths)	Curb Reveal (Inches)	Curb Recommendation
10,558	0.182	NOT APPLICABLE	NOT APPLICABLE
Curb Type		Curb & Gutter Type	
NO CURB		NO CURB AND GUTTER	
Pavement Recommendation		Condition Rating / PCR	
PREVENTIVE MAINTENANCE		GOOD / 90

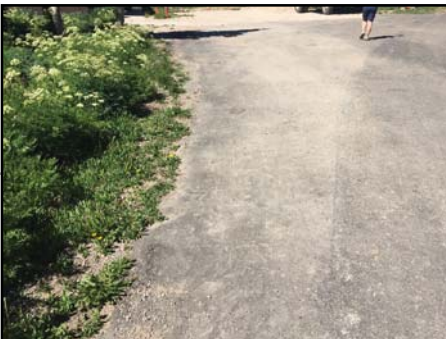
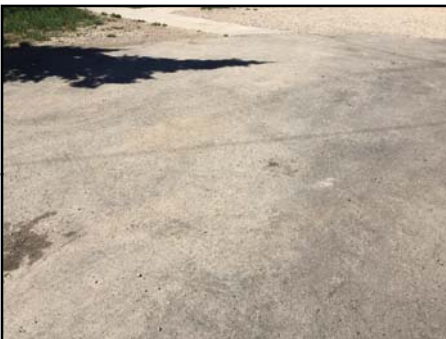
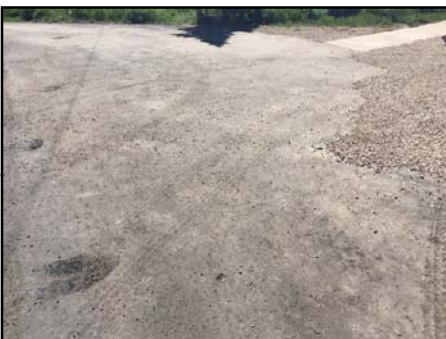
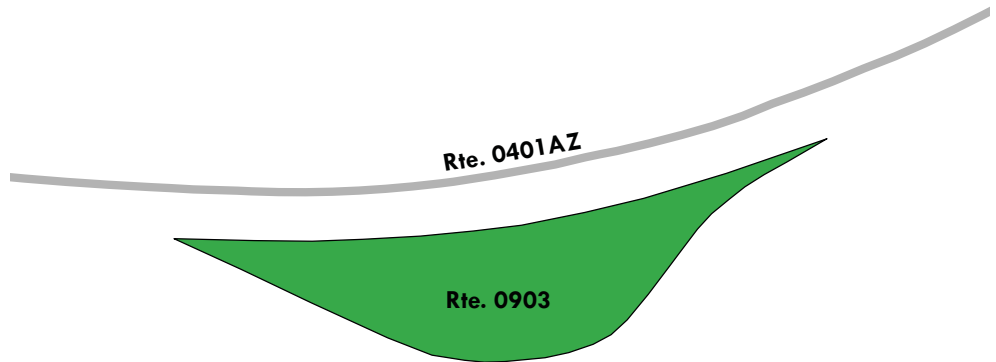
ROUTE 0903: APARTMENT HOUSING AREA

Inspection Date	FMSS Number	User Access	Surface Type
7/12/2016	47433	NONPUBLIC	ASPHALT
Area (Sq. Ft.)	Lane Miles (11' Widths)	Curb Reveal (Inches)	Curb Recommendation
897	0.015	NOT APPLICABLE	NOT APPLICABLE
Curb Type		Curb & Gutter Type	
NO CURB		NO CURB AND GUTTER	
Pavement Recommendation		Condition Rating / PCR	
PREVENTIVE MAINTENANCE		GOOD / 90

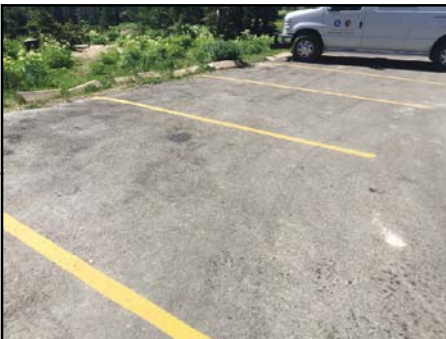
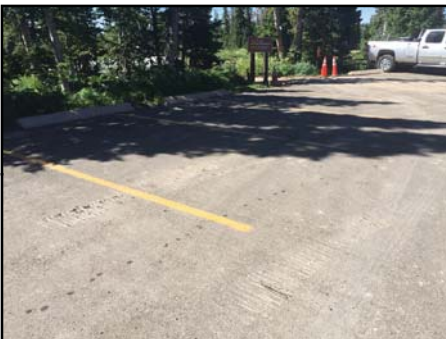
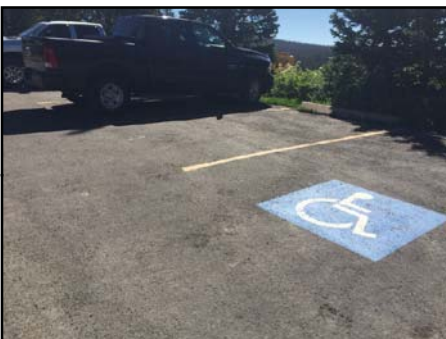
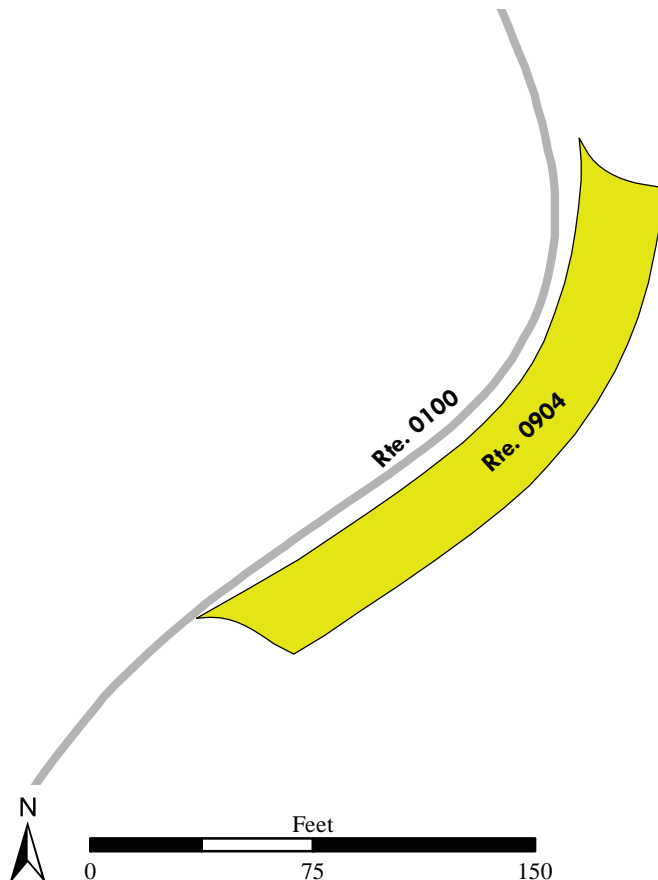
ROUTE 0904: PICNIC AREA PARKING

Inspection Date	FMSS Number	User Access	Surface Type
7/12/2016	92114	PUBLIC	ASPHALT
Area (Sq. Ft.)	Lane Miles (11' Widths)	Curb Reveal (Inches)	Curb Recommendation
4,404	0.076	NOT APPLICABLE	NOT APPLICABLE
Curb Type		Curb & Gutter Type	
NO CURB		NO CURB AND GUTTER	
Pavement Recommendation		Condition Rating / PCR	
LIGHT 3R TREATMENTS		FAIR / 73

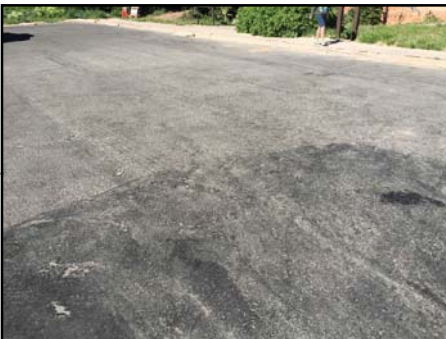
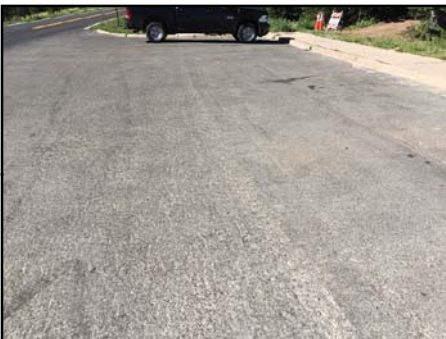
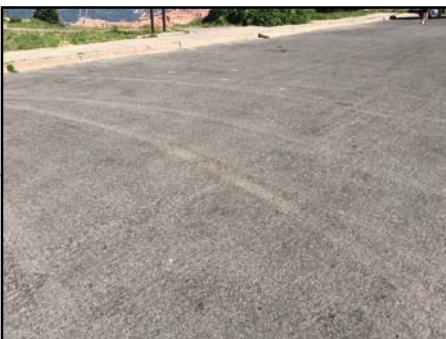
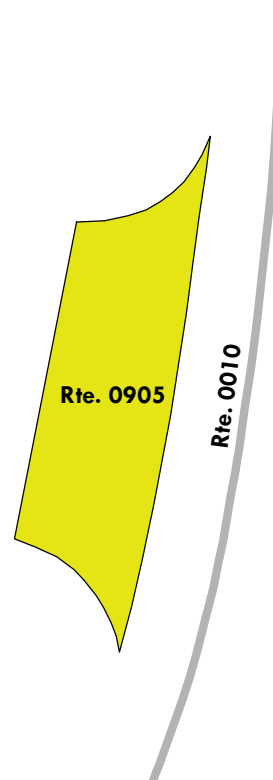
ROUTE 0905: SUNSET OVERLOOK PARKING

Inspection Date	FMSS Number	User Access	Surface Type
7/12/2016	67728	PUBLIC	ASPHALT
Area (Sq. Ft.)	Lane Miles (11' Widths)	Curb Reveal (Inches)	Curb Recommendation
4,218	0.073	NOT APPLICABLE	MODERATE REPAIR
Curb Type		Curb & Gutter Type	
NO CURB		CONCRETE	
Pavement Recommendation		Condition Rating / PCR	
LIGHT 3R TREATMENTS		FAIR / 73

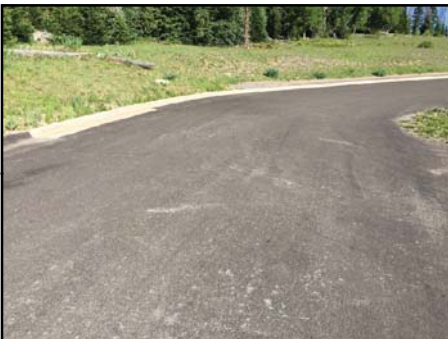
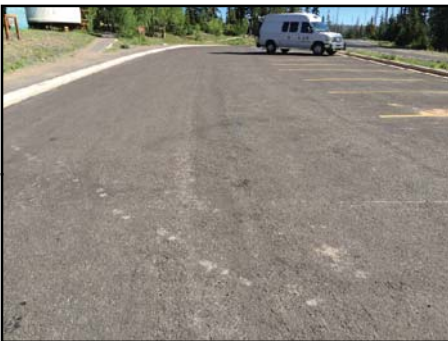
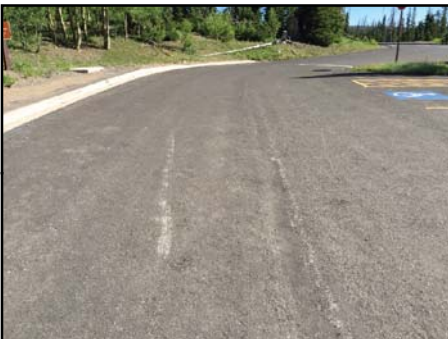
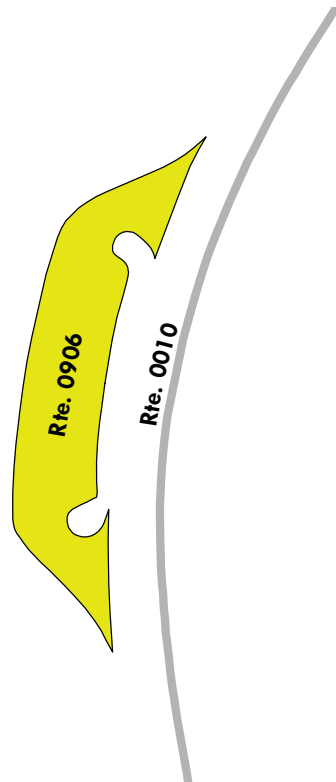
ROUTE 0906: ALPINE POND TRAILHEAD PARKING AREA

Inspection Date	FMSS Number	User Access	Surface Type
7/12/2016	75414	PUBLIC	ASPHALT
Area (Sq. Ft.)	Lane Miles (11' Widths)	Curb Reveal (Inches)	Curb Recommendation
11,554	0.199	NOT APPLICABLE	DO NOTHING
Curb Type		Curb & Gutter Type	
NO CURB		CONCRETE	
Pavement Recommendation		Condition Rating / PCR	
LIGHT 3R TREATMENTS		FAIR / 73

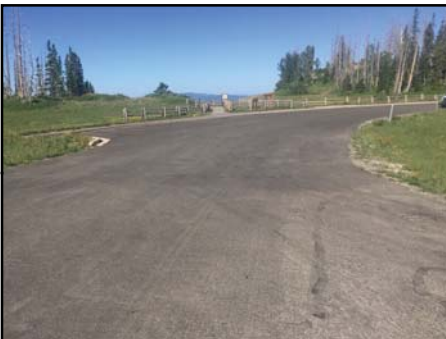
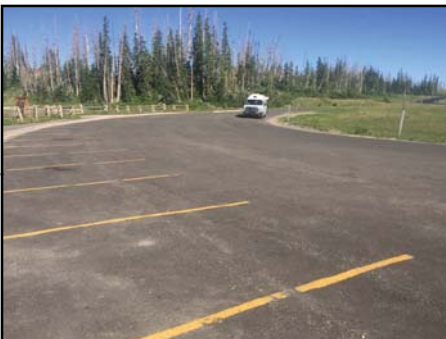
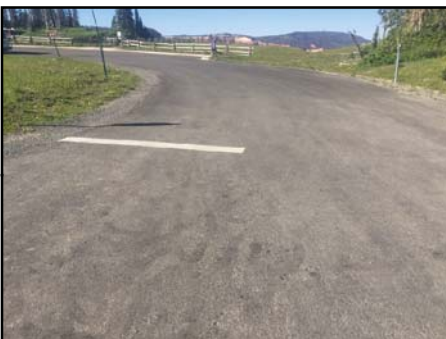
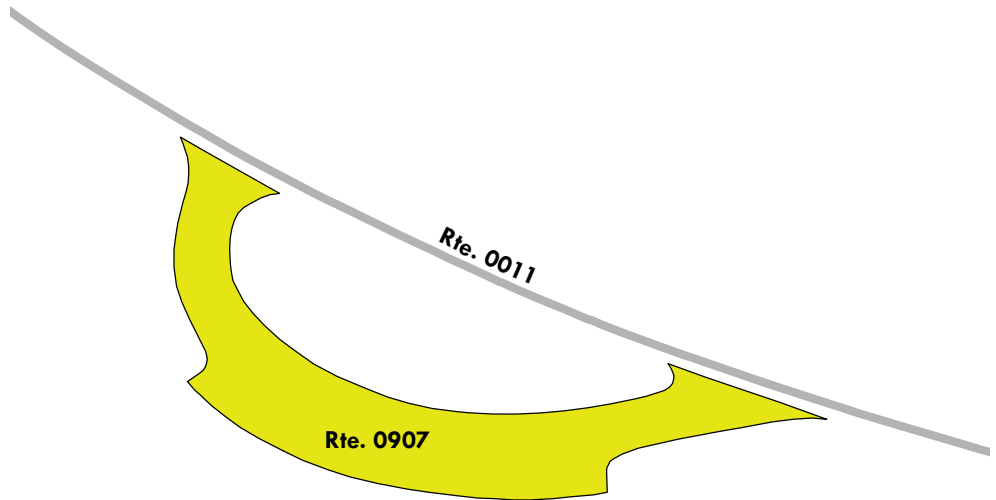
ROUTE 0907: NORTH VIEW OVERLOOK PARKING

Inspection Date	FMSS Number	User Access	Surface Type
7/12/2016	67851	PUBLIC	ASPHALT
Area (Sq. Ft.)	Lane Miles (11' Widths)	Curb Reveal (Inches)	Curb Recommendation
20,047	0.345	NOT APPLICABLE	LIGHT REPAIR
Curb Type		Curb & Gutter Type	
NO CURB		CONCRETE	
Pavement Recommendation		Condition Rating / PCR	
LIGHT 3R TREATMENTS		FAIR / 73

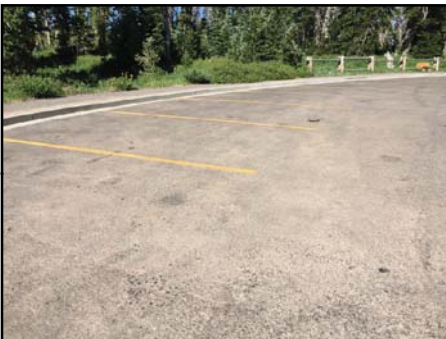
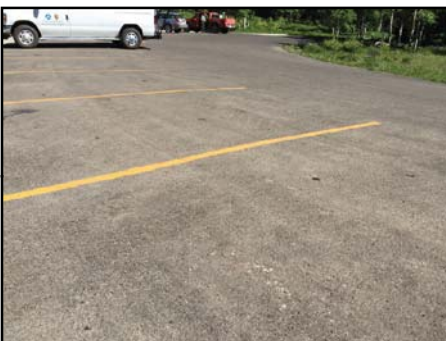
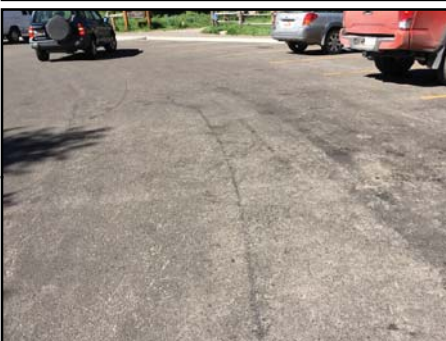
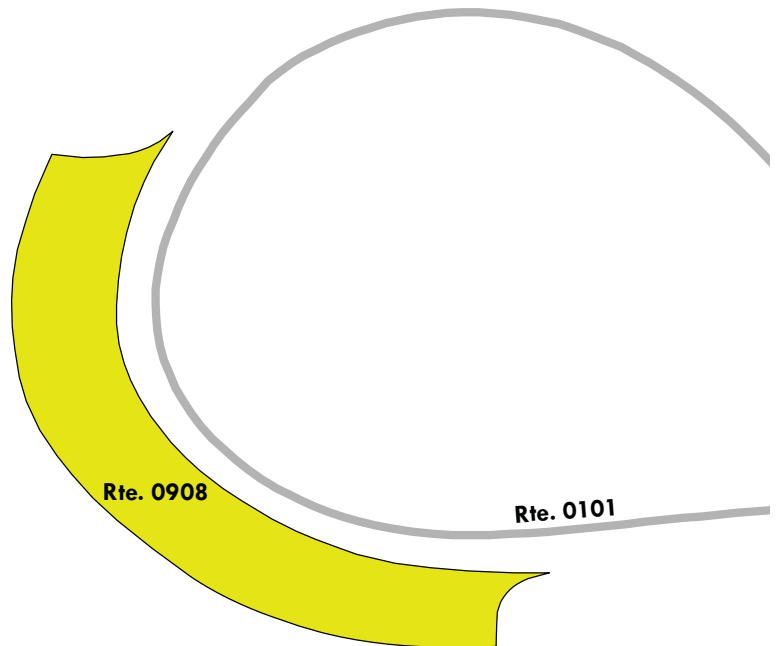
ROUTE 0908: CHESSMAN OVERLOOK PARKING

Inspection Date	FMSS Number	User Access	Surface Type
7/12/2016	67844	PUBLIC	ASPHALT
Area (Sq. Ft.)	Lane Miles (11' Widths)	Curb Reveal (Inches)	Curb Recommendation
5,085	0.088	NOT APPLICABLE	LIGHT REPAIR
Curb Type		Curb & Gutter Type	
NO CURB		CONCRETE	
Pavement Recommendation		Condition Rating / PCR	
LIGHT 3R TREATMENTS		FAIR / 73
