# CHRI Cycle 6

# Final Report

# Road Inventory and Condition Assessment of Paved Routes Christiansted National Historic Site

# Christiansted National Historic Site in U.S. Virgin Islands

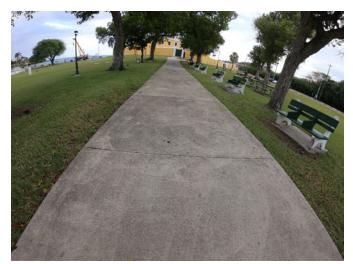
CHRI\_0014AZ\_0.006.JPG

JOINT FAULTING-EXCELLENT, SLAB CRACKING-EXCELLENT, PATCHES-EXCELLENT, SURFACE DELAMINATION AND POPOUTS-EXCELLENT, JOINT DISTRESS-EXCELLENT.

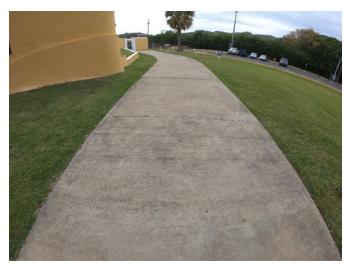
CHRI\_0014BZ\_0.005.JPG

JOINT FAULTING-EXCELLENT, SLAB CRACKING-EXCELLENT, PATCHES-EXCELLENT, SURFACE DELAMINATION AND POPOUTS-EXCELLENT, JOINT DISTRESS-EXCELLENT.

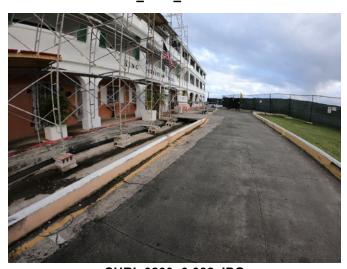
CHRI\_0200\_0.032.JPG

JOINT FAULTING-EXCELLENT, SLAB CRACKING-EXCELLENT, PATCHES-GOOD, SURFACE DELAMINATION AND POPOUTS-EXCELLENT, JOINT DISTRESS-EXCELLENT.
