CRLA Cycle 6

Final Report

Road Inventory and Condition Assessment of Paved Routes Crater Lake National Park

Report Date: February 2016

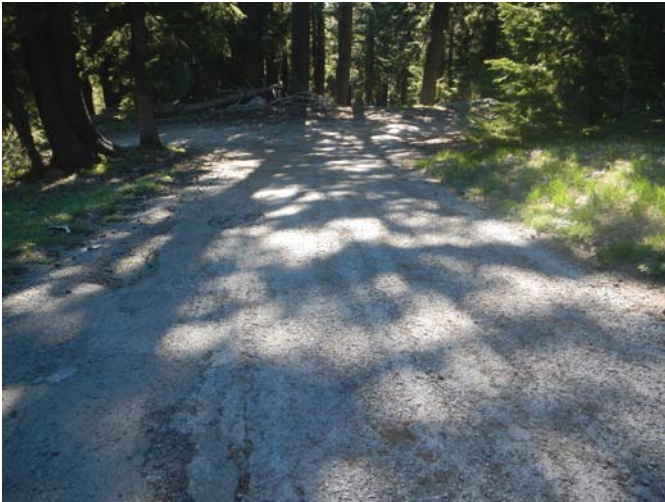
CRLA_0207BZ_1911.JPG

Route 0207BZ, 0207DZ and 0404BZ were given a Pavement Condition Rating (PCR) of 0 because it is in very poor condition. Individual distress indices could not be determined because of the excessive distress quantity and missing sections of pavement.
