Final Report

Road Inventory and Condition Assessment of Paved Routes Craters of the Moon National Monument and Preserve

Federal Lands Highway Road Inventory Program Prepared By: Federal Highway Administration Eastern Federal Lands Highway Division Road Inventory Program (RIP)

Report Date: February 2017

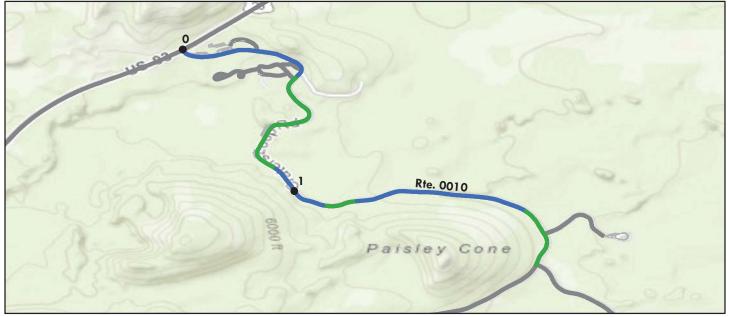
Craters of the Moon National Monument and Preserve ROUTE 0010: ENTRANCE ROAD

| Route Condition Legend – Pavement Condition Rating (PCR) | | | | | | | | | |
|---|---|---|---|---|--|--|--|--|--|
| Pavement Condition Rating (PCR) | 94 | 92 | 95 | | | | | | |
| Surface Condition Rating (SCR) | 96 | 96 | 95 | | | | | | |
| Roughness Condition Index (RCI) | 90 | 85 | 94 | | | | | | |
| Transverse Cracking Index | 96 | 96 | 95 | | | | | | |

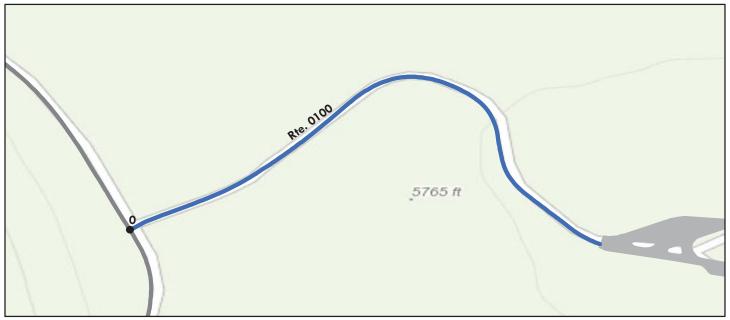
Craters of the Moon National Monument and Preserve ROUTE 0100: DEVIL'S ORCHARD ROAD

| Route Condition Legend – Pavement Condition Rating (PCR) | | | | | | | | | | | |
|--|---|---|---|---|--|--|--|--|--|--|--|
| Pavement Condition Rating (PCR) | 100 | 100 | | | | | | | | | |
| Surface Condition Rating (SCR) | 100 | 100 | | | | | | | | | |
| Structural Crack Index | 100 | 100 | | | | | | | | | |

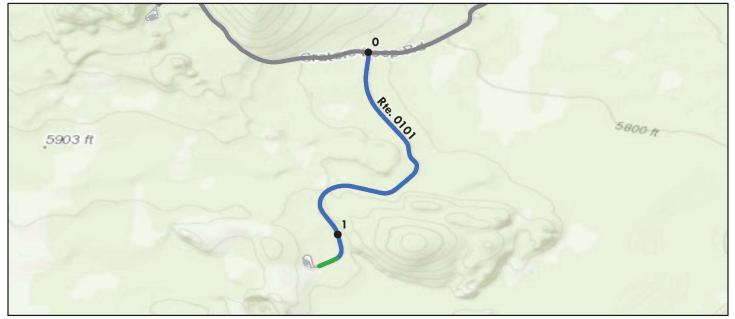
Craters of the Moon National Monument and Preserve ROUTE 0101: TREE MOLDS ROAD

| Route Condition Legend – Pavement Condition Rating (PCR) | | | | | | | | | |
|---|---|---|---|---|---|--|--|--|--|
| Pavement Condition Rating (PCR) | 100 | 100 | 100 | | | | | | |
| Surface Condition Rating (SCR) | 100 | 100 | 100 | | | | | | |
| Roughness Condition Index (RCI) | 100 | 100 | 100 | | | | | | |

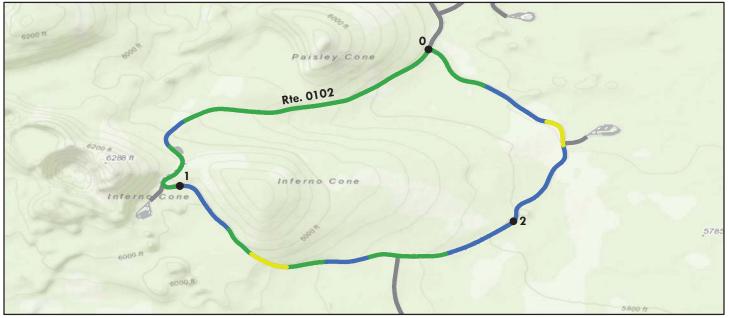
Craters of the Moon National Monument and Preserve ROUTE 0102: SCENIC LOOP DRIVE

| Route Condition Legend – Pavement Condition Rating (PCR) | | | | | | | | | |
|---|---|---|---|---|---|--|--|--|--|
| Pavement Condition Rating (PCR) | 93 | 94 | 93 | 93 | | | | | |
| Surface Condition Rating (SCR) | 93 | 90 | 95 | 93 | | | | | |
| Roughness Condition Index (RCI) | 94 | 100 | 91 | 93 | | | | | |
| Transverse Cracking Index | 93 | 90 | 95 | 93 | | | | | |

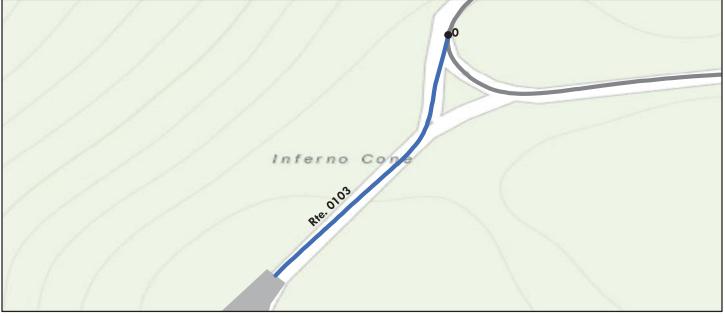
Craters of the Moon National Monument and Preserve ROUTE 0103: SPATTER CONE ROAD

| Route Condition Legend – Pavement Condition Rating (PCR) | | | | | | | | | |
|---|---|---|---|---|--|--|--|--|--|
| Pavement Condition Rating (PCR) | 99 | 99 | | | | | | | |
| Surface Condition Rating (SCR) | 99 | 99 | | | | | | | |
| Structural Crack Index | 100 | 100 | | | | | | | |

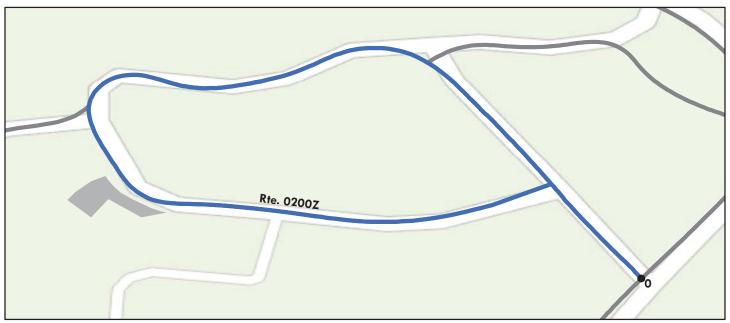
Craters of the Moon National Monument and Preserve ROUTE 0200Z: CAMPGROUND ENTRANCE ROAD

| Route Condition Legend – Pavement Condition Rating (PCR) | | | | | | | |
|---|---|--|---|---|--|--|--|
| Pavement Condition Rating (PCR) | 98 | 98 | | | | | |
| Surface Condition Rating (SCR) | 98 | 98 | | | | | |

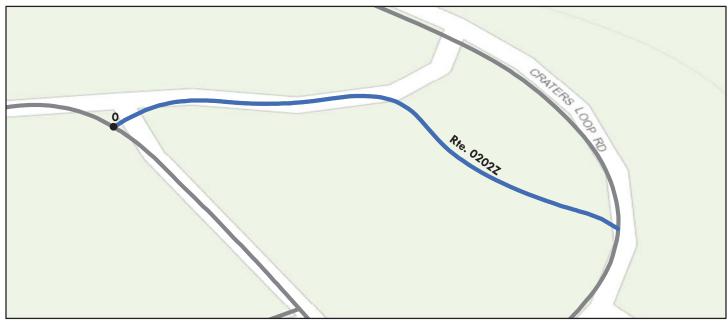
Craters of the Moon National Monument and Preserve ROUTE 0202Z: CAMPGROUND EXIT ROAD

| Route C | Condition Legend – Pav | ement Condi | tion Rating (PCR) | |
|---|---|---|---|---|
| Pavement Condition Rating (PCR) | 97 | 97 | | |
| Surface Condition Rating (SCR) | 97 | 97 | | |

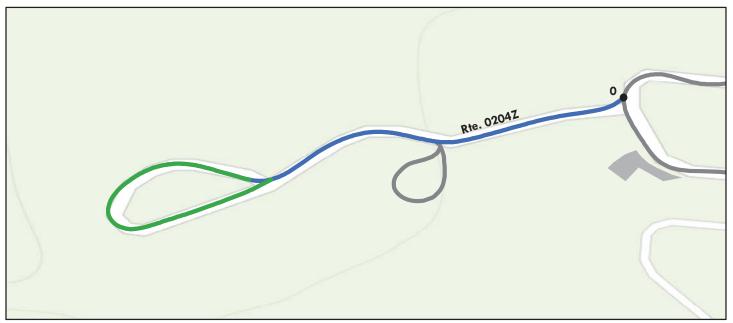
Craters of the Moon National Monument and Preserve ROUTE 0204Z: CAMPGROUND LOOPS A/B

| Route Condition Legend – Pavement Condition Rating (PCR) | | | | | | | |
|---|---|---|---|---|--|--|--|
| Pavement Condition Rating (PCR) | 95 | 95 | | | | | |
| Surface Condition Rating (SCR) | 95 | 95 | | | | | |
| Structural Crack Index | 95 | 95 | | | | | |
| Longitudinal Crack Index | 95 | 95 | | | | | |

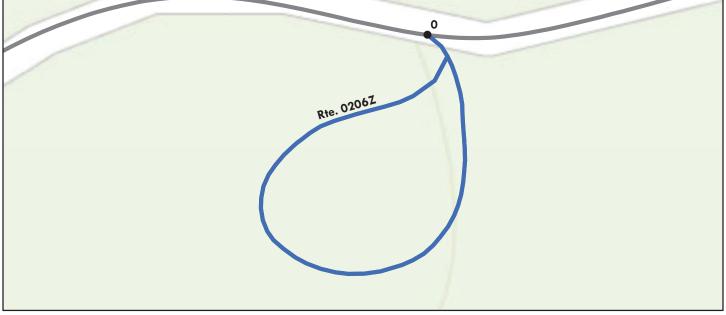
Craters of the Moon National Monument and Preserve ROUTE 0206Z: CAMPGROUND LOOP

| Route Condition Legend – Pavement Condition Rating (PCR) | | | | | | | |
|---|---|--|---|---|--|--|--|
| Pavement Condition Rating (PCR) | 99 | 99 | | | | | |
| Surface Condition Rating (SCR) | 99 | 99 | | | | | |

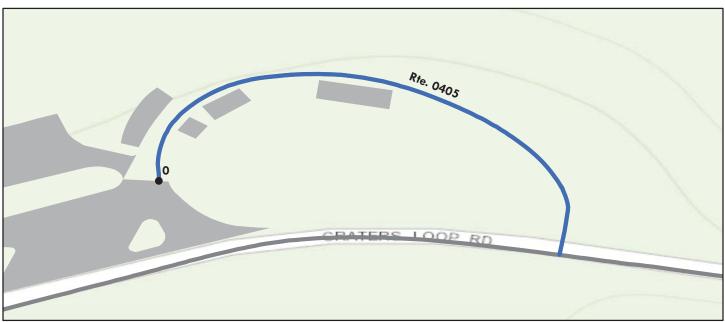
ROUTE 0405: EMPLOYEE HOUSING

| Route Condition Legend – Pavement Condition Rating (PCR) | | | | | | | |
|---|---|--|---|--|--|--|--|
| Pavement Condition Rating (PCR) | 96 | 96 | | | | | |
| Surface Condition Rating (SCR) | 96 | 96 | | | | | |
| Structural Crack Index | 97 | 97 | | | | | |
| Longitudinal Crack Index | 97 | 97 | | | | | |
| Transverse Cracking Index | 96 | 96 | | | | | |
