CUGA Cycle 6

Final Report

Road Inventory and Condition Assessment of Paved Routes Cumberland Gap National Historical Park

Report Date: March 2022

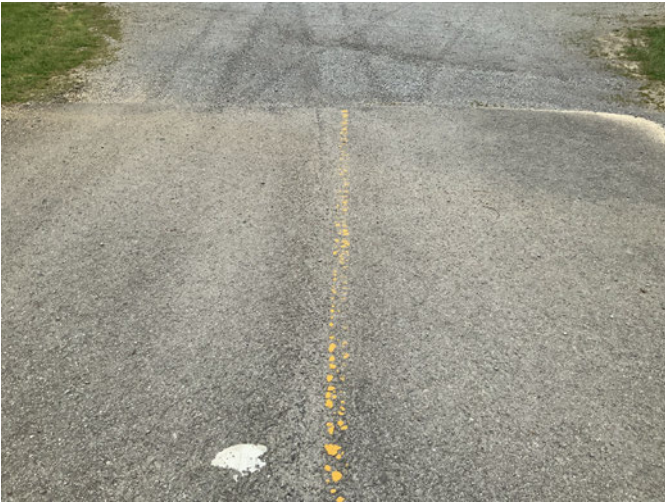
CUGA_0102_1.jpg

Route Condition Legend – Pavement Condition Rating (PCR)						
Poor (0 - 60)	Fair (61- 84)	Good (85 - 94)	Excellent (95 - 100)	Not Rated		
See Appendix for definitions and formulas						
Inspection Date: 4/13/2021	Beginning Section MP	0.00				
Paved Length (Miles): 0.07	Section Length (MI)	0.07				
Surface Type: ASPHALT	Route Summary					
Roadway Condition Information						
Pavement Condition Rating (PCR)	90	90				
Surface Condition Rating (SCR)	90	90				
Roughness Condition Index (RCI)	N/A	N/A				
Distress Index Values						
Structural Crack Index	N/A	N/A				
Alligator Crack Index	90	90				
Longitudinal Crack Index	90	90				
Transverse Cracking Index	90	90				
Patching Index	90	90				
Rutting Index	97	97				
International Roughness Index (IRI)	N/A	N/A				
Lane & Width Information						
Number of Lanes	2	2				
Paved Width (ft)	21	21				
Lane Width (ft)	10.5	10.5
