CUIS Cycle 6

Final Report

Road Inventory and Condition Assessment for Cumberland Island National Seashore

Report Date: July 2021

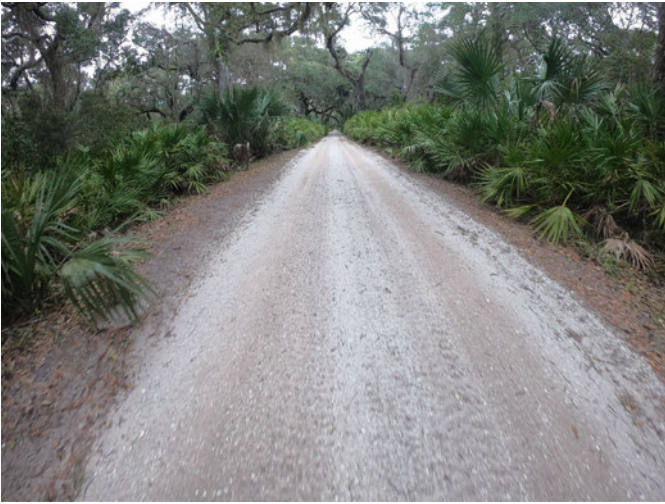
CUIS_0010_1.009

Begin MP	End MP	Section Length	# of Lanes	Lane Width	Road Width	Treatment Recommendation	Treatment Cost	Unpaved Rating (Paser +)	Crown Severity	Drainage Severity	Rutting, Washboard Severity	Potholes / Loose Aggregate Severity
10.00	11.00	1.00	1	8.0	8.0	Light Rehabilitation	\$10,000	2	Med	High	Med	Med
11.00	12.00	1.00	1	8.0	8.0	Light Rehabilitation	\$10,000	2	Med	High	Low	Med
12.00	13.00	1.00	1	8.0	8.0	Light Rehabilitation	\$10,000	2	Med	High	Low	Med
13.00	13.55	0.55	1	8.0	8.0	Heavy Rehabilitation	\$22,040	1	Med	High	Low	High
Route Level Data:		13.55	1	8.0	8.0	Light Rehabilitation	\$96,040	2	Med	High	Low	Med

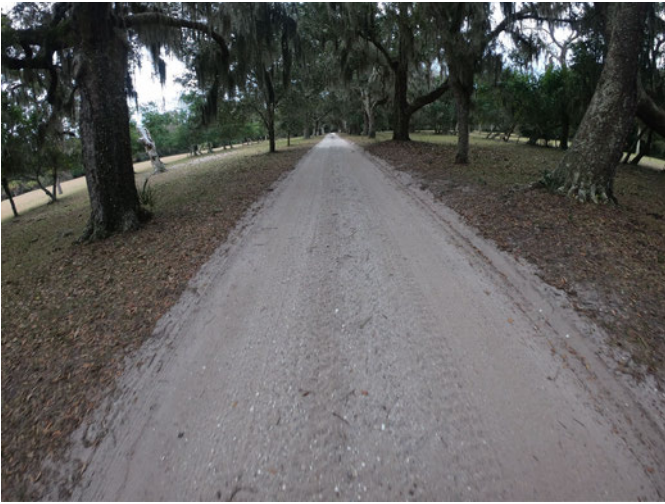
CUIS_0100_0.053

Begin MP	End MP	Section Length	# of Lanes	Lane Width	Road Width	Treatment Recommendation	Treatment Cost	Unpaved Rating (Paser +)	Crown Severity	Drainage Severity	Rutting, Washboard Severity	Potholes / Loose Aggregate Severity
0.00	0.90	0.90	1	8.0	8.0	Routine Maintenance	\$1,790	3	Med	Med	Low	Med

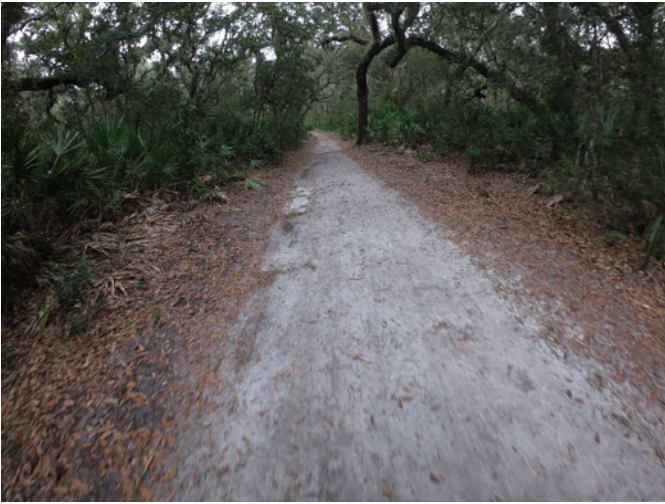
CUIS_0101_0.020

Begin MP	End MP	Section Length	# of Lanes	Lane Width	Road Width	Treatment Recommendation	Treatment Cost	Unpaved Rating (Paser +)	Crown Severity	Drainage Severity	Rutting, Washboard Severity	Potholes / Loose Aggregate Severity
0.00	0.34	0.34	1	7.0	7.0	Routine Maintenance	\$670	3	Med	Med	Low	Low
Route Level Data:		0.34	1	7.0	7.0	Routine Maintenance	\$670	3	Med	Med	Low	Low

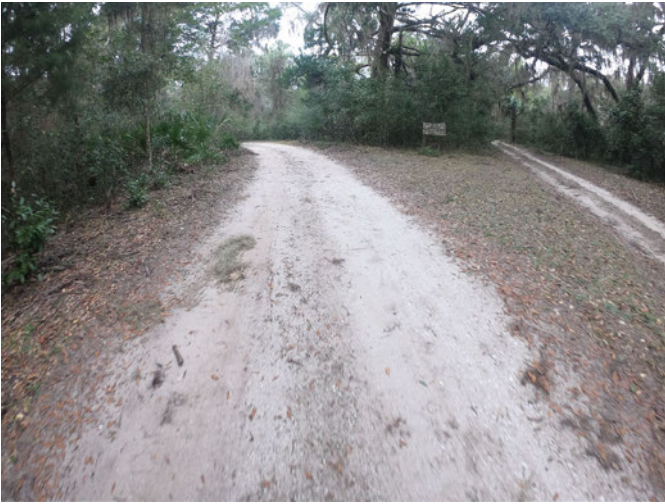
CUIS_0102_0.078

Begin MP	End MP	Section Length	# of Lanes	Lane Width	Road Width	Treatment Recommendation	Treatment Cost	Unpaved Rating (Paser +)	Crown Severity	Drainage Severity	Rutting, Washboard Severity	Potholes / Loose Aggregate Severity
0.00	0.90	0.90	1	8.0	8.0	Light Rehabilitation	\$9,000	2	Med	High	Low	Med
Route Level Data:		0.90	1	8.0	8.0	Light Rehabilitation	\$9,000	2	Med	High	Low	Med

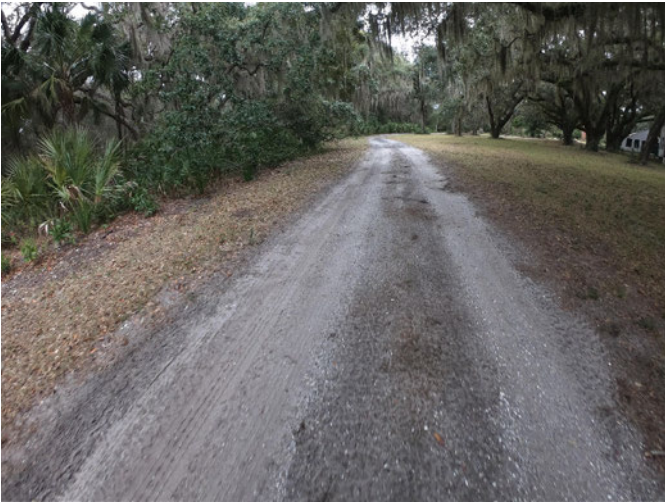
CUIS_0201_0.015

Begin MP	End MP	Section Length	# of Lanes	Lane Width	Road Width	Treatment Recommendation	Treatment Cost	Unpaved Rating (Paser +)	Crown Severity	Drainage Severity	Rutting, Washboard Severity	Potholes / Loose Aggregate Severity
0.00	0.30	0.30	1	7.0	7.0	Routine Maintenance	\$596	3	Med	Med	Low	Med
Route Level Data:		0.30	1	7.0	7.0	Routine Maintenance	\$596	3	Med	Med	Low	Med

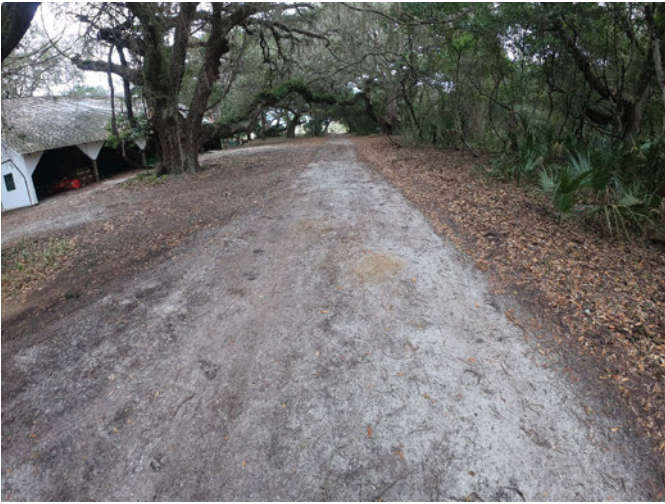
CUIS_0202_0.005

Begin MP	End MP	Section Length	# of Lanes	Lane Width	Road Width	Treatment Recommendation	Treatment Cost	Unpaved Rating (Paser +)	Crown Severity	Drainage Severity	Rutting, Washboard Severity	Potholes / Loose Aggregate Severity
0.00	0.20	0.20	1	7.0	7.0	Routine Maintenance	\$402	3	Med	Med	Low	Med
Route Level Data:		0.20	1	7.0	7.0	Routine Maintenance	\$402	3	Med	Med	Low	Med

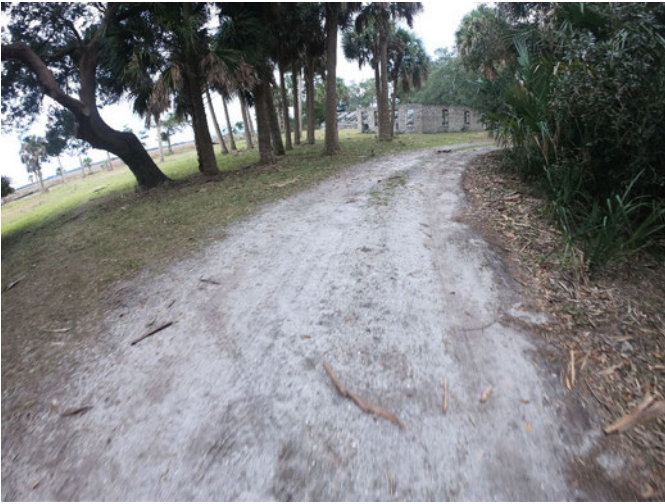
CUIS_0203_0.118

Begin MP	End MP	Section Length	# of Lanes	Lane Width	Road Width	Treatment Recommendation	Treatment Cost	Unpaved Rating (Paser +)	Crown Severity	Drainage Severity	Rutting, Washboard Severity	Potholes / Loose Aggregate Severity
0.00	0.76	0.76	1	10.0	10.0	Light Rehabilitation	\$7,610	2	Med	High	Med	Med
Route Level Data:		0.76	1	10.0	10.0	Light Rehabilitation	\$7,610	2	Med	High	Med	Med

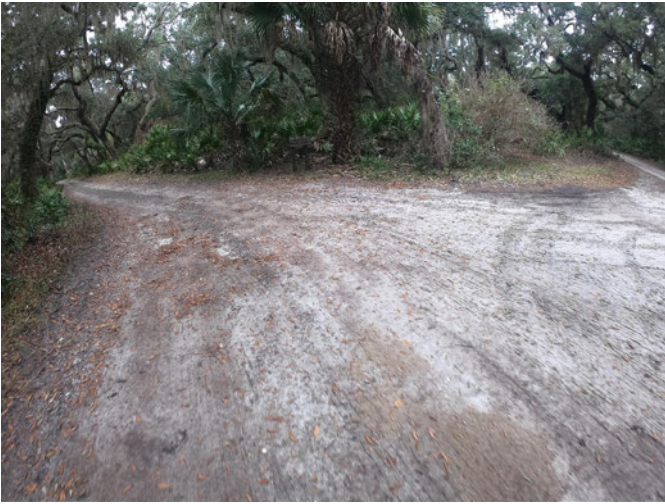
CUIS_0204_0.005

Begin MP	End MP	Section Length	# of Lanes	Lane Width	Road Width	Treatment Recommendation	Treatment Cost	Unpaved Rating (Paser +)	Crown Severity	Drainage Severity	Rutting, Washboard Severity	Potholes / Loose Aggregate Severity
0.00	0.15	0.15	1	8.0	8.0	Heavy Rehabilitation	\$6,040	1	Med	High	High	Med
Route Level Data:		0.15	1	8.0	8.0	Heavy Rehabilitation	\$6,040	1	Med	High	High	Med

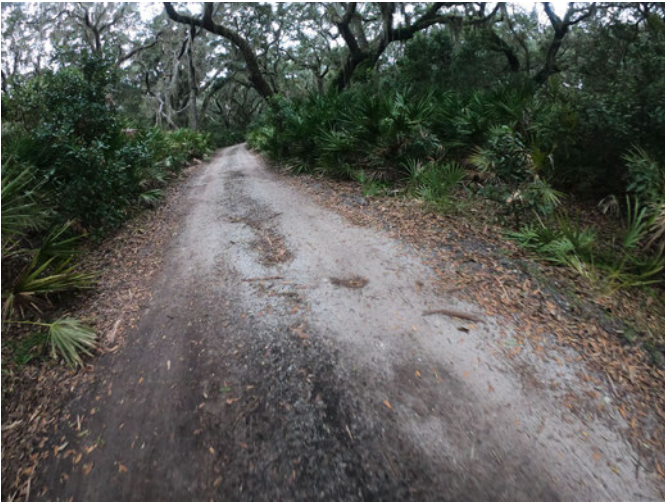
CUIS_0205_0.010

Begin MP	End MP	Section Length	# of Lanes	Lane Width	Road Width	Treatment Recommendation	Treatment Cost	Unpaved Rating (Paser +)	Crown Severity	Drainage Severity	Rutting, Washboard Severity	Potholes / Loose Aggregate Severity
0.00	0.12	0.12	1	7.0	7.0	Routine Maintenance	\$232	3	Med	Med	Low	Med
Route Level Data:		0.12	1	7.0	7.0	Routine Maintenance	\$232	3	Med	Med	Low	Med

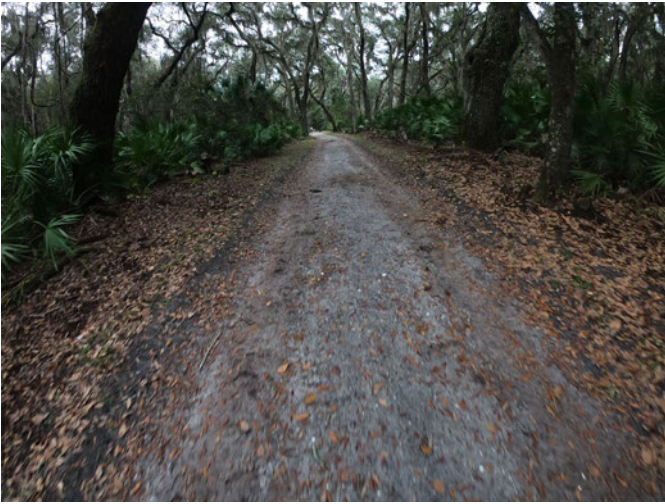
CUIS_0206_0.026

Begin MP	End MP	Section Length	# of Lanes	Lane Width	Road Width	Treatment Recommendation	Treatment Cost	Unpaved Rating (Paser +)	Crown Severity	Drainage Severity	Rutting, Washboard Severity	Potholes / Loose Aggregate Severity
0.00	0.35	0.35	1	7.0	7.0	Routine Maintenance	\$700	3	Med	High	Low	Low
Route Level Data:		0.35	1	7.0	7.0	Routine Maintenance	\$700	3	Med	High	Low	Low

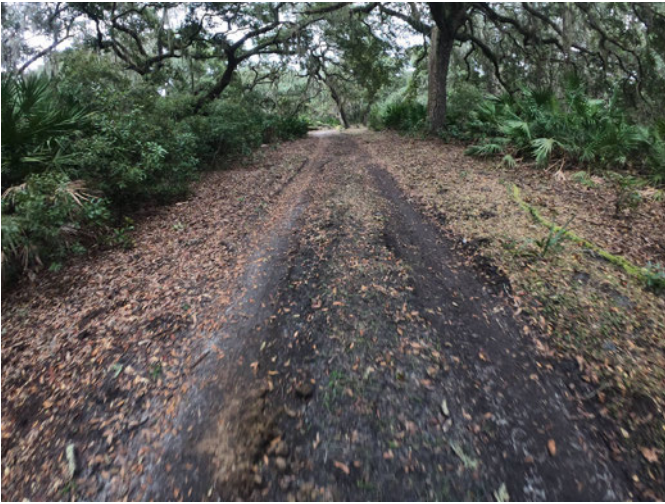
CUIS_0207_0.025

Begin MP	End MP	Section Length	# of Lanes	Lane Width	Road Width	Treatment Recommendation	Treatment Cost	Unpaved Rating (Paser +)	Crown Severity	Drainage Severity	Rutting, Washboard Severity	Potholes / Loose Aggregate Severity
0.00	0.33	0.33	1	7.0	7.0	Light Rehabilitation	\$3,250	2	Med	High	Low	Med
Route Level Data:		0.33	1	7.0	7.0	Light Rehabilitation	\$3,250	2	Med	High	Low	Med
