DINO Cycle 6

Final Report

Road Inventory and Condition Assessment of Paved Routes Dinosaur National Monument

Report Date: June 2018

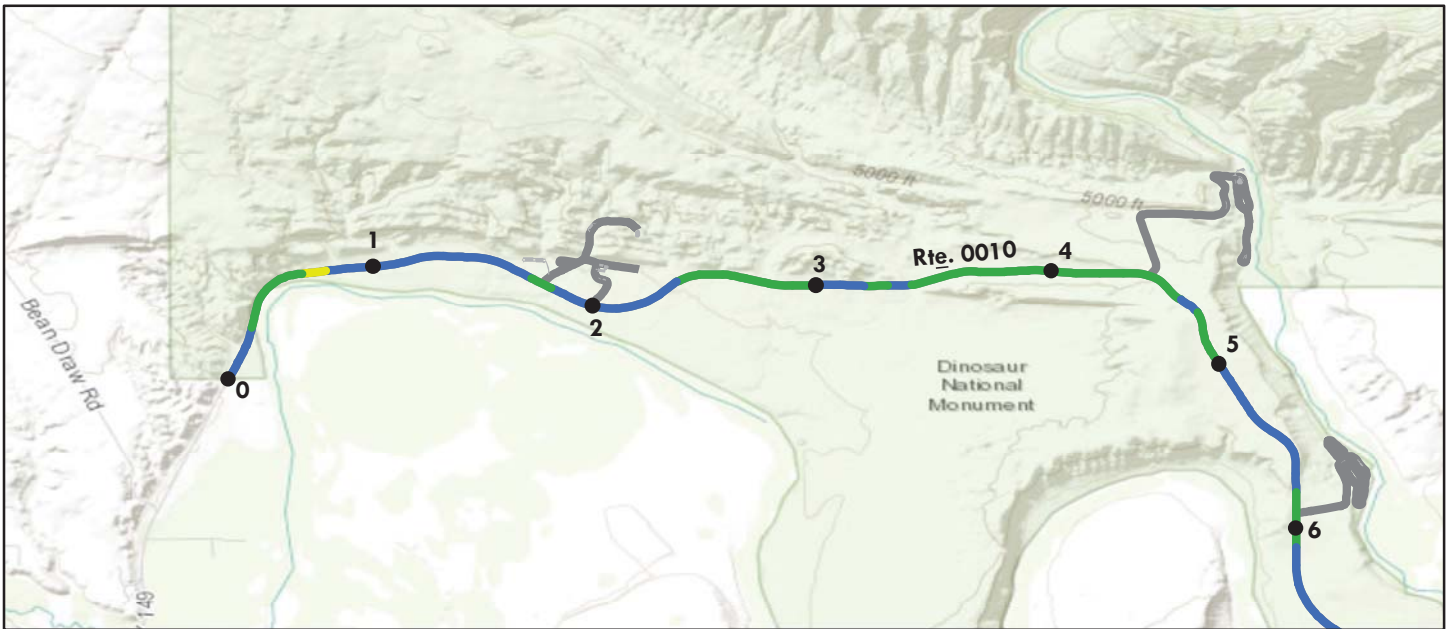
Inspection Date:	8/15/2017	Beginning Section MP	0	1	2	3	4
Paved Length (Miles):	9.81	Section Length (MI)	1	1	1	1	1
Surface Type:	ASPHALT	Route Summary					
Roadway Condition Information							
Pavement Condition Rating (PCR)	95	95	99	94	92	94	
Surface Condition Rating (SCR)	91	98	98	90	90	90	
Roughness Condition Index (RCI)	100	91	100	100	95	100	
Distress Index Values							
Structural Crack Index	95	98	100	99	98	98	
Alligator Crack Index	99	100	100	100	100	100	
Longitudinal Crack Index	96	98	100	99	98	98	
Transverse Cracking Index	91	98	98	90	90	90	
Patching Index	99	100	98	100	100	100	
Rutting Index	99	99	99	100	100	100	
International Roughness Index (IRI)	93	139	75	96	127	89	
Lane & Width Information							
Number of Lanes	2	2	2	2	2	2	
Paved Width (ft)	27.1	26.8	31.4	26.1	26.2	27.2	
Lane Width (ft)	10.2	10.3	10.6	9.9	10.3	10.4

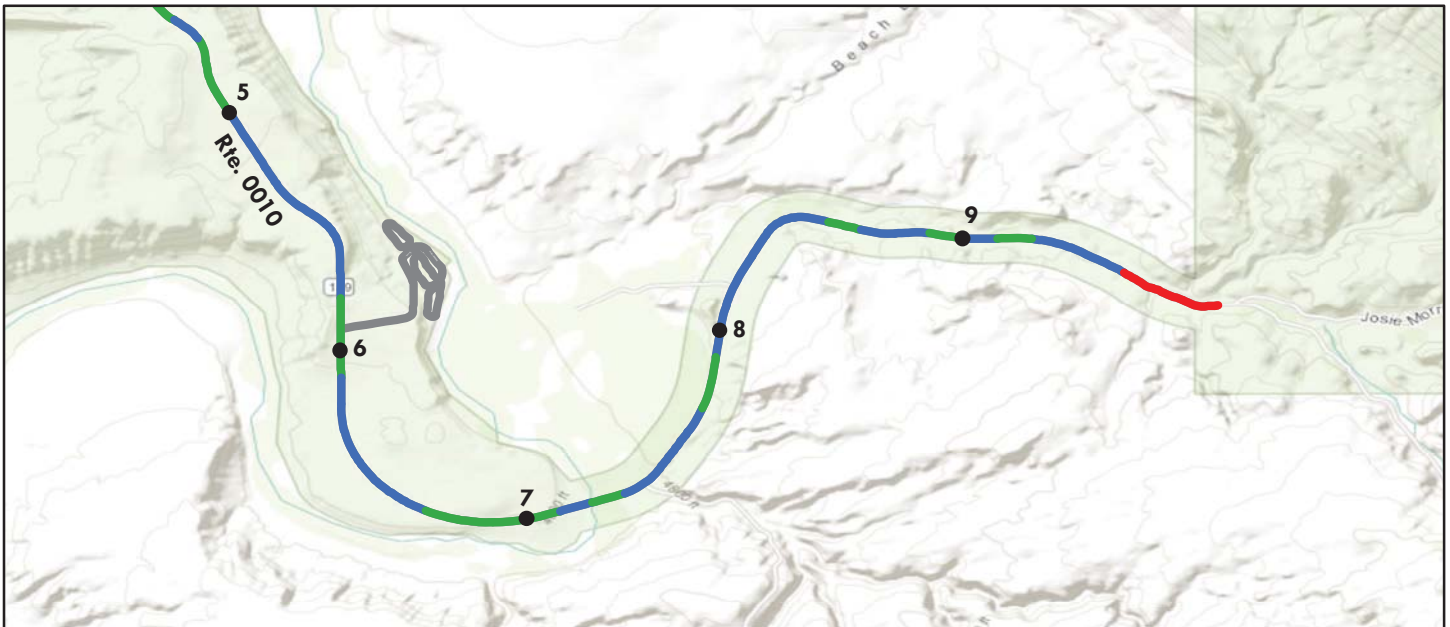
Inspection Date:	8/15/2017	Beginning Section MP	5	6	7	8	9
Paved Length (Miles):	9.81	Section Length (MI)	1	1	1	1	0.81
Surface Type:	ASPHALT	Route Summary					
Roadway Condition Information							
Pavement Condition Rating (PCR)	95	96	95	95	97	70	
Surface Condition Rating (SCR)	91	94	92	92	95	58	
Roughness Condition Index (RCI)	100	100	100	100	100	89	
Distress Index Values							
Structural Crack Index	95	96	100	100	99	58	
Alligator Crack Index	99	100	100	100	100	89	
Longitudinal Crack Index	96	96	100	100	99	69	
Transverse Cracking Index	91	94	92	92	95	63	
Patching Index	99	100	100	100	100	96	
Rutting Index	99	100	100	100	99	95	
International Roughness Index (IRI)	93	56	49	78	90	143	
Lane & Width Information							
Number of Lanes	2	2	2	2	2	2	
Paved Width (ft)	27.1	28.6	26.4	26.3	27.2	24.6	
Lane Width (ft)	10.2	10.3	10.2	10.2	10.3	9.9

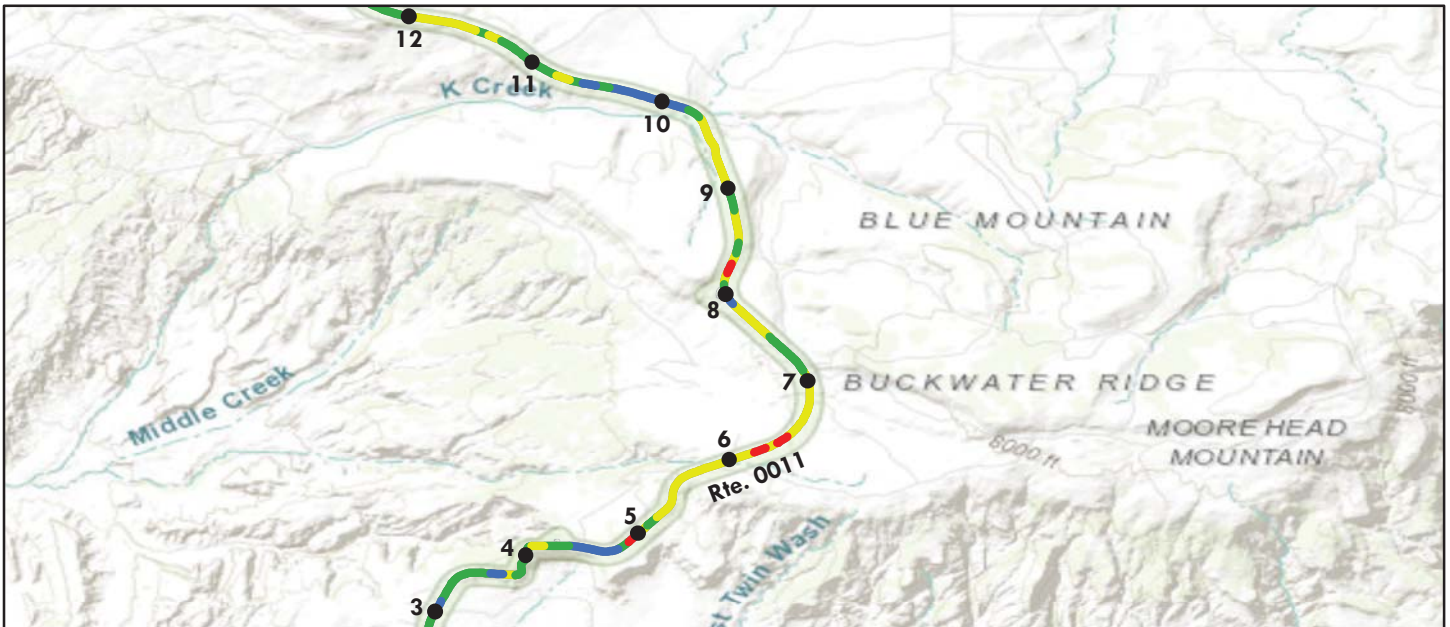
Inspection Date:	8/15/2017	Beginning Section MP	5	6	7	8	9
Paved Length (Miles):	31.88	Section Length (MI)	1	1	1	1	1
Surface Type:	ASPHALT	Route Summary					
Roadway Condition Information							
Pavement Condition Rating (PCR)	90	76	70	85	78	86	
Surface Condition Rating (SCR)	94	87	80	89	86	94	
Roughness Condition Index (RCI)	85	60	55	79	66	75	
Distress Index Values							
Structural Crack Index	95	91	80	92	86	98	
Alligator Crack Index	100	100	100	100	100	100	
Longitudinal Crack Index	95	91	80	92	86	98	
Transverse Cracking Index	94	92	90	89	90	95	
Patching Index	100	100	100	100	98	100	
Rutting Index	94	87	87	92	90	94	
International Roughness Index (IRI)	154	239	260	172	217	186	
Lane & Width Information							
Number of Lanes	2	2	2	2	2	2	
Paved Width (ft)	26.7	31	32.5	28.3	26.8	30.8	
Lane Width (ft)	10.3	11.8	13.1	11.6	10.7	10.8

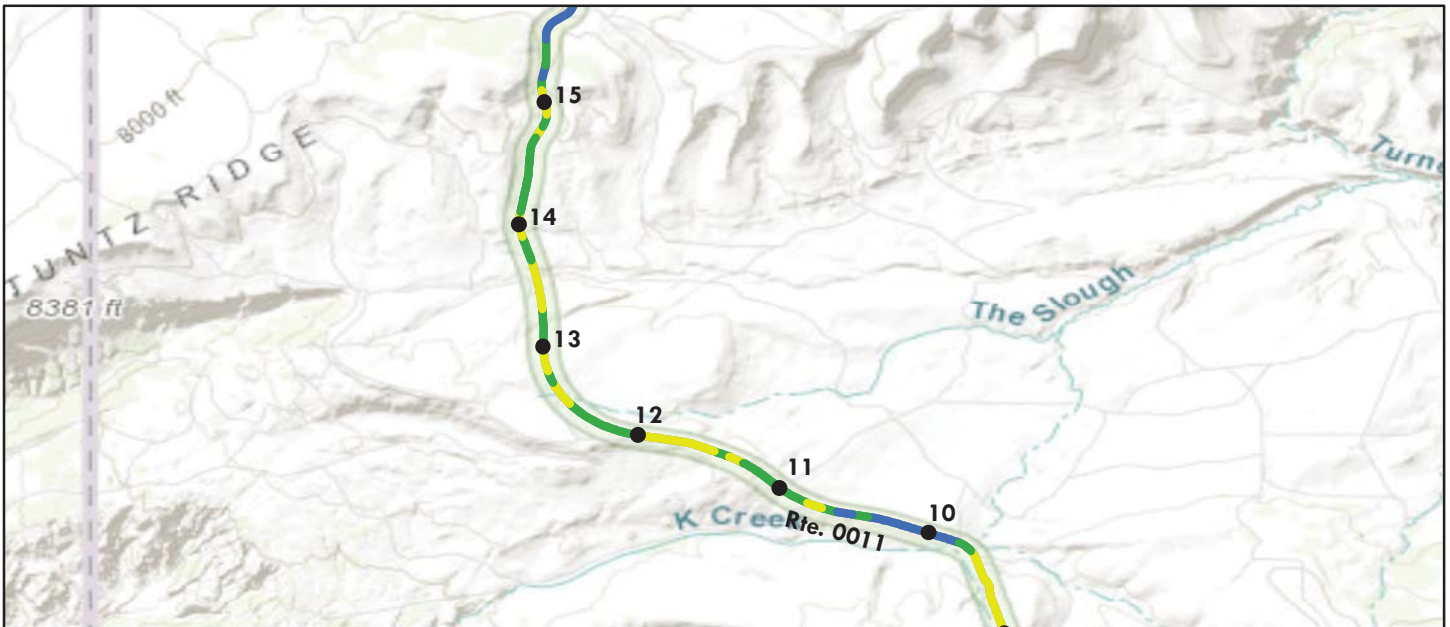
Inspection Date:	8/15/2017	Beginning Section MP	10	11	12	13	14
Paved Length (Miles):	31.88	Section Length (MI)	1	1	1	1	1
Surface Type:	ASPHALT	Route Summary					
Roadway Condition Information							
Pavement Condition Rating (PCR)	90	92	86	86	83	87	
Surface Condition Rating (SCR)	94	91	85	88	83	89	
Roughness Condition Index (RCI)	85	93	87	82	84	85	
Distress Index Values							
Structural Crack Index	95	97	85	89	93	96	
Alligator Crack Index	100	100	100	100	100	100	
Longitudinal Crack Index	95	97	85	89	93	96	
Transverse Cracking Index	94	91	86	88	83	89	
Patching Index	100	100	100	100	100	100	
Rutting Index	94	95	94	90	95	93	
International Roughness Index (IRI)	154	131	150	164	156	156	
Lane & Width Information							
Number of Lanes	2	2	2	2	2	2	
Paved Width (ft)	26.7	25.8	26.3	27.1	28.3	26.8	
Lane Width (ft)	10.3	10.3	9.8	10.2	9.9	10.3

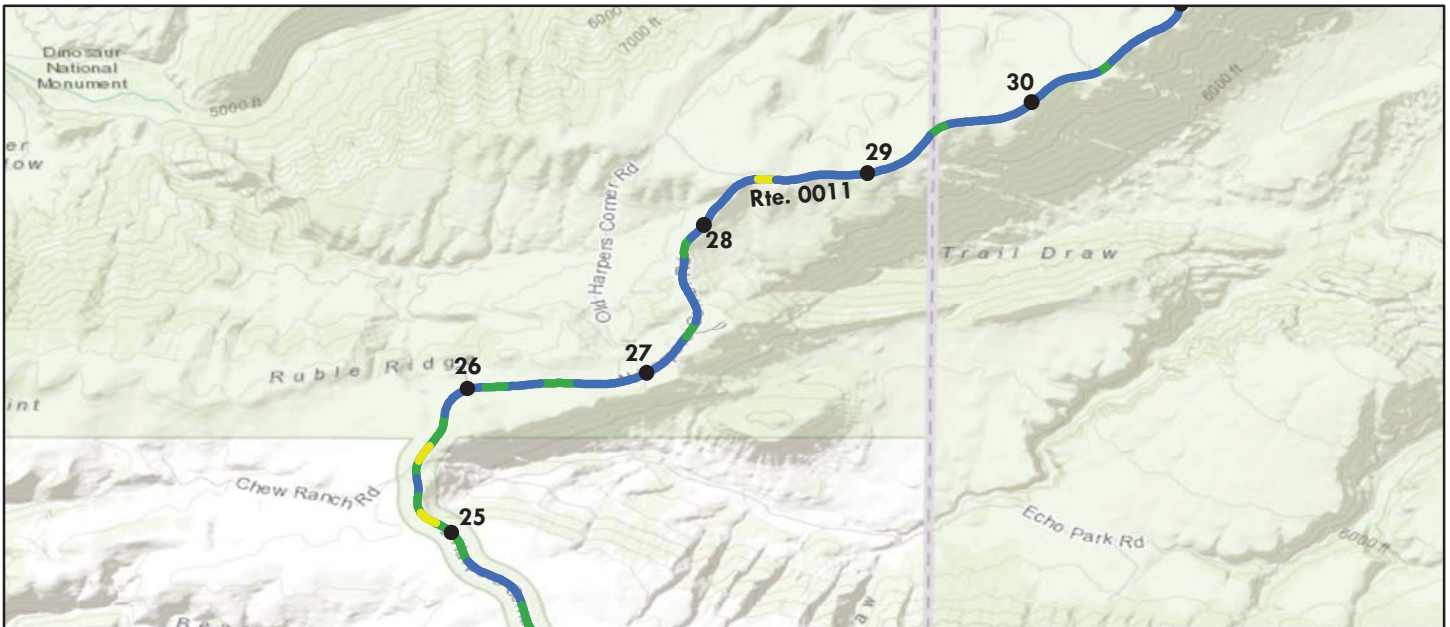
Inspection Date:	8/15/2017	Beginning Section MP	25	26	27	28	29
Paved Length (Miles):	31.88	Section Length (MI)	1	1	1	1	1
Surface Type:	ASPHALT	Route Summary					
Roadway Condition Information							
Pavement Condition Rating (PCR)	90	89	95	98	98	99	
Surface Condition Rating (SCR)	94	92	95	97	96	98	
Roughness Condition Index (RCI)	85	84	94	100	100	100	
Distress Index Values							
Structural Crack Index	95	99	100	100	100	100	
Alligator Crack Index	100	100	100	100	100	100	
Longitudinal Crack Index	95	99	100	100	100	100	
Transverse Cracking Index	94	99	99	99	100	100	
Patching Index	100	99	100	100	100	100	
Rutting Index	94	92	95	97	96	98	
International Roughness Index (IRI)	154	158	129	114	99	98	
Lane & Width Information							
Number of Lanes	2	2	2	2	2	2	
Paved Width (ft)	26.7	25.6	22.6	21.9	22.6	22.2	
Lane Width (ft)	10.3	10	9.9	9.6	9.6	9.9
