FLNI Cycle 6

Final Report

Road Inventory and Condition Assessment of Paved Routes Flight 93 National Memorial

Flight 93 National Memorial in Pennsylvania

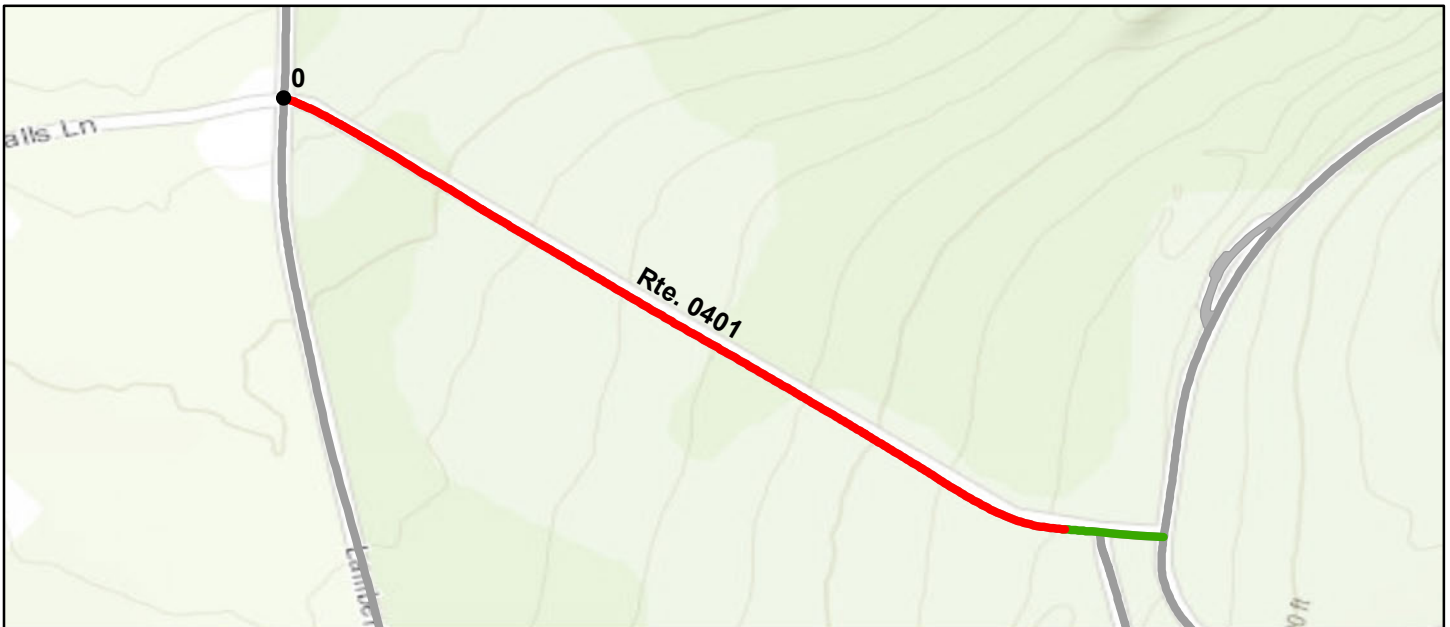
Inspection Date:	11/12/2020	Beginning Section MP	0				
Paved Length (Miles):	0.44	Section Length (MI)	0.44				
Surface Type:	ASPHALT	Route Summary					
Roadway Condition Information							
Pavement Condition Rating (PCR)	48	48					
Surface Condition Rating (SCR)	48	48					
Roughness Condition Index (RCI)	N/A	N/A					
Distress Index Values							
Structural Crack Index	48	48					
Alligator Crack Index	90	90					
Longitudinal Crack Index	58	58					
Transverse Cracking Index	92	92					
Patching Index	90	90					
Rutting Index	90	90					
International Roughness Index (IRI)	N/A	N/A					
Lane & Width Information							
Number of Lanes	2	2					
Paved Width (ft)	17.8	17.8					
Lane Width (ft)	8.9	8.9

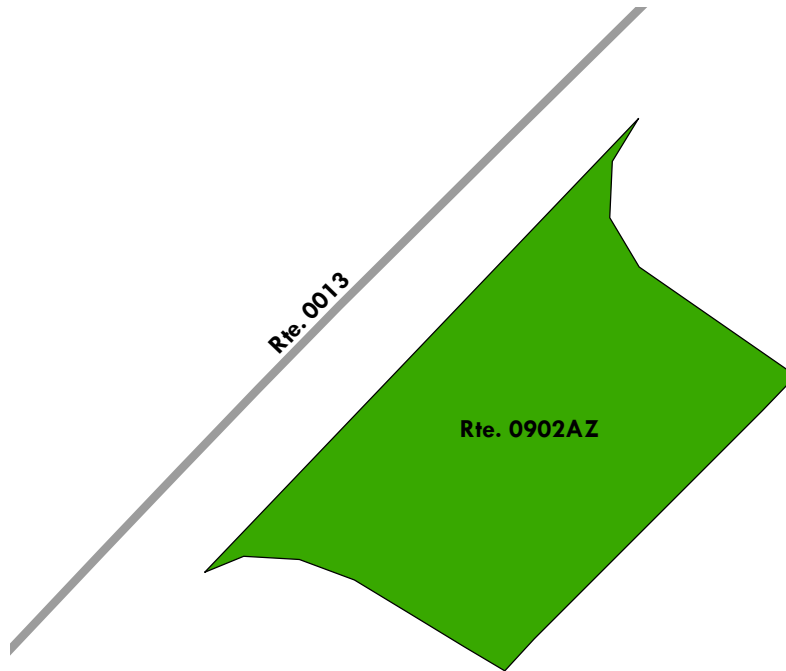
ROUTE 0902AZ: TOWER OF VOICES HANDICAPPED PARKING

Inspection Date	FMSS Number	User Access	Surface Type
10/21/2019	239299	PUBLIC	ASPHALT
Area (Sq. Ft.)	Lane Miles (11' Widths)	Curb Reveal (Inches)	Curb Recommendation
532	0.009	NOT APPLICABLE	NOT APPLICABLE
Curb Type		Curb & Gutter Type	
NO CURB		NO CURB AND GUTTER	
Pavement Recommendation		Condition Rating / PCR	
PREVENTIVE MAINTENANCE		GOOD / 90

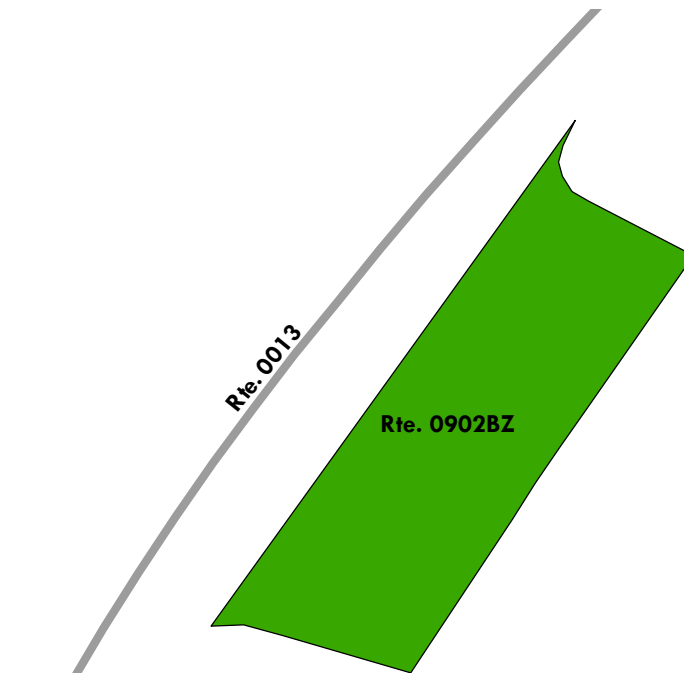
ROUTE 0902BZ: TOWER OF VOICES PARKING AREA B

Inspection Date	FMSS Number	User Access	Surface Type
10/21/2019	239299	PUBLIC	ASPHALT
Area (Sq. Ft.)	Lane Miles (11' Widths)	Curb Reveal (Inches)	Curb Recommendation
942	0.016	NOT APPLICABLE	NOT APPLICABLE
Curb Type		Curb & Gutter Type	
NO CURB		NO CURB AND GUTTER	
Pavement Recommendation		Condition Rating / PCR	
PREVENTIVE MAINTENANCE		GOOD / 90

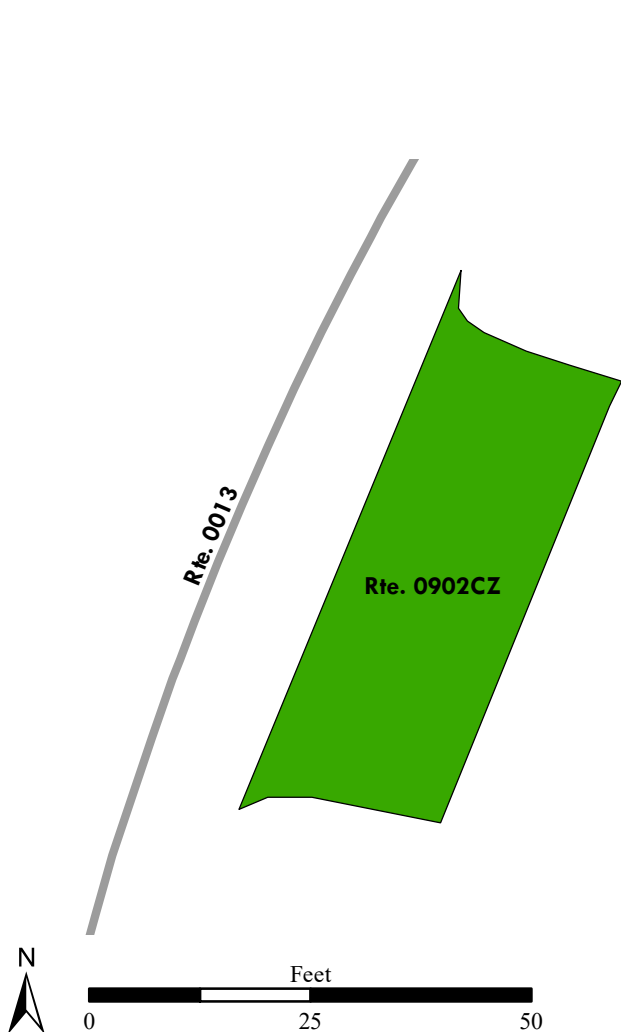
ROUTE 0902CZ: TOWER OF VOICES PARKING AREA C

Inspection Date	FMSS Number	User Access	Surface Type
10/21/2019	239299	PUBLIC	ASPHALT
Area (Sq. Ft.)	Lane Miles (11' Widths)	Curb Reveal (Inches)	Curb Recommendation
926	0.016	NOT APPLICABLE	NOT APPLICABLE
Curb Type		Curb & Gutter Type	
NO CURB		NO CURB AND GUTTER	
Pavement Recommendation		Condition Rating / PCR	
PREVENTIVE MAINTENANCE		GOOD / 90
