FOMA Cycle 6

Final Report

Road Inventory and Condition Assessment of Paved Routes Fort Matanzas National Monument

Report Date: April 2020

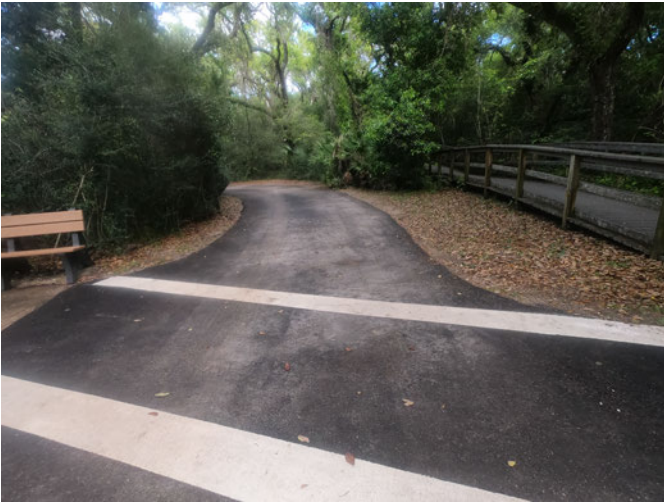
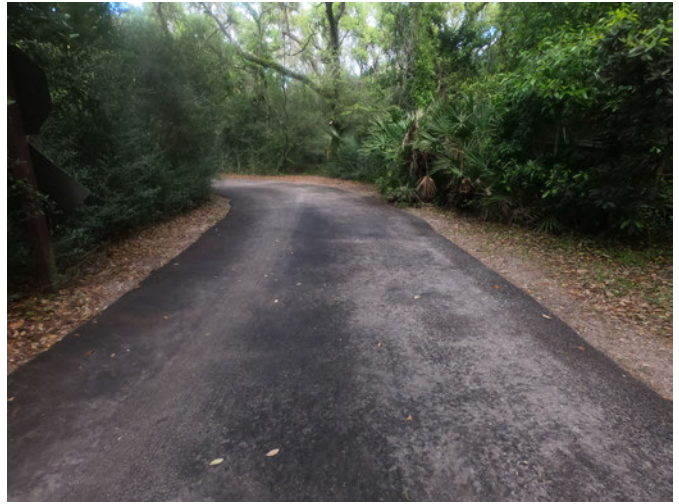
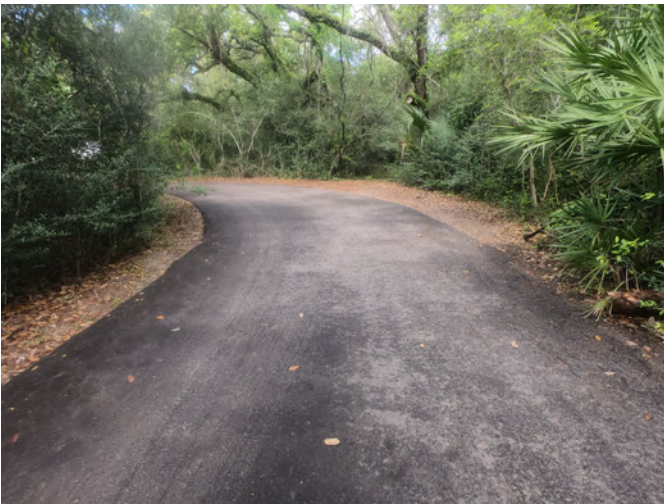
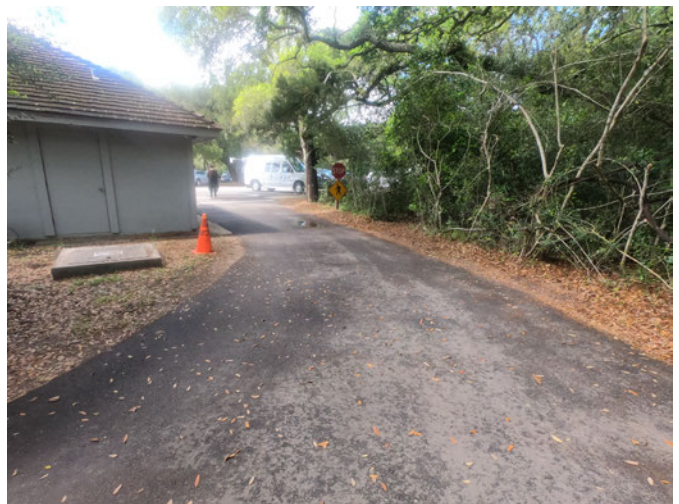
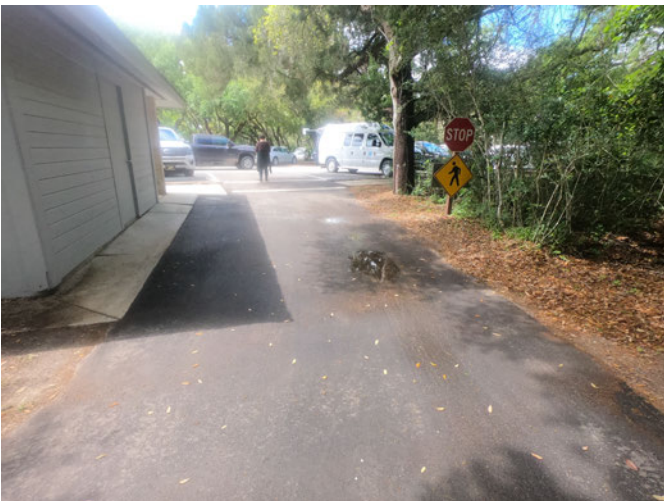
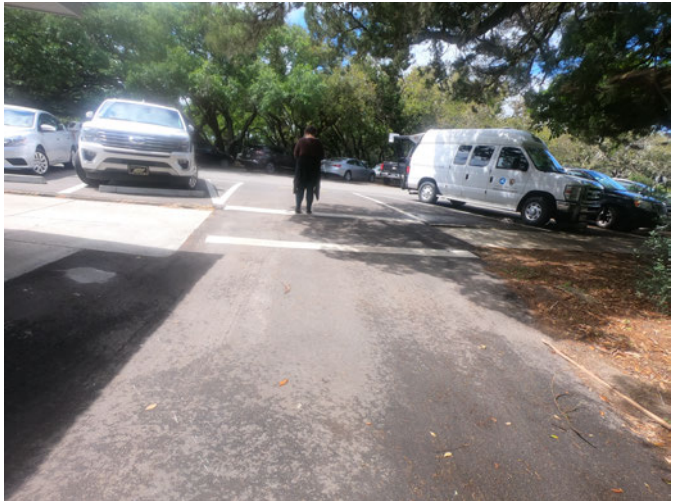
Subcomponent of Route FOMA-0400ZZ

Route Condition Legend – Pavement Condition Rating (PCR)						
Poor (0 - 60)	Fair (61- 84)	Good (85 - 94)	Excellent (95 - 100)	Not Rated		
See Appendix for definitions and formulas						
Inspection Date: 4/4/2019	Beginning Section MP	0.00				
Paved Length (Miles): 0.02	Section Length (MI)	0.02				
Surface Type: ASPHALT	Route Summary					
Roadway Condition Information						
Pavement Condition Rating (PCR)	97	97				
Surface Condition Rating (SCR)	97	97				
Roughness Condition Index (RCI)	N/A	N/A				
Distress Index Values						
Structural Crack Index	97	97				
Alligator Crack Index	97	97				
Longitudinal Crack Index	97	97				
Transverse Cracking Index	97	97				
Patching Index	97	97				
Rutting Index	97	97				
International Roughness Index (IRI)	N/A	N/A				
Lane & Width Information						
Number of Lanes	1	1				
Paved Width (ft)	13.6	13.6				
Lane Width (ft)	13.6	13.6

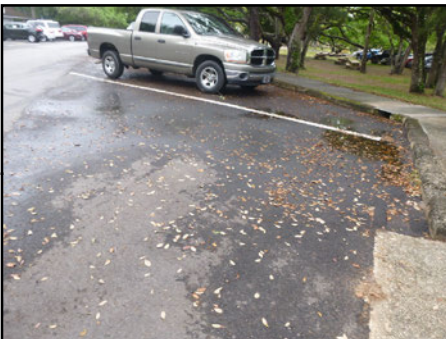
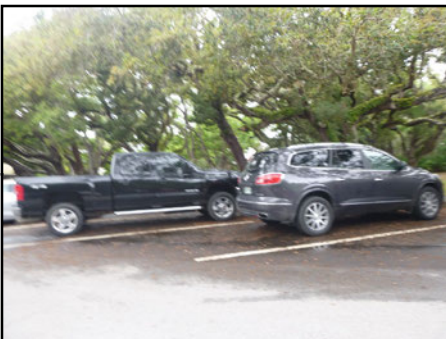
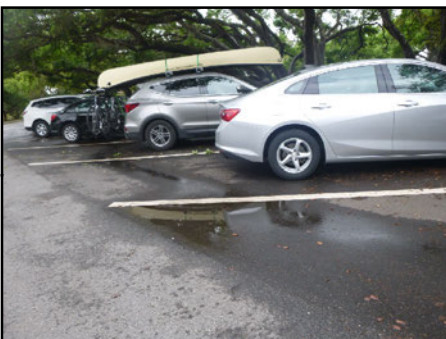
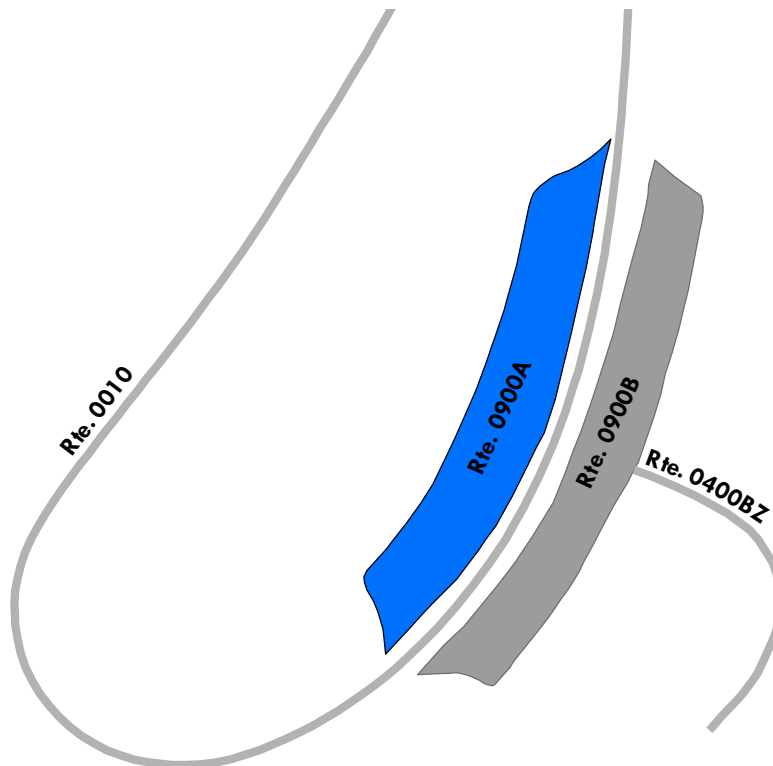
Inspection Date	FMSS Number	User Access	Surface Type
4/4/2019	104762	PUBLIC	ASPHALT
Area (Sq. Ft.)	Lane Miles (11' Widths)	Curb Reveal (Inches)	Curb Recommendation
4,461	0.077	4	MODERATE REPAIR
Curb Type		Curb & Gutter Type	
CONCRETE		NO CURB AND GUTTER	
Pavement Recommendation		Condition Rating / PCR	
DO NOTHING		EXCELLENT / 97

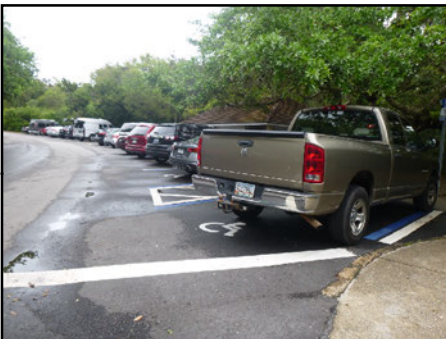
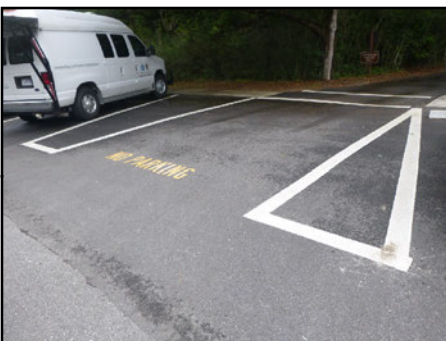
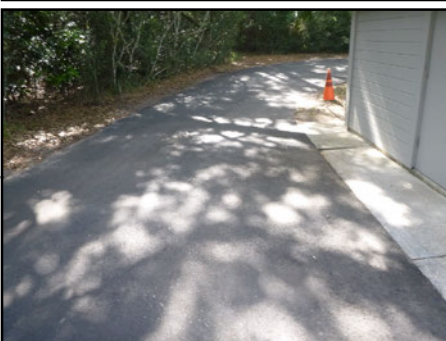
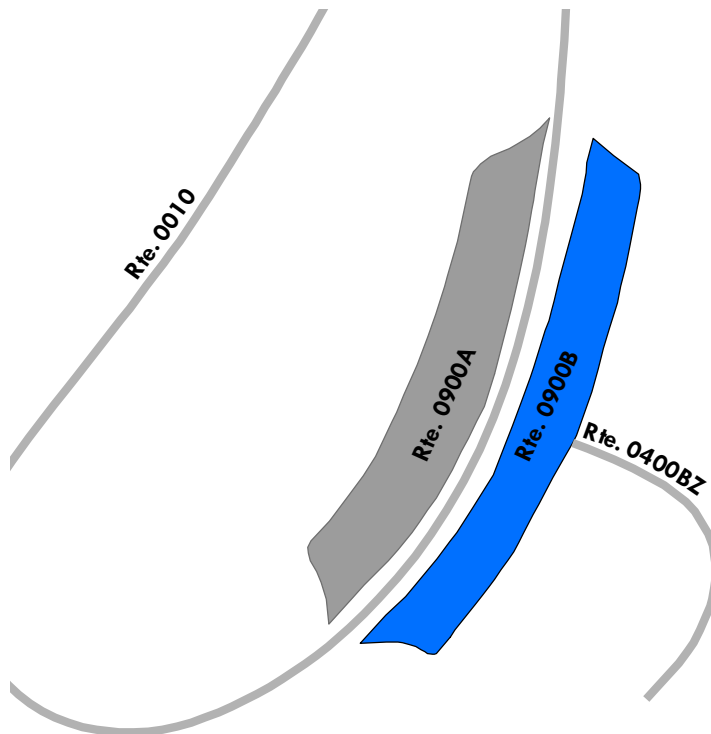
ROUTE 0900B: VISITOR CENTER PARKING B

Inspection Date	FMSS Number	User Access	Surface Type
4/4/2019	104768	PUBLIC	ASPHALT
Area (Sq. Ft.)	Lane Miles (11' Widths)	Curb Reveal (Inches)	Curb Recommendation
4,161	0.072	NOT APPLICABLE	NOT APPLICABLE
Curb Type		Curb & Gutter Type	
NO CURB		NO CURB AND GUTTER	
Pavement Recommendation		Condition Rating / PCR	
DO NOTHING		EXCELLENT / 97

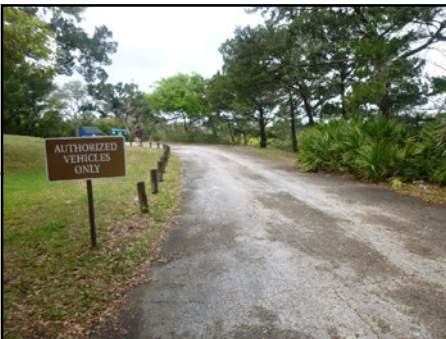
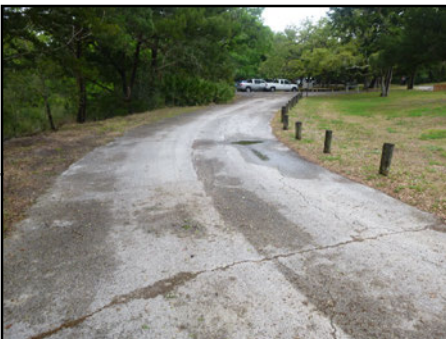
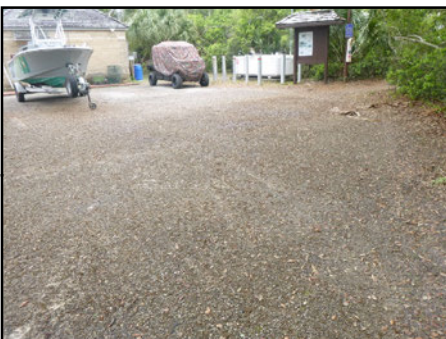
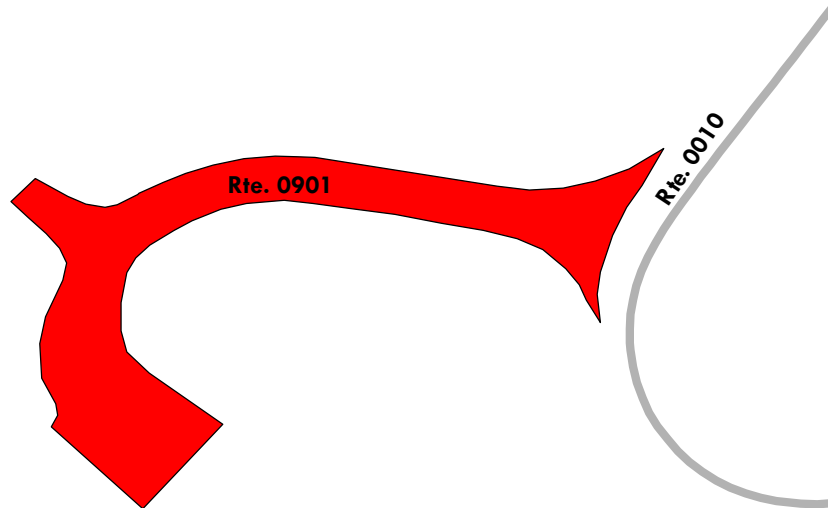
ROUTE 0901: MAINTENANCE AREA PARKING

Inspection Date	FMSS Number	User Access	Surface Type
4/4/2019	37039	NONPUBLIC	ASPHALT
Area (Sq. Ft.)	Lane Miles (11' Widths)	Curb Reveal (Inches)	Curb Recommendation
5,865	0.101	NOT APPLICABLE	NOT APPLICABLE
Curb Type		Curb & Gutter Type	
NO CURB		NO CURB AND GUTTER	
Pavement Recommendation		Condition Rating / PCR	
HEAVY 3R TREATMENTS		POOR / 53

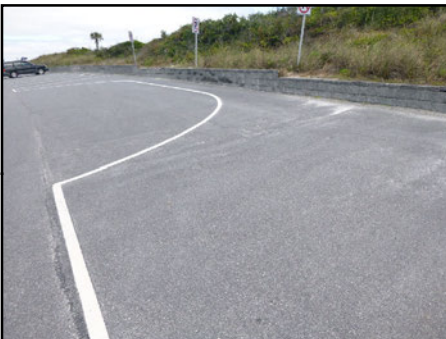
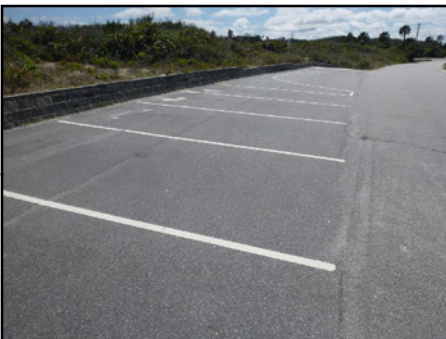
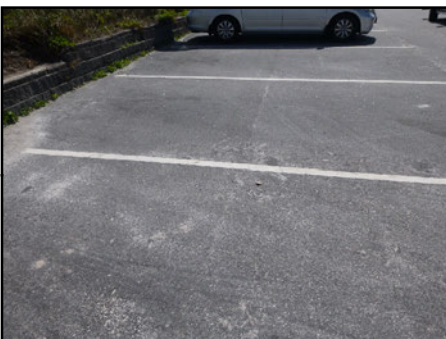
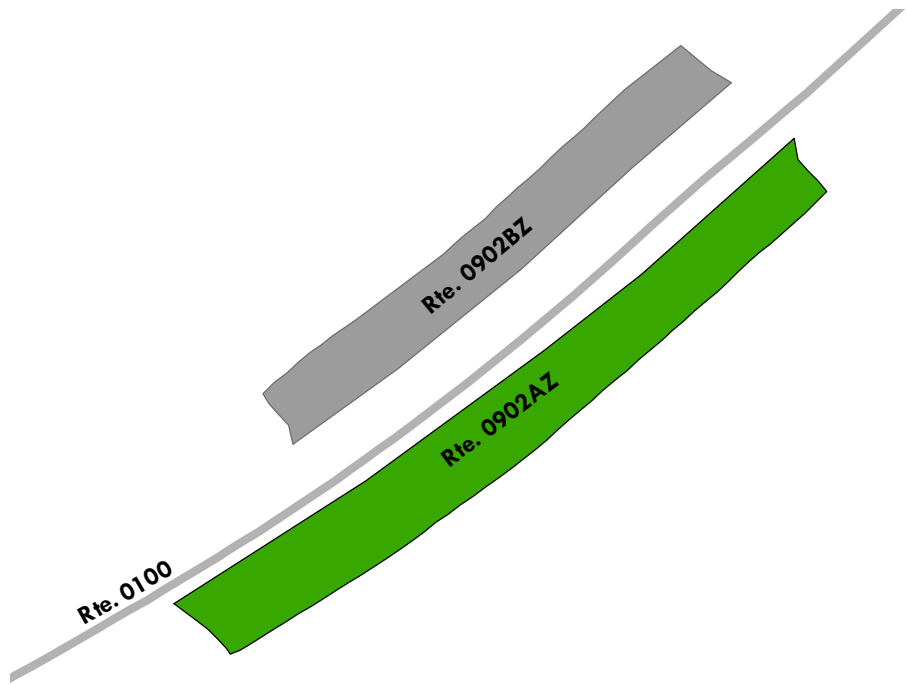
ROUTE 0902AZ: BEACH ACCESS PARKING AREA A

Inspection Date	FMSS Number	User Access	Surface Type
4/4/2019	37040	PUBLIC	ASPHALT
Area (Sq. Ft.)	Lane Miles (11' Widths)	Curb Reveal (Inches)	Curb Recommendation
4,681	0.081	NOT APPLICABLE	NOT APPLICABLE
Curb Type		Curb & Gutter Type	
NO CURB		NO CURB AND GUTTER	
Pavement Recommendation		Condition Rating / PCR	
PREVENTIVE MAINTENANCE		GOOD / 90

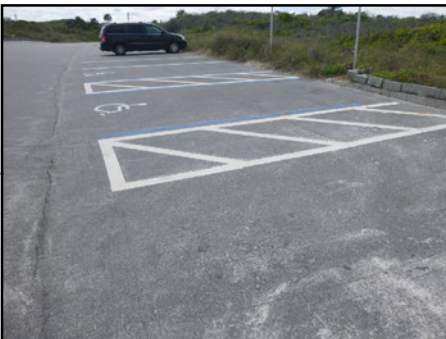
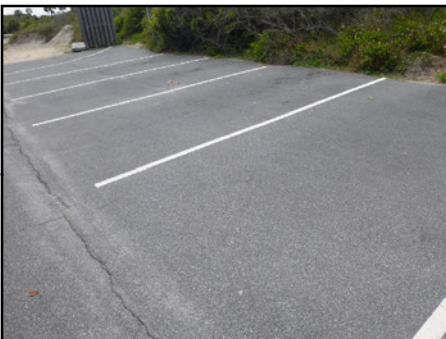
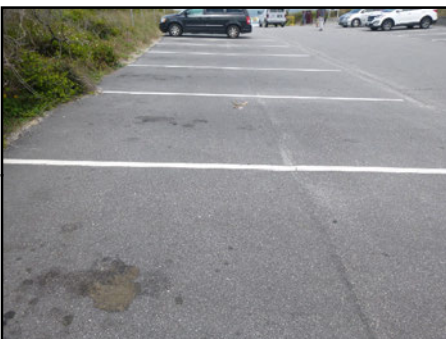
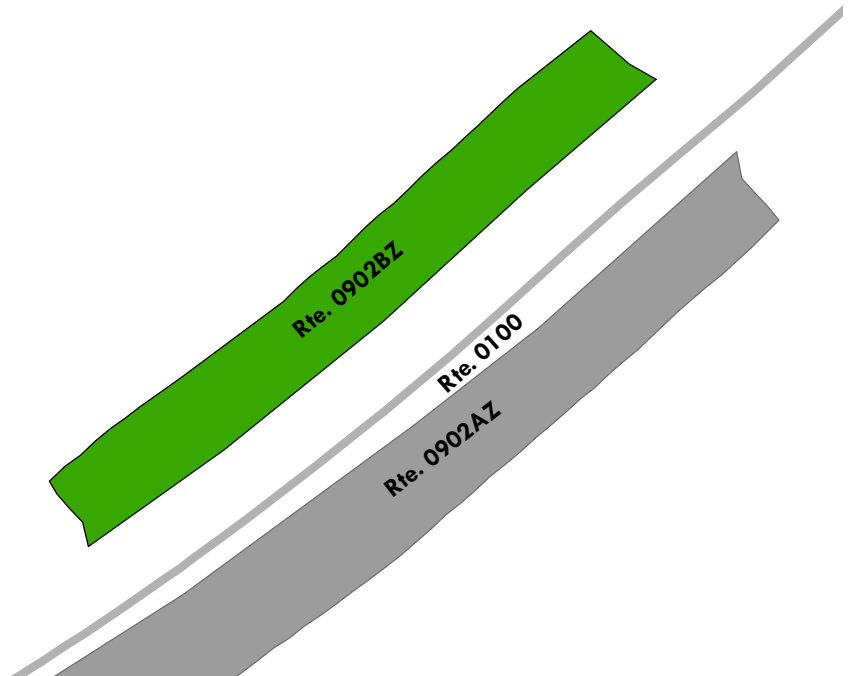
ROUTE 0902BZ: BEACH ACCESS PARKING AREA B

Inspection Date	FMSS Number	User Access	Surface Type
4/4/2019	37040	PUBLIC	ASPHALT
Area (Sq. Ft.)	Lane Miles (11' Widths)	Curb Reveal (Inches)	Curb Recommendation
3,026	0.052	NOT APPLICABLE	NOT APPLICABLE
Curb Type		Curb & Gutter Type	
NO CURB		NO CURB AND GUTTER	
Pavement Recommendation		Condition Rating / PCR	
PREVENTIVE MAINTENANCE		GOOD / 90

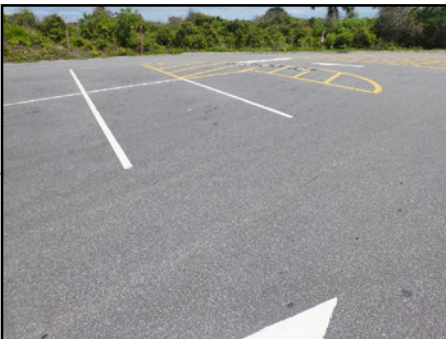
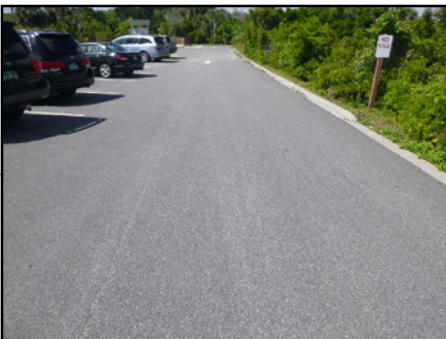
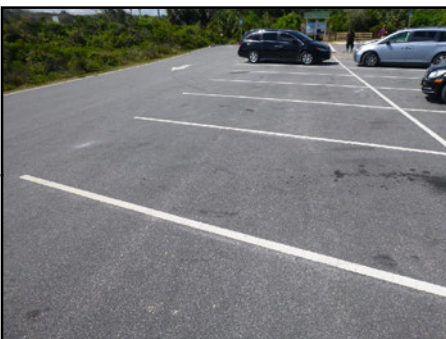
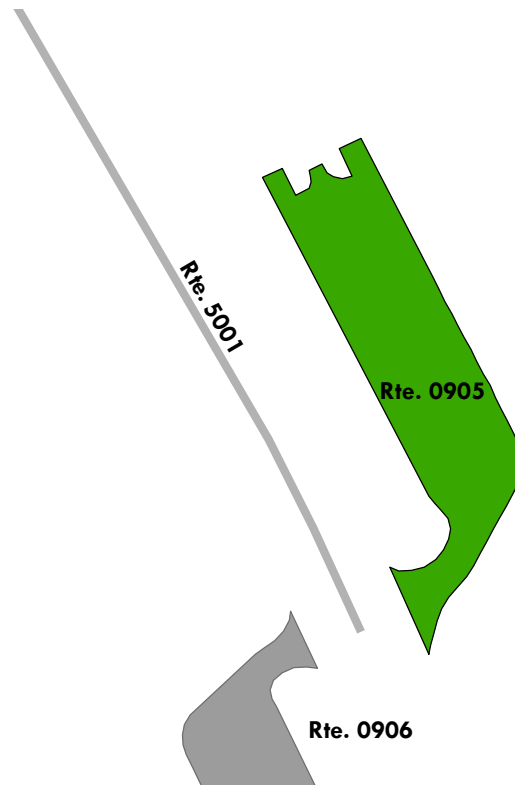
ROUTE 0905: DUNES PARKING

Inspection Date	FMSS Number	User Access	Surface Type
4/4/2019	37041	PUBLIC	ASPHALT
Area (Sq. Ft.)	Lane Miles (11' Widths)	Curb Reveal (Inches)	Curb Recommendation
23,122	0.398	4	DO NOTHING
Curb Type		Curb & Gutter Type	
CONCRETE		CONCRETE	
Pavement Recommendation		Condition Rating / PCR	
PREVENTIVE MAINTENANCE		GOOD / 90

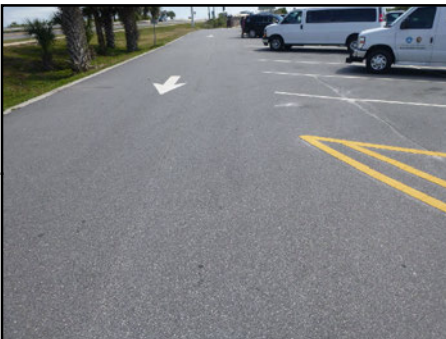
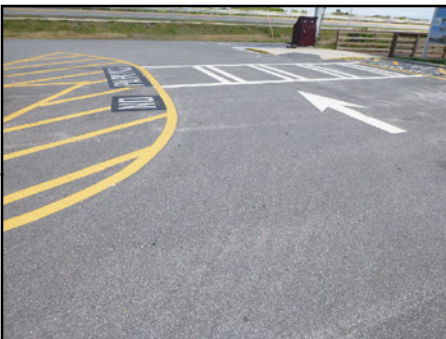
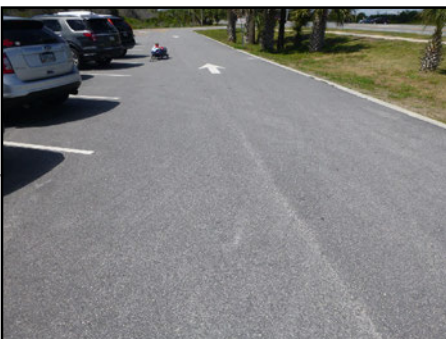
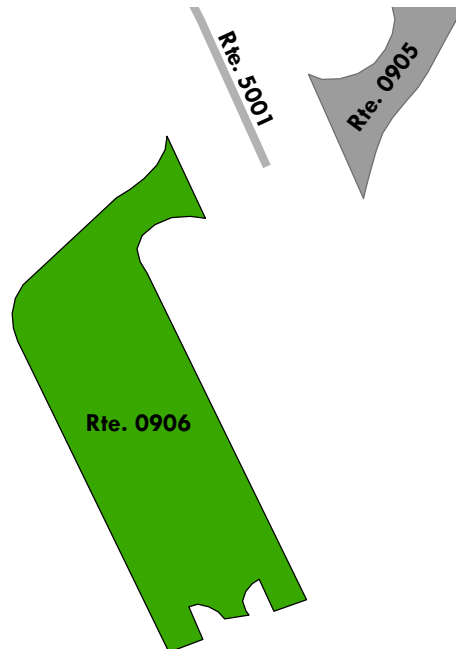
ROUTE 0906: RIVER PARKING

Inspection Date	FMSS Number	User Access	Surface Type
4/4/2019	37042	PUBLIC	ASPHALT
Area (Sq. Ft.)	Lane Miles (11' Widths)	Curb Reveal (Inches)	Curb Recommendation
16,011	0.276	4	DO NOTHING
Curb Type		Curb & Gutter Type	
CONCRETE		NO CURB AND GUTTER	
Pavement Recommendation		Condition Rating / PCR	
PREVENTIVE MAINTENANCE		GOOD / 90

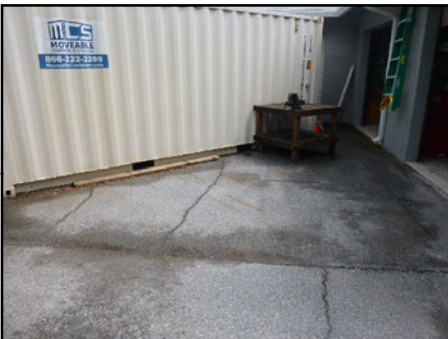
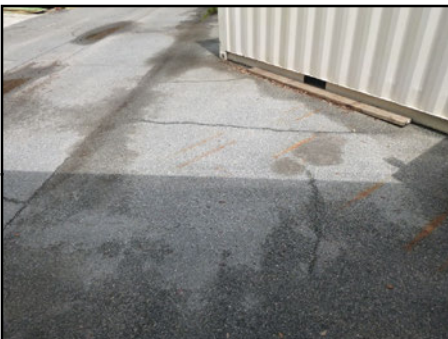
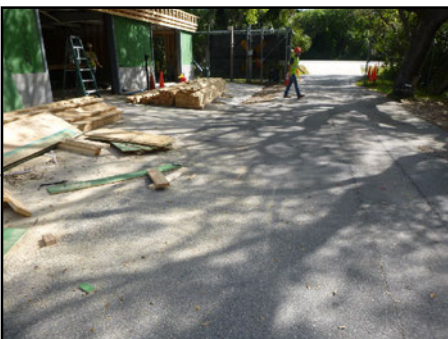
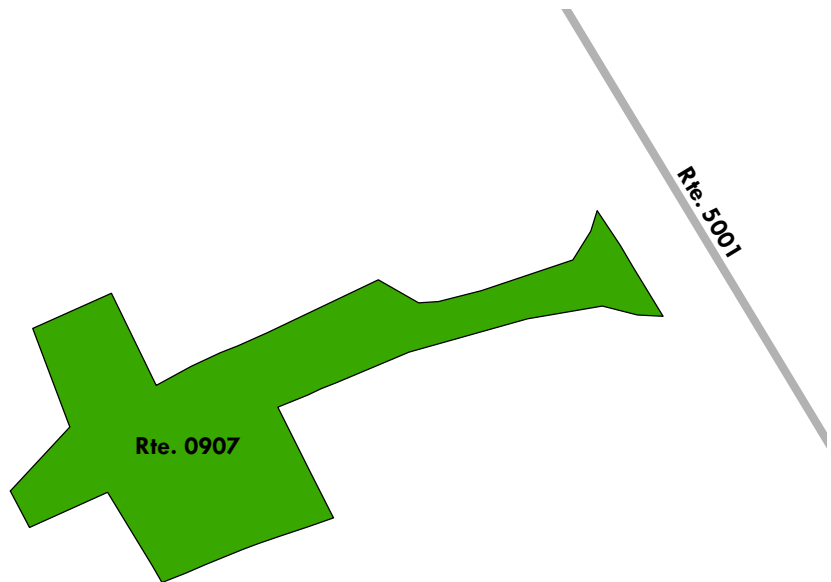
ROUTE 0907: FOMA MAINTENANCE PARKING AREA

Inspection Date	FMSS Number	User Access	Surface Type
4/4/2019	254112	PUBLIC	ASPHALT
Area (Sq. Ft.)	Lane Miles (11' Widths)	Curb Reveal (Inches)	Curb Recommendation
4,898	0.084	NOT APPLICABLE	NOT APPLICABLE
Curb Type		Curb & Gutter Type	
NO CURB		NO CURB AND GUTTER	
Pavement Recommendation		Condition Rating / PCR	
PREVENTIVE MAINTENANCE		GOOD / 90
