FOMR Cycle 6

Final Report

Road Inventory and Condition Assessment of Paved Routes Fort Monroe National Monument

Report Date: September 2021

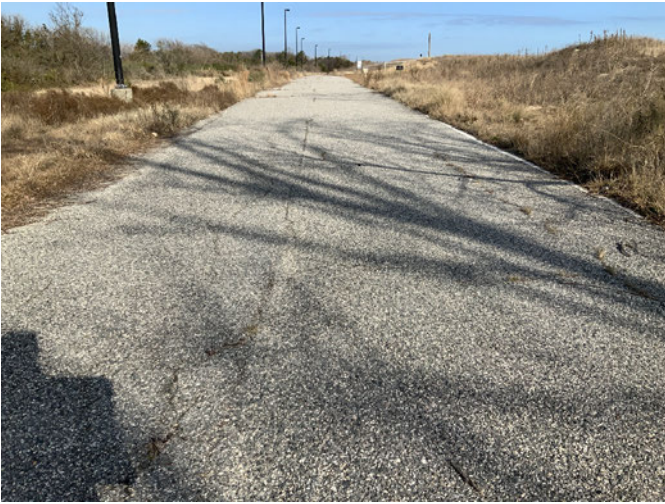
FOMR_0010BZ_1.jpg

Inspection Date:	12/11/2020	Beginning Section MP	0.00				
Paved Length (Miles):	0.59	Section Length (MI)	0.59				
Surface Type:	ASPHALT	Route Summary					
Roadway Condition Information							
Pavement Condition Rating (PCR)	53	53					
Surface Condition Rating (SCR)	53	53					
Roughness Condition Index (RCI)	N/A	N/A					
Distress Index Values							
Structural Crack Index	N/A	N/A					
Alligator Crack Index	53	53					
Longitudinal Crack Index	73	73					
Transverse Cracking Index	53	53					
Patching Index	73	73					
Rutting Index	73	73					
International Roughness Index (IRI)	N/A	N/A					
Lane & Width Information							
Number of Lanes	2	2					
Paved Width (ft)	24.9	24.9					
Lane Width (ft)	12.5	12.5

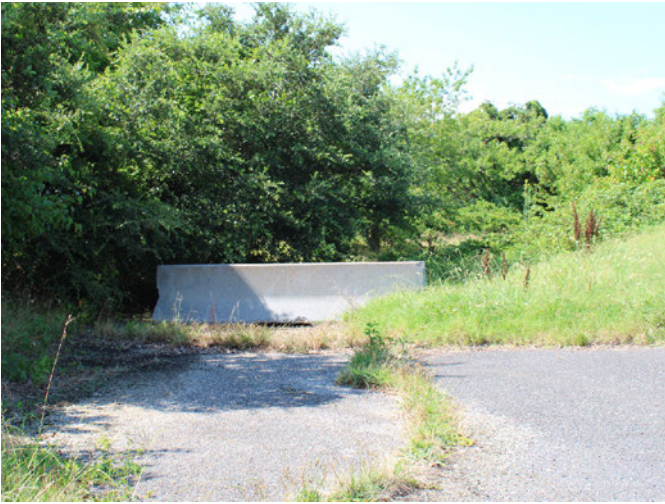
FOMR_0103BZ_2485.JPG

Route Condition Legend – Pavement Condition Rating (PCR)						
Poor (0 - 60)	Fair (61- 84)	Good (85 - 94)	Excellent (95 - 100)	Not Rated		
See Appendix for definitions and formulas						
Inspection Date: 7/19/2019	Beginning Section MP	0.00				
Paved Length (Miles): 0.06	Section Length (MI)	0.06				
Surface Type: ASPHALT	Route Summary					
Roadway Condition Information						
Pavement Condition Rating (PCR)	N/A	N/A				
Surface Condition Rating (SCR)	N/A	N/A				
Roughness Condition Index (RCI)	N/A	N/A				
Distress Index Values						
Structural Crack Index	N/A	N/A				
Alligator Crack Index	N/A	N/A				
Longitudinal Crack Index	N/A	N/A				
Transverse Cracking Index	N/A	N/A				
Patching Index	N/A	N/A				
Rutting Index	N/A	N/A				
International Roughness Index (IRI)	N/A	N/A				
Lane & Width Information						
Number of Lanes	1	1				
Paved Width (ft)	9.6	9.6				
Lane Width (ft)	9.6	9.6

NOT RATED DUE TO OVERGROWN CONDITIONS.
