GARI Cycle 6

Final Report

Road Inventory and Condition Assessment of Paved Routes Gauley River National Recreation Area

Report Date: April 2022

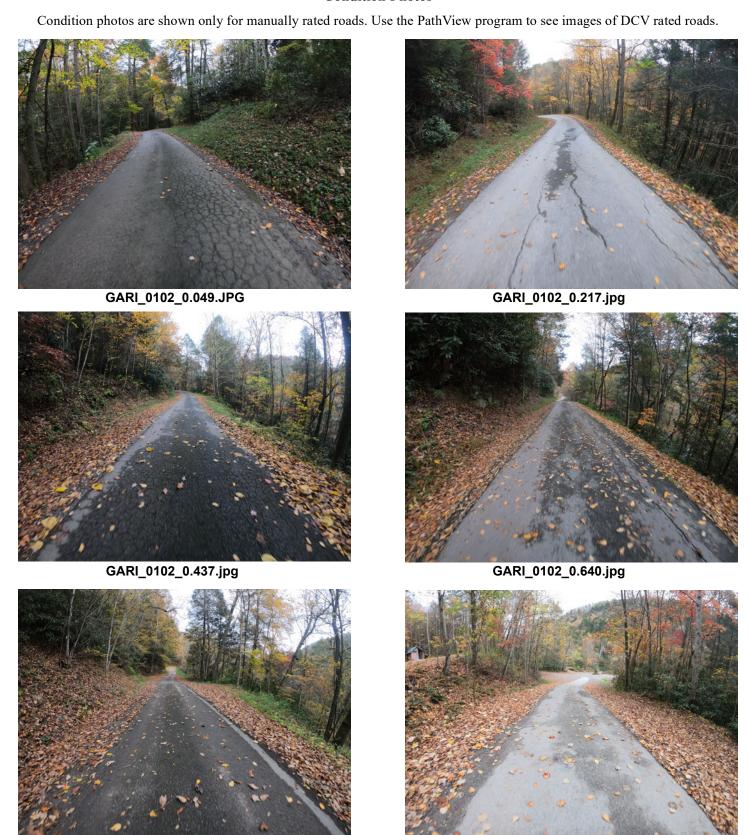
ROUTE 0102: MASONS BRANCH ACCESS ROAD

Route (Condition Legend – Pav	ement Condi	tion Rating (PCR)		
Poor (0 - 60	_		(85 - 94)	Excellent (9		Not Ra	ted
,		See Appendix for def					
Inspection Date:	10/26/2020	Beginning Section MP	0.00				
Paved Length (Mile	es): 1.05	Section Length (MI)	1.05				
Surface Type:	ASPHALT	Route Summary					
Roadway Condition	n Information						
Pavement Conditio	on Rating (PCR)	53	53				
Surface Condition R	Rating (SCR)	53	53				
Roughness Conditio	on Index (RCI)	N/A	N/A				
Distress Index Valu	es						
Structural Crack In	ıdex	N/A	N/A				
Alligator Crack Inc	dex	53	53				
Longitudinal Crack	x Index	90	90				
Transverse Crackin	ng Index	90	90				
Patching Index		73	73				
Rutting Index		90	90				
International Roug	hness Index (IRI)	N/A	N/A				
Lane & Width Info	rmation						
Number of Lanes		1	1				
Paved Width (ft)		9	9				
Lane Width (ft)		9	9

GARI_0102_0.871.jpg

GARI_0102_1.035.jpg

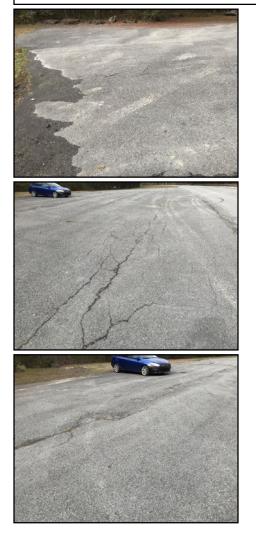
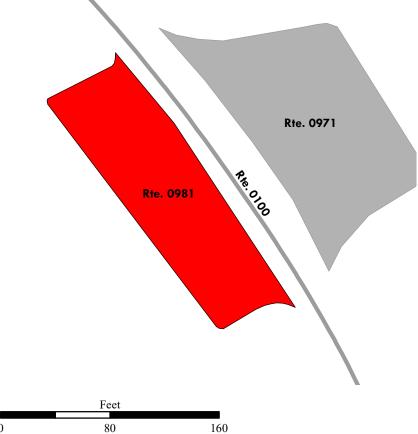
ROUTE 0981: GAULEY TAILWATERS OVERFLOW PARKING

Inspection Date	FMSS Number	User Access	Surface Type
10/26/2020	254872	PUBLIC	ASPHALT
Area (Sq. Ft.)	Lane Miles (11' Widths)	Curb Reveal (Inches)	Curb Recommendation
10,253	0.177	NOT APPLICABLE	NOT APPLICABLE
Curb Type		Curb & Gutter Type	
NO CURB		NO CURB AND GUTTER	
Pavement Recommendation		Condition Rating / PCR	
RECONSTRUCTION		POOR / 30	
Route Condition Legend – Pavement Condition Rating (PCR)			
Poor (0 - 60)	Fair (61- 84) Good ((85 - 94) Excellent (95 - 10	0) Not Rated
See Appendix for definitions and formulas
