GRSA Cycle 6

Final Report

Road Inventory and Condition Assessment of Paved Routes Great Sand Dunes National Park and Preserve

Report Date: December 2017

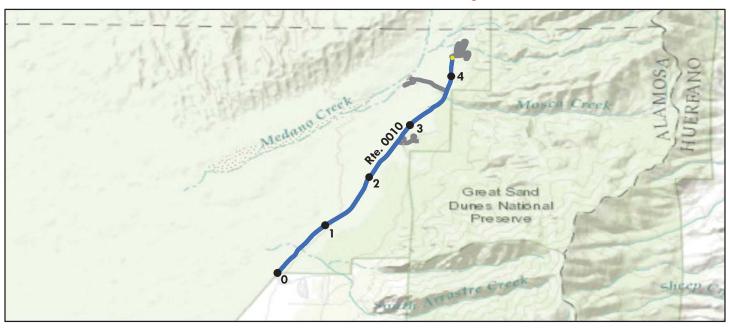
ROUTE 0010: PARK ENTRANCE ROAD

Route Co	ondition Legend – Pav	ement Condi	tion Rating (PCR)		
Poor (0 - 60) Fair (61				Excellent (95 - 100)		Not Rated	
See Appendix for definitions and formulas							
Inspection Date: 5/30/201	.7	Seginning Section MP 0 1 2		2	3	4	
Paved Length (Miles): 4.31		Section Length (MI)	1	1	1	1	0.31
Surface Type: ASPHA	LT I	Route Summary				•	
Roadway Condition Information							
Pavement Condition Rating (Po	CR)	100	100	100	100	99	99
Surface Condition Rating (SCR)		100	100	100	100	99	99
Roughness Condition Index (RC)		100	100	100	100	100	100
Distress Index Values							
Structural Crack Index		100	100	100	100	100	100
Alligator Crack Index		100	100	100	100	100	100
Longitudinal Crack Index		100	100	100	100	100	100
Transverse Cracking Index		100	100	100	100	99	99
Patching Index		100	100	100	100	100	100
Rutting Index		100	100	100	100	99	99
International Roughness Index (IRI)		71	66	63	84	67	82
Lane & Width Information

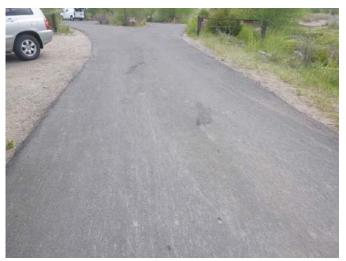
GRSA_0201AZ_0638.JPG

Route	Condition Legend – Pav	ement Condi	ition Rating (P	CR)		
Poor (0 - 60) Fair (61- 84) Good ((85 - 94)	Excellent (95	5 - 100)	Not Ra	ted
	See Appendix for def	initions and f	ormulas			
Inspection Date: 5/30/2017	Beginning Section MP	0.00				
Paved Length (Miles): 0.05	Section Length (MI)	0.05				
Surface Type: ASPHALT	Route Summary					
Roadway Condition Information						
Pavement Condition Rating (PCR)	90	90				
Surface Condition Rating (SCR)	90	90				
Roughness Condition Index (RCI)	N/A	N/A				
Distress Index Values						
Structural Crack Index	N/A	N/A				
Alligator Crack Index	97	97				
Longitudinal Crack Index	97	97				
Transverse Cracking Index	90	90				
Patching Index	97	97				
Rutting Index	90	90				
International Roughness Index (IRI)	N/A	N/A				
Lane & Width Information						
Number of Lanes	1	1				
Paved Width (ft)	10	10				
Lane Width (ft)	10	10

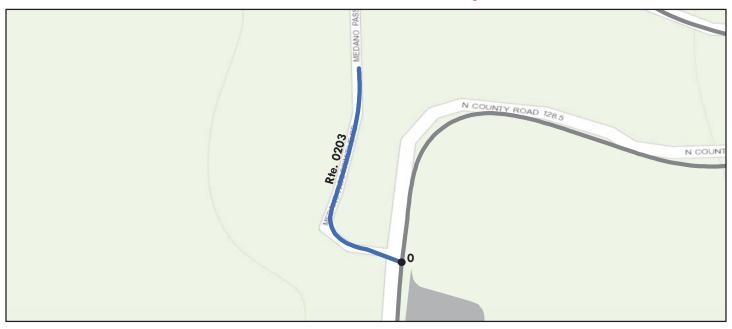
ROUTE 0203: MEDANO ROAD

Route (Condition Legend – Pav	ement Condi	tion Rating (PCR)		
Poor (0 - 6			(85 - 94)	Excellent (Not Ra	ted
		See Appendix for def	finitions and f	ormulas			
Inspection Date:	5/30/2017	Beginning Section MP	0				
Paved Length (Mile	es): 0.06	Section Length (MI)	0.06				
Surface Type:	ASPHALT	Route Summary					
Roadway Condition	n Information						
Pavement Condition	on Rating (PCR)	97	97				
Surface Condition R	Rating (SCR)	97	97				
Roughness Condition	on Index (RCI)	N/A	N/A				
Distress Index Valu	ies						
Structural Crack In	ıdex	100	100				
Alligator Crack Inc	dex	100	100				
Longitudinal Crack	x Index	100	100				
Transverse Crackin	ng Index	97	97				
Patching Index		100	100				
Rutting Index		98	98				
International Roug	hness Index (IRI)	N/A	N/A				
Lane & Width Info	rmation						
Number of Lanes		1	1				
Paved Width (ft)		12.3	12.3				
Lane Width (ft)		12.3	12.3

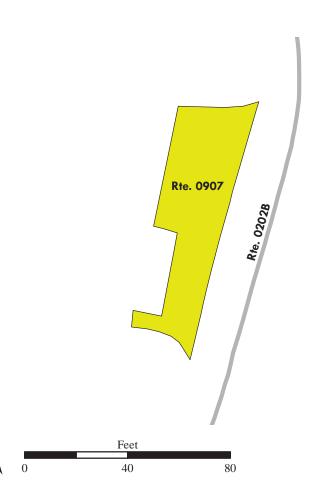
Inspection Date	FMSS Number	User Access	Surface Type	
5/30/2017	231238	PUBLIC	ASPHALT	
Area (Sq. Ft.)	Lane Miles (11' Widths)	Curb Reveal (Inches)	Curb Recommendation	
1,690	0.029	8	DO NOTHING	
Curb Type		Curb & Gutter Type		
CONCRETE		NO CURB AND GUTTER		
Pavement Recommendation		Condition Rating / PCR		
LIGHT 3R TREATMENTS		FAIR / 73
