GUCO Cycle 6

Final Report

Road Inventory and Condition Assessment of Paved Routes Guilford Courthouse National Military Park

Report Date: October 2021

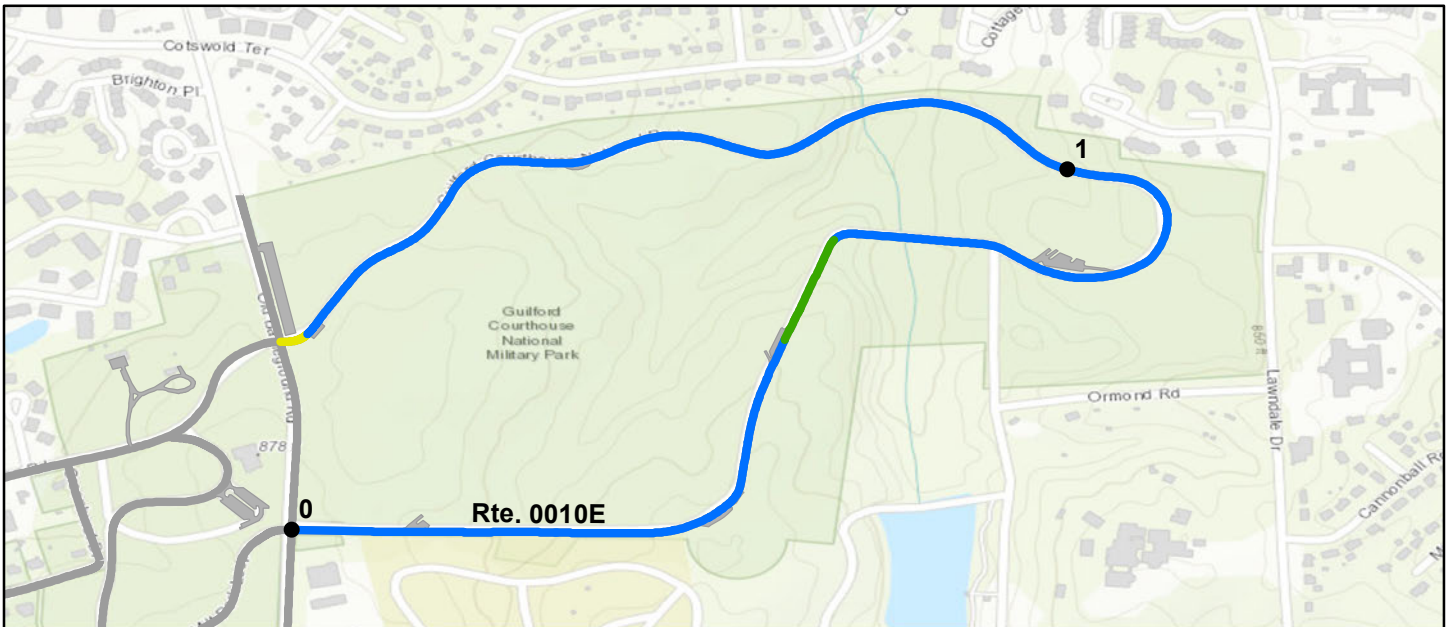
ROUTE 0010E: TOUR ROAD EAST

Inspection Date:	2/9/2021	Beginning Section MP	0	1			
Paved Length (Miles):	1.73	Section Length (MI)	1	0.73			
Surface Type:	ASPHALT	Route Summary					
Roadway Condition Information							
Pavement Condition Rating (PCR)	98	97	98				
Surface Condition Rating (SCR)	98	97	98				
Roughness Condition Index (RCI)	N/A	N/A	N/A				
Distress Index Values							
Structural Crack Index	100	100	100				
Alligator Crack Index	100	100	100				
Longitudinal Crack Index	100	100	100				
Transverse Cracking Index	100	99	100				
Patching Index	100	100	99				
Rutting Index	98	97	98				
International Roughness Index (IRI)	N/A	N/A	N/A				
Lane & Width Information							
Number of Lanes	2	2	2				
Paved Width (ft)	20.9	20.7	21.1				
Lane Width (ft)	10.4	10.3	10.6

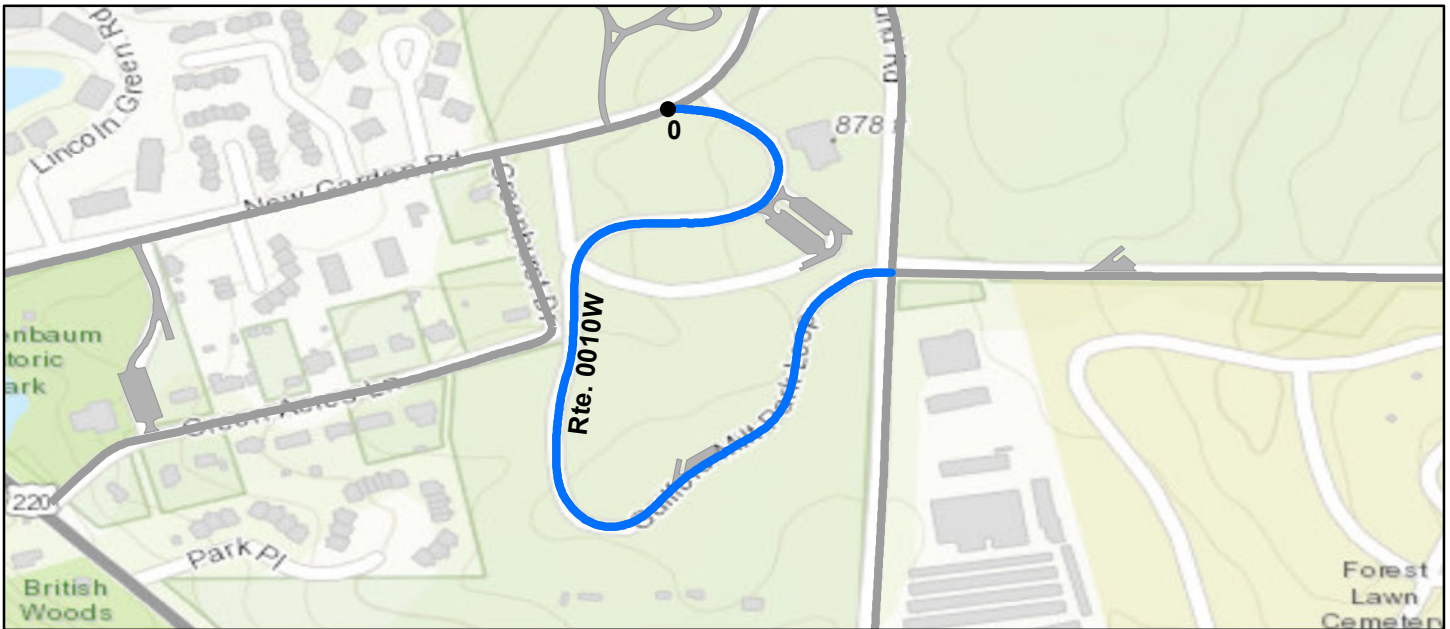
ROUTE 0010W: TOUR ROAD WEST

Inspection Date: 2/9/2021	Beginning Section MP	0				
Paved Length (Miles): 0.53	Section Length (MI)	0.53				
Surface Type: ASPHALT	Route Summary					
Roadway Condition Information						
Pavement Condition Rating (PCR)	98	98				
Surface Condition Rating (SCR)	98	98				
Roughness Condition Index (RCI)	N/A	N/A				
Distress Index Values						
Structural Crack Index	100	100				
Alligator Crack Index	100	100				
Longitudinal Crack Index	100	100				
Transverse Cracking Index	100	100				
Patching Index	100	100				
Rutting Index	98	98				
International Roughness Index (IRI)	N/A	N/A				
Lane & Width Information						
Number of Lanes	2	2				
Paved Width (ft)	19.5	19.5				
Lane Width (ft)	11.7	11.7

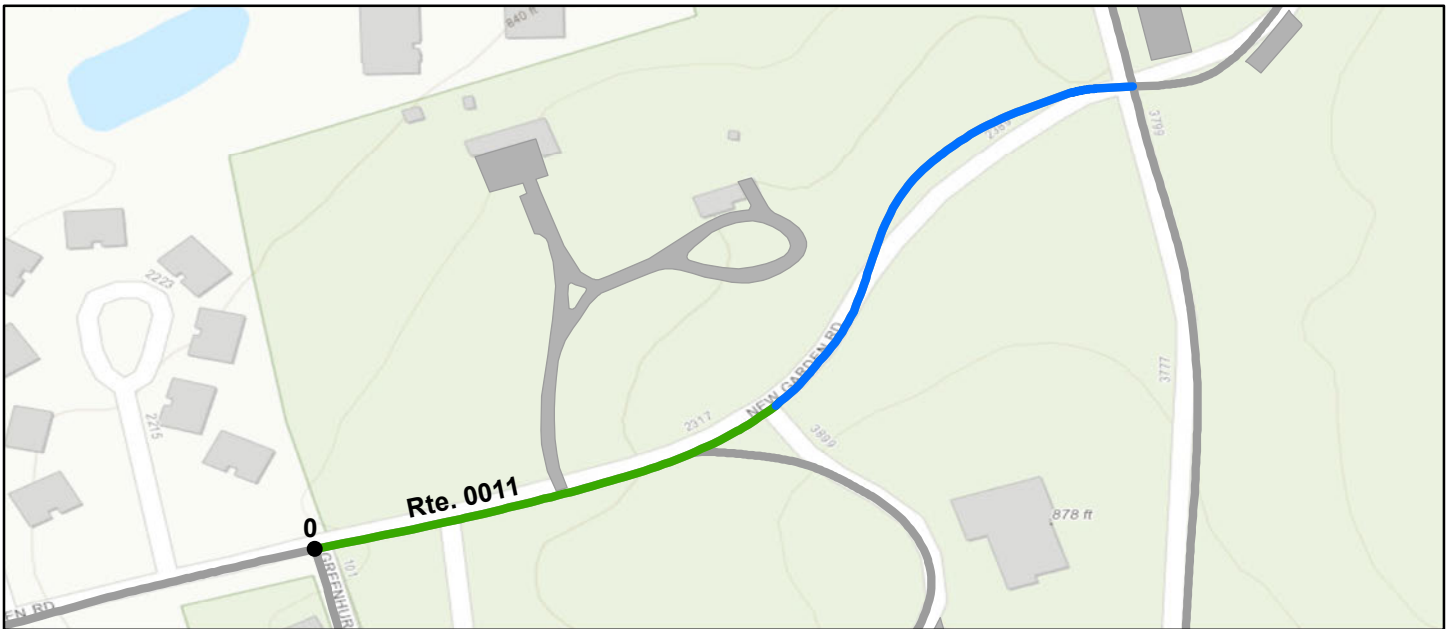
ROUTE 0011: NEW GARDEN ROAD

Inspection Date: 2/9/2021	Beginning Section MP	0				
Paved Length (Miles): 0.21	Section Length (MI)	0.21				
Surface Type: ASPHALT	Route Summary					
Roadway Condition Information						
Pavement Condition Rating (PCR)	95	95				
Surface Condition Rating (SCR)	95	95				
Roughness Condition Index (RCI)	N/A	N/A				
Distress Index Values						
Structural Crack Index	97	97				
Alligator Crack Index	100	100				
Longitudinal Crack Index	97	97				
Transverse Cracking Index	95	95				
Patching Index	100	100				
Rutting Index	99	99				
International Roughness Index (IRI)	N/A	N/A				
Lane & Width Information						
Number of Lanes	2	2				
Paved Width (ft)	20.8	20.8				
Lane Width (ft)	9.6	9.6

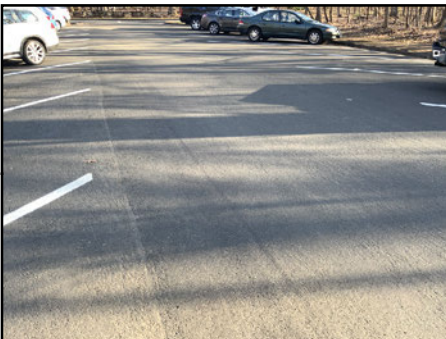
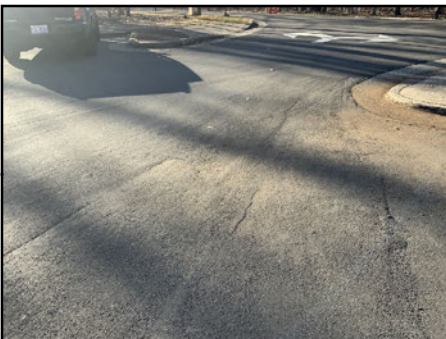
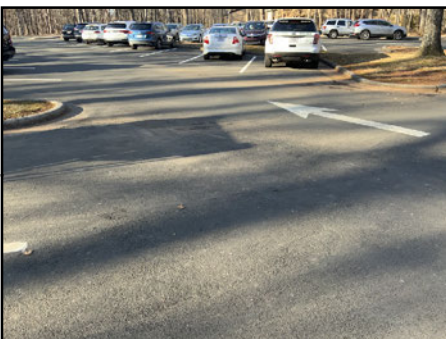
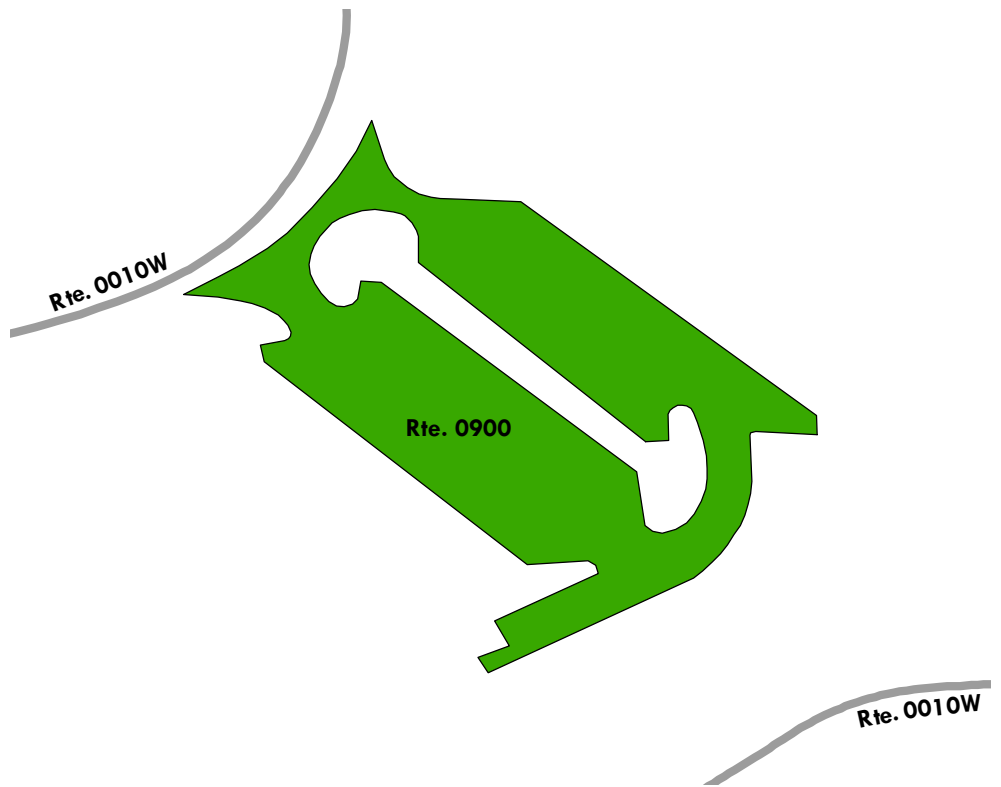
Inspection Date	FMSS Number	User Access	Surface Type
2/9/2021	69342	PUBLIC	ASPHALT
Area (Sq. Ft.)	Lane Miles (11' Widths)	Curb Reveal (Inches)	Curb Recommendation
18,585	0.32	NOT APPLICABLE	LIGHT REPAIR
Curb Type		Curb & Gutter Type	
NO CURB		CONCRETE	
Pavement Recommendation		Condition Rating / PCR	
PREVENTIVE MAINTENANCE		GOOD / 90

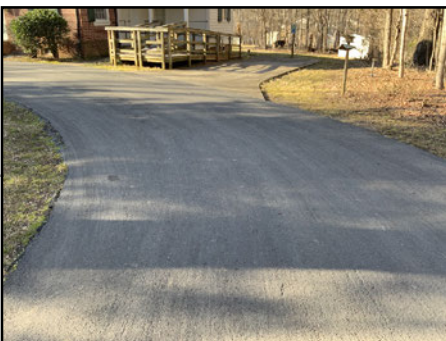
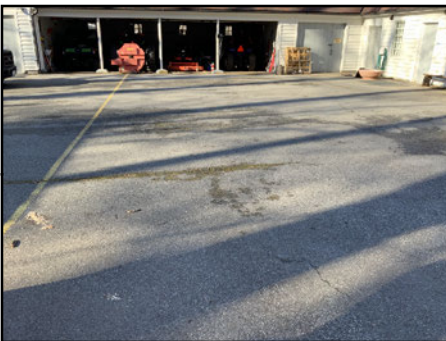
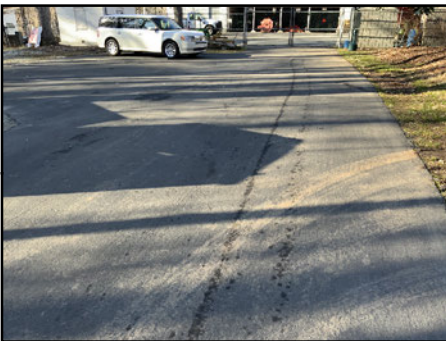
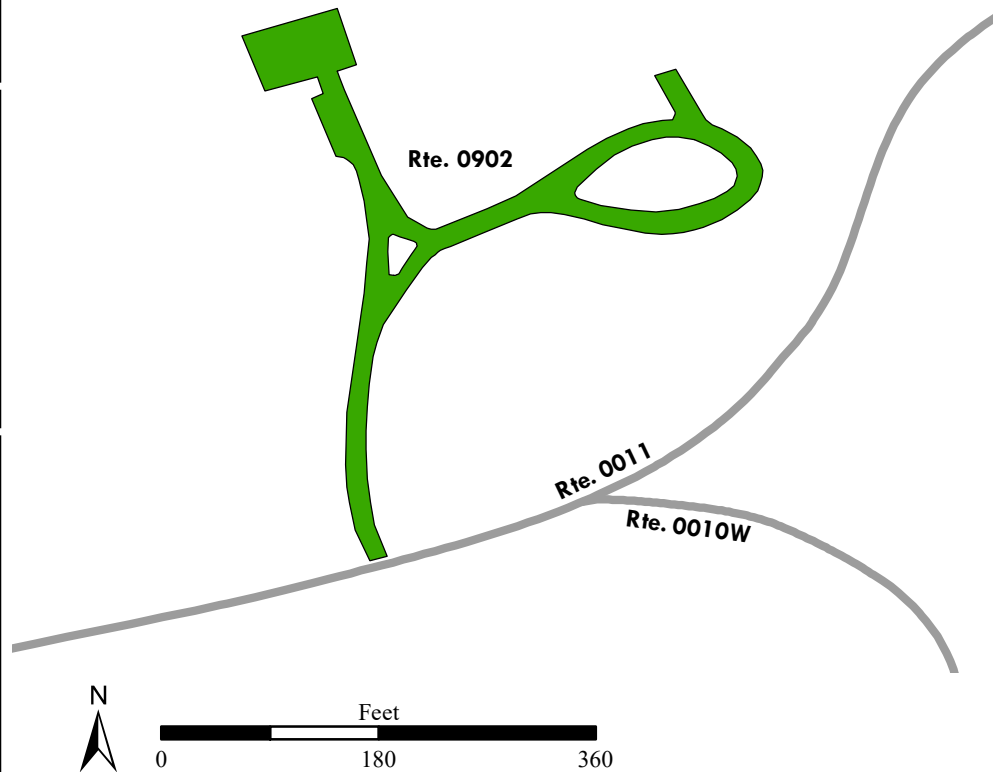
ROUTE 0902: MAINTENANCE AREA / ADMINISTRATION PARKING

Inspection Date	FMSS Number	User Access	Surface Type
2/9/2021	78635	NONPUBLIC	ASPHALT
Area (Sq. Ft.)	Lane Miles (11' Widths)	Curb Reveal (Inches)	Curb Recommendation
18,488	0.318	NOT APPLICABLE	NOT APPLICABLE
Curb Type		Curb & Gutter Type	
NO CURB		NO CURB AND GUTTER	
Pavement Recommendation		Condition Rating / PCR	
PREVENTIVE MAINTENANCE		GOOD / 90

Multiple Surface Types: Asphalt = 17,780 sq ft; Concrete = 708 sq ft.

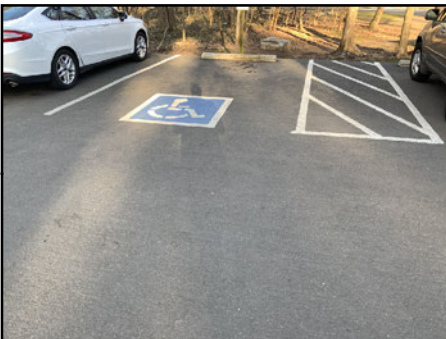
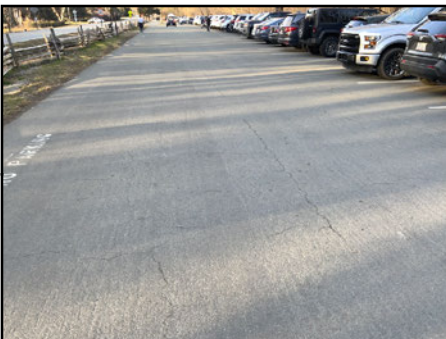
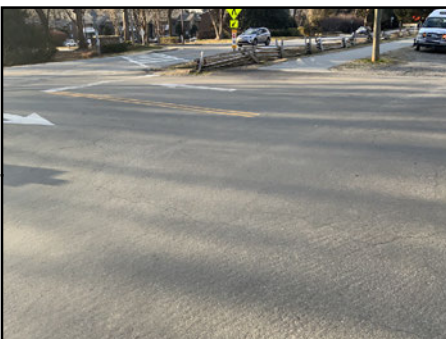
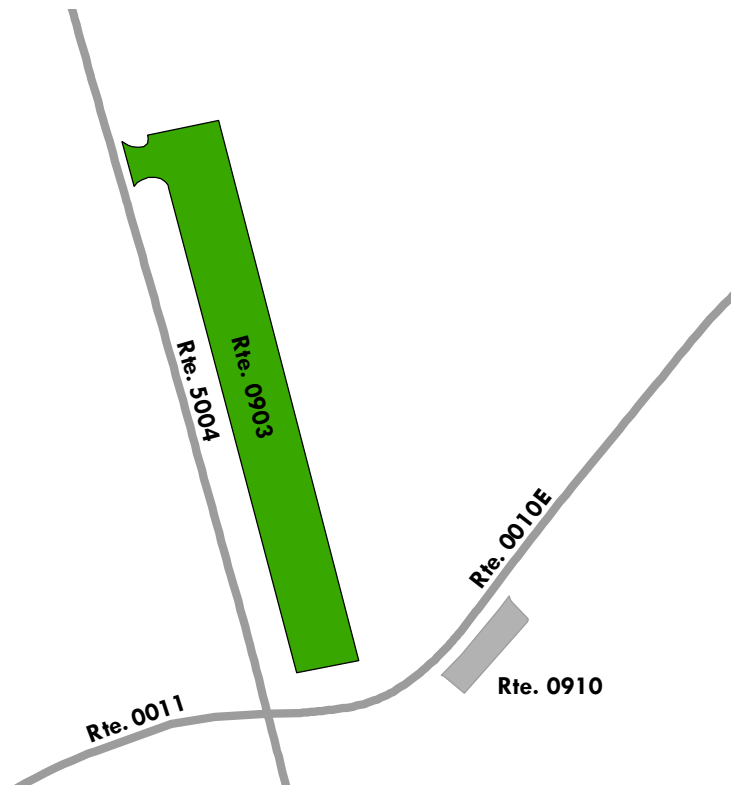
ROUTE 0903: OVERFLOW PARKING

Inspection Date	FMSS Number	User Access	Surface Type
2/9/2021	69361	PUBLIC	ASPHALT
Area (Sq. Ft.)	Lane Miles (11' Widths)	Curb Reveal (Inches)	Curb Recommendation
21,351	0.368	NOT APPLICABLE	NOT APPLICABLE
Curb Type		Curb & Gutter Type	
NO CURB		NO CURB AND GUTTER	
Pavement Recommendation		Condition Rating / PCR	
PREVENTIVE MAINTENANCE		GOOD / 90

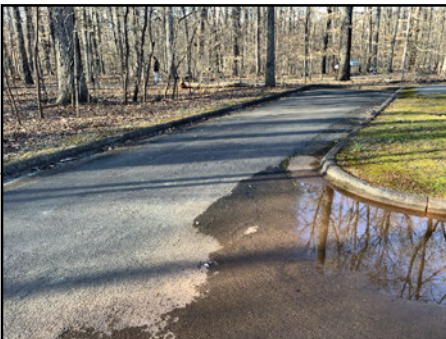
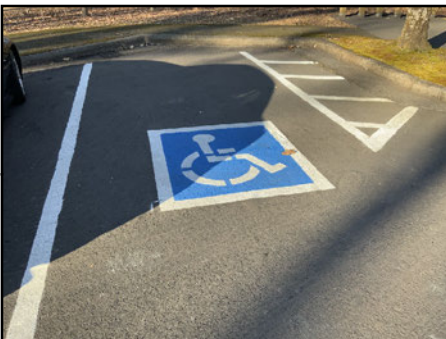
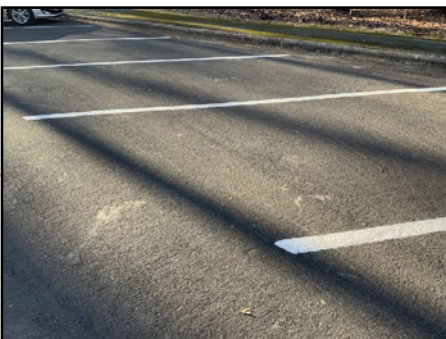
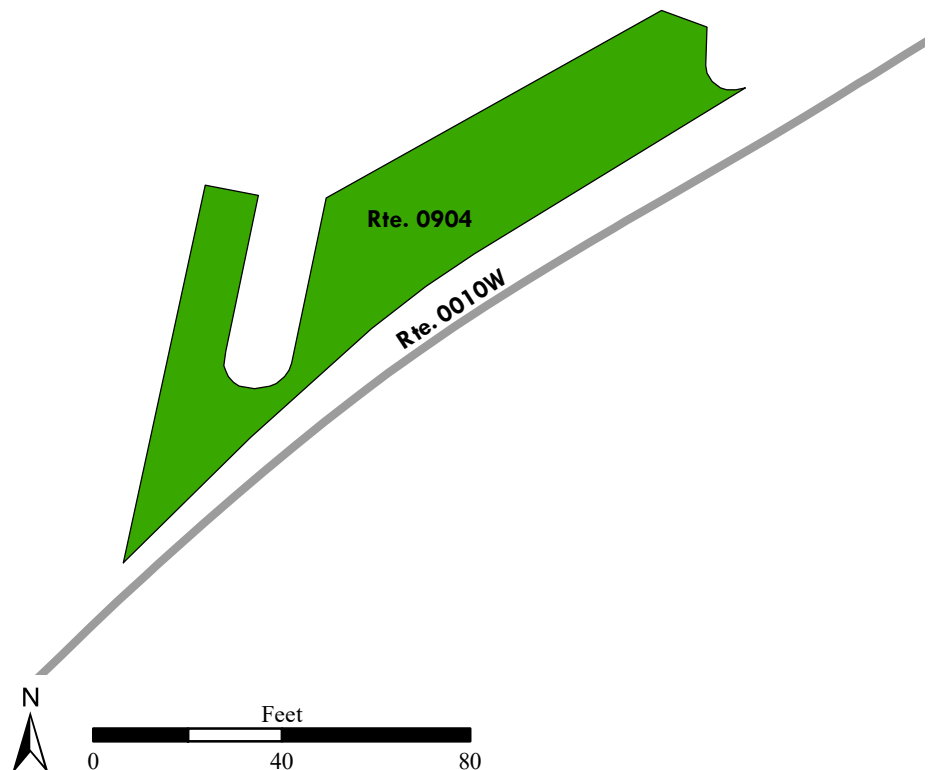
ROUTE 0904: TOUR STOP #2

Inspection Date	FMSS Number	User Access	Surface Type
2/9/2021	78638	PUBLIC	ASPHALT
Area (Sq. Ft.)	Lane Miles (11' Widths)	Curb Reveal (Inches)	Curb Recommendation
2,921	0.05	NOT APPLICABLE	LIGHT REPAIR
Curb Type		Curb & Gutter Type	
NO CURB		CONCRETE	
Pavement Recommendation		Condition Rating / PCR	
PREVENTIVE MAINTENANCE		GOOD / 90

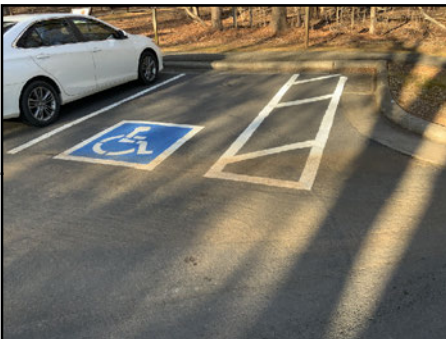
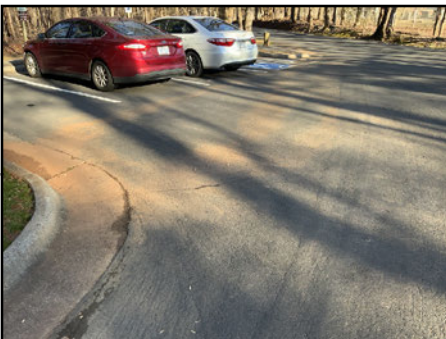
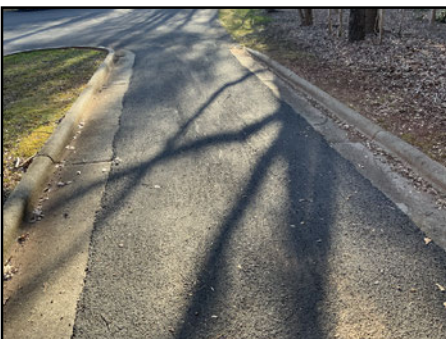
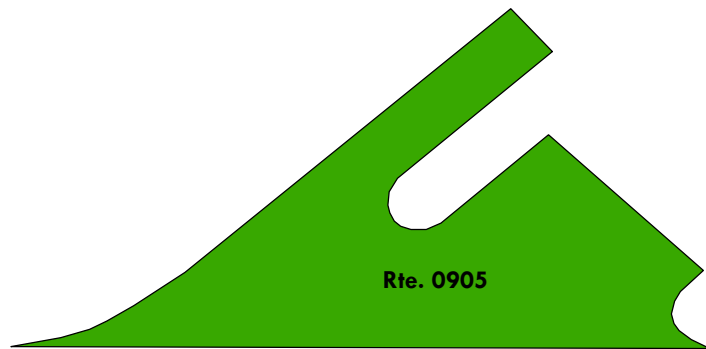
ROUTE 0905: TOUR STOP #3

Inspection Date	FMSS Number	User Access	Surface Type
2/9/2021	78642	PUBLIC	ASPHALT
Area (Sq. Ft.)	Lane Miles (11' Widths)	Curb Reveal (Inches)	Curb Recommendation
3,165	0.054	NOT APPLICABLE	DO NOTHING
Curb Type		Curb & Gutter Type	
NO CURB		CONCRETE	
Pavement Recommendation		Condition Rating / PCR	
PREVENTIVE MAINTENANCE		GOOD / 90

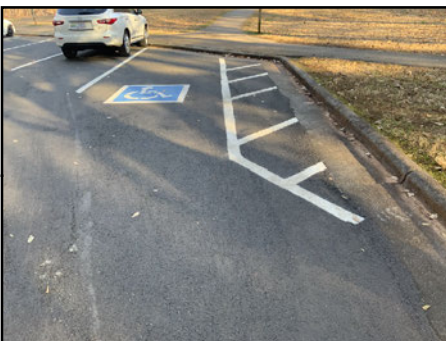
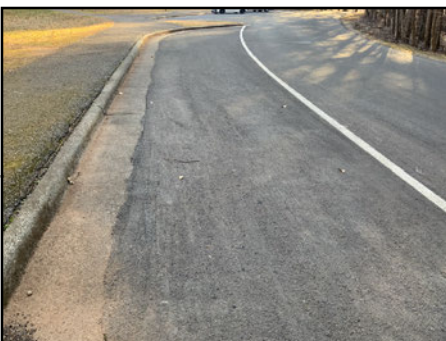
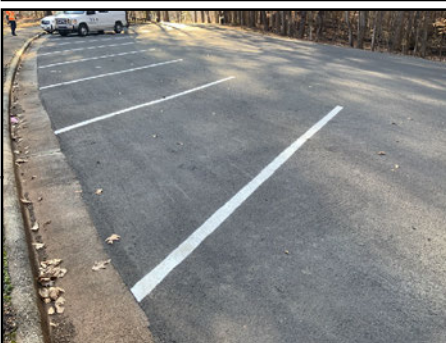
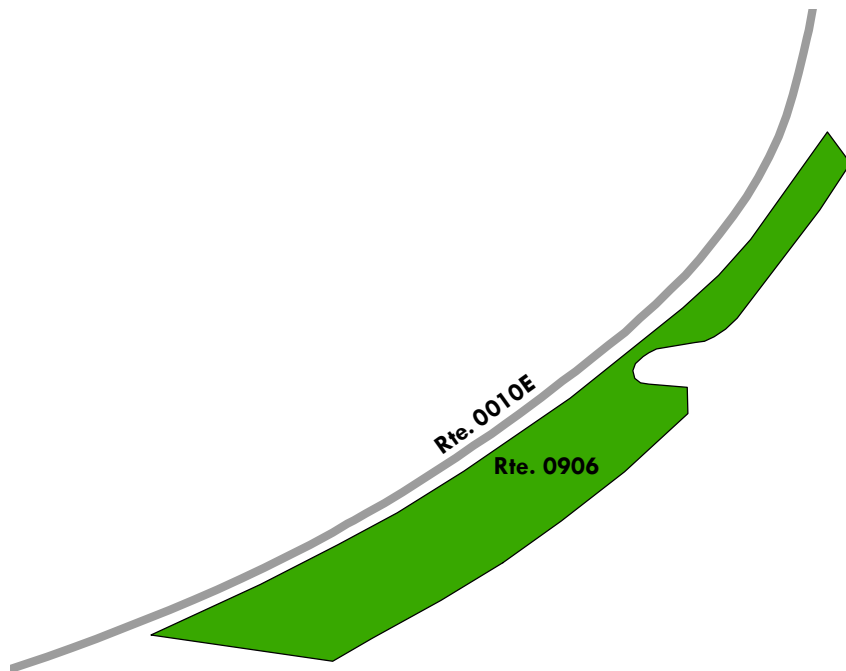
ROUTE 0906: TOUR STOP #4

Inspection Date	FMSS Number	User Access	Surface Type
2/9/2021	78644	PUBLIC	ASPHALT
Area (Sq. Ft.)	Lane Miles (11' Widths)	Curb Reveal (Inches)	Curb Recommendation
5,459	0.094	NOT APPLICABLE	LIGHT REPAIR
Curb Type		Curb & Gutter Type	
NO CURB		CONCRETE	
Pavement Recommendation		Condition Rating / PCR	
PREVENTIVE MAINTENANCE		GOOD / 90

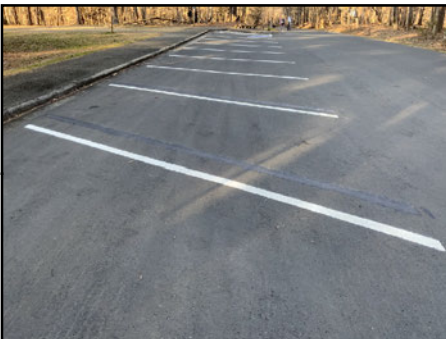
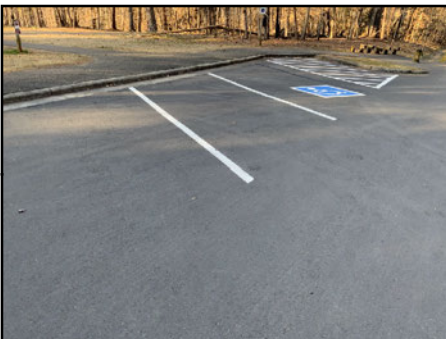
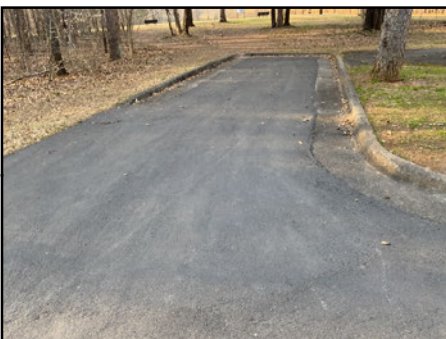
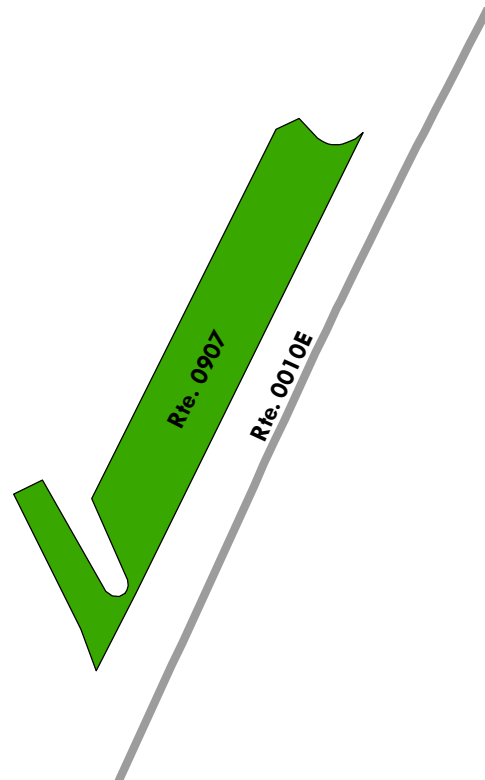
ROUTE 0907: TOUR STOP #5

Inspection Date	FMSS Number	User Access	Surface Type
2/9/2021	78646	PUBLIC	ASPHALT
Area (Sq. Ft.)	Lane Miles (11' Widths)	Curb Reveal (Inches)	Curb Recommendation
3,565	0.061	NOT APPLICABLE	LIGHT REPAIR
Curb Type		Curb & Gutter Type	
NO CURB		CONCRETE	
Pavement Recommendation		Condition Rating / PCR	
PREVENTIVE MAINTENANCE		GOOD / 90

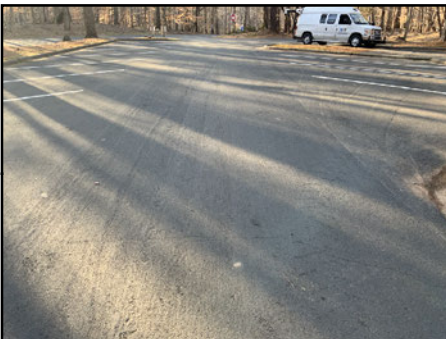
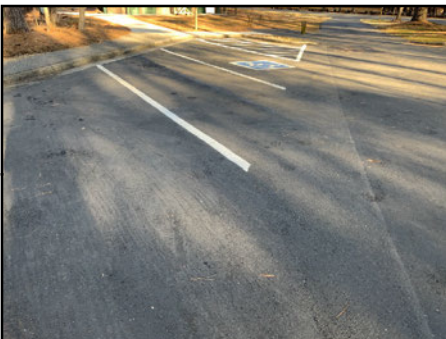
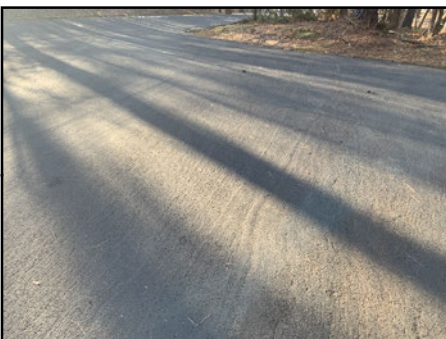
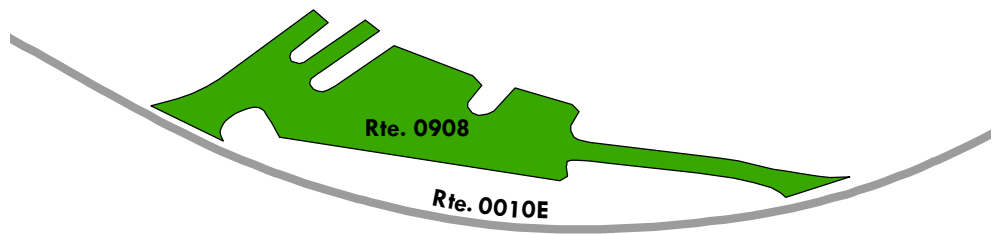
ROUTE 0908: TOUR STOP #6

Inspection Date	FMSS Number	User Access	Surface Type
2/9/2021	69350	PUBLIC	ASPHALT
Area (Sq. Ft.)	Lane Miles (11' Widths)	Curb Reveal (Inches)	Curb Recommendation
13,459	0.232	NOT APPLICABLE	LIGHT REPAIR
Curb Type		Curb & Gutter Type	
NO CURB		CONCRETE	
Pavement Recommendation		Condition Rating / PCR	
PREVENTIVE MAINTENANCE		GOOD / 90

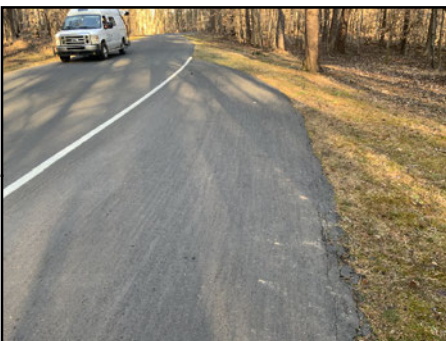
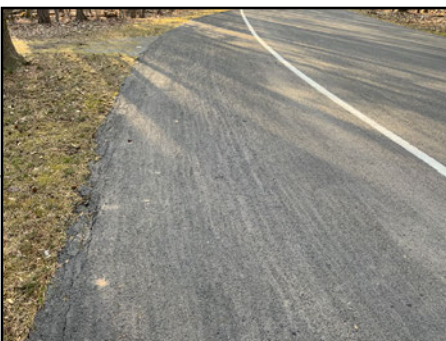
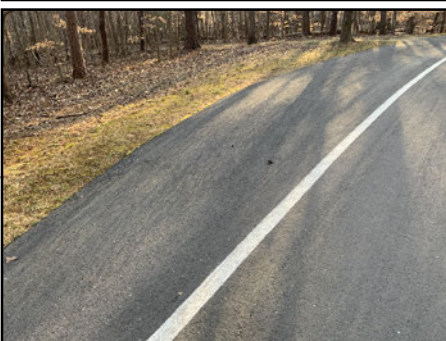
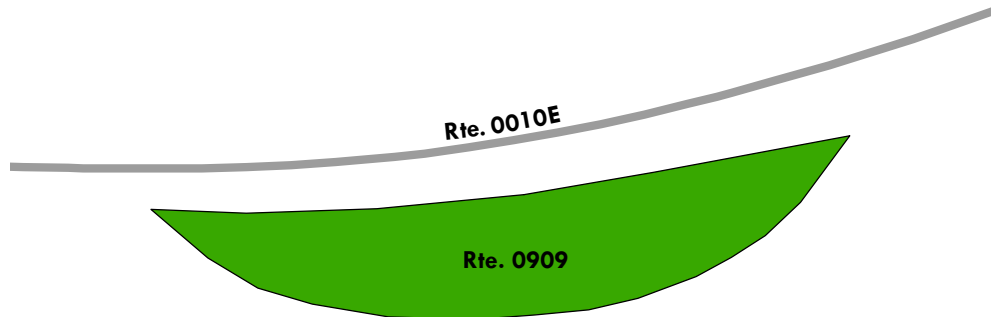
ROUTE 0909: TOUR STOP #7

Inspection Date	FMSS Number	User Access	Surface Type
2/9/2021	78648	PUBLIC	ASPHALT
Area (Sq. Ft.)	Lane Miles (11' Widths)	Curb Reveal (Inches)	Curb Recommendation
2,165	0.037	NOT APPLICABLE	NOT APPLICABLE
Curb Type		Curb & Gutter Type	
NO CURB		NO CURB AND GUTTER	
Pavement Recommendation		Condition Rating / PCR	
PREVENTIVE MAINTENANCE		GOOD / 90

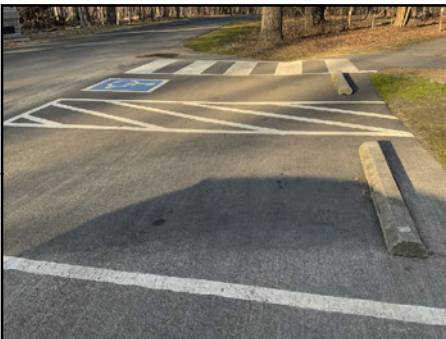
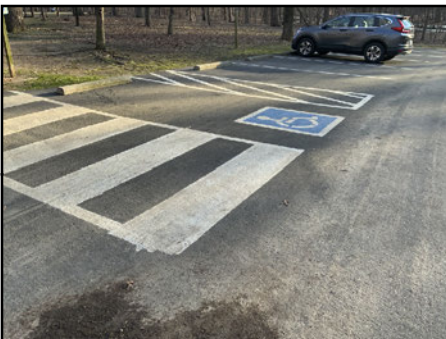
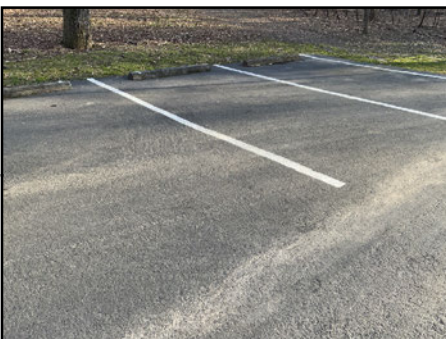
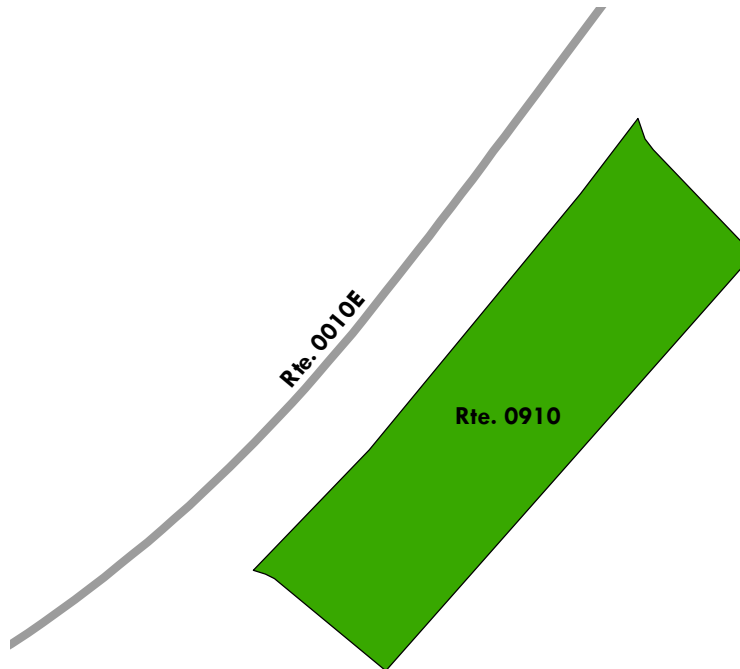
ROUTE 0910: TOUR STOP #8

Inspection Date	FMSS Number	User Access	Surface Type
2/9/2021	78649	PUBLIC	ASPHALT
Area (Sq. Ft.)	Lane Miles (11' Widths)	Curb Reveal (Inches)	Curb Recommendation
1,660	0.029	NOT APPLICABLE	NOT APPLICABLE
Curb Type		Curb & Gutter Type	
NO CURB		NO CURB AND GUTTER	
Pavement Recommendation		Condition Rating / PCR	
PREVENTIVE MAINTENANCE		GOOD / 90

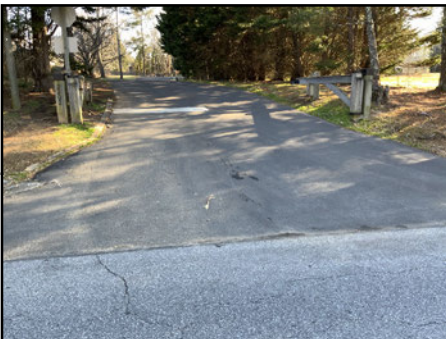
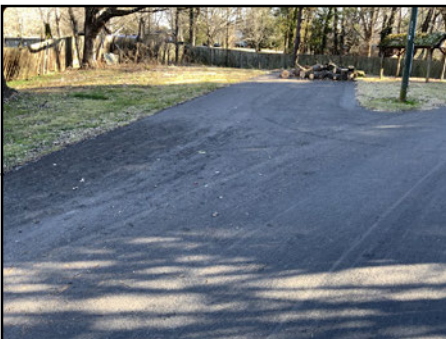
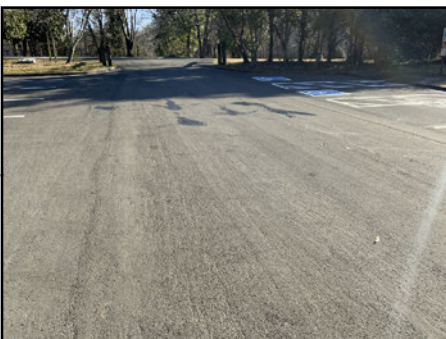
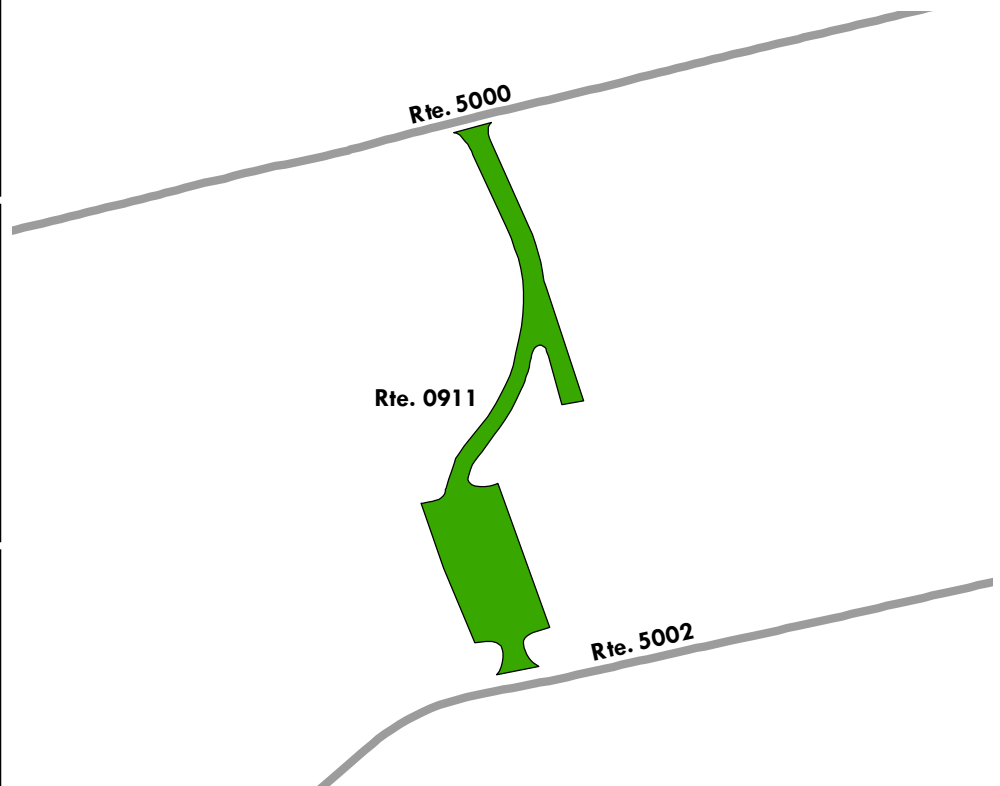
ROUTE 0911: HOSKINS FARM PARKING

Inspection Date	FMSS Number	User Access	Surface Type
2/9/2021	233133	PUBLIC	ASPHALT
Area (Sq. Ft.)	Lane Miles (11' Widths)	Curb Reveal (Inches)	Curb Recommendation
17,321	0.298	NOT APPLICABLE	LIGHT REPAIR
Curb Type		Curb & Gutter Type	
NO CURB		CONCRETE	
Pavement Recommendation		Condition Rating / PCR	
PREVENTIVE MAINTENANCE		GOOD / 90
