GUIIS Cycle 6

Final Report

Road Inventory and Condition Assessment of Paved Routes Gulf Islands National Seashore

Report Date: October 2020

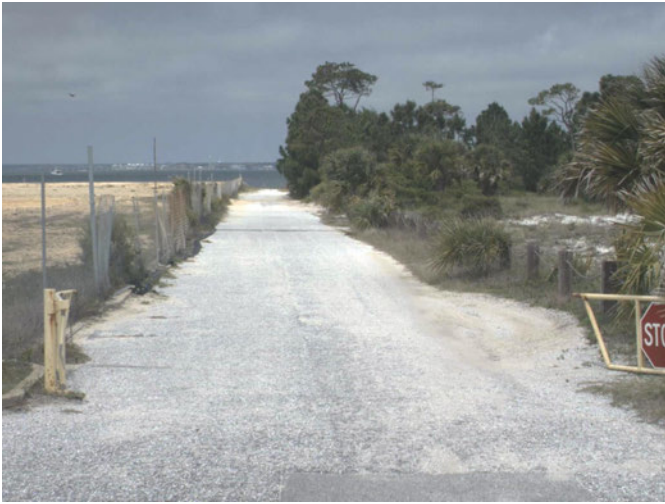
GUIS_0211_3281.jpg

Route No.	FMSS No.	Route Name	Functional Class	Surf. Type	Paved Length (Miles)	Pavement Condition Rating (PCR)	Roughness Condition Index (RCI)	Surface Condition Rating (SCR)	Structural Crack Index	Alligator Crack Index	Longitudinal Cracking Index	Transverse Cracking Index	Patch / Pothole Index	Rutting Index
GUIS-0211	59042	OKALOOSA WEST ACCESS ROAD	3	AS	0.14	73	NR	73	NR	90	90	73	90	73
