GUMO Cycle 6

Final Report

Road Inventory and Condition Assessment of Paved Routes Guadalupe Mountains National Park

Report Date: July 2017

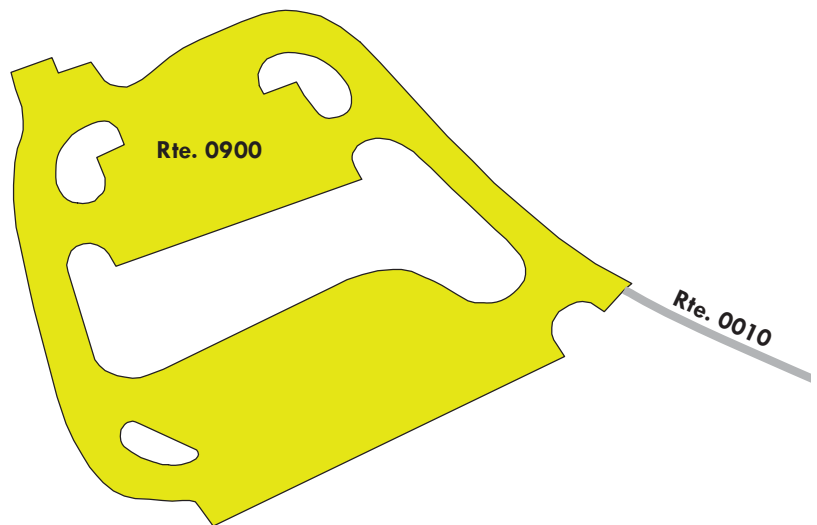
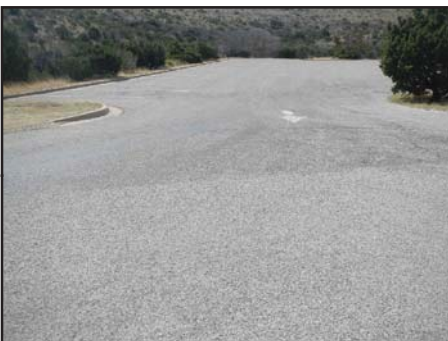
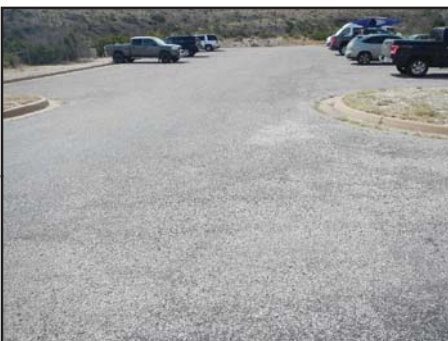
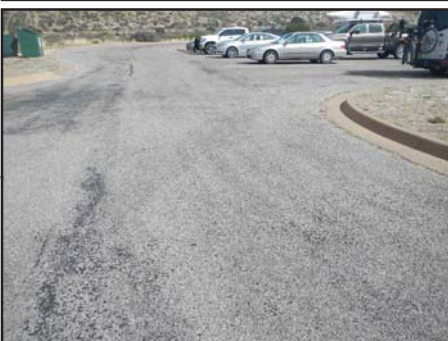
Inspection Date	FMSS Number	User Access	Surface Type
2/26/2017	72305	PUBLIC	ASPHALT
Area (Sq. Ft.)	Lane Miles (11' Widths)	Curb Reveal (Inches)	Curb Recommendation
53,364	0.919	NOT APPLICABLE	DO NOTHING
Curb Type		Curb & Gutter Type	
NO CURB		CONCRETE	
Pavement Recommendation		Condition Rating / PCR	
LIGHT 3R TREATMENTS		FAIR / 73

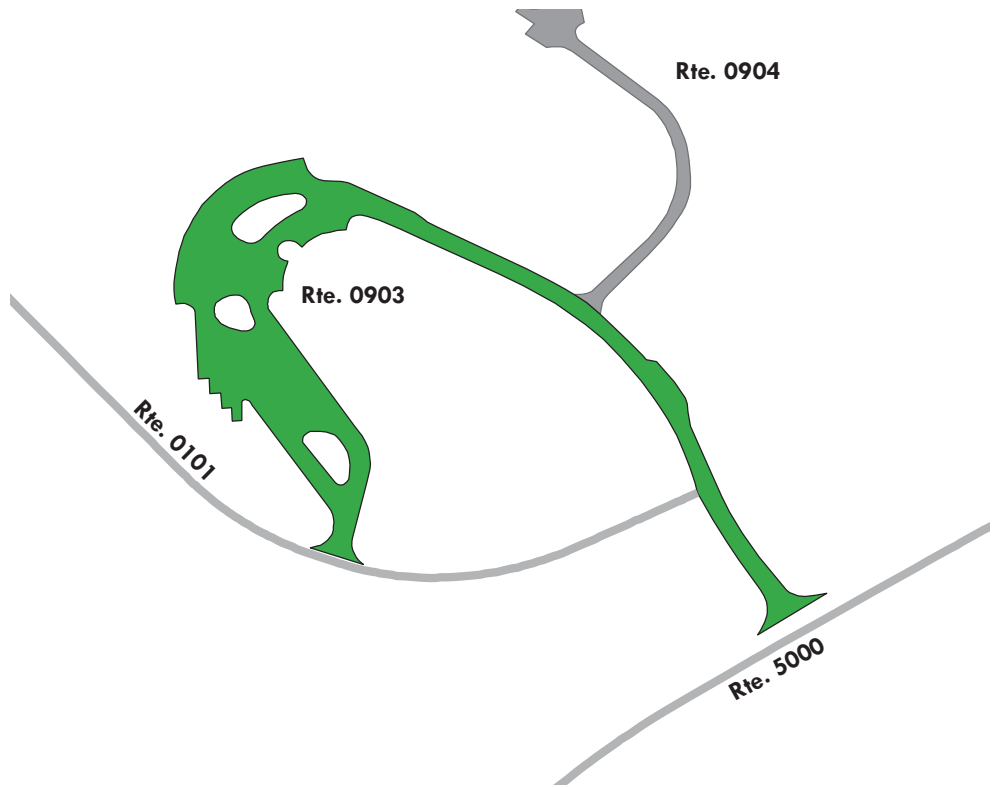
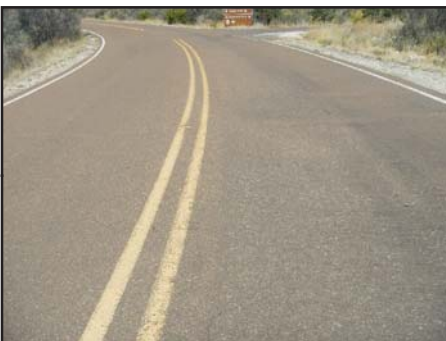
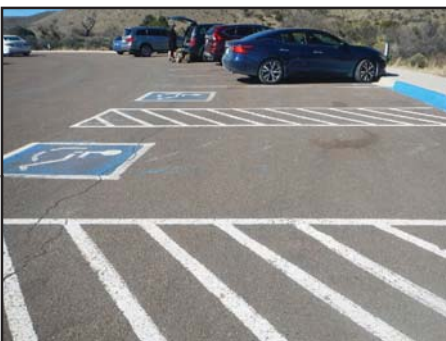
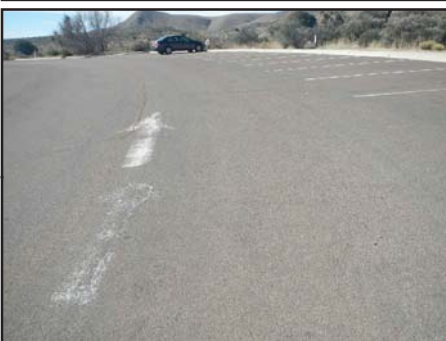
ROUTE 0903: VISITOR CENTER PARKING

Inspection Date	FMSS Number	User Access	Surface Type
2/26/2017	72164	PUBLIC	ASPHALT
Area (Sq. Ft.)	Lane Miles (11' Widths)	Curb Reveal (Inches)	Curb Recommendation
68,513	1.18	NOT APPLICABLE	DO NOTHING
Curb Type		Curb & Gutter Type	
NO CURB		CONCRETE	
Pavement Recommendation		Condition Rating / PCR	
PREVENTIVE MAINTENANCE		GOOD / 90

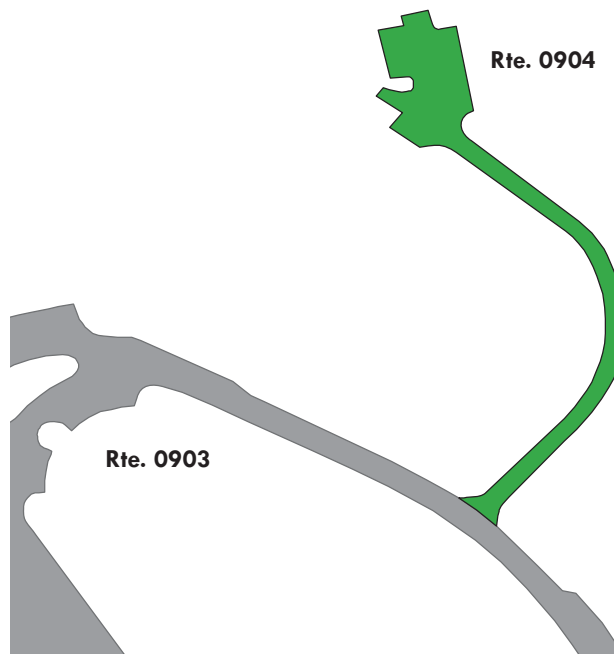
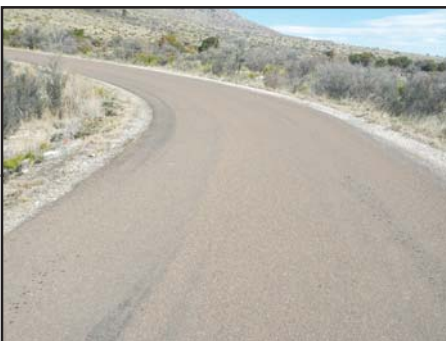
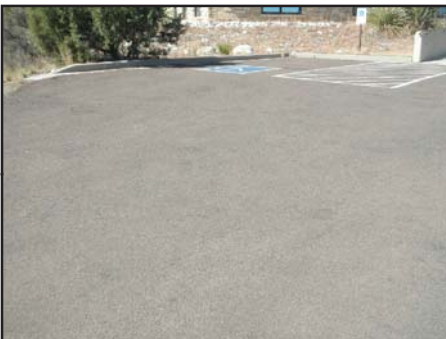
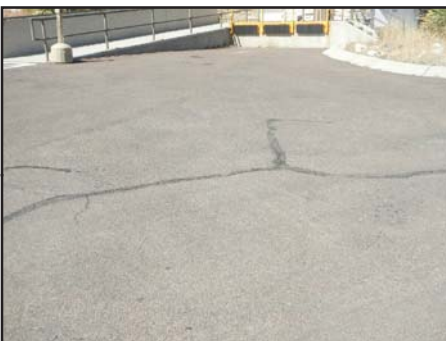
ROUTE 0904: EMPLOYEE PARKING

Inspection Date	FMSS Number	User Access	Surface Type
2/26/2017	72161	NONPUBLIC	ASPHALT
Area (Sq. Ft.)	Lane Miles (11' Widths)	Curb Reveal (Inches)	Curb Recommendation
13,963	0.24	NOT APPLICABLE	DO NOTHING
Curb Type		Curb & Gutter Type	
NO CURB		CONCRETE	
Pavement Recommendation		Condition Rating / PCR	
PREVENTIVE MAINTENANCE		GOOD / 90

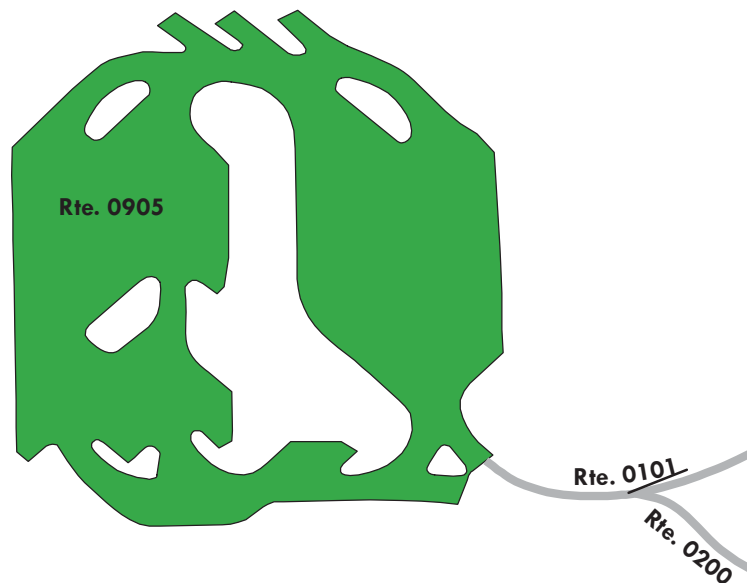
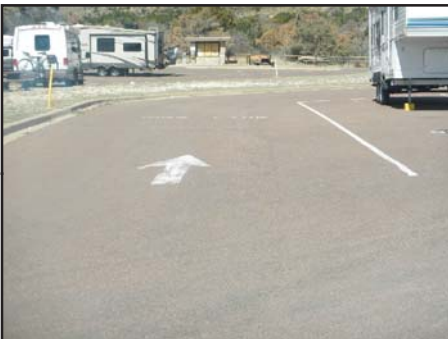
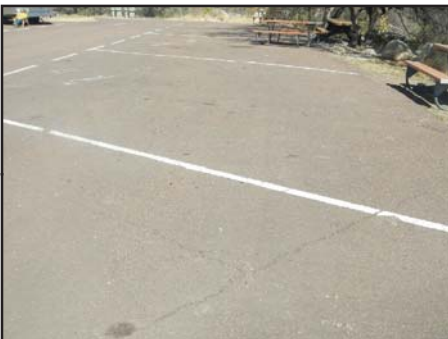
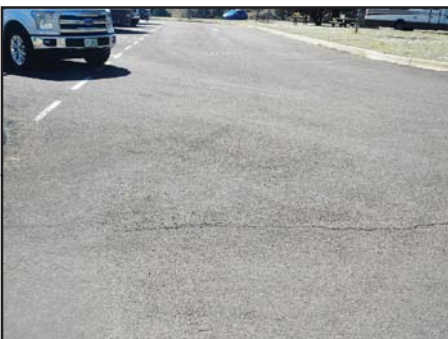
ROUTE 0905: RV CAMPGROUND

Inspection Date	FMSS Number	User Access	Surface Type
2/26/2017	71022	PUBLIC	ASPHALT
Area (Sq. Ft.)	Lane Miles (11' Widths)	Curb Reveal (Inches)	Curb Recommendation
45,904	0.79	NOT APPLICABLE	DO NOTHING
Curb Type		Curb & Gutter Type	
NO CURB		CONCRETE	
Pavement Recommendation		Condition Rating / PCR	
PREVENTIVE MAINTENANCE		GOOD / 90

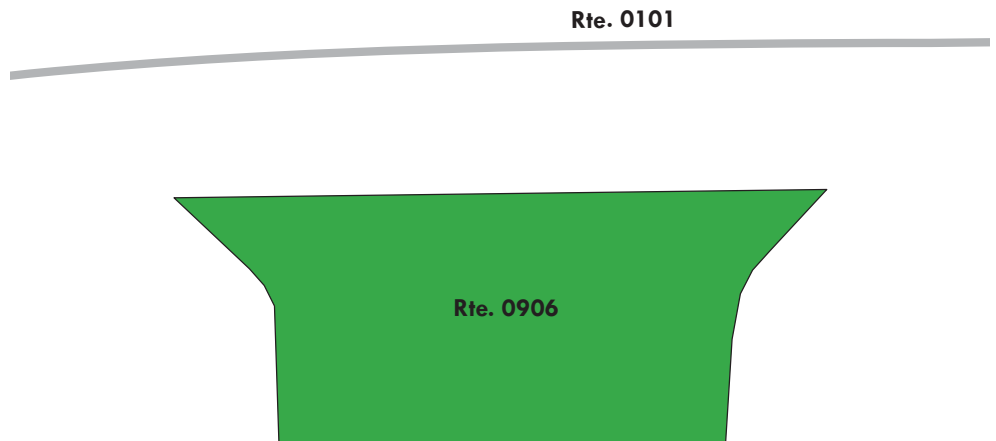
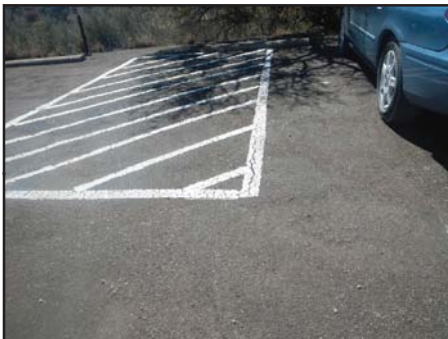
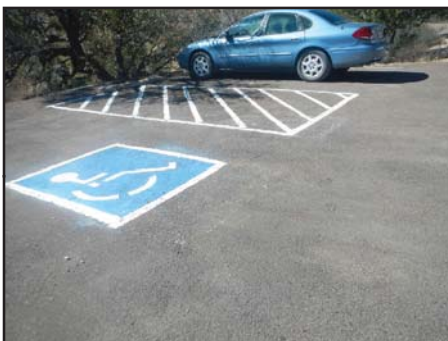
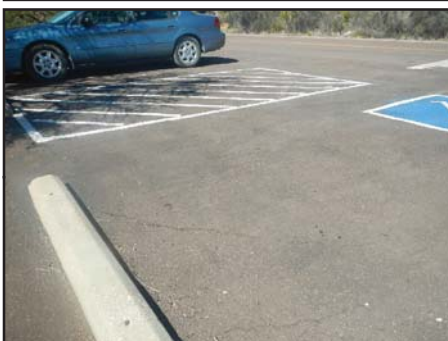
ROUTE 0906: AMPHITHEATER PARKING

Inspection Date	FMSS Number	User Access	Surface Type
2/26/2017	71017	PUBLIC	ASPHALT
Area (Sq. Ft.)	Lane Miles (11' Widths)	Curb Reveal (Inches)	Curb Recommendation
878	0.015	NOT APPLICABLE	NOT APPLICABLE
Curb Type		Curb & Gutter Type	
NO CURB		NO CURB AND GUTTER	
Pavement Recommendation		Condition Rating / PCR	
PREVENTIVE MAINTENANCE		GOOD / 90

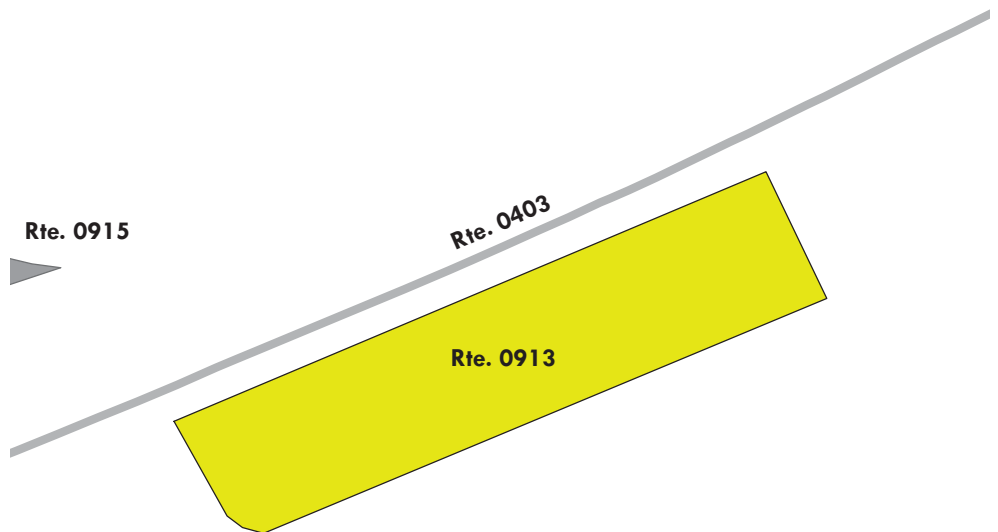
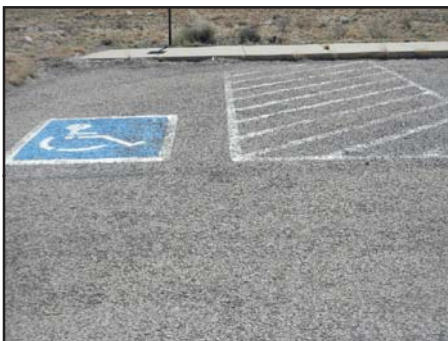
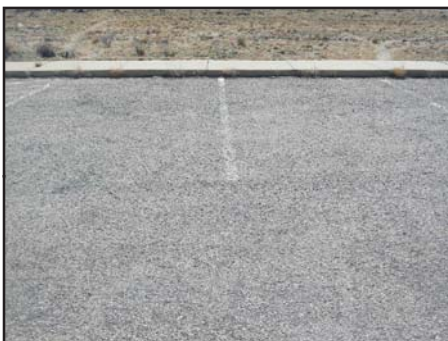
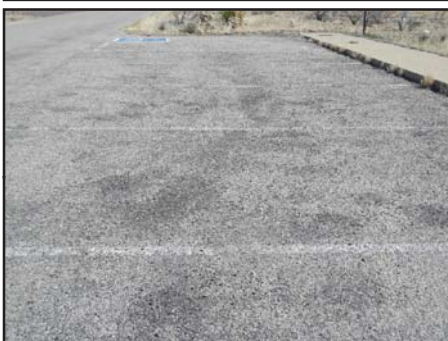
ROUTE 0913: CHOLLA CHATEAU PARKING LOT

Inspection Date	FMSS Number	User Access	Surface Type
2/26/2017	68330	NONPUBLIC	ASPHALT
Area (Sq. Ft.)	Lane Miles (11' Widths)	Curb Reveal (Inches)	Curb Recommendation
1,363	0.023	NOT APPLICABLE	NOT APPLICABLE
Curb Type		Curb & Gutter Type	
NO CURB		NO CURB AND GUTTER	
Pavement Recommendation		Condition Rating / PCR	
LIGHT 3R TREATMENTS		FAIR / 73

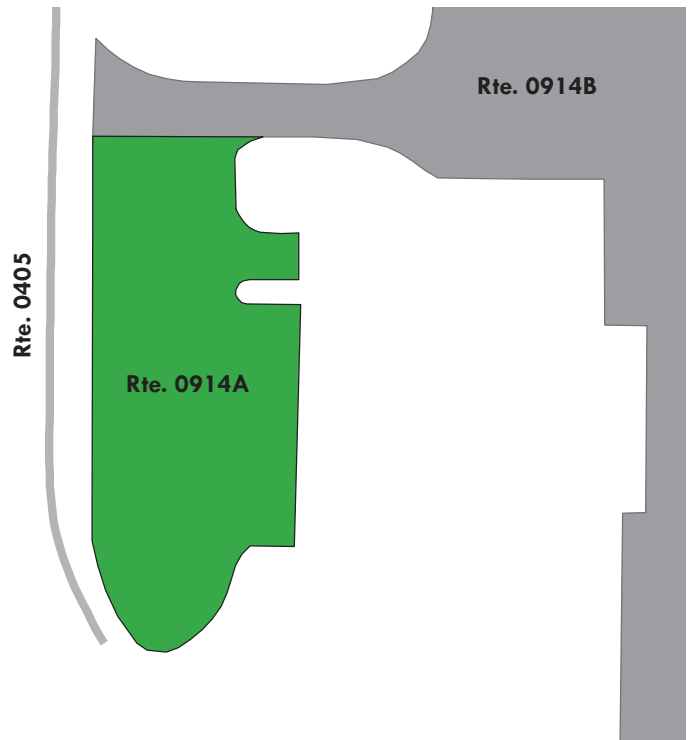
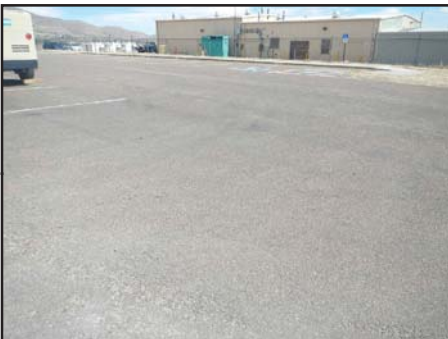
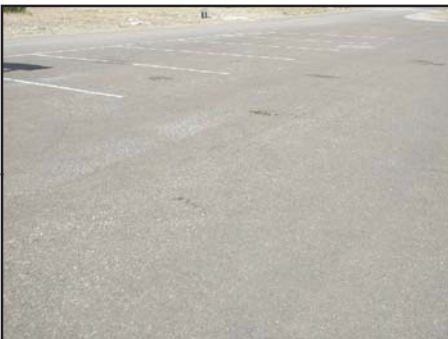
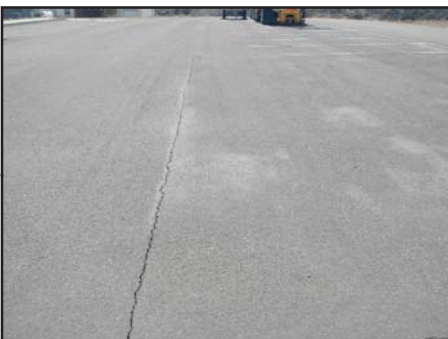
ROUTE 0914A: MAINTENANCE EMPLOYEE PARKING

Inspection Date	FMSS Number	User Access	Surface Type
2/26/2017	81921	NONPUBLIC	ASPHALT
Area (Sq. Ft.)	Lane Miles (11' Widths)	Curb Reveal (Inches)	Curb Recommendation
10,859	0.187	4	DO NOTHING
Curb Type		Curb & Gutter Type	
CONCRETE		NO CURB AND GUTTER	
Pavement Recommendation		Condition Rating / PCR	
PREVENTIVE MAINTENANCE		GOOD / 90

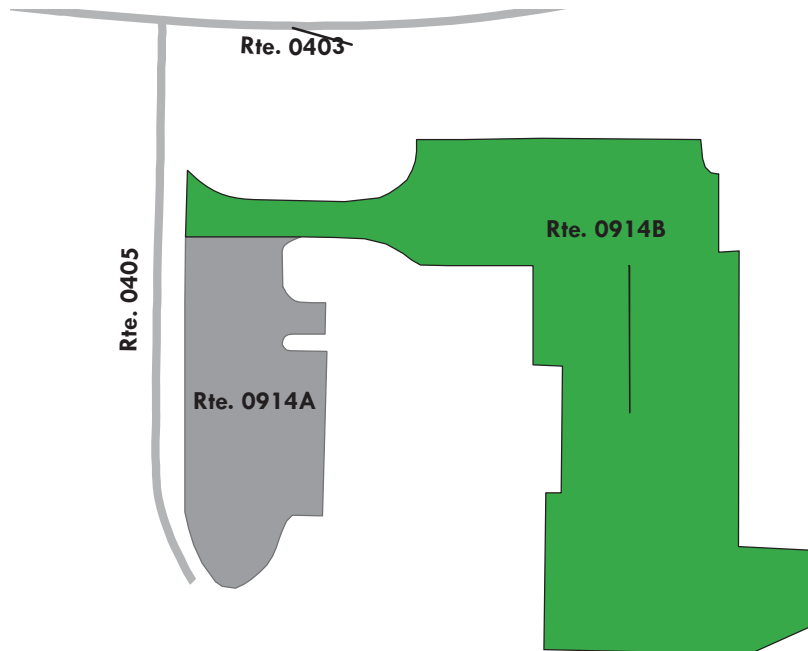
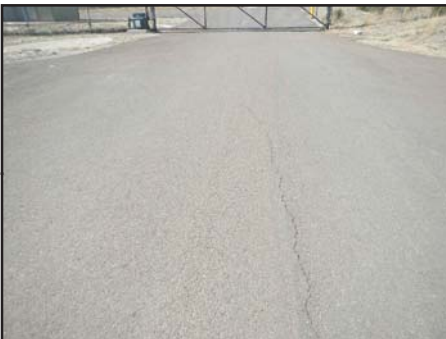
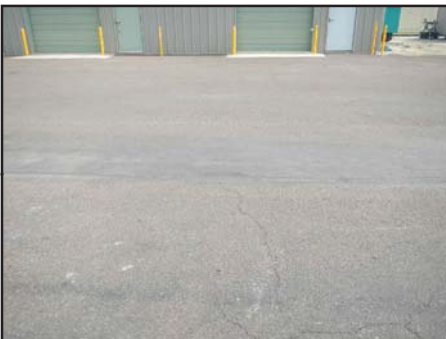
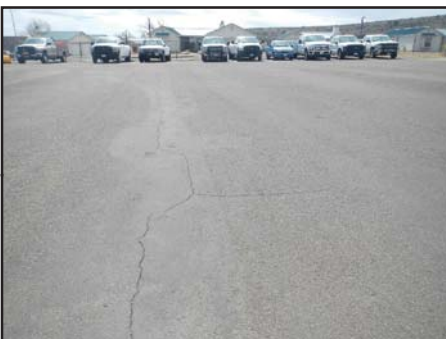
ROUTE 0914B: MAINTENANCE YARD

Inspection Date	FMSS Number	User Access	Surface Type
2/26/2017	68418	NONPUBLIC	ASPHALT
Area (Sq. Ft.)	Lane Miles (11' Widths)	Curb Reveal (Inches)	Curb Recommendation
34,373	0.592	NOT APPLICABLE	NOT APPLICABLE
Curb Type		Curb & Gutter Type	
NO CURB		NO CURB AND GUTTER	
Pavement Recommendation		Condition Rating / PCR	
PREVENTIVE MAINTENANCE		GOOD / 90

Note: Parking area consists of multiple surface types: 1 part asphalt at 29,309 square feet; 2 parts concrete at 5,064 square feet.

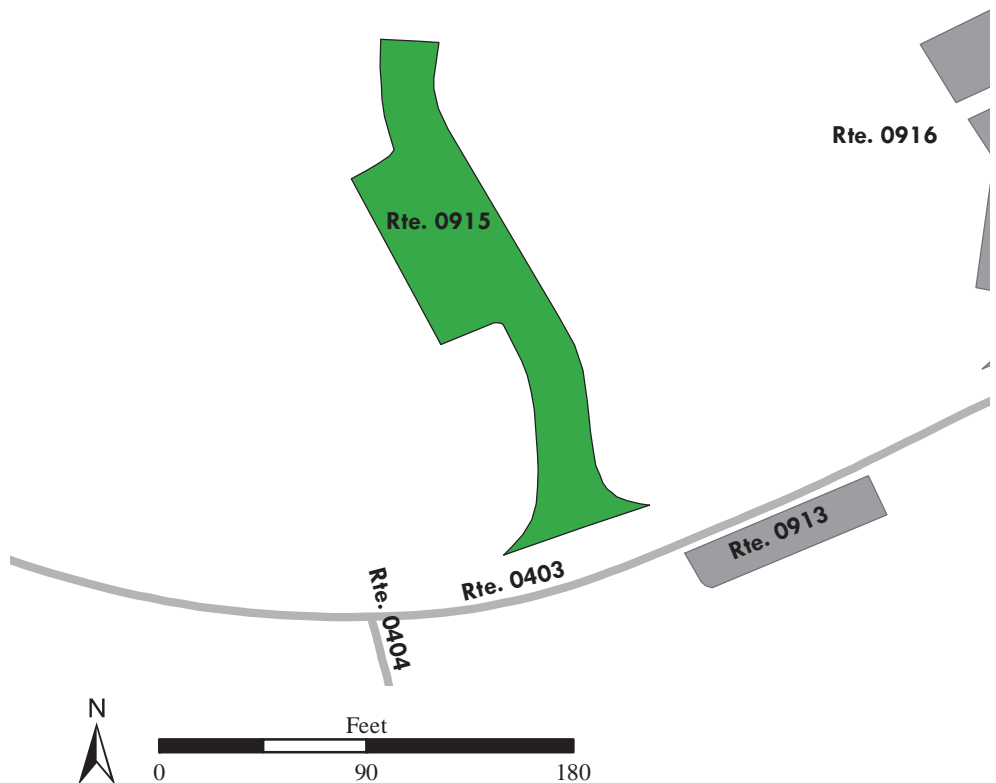
ROUTE 0915: SEASONAL HOUSING WEST PARKING LOT

Inspection Date	FMSS Number	User Access	Surface Type
2/26/2017	68302	NONPUBLIC	ASPHALT
Area (Sq. Ft.)	Lane Miles (11' Widths)	Curb Reveal (Inches)	Curb Recommendation
6,706	0.115	NOT APPLICABLE	NOT APPLICABLE
Curb Type		Curb & Gutter Type	
NO CURB		NO CURB AND GUTTER	
Pavement Recommendation		Condition Rating / PCR	
PREVENTIVE MAINTENANCE		GOOD / 90

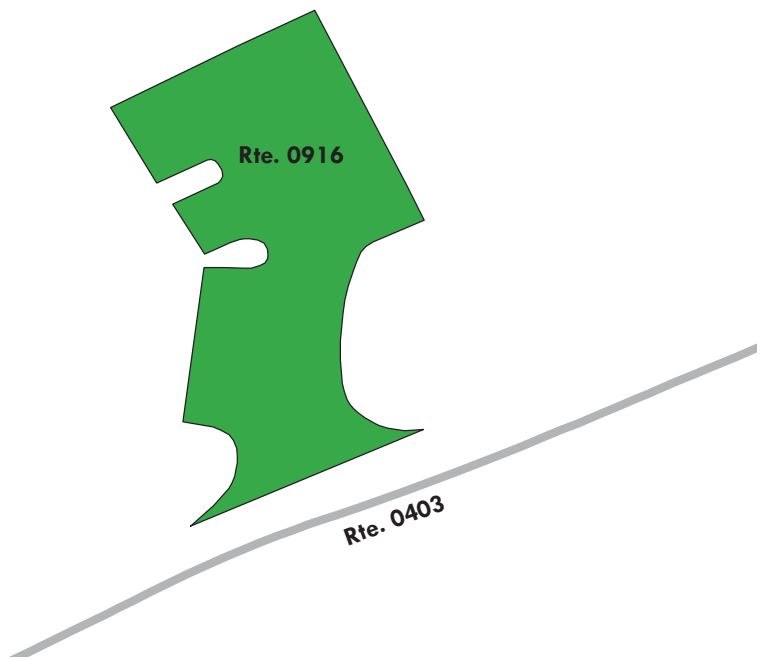
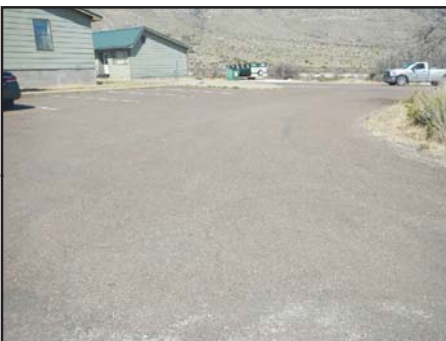
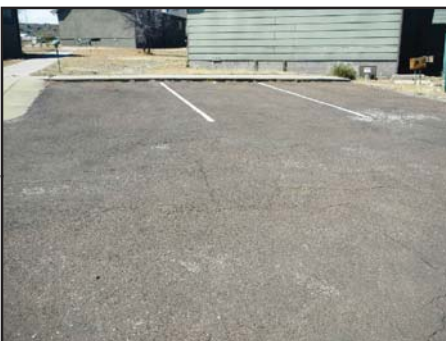
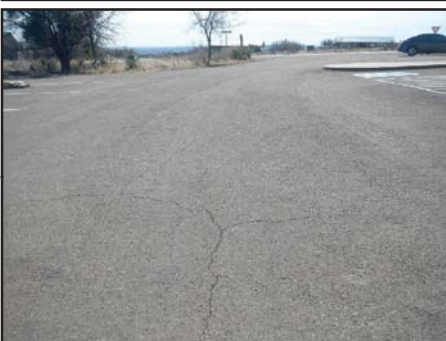
ROUTE 0916: SEASONAL HOUSING EAST PARKING LOT

Inspection Date	FMSS Number	User Access	Surface Type
2/26/2017	68301	NONPUBLIC	ASPHALT
Area (Sq. Ft.)	Lane Miles (11' Widths)	Curb Reveal (Inches)	Curb Recommendation
7,624	0.131	NOT APPLICABLE	NOT APPLICABLE
Curb Type		Curb & Gutter Type	
NO CURB		NO CURB AND GUTTER	
Pavement Recommendation		Condition Rating / PCR	
PREVENTIVE MAINTENANCE		GOOD / 90

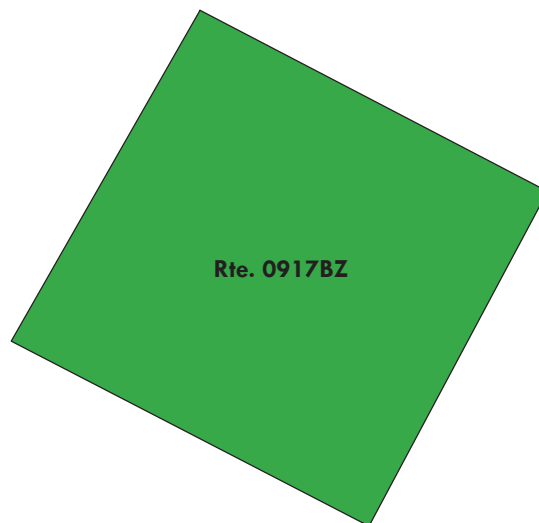
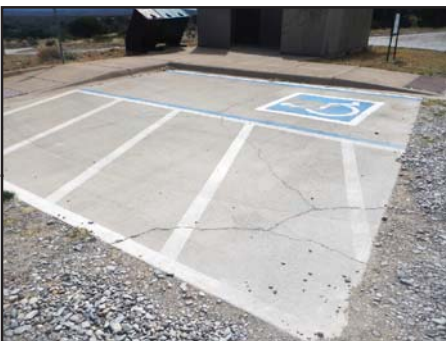
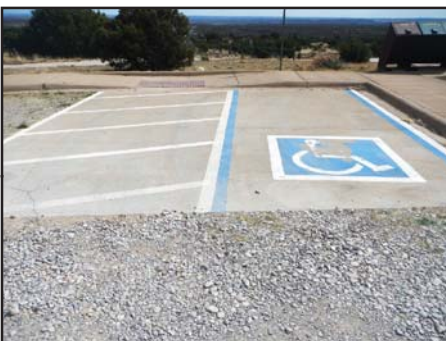
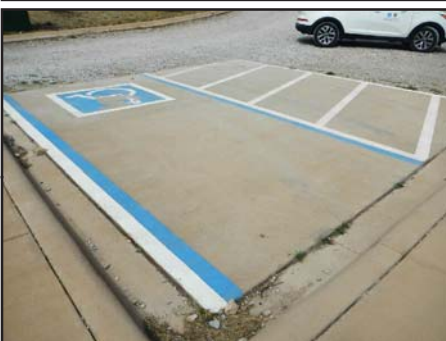
ROUTE 0917BZ: FRIJOLE RANCH HANDICAP PARKING A

Inspection Date	FMSS Number	User Access	Surface Type
2/26/2017	110166	PUBLIC	CONCRETE
Area (Sq. Ft.)	Lane Miles (11' Widths)	Curb Reveal (Inches)	Curb Recommendation
320	0.006	NOT APPLICABLE	DO NOTHING
Curb Type		Curb & Gutter Type	
NO CURB		CONCRETE	
Pavement Recommendation		Condition Rating / PCR	
PREVENTIVE MAINTENANCE		GOOD / 90

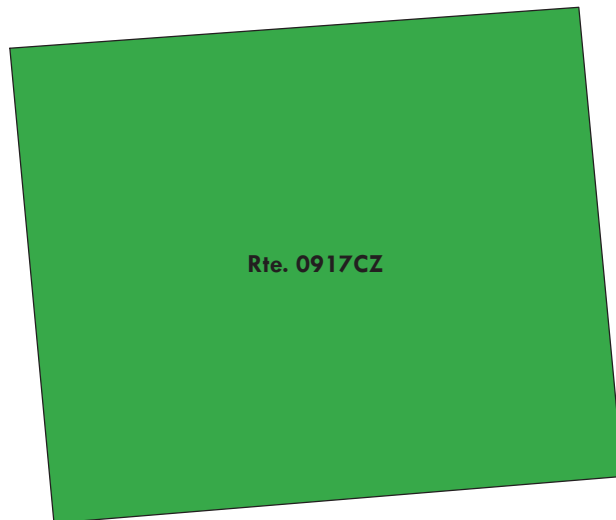
ROUTE 0917CZ: FRIJOLE RANCH HANDICAP PARKING B

Inspection Date	FMSS Number	User Access	Surface Type
2/26/2017	110166	PUBLIC	CONCRETE
Area (Sq. Ft.)	Lane Miles (11' Widths)	Curb Reveal (Inches)	Curb Recommendation
353	0.006	NOT APPLICABLE	DO NOTHING
Curb Type		Curb & Gutter Type	
NO CURB		CONCRETE	
Pavement Recommendation		Condition Rating / PCR	
PREVENTIVE MAINTENANCE		GOOD / 90
