HEHO Cycle 6

Final Report

Road Inventory and Condition Assessment of Paved Routes Herbert Hoover National Historic Site

Report Date: August 2018

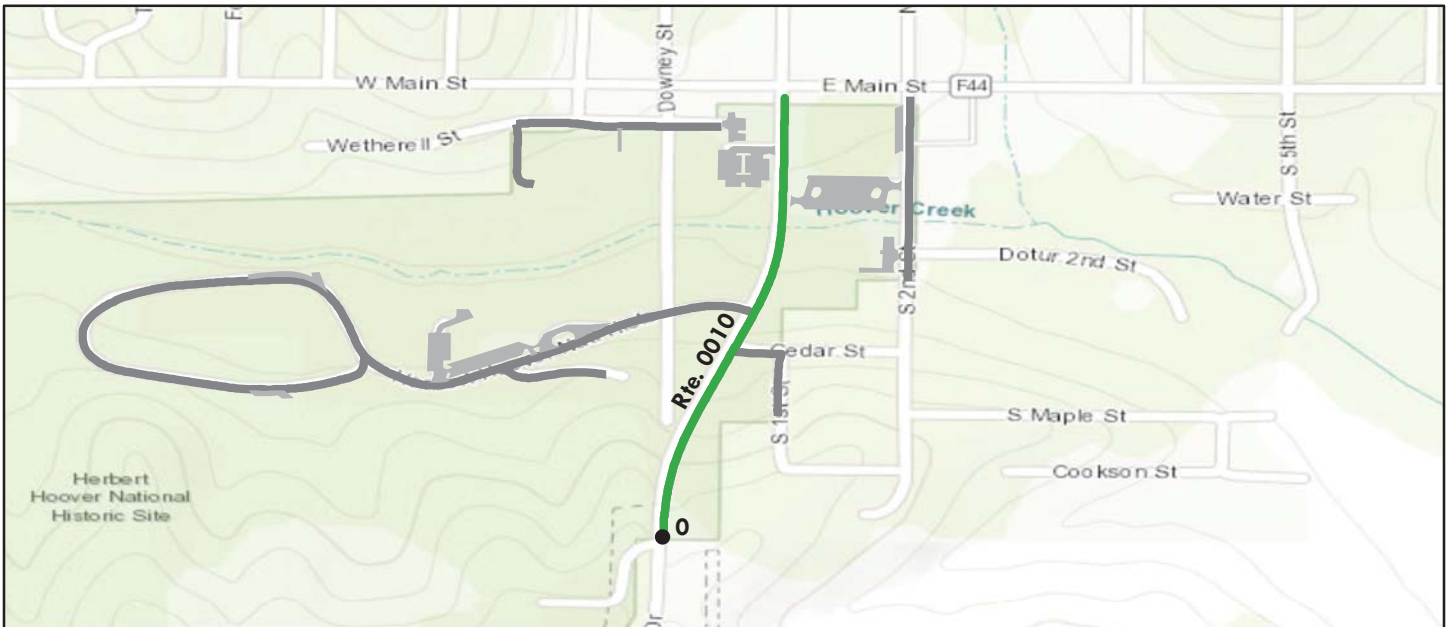
ROUTE 0010: PARKSIDE DRIVE

Section Number	Begin Milepost	End Milepost	Section Length	Paved Width	Surface Type	Pavement Condition Rating (PCR)	Joint Faulting Index	Delamination / Pop-Outs Index	Slab Cracking Index	Joint Distresses Index	Potholes / Patching Index
1	0.00	0.10	0.10	35.2	CONCRETE	90	90	90	97	90	90
2	0.10	0.20	0.10	35.2	CONCRETE	90	90	90	90	90	90
3	0.20	0.32	0.12	35.2	CONCRETE	90	90	90	90	90	90
OVERALL			0.32	35.2	CONCRETE	90	90	90	92	90	90

NOTE: Because Route 0010 is concrete, the road was manually rated for surface condition. The RIP Data Collection Vehicle (DCV) drove the route for video and GPS, but not for condition. The DCV only collects roughness on concrete roads when the speed limit is at least 25 mph and the length is at least 0.5 miles.

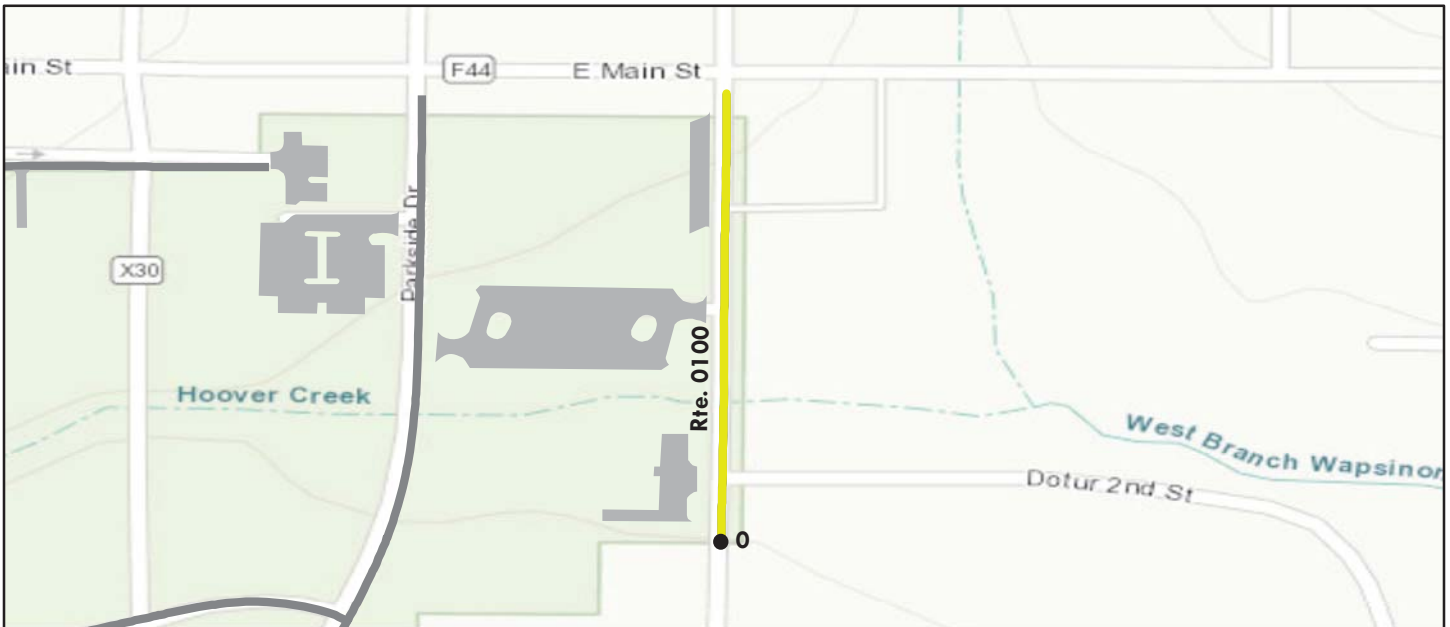
ROUTE 0100: SECOND STREET

Section Number	Begin Milepost	End Milepost	Section Length	Paved Width	Surface Type	Pavement Condition Rating (PCR)	Joint Faulting Index	Delamination / Pop-Outs Index	Slab Cracking Index	Joint Distresses Index	Potholes / Patching Index
1	0.00	0.13	0.13	28.8	CONCRETE	73	90	73	90	90	90

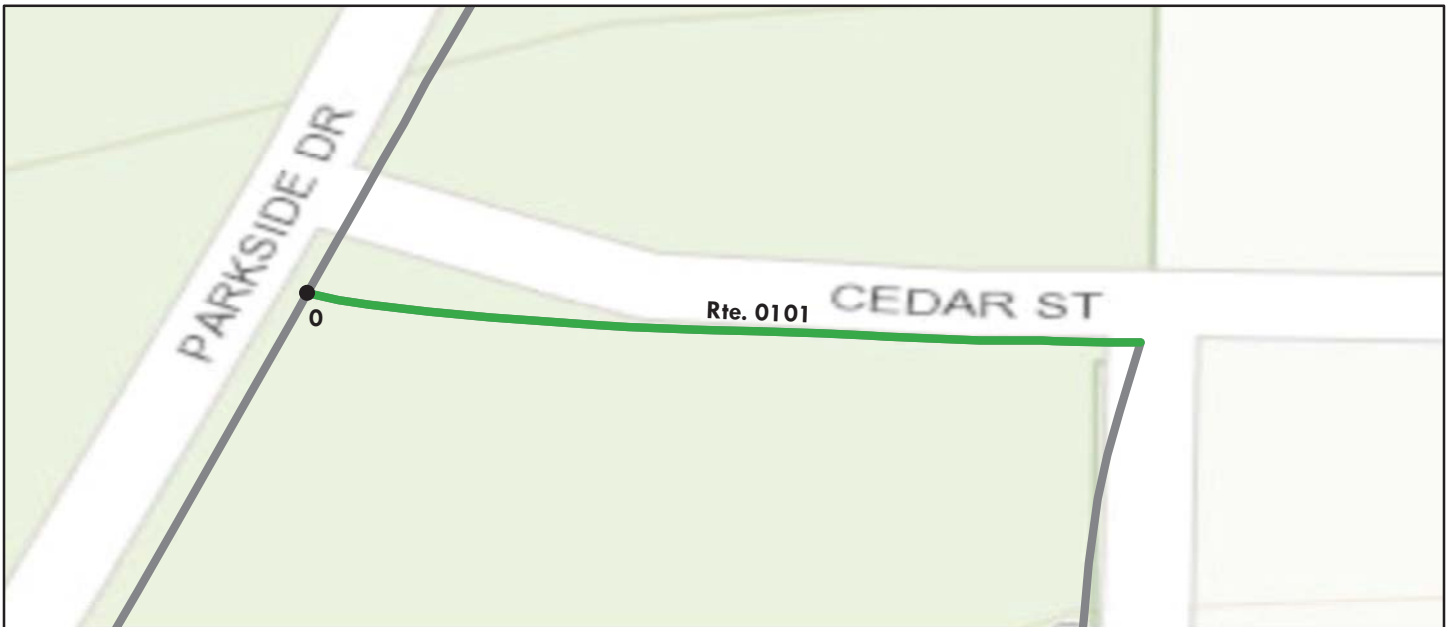
ROUTE 0101: CEDAR STREET

Section Number	Begin Milepost	End Milepost	Section Length	Paved Width	Surface Type	Pavement Condition Rating (PCR)	Joint Faulting Index	Delamination / Pop-Outs Index	Slab Cracking Index	Joint Distresses Index	Potholes / Patching Index
1	0.00	0.02	0.02	25.8	CONCRETE	90	97	90	97	97	97

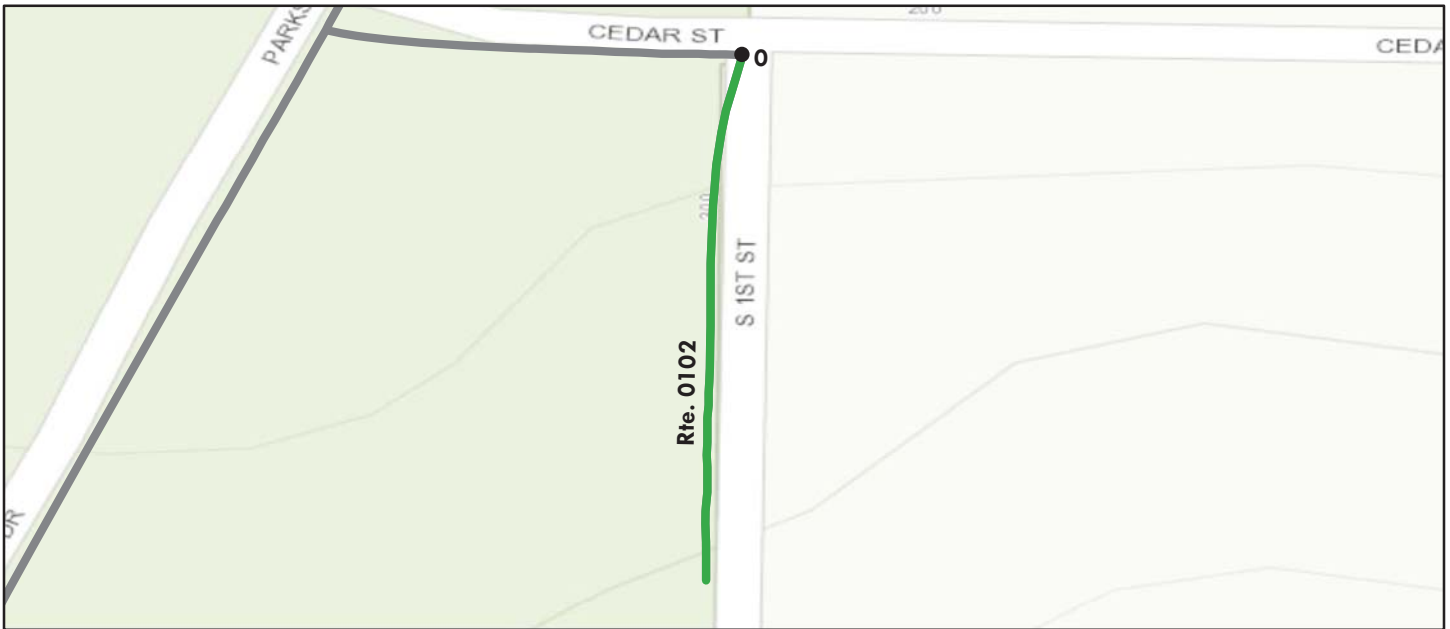
ROUTE 0102: 1ST STREET

Section Number	Begin Milepost	End Milepost	Section Length	Paved Width	Surface Type	Pavement Condition Rating (PCR)	Joint Faulting Index	Delamination / Pop-Outs Index	Slab Cracking Index	Joint Distresses Index	Potholes / Patching Index
1	0.00	0.04	0.04	24.8	CONCRETE	90	90	90	90	90	90

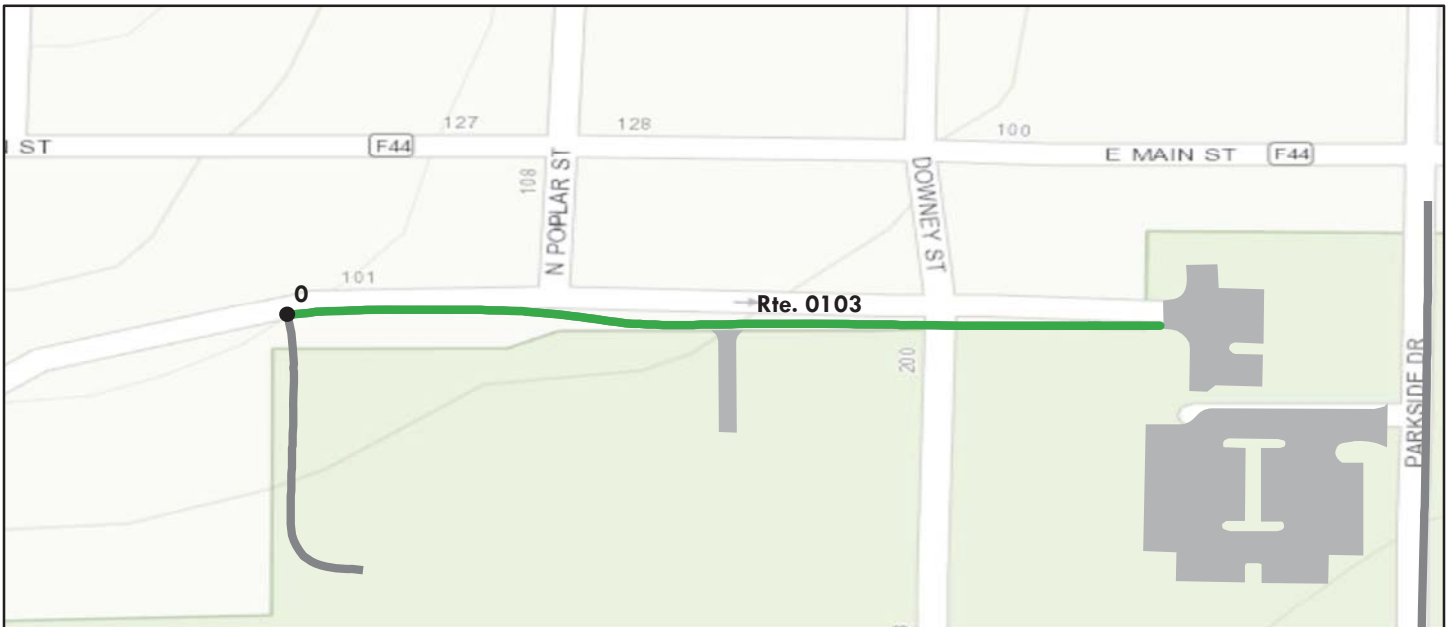
ROUTE 0103: WETHERELL STREET

Section Number	Begin Milepost	End Milepost	Section Length	Paved Width	Surface Type	Pavement Condition Rating (PCR)	Joint Faulting Index	Delamination / Pop-Outs Index	Slab Cracking Index	Joint Distresses Index	Potholes / Patching Index
1	0.00	0.11	0.11	22.2	CONCRETE	90	90	90	90	90	97

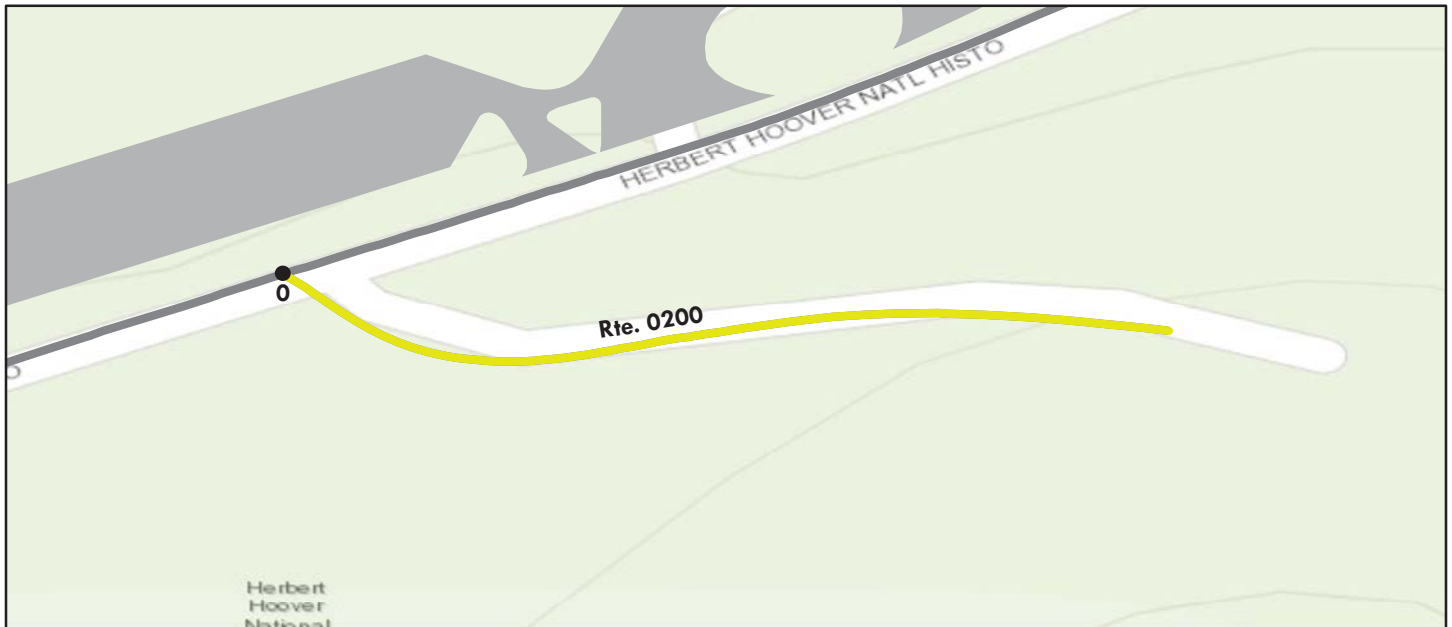
ROUTE 0200: ASSOCIATION DRIVE

Inspection Date:	12/8/2017	Beginning Section MP	0				
Paved Length (Miles):	0.05	Section Length (MI)	0.05				
Surface Type:	ASPHALT	Route Summary					
Roadway Condition Information							
Pavement Condition Rating (PCR)	64	64					
Surface Condition Rating (SCR)	64	64					
Roughness Condition Index (RCI)	N/A	N/A					
Distress Index Values							
Structural Crack Index	64	64					
Alligator Crack Index	98	98					
Longitudinal Crack Index	66	66					
Transverse Cracking Index	92	92					
Patching Index	100	100					
Rutting Index	86	86					
International Roughness Index (IRI)	N/A	N/A					
Lane & Width Information							
Number of Lanes	1	1					
Paved Width (ft)	11.3	11.3					
Lane Width (ft)	11.3	11.3

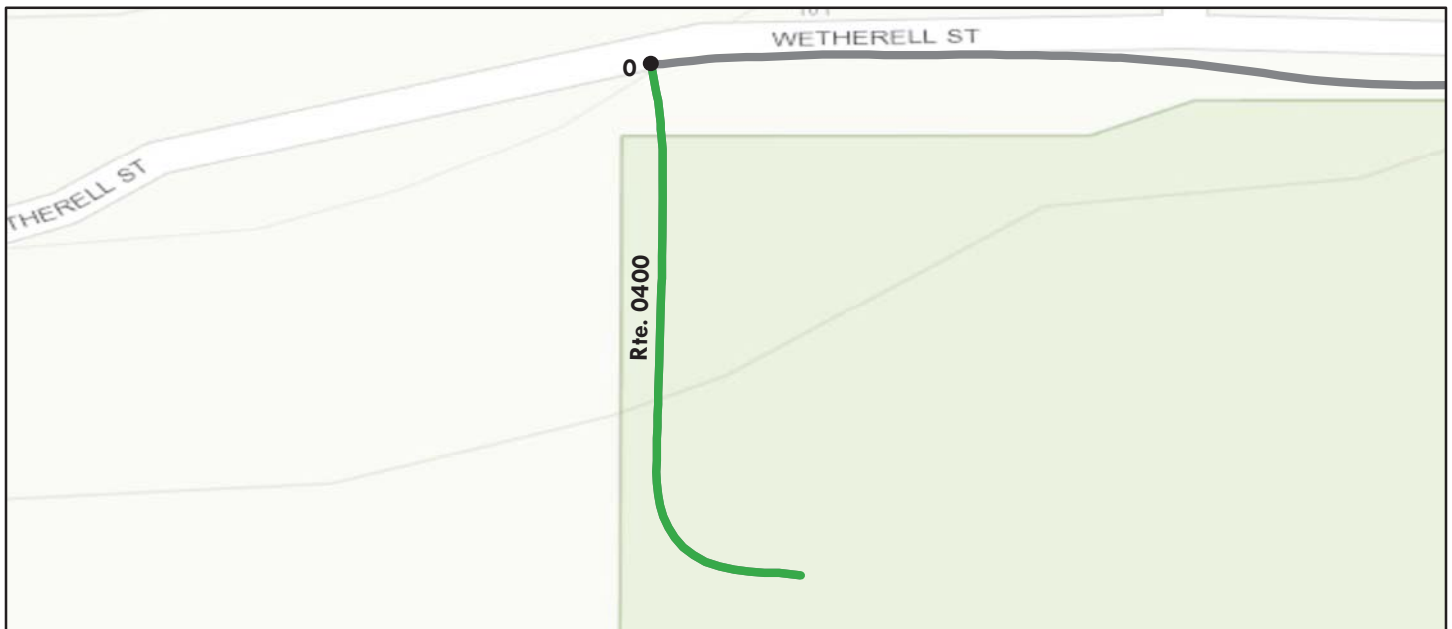
ROUTE 0400: MAINTENANCE SERVICE ROAD

Section Number	Begin Milepost	End Milepost	Section Length	Paved Width	Surface Type	Pavement Condition Rating (PCR)	Joint Faulting Index	Delamination/ Pop-Outs Index	Slab Cracking Index	Joint Distresses Index	Potholes / Patching Index
1	0.00	0.05	0.05	12.7	CONCRETE	90	97	97	97	90	97

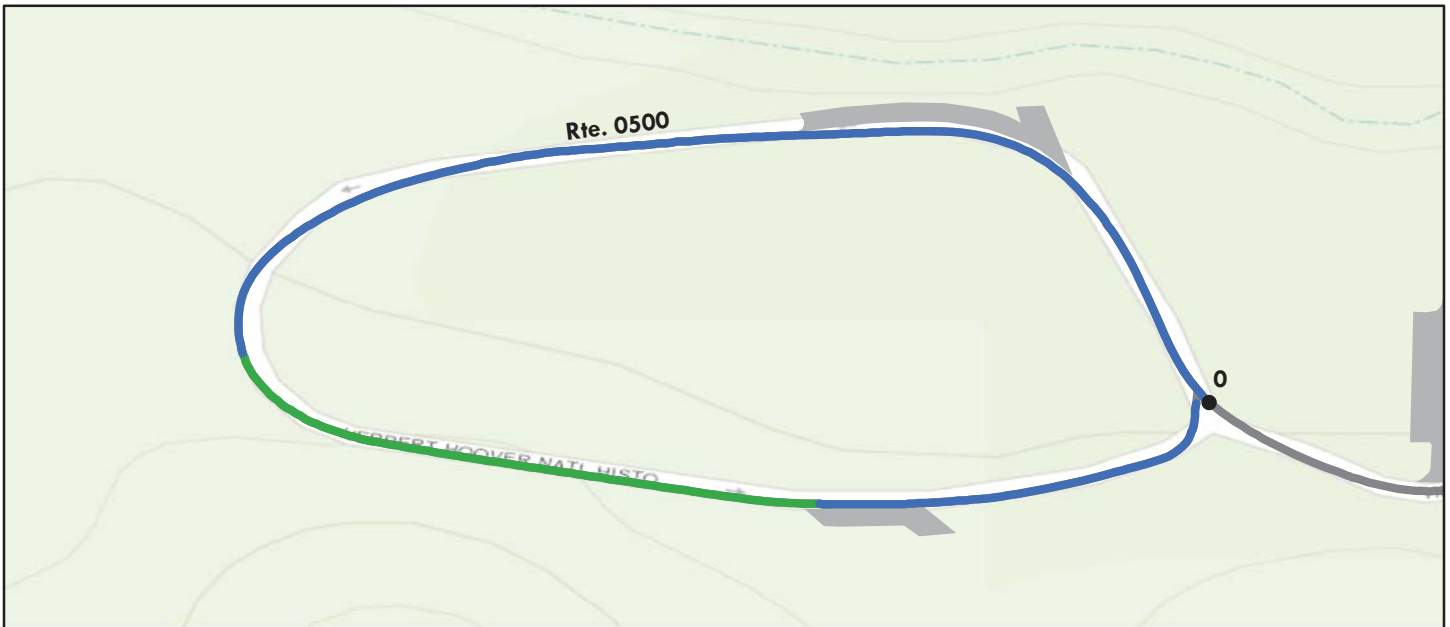
ROUTE 0500: HS-48 LOOP ROAD

Inspection Date:	12/8/2017	Beginning Section MP	0				
Paved Length (Miles):	0.37	Section Length (MI)	0.37				
Surface Type:	ASPHALT	Route Summary					
Roadway Condition Information							
Pavement Condition Rating (PCR)	95	95					
Surface Condition Rating (SCR)	95	95					
Roughness Condition Index (RCI)	N/A	N/A					
Distress Index Values							
Structural Crack Index	99	99					
Alligator Crack Index	100	100					
Longitudinal Crack Index	99	99					
Transverse Cracking Index	97	97					
Patching Index	100	100					
Rutting Index	95	95					
International Roughness Index (IRI)	N/A	N/A					
Lane & Width Information							
Number of Lanes	1	1					
Paved Width (ft)	12	12					
Lane Width (ft)	11.3	11.3

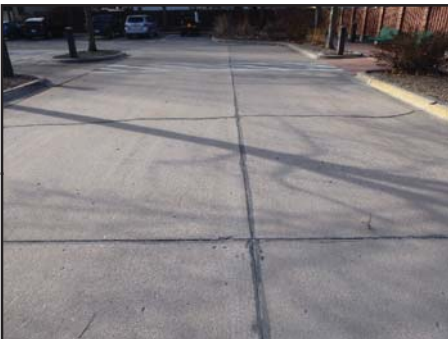
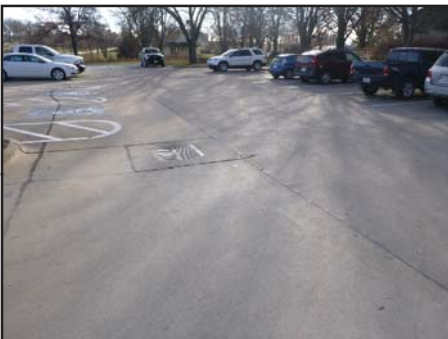
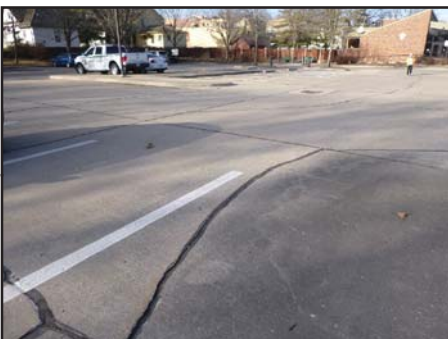
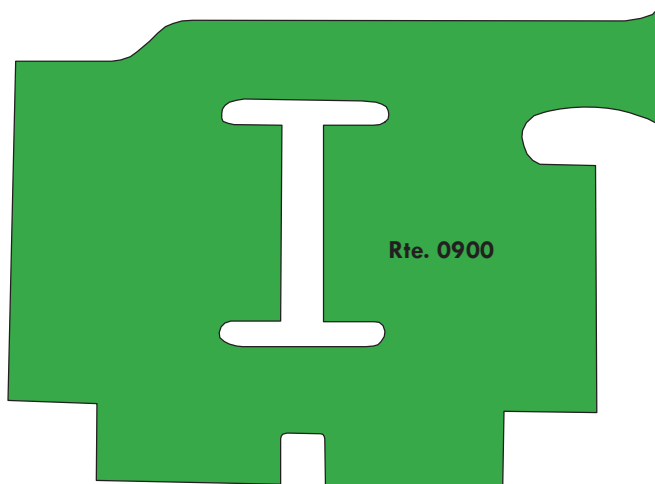
Rte. 0010

Inspection Date	FMSS Number	User Access	Surface Type
12/8/2017	64293	PUBLIC	CONCRETE
Area (Sq. Ft.)	Lane Miles (11' Widths)	Curb Reveal (Inches)	Curb Recommendation
18,624	0.321	5	LIGHT REPAIR
Curb Type		Curb & Gutter Type	
CONCRETE		NO CURB AND GUTTER	
Pavement Recommendation		Condition Rating / PCR	
PREVENTIVE MAINTENANCE		GOOD / 90

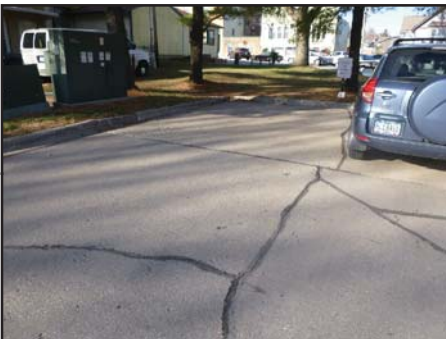
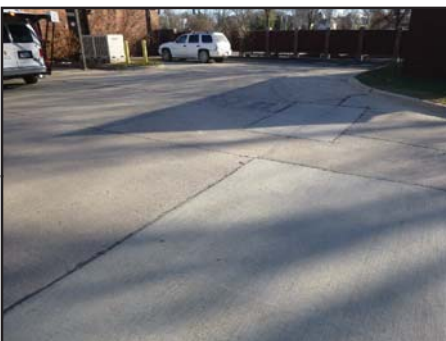
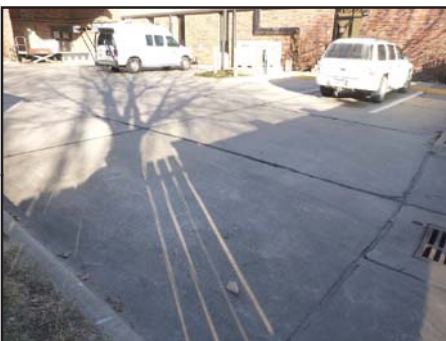
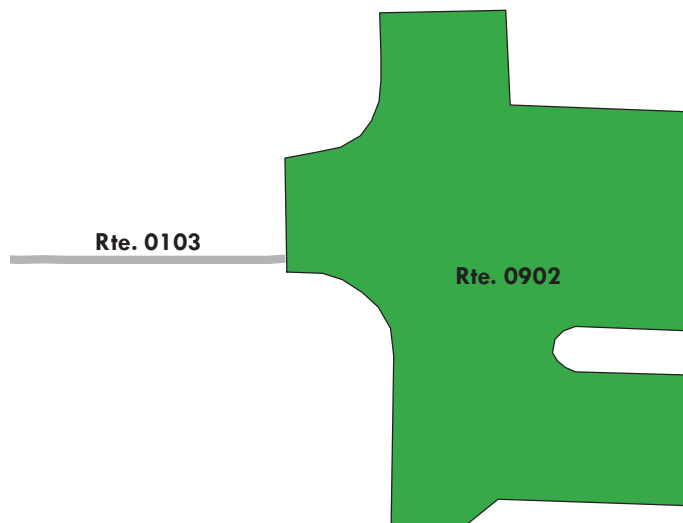
ROUTE 0902: POST OFFICE DOCK PARKING

Inspection Date	FMSS Number	User Access	Surface Type
12/8/2017	64593	NONPUBLIC	CONCRETE
Area (Sq. Ft.)	Lane Miles (11' Widths)	Curb Reveal (Inches)	Curb Recommendation
4,908	0.085	6	DO NOTHING
Curb Type		Curb & Gutter Type	
CONCRETE		CONCRETE	
Pavement Recommendation		Condition Rating / PCR	
PREVENTIVE MAINTENANCE		GOOD / 90

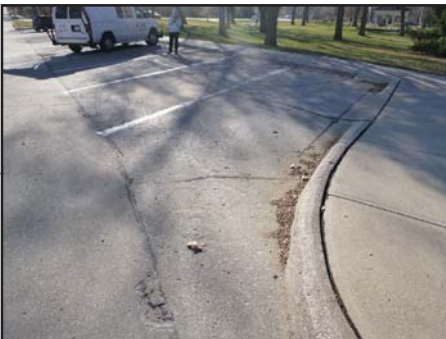
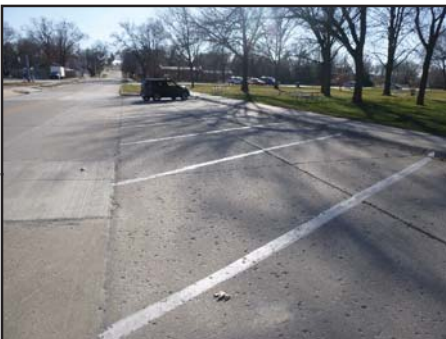
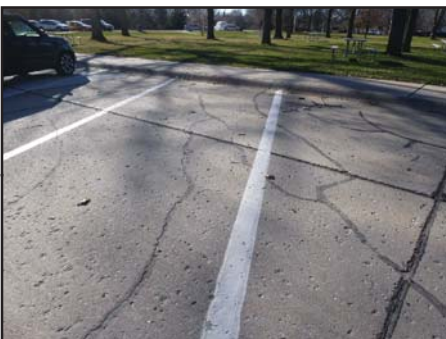
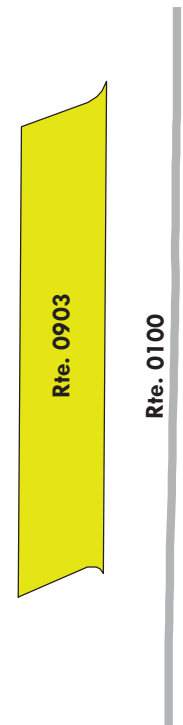
ROUTE 0903: SECOND STREET PARKING LOT

Inspection Date	FMSS Number	User Access	Surface Type
12/8/2017	64302	PUBLIC	CONCRETE
Area (Sq. Ft.)	Lane Miles (11' Widths)	Curb Reveal (Inches)	Curb Recommendation
3,853	0.066	5	LIGHT REPAIR
Curb Type		Curb & Gutter Type	
CONCRETE		NO CURB AND GUTTER	
Pavement Recommendation		Condition Rating / PCR	
LIGHT 3R TREATMENTS		FAIR / 73
