HOBE Cycle 6

Final Report

Road Inventory and Condition Assessment of Paved Routes Horseshoe Bend National Military Park

**Federal Highway Administration
Eastern Federal Lands Highway Division
Road Inventory Program (RIP)**

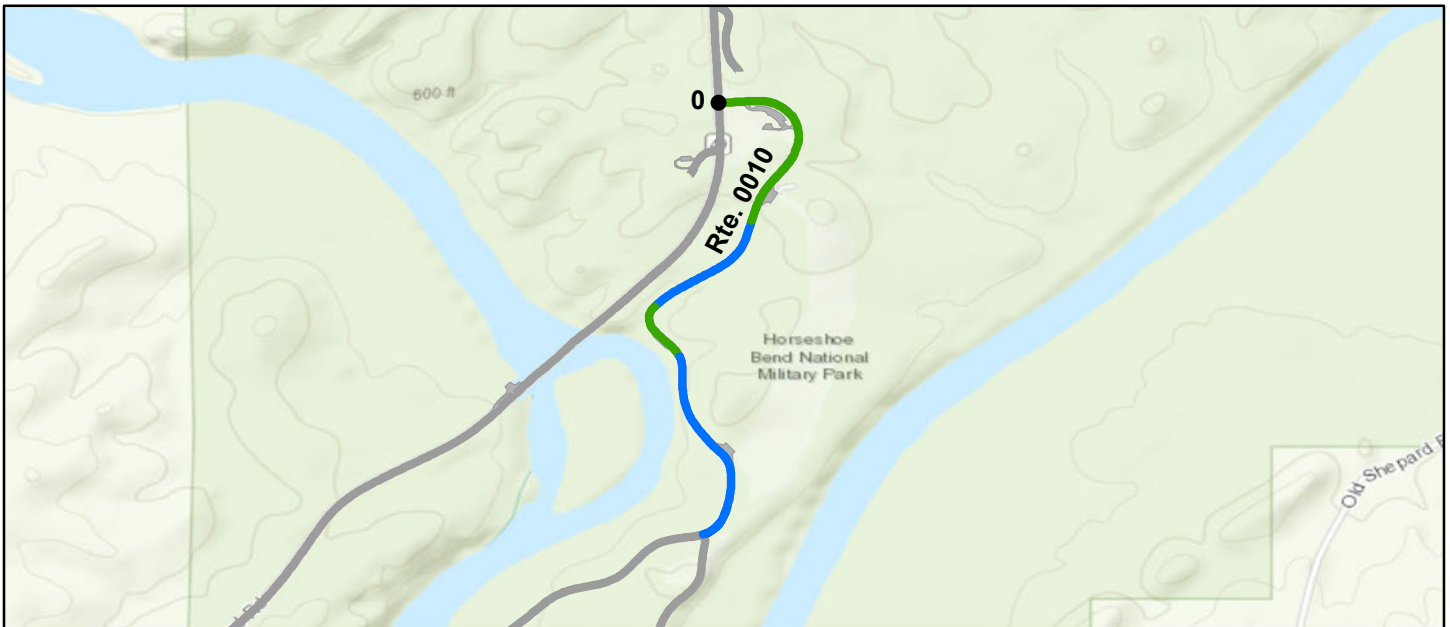
ROUTE 0010: TOUR ROAD

Inspection Date: 10/17/2020	Beginning Section MP	0				
Paved Length (Miles): 0.93	Section Length (MI)	0.93				
Surface Type: ASPHALT	Route Summary					
Roadway Condition Information						
Pavement Condition Rating (PCR)	98	98				
Surface Condition Rating (SCR)	99	99				
Roughness Condition Index (RCI)	96	96				
Distress Index Values						
Structural Crack Index	100	100				
Alligator Crack Index	100	100				
Longitudinal Crack Index	100	100				
Transverse Cracking Index	100	100				
Patching Index	100	100				
Rutting Index	99	99				
International Roughness Index (IRI)	125	125				
Lane & Width Information						
Number of Lanes	2	2				
Paved Width (ft)	19.5	19.5				
Lane Width (ft)	9.7	9.7

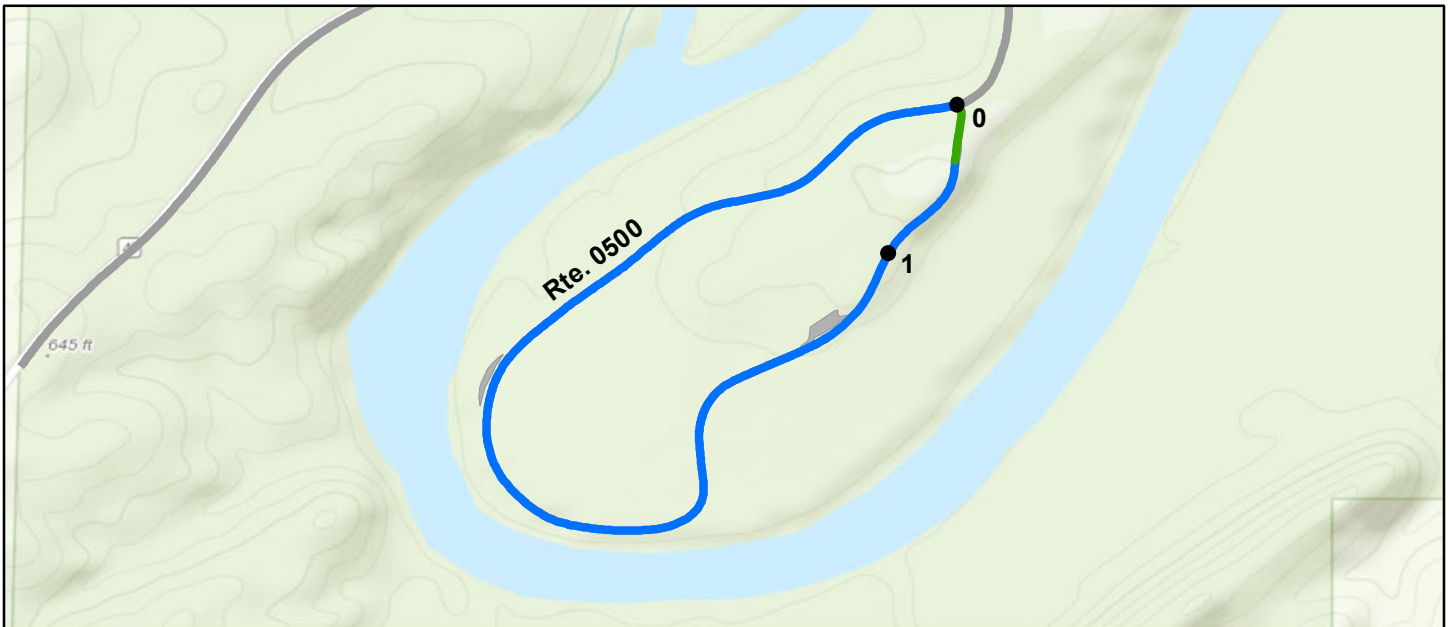
ROUTE 0500: ONE WAY LOOP TOUR ROAD

Inspection Date:	10/17/2020	Beginning Section MP	0	1			
Paved Length (Miles):	1.15	Section Length (MI)	1	0.15			
Surface Type:	ASPHALT	Route Summary					
Roadway Condition Information							
Pavement Condition Rating (PCR)	100	100	98				
Surface Condition Rating (SCR)	100	100	100				
Roughness Condition Index (RCI)	99	100	95				
Distress Index Values							
Structural Crack Index	100	100	100				
Alligator Crack Index	100	100	100				
Longitudinal Crack Index	100	100	100				
Transverse Cracking Index	100	100	100				
Patching Index	100	100	100				
Rutting Index	100	100	100				
International Roughness Index (IRI)	116	114	127				
Lane & Width Information							
Number of Lanes	1	1	1				
Paved Width (ft)	13.4	13.6	12.2				
Lane Width (ft)	13.4	13.6	12.2

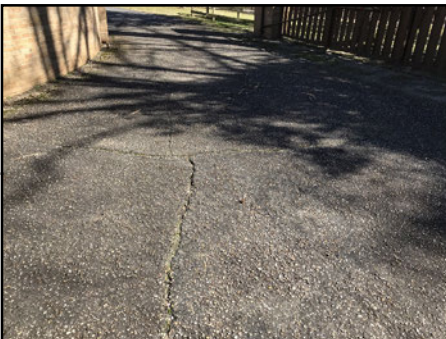
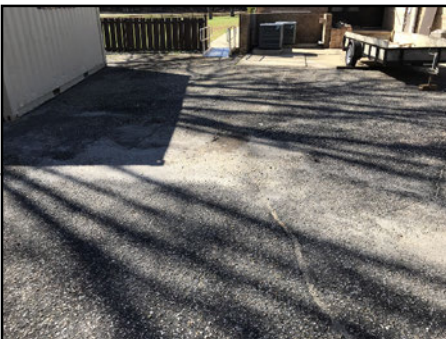
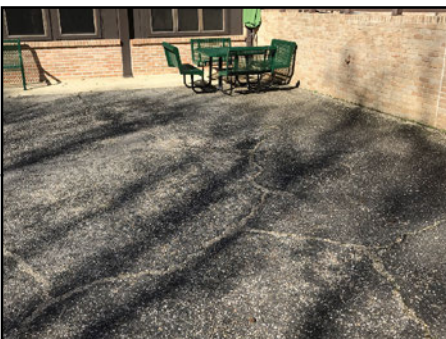
ROUTE 0901: EMPLOYEE PARKING

Inspection Date	FMSS Number	User Access	Surface Type
2/22/2020	50268	NONPUBLIC	ASPHALT
Area (Sq. Ft.)	Lane Miles (11' Widths)	Curb Reveal (Inches)	Curb Recommendation
3,498	0.06	NOT APPLICABLE	NOT APPLICABLE
Curb Type		Curb & Gutter Type	
NO CURB		NO CURB AND GUTTER	
Pavement Recommendation		Condition Rating / PCR	
HEAVY 3R TREATMENTS		POOR / 53

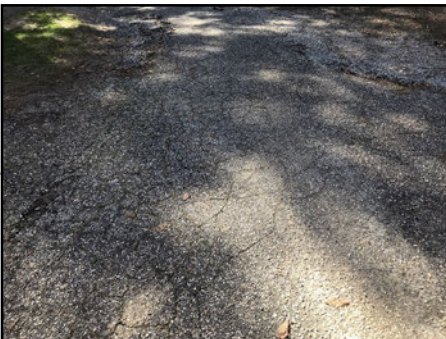
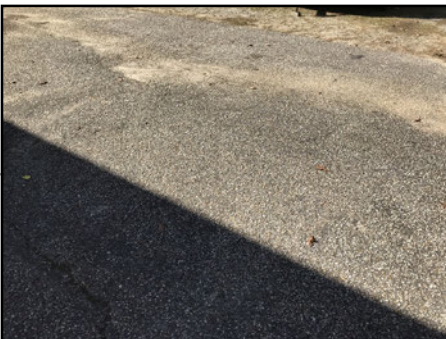
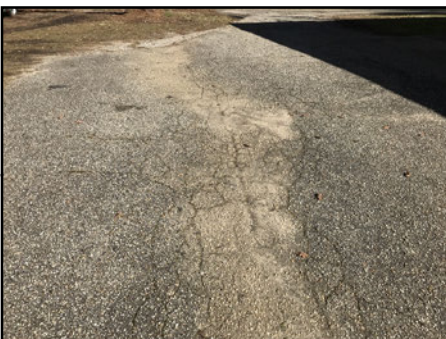
ROUTE 0902: MAINTENANCE AREA PARKING

Inspection Date	FMSS Number	User Access	Surface Type
2/22/2020	50269	NONPUBLIC	ASPHALT
Area (Sq. Ft.)	Lane Miles (11' Widths)	Curb Reveal (Inches)	Curb Recommendation
5,550	0.096	NOT APPLICABLE	NOT APPLICABLE
Curb Type		Curb & Gutter Type	
NO CURB		NO CURB AND GUTTER	
Pavement Recommendation		Condition Rating / PCR	
RECONSTRUCTION		POOR / 30

Multiple Surface Types:
 Asphalt = 5,324 sq. ft.
 Concrete = 226 sq. ft.
