HOFR Cycle 6

Final Report

Road Inventory and Condition Assessment of Paved Routes Home of Franklin D. Roosevelt National Historic Site

Report Date: June 2021

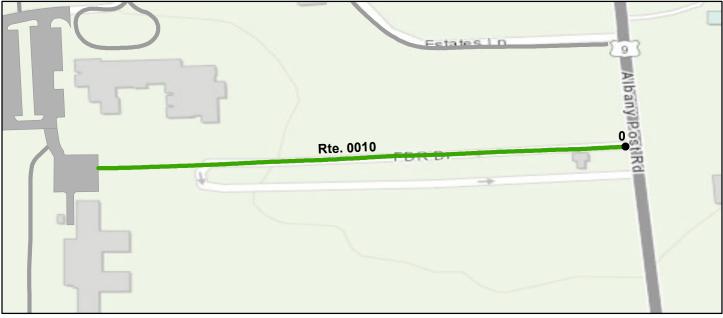
| Route Condition Legend – Pavement Condition Rating (PCR) | | | | | | | |
|---|---|---|---|---|--|--|--|
| Pavement Condition Rating (PCR) | 93 | 93 | | | | | |
| Surface Condition Rating (SCR) | 93 | 93 | | | | | |
| Structural Crack Index | 93 | 93 | | | | | |
| Alligator Crack Index | 100 | 100 | | | | | |
| Longitudinal Crack Index | 93 | 93 | | | | | |
| Transverse Cracking Index | 93 | 93 | | | | | |

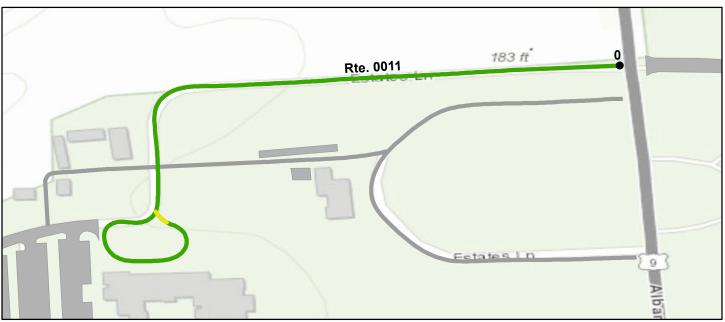
ROUTE 0011: WALLACE CENTER ENTRANCE / EXIT ROAD

| Route Condition Legend – Pavement Condition Rating (PCR) | | | | | | | |
|---|---|---|---|---|--|--|--|
| Pavement Condition Rating (PCR) | 90 | 90 | | | | | |
| Surface Condition Rating (SCR) | 90 | 90 | | | | | |
| Structural Crack Index | 90 | 90 | | | | | |
| Alligator Crack Index | 100 | 100 | | | | | |
| Longitudinal Crack Index | 90 | 90 | | | | | |
| Transverse Cracking Index | 97 | 97 | | | | | |

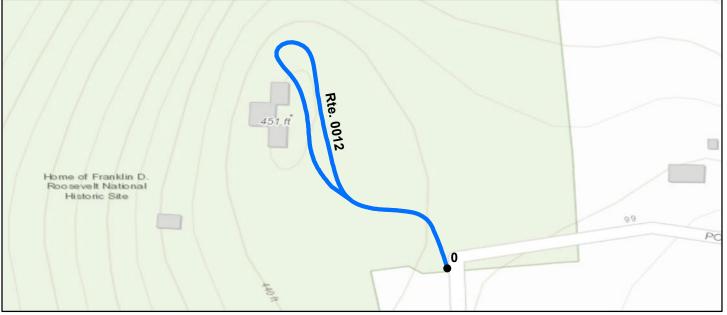
| Route Condition Legend – Pavement Condition Rating (PCR) | | | | | | | |
|---|---|---|---|---|--|--|--|
| Pavement Condition Rating (PCR) | 96 | 96 | | | | | |
| Surface Condition Rating (SCR) | 96 | 96 | | | | | |
| Structural Crack Index | 99 | 99 | | | | | |
| Alligator Crack Index | 100 | 100 | | | | | |
| Longitudinal Crack Index | 99 | 99 | | | | | |
| Transverse Cracking Index | 100 | 100 | | | | | |

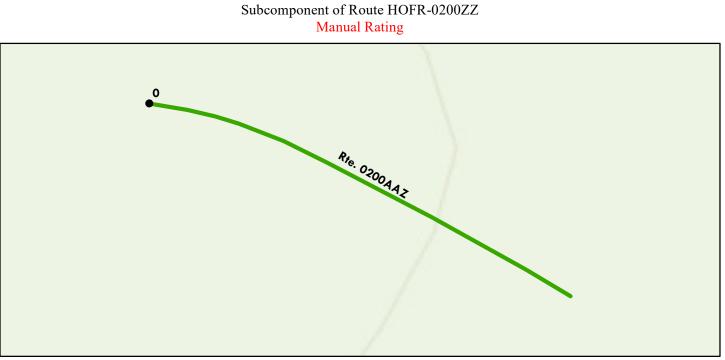
ROUTE 0200AAZ: ROOSEVELT FARM LANE ROAD SECTION 01

| Route Condition Legend – Pavement Condition Rating (PCR) | | | | | | | | |
|--|---|---|---|---|---|---|--|--|
| Pavement Condition Rating (PCR) | 90 | 90 | | | | | | |
| Surface Condition Rating (SCR) | 90 | 90 | | | | | | |
| Structural Crack Index | N/A | N/A | | | | | | |
| Alligator Crack Index | 97 | 97 | | | | | | |
| Longitudinal Crack Index | 97 | 97 | | | | | | |
| Transverse Cracking Index | 97 | 97 | | | | | | |

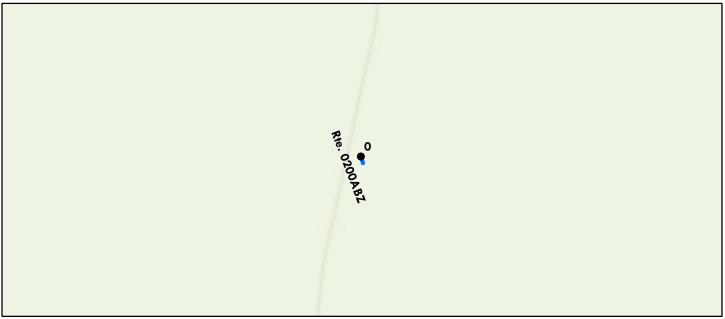
Subcomponent of Route HOFR-0200ZZ Manual Rating

| Route Condition Legend – Pavement Condition Rating (PCR) | | | | | | | |
|--|---|---|---|---|--|--|--|
| Pavement Condition Rating (PCR) | 97 | 97 | | | | | |
| Surface Condition Rating (SCR) | 97 | 97 | | | | | |
| Structural Crack Index | N/A | N/A | | | | | |
| Alligator Crack Index | 97 | 97 | | | | | |
| Longitudinal Crack Index | 97 | 97 | | | | | |
| Transverse Cracking Index | 97 | 97 | | | | | |
