HOSP Cycle 6

Final Report

Road Inventory and Condition Assessment of Paved Routes Hot Springs National Park

**Federal Highway Administration
Eastern Federal Lands Highway Division
Road Inventory Program (RIP)**

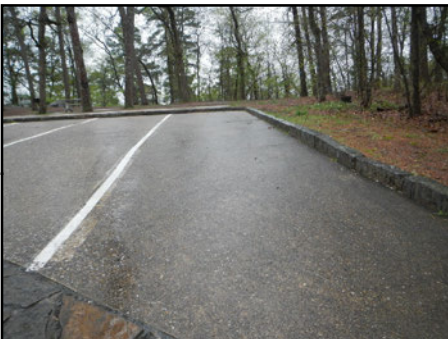
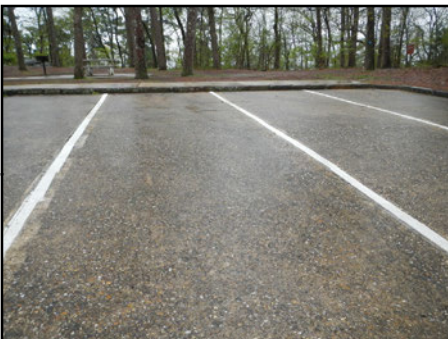
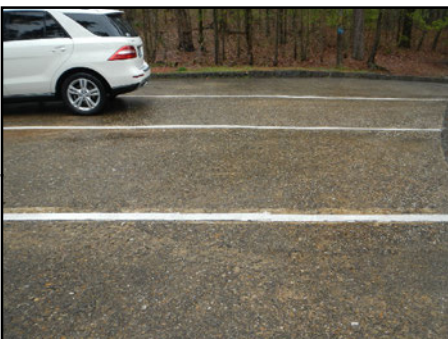
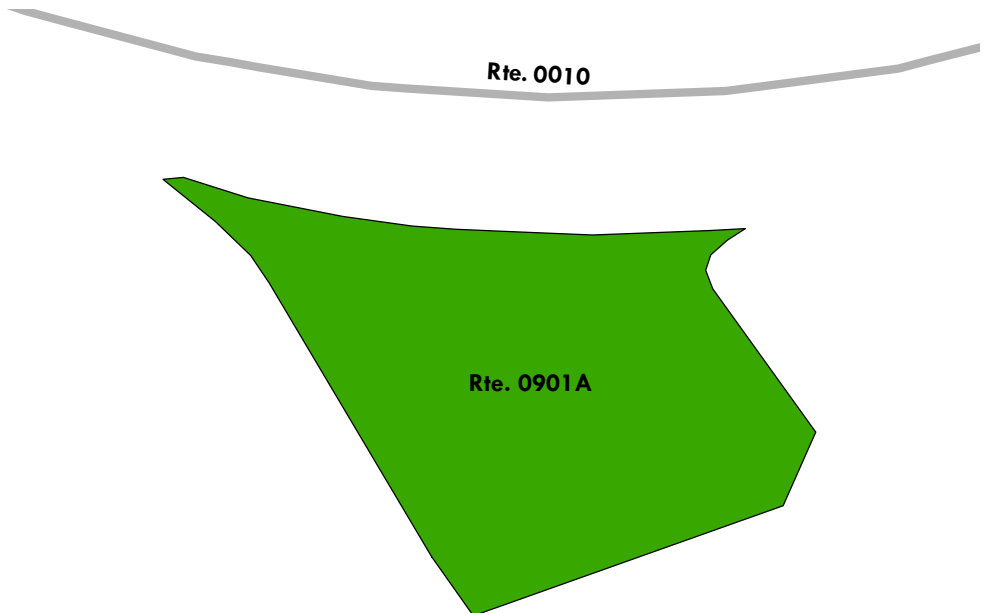
Inspection Date	FMSS Number	User Access	Surface Type
4/7/2018	82246	PUBLIC	CONCRETE
Area (Sq. Ft.)	Lane Miles (11' Widths)	Curb Reveal (Inches)	Curb Recommendation
1,261	0.022	6	DO NOTHING
Curb Type		Curb & Gutter Type	
STONE		NO CURB AND GUTTER	
Pavement Recommendation		Condition Rating / PCR	
PREVENTIVE MAINTENANCE		GOOD / 90

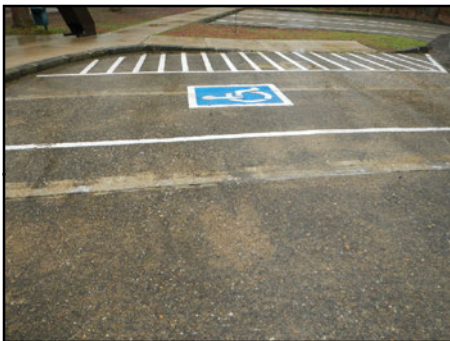
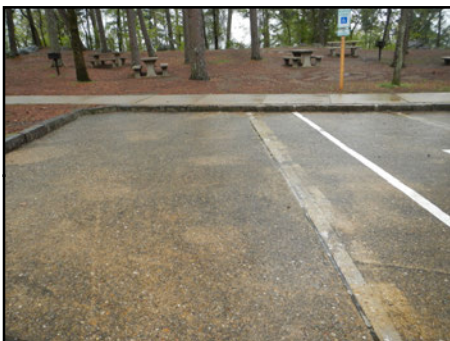
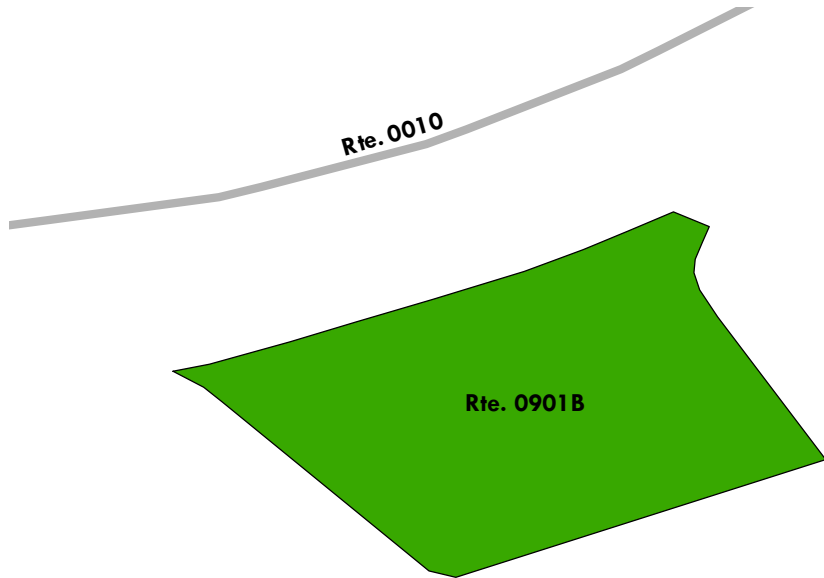
Inspection Date	FMSS Number	User Access	Surface Type
4/7/2018	82247	PUBLIC	CONCRETE
Area (Sq. Ft.)	Lane Miles (11' Widths)	Curb Reveal (Inches)	Curb Recommendation
676	0.012	6	DO NOTHING
Curb Type		Curb & Gutter Type	
STONE		NO CURB AND GUTTER	
Pavement Recommendation		Condition Rating / PCR	
PREVENTIVE MAINTENANCE		GOOD / 90

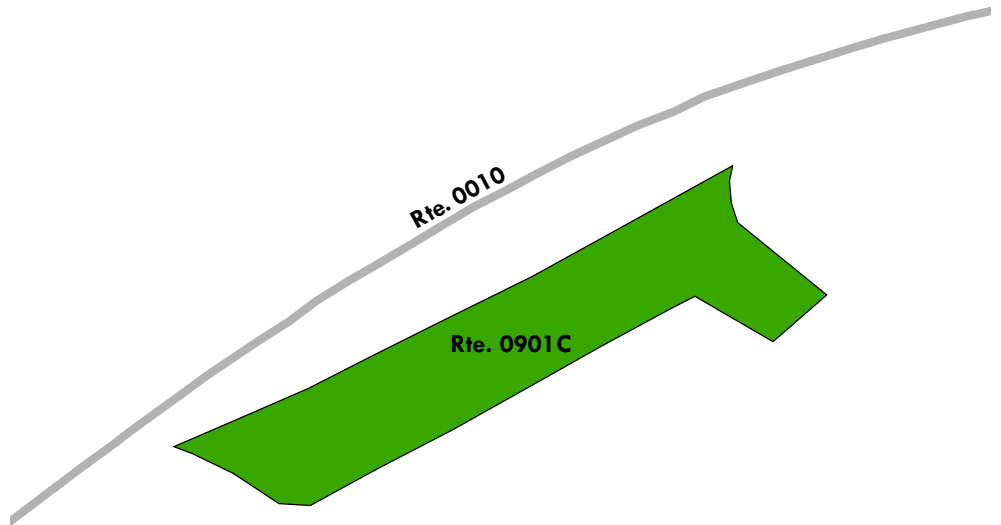
Inspection Date	FMSS Number	User Access	Surface Type
4/7/2018	82248	PUBLIC	CONCRETE
Area (Sq. Ft.)	Lane Miles (11' Widths)	Curb Reveal (Inches)	Curb Recommendation
1,641	0.028	6	DO NOTHING
Curb Type		Curb & Gutter Type	
STONE		NO CURB AND GUTTER	
Pavement Recommendation		Condition Rating / PCR	
PREVENTIVE MAINTENANCE		GOOD / 90

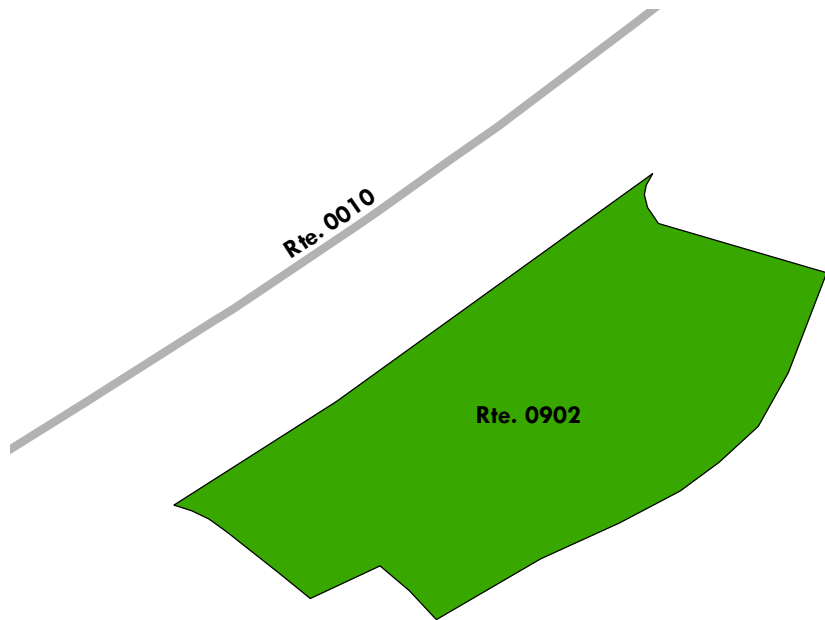
Inspection Date	FMSS Number	User Access	Surface Type
4/7/2018	82249	PUBLIC	ASPHALT
Area (Sq. Ft.)	Lane Miles (11' Widths)	Curb Reveal (Inches)	Curb Recommendation
1,053	0.018	6	DO NOTHING
Curb Type		Curb & Gutter Type	
STONE		NO CURB AND GUTTER	
Pavement Recommendation		Condition Rating / PCR	
PREVENTIVE MAINTENANCE		GOOD / 90

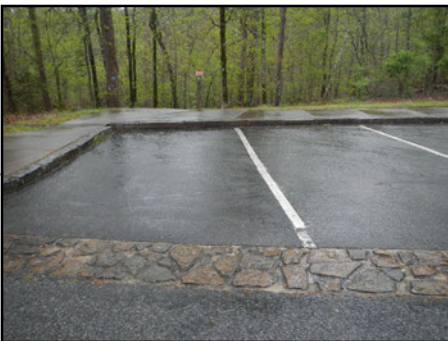
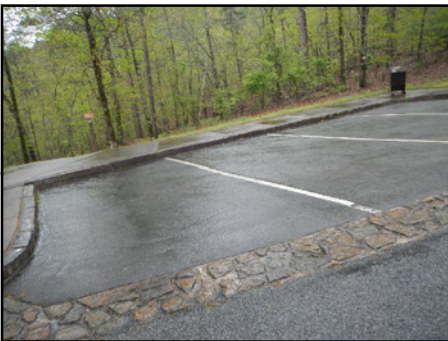
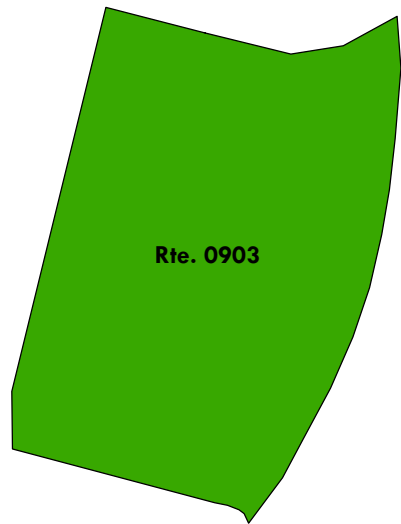
Inspection Date	FMSS Number	User Access	Surface Type
4/7/2018	82250	PUBLIC	ASPHALT
Area (Sq. Ft.)	Lane Miles (11' Widths)	Curb Reveal (Inches)	Curb Recommendation
935	0.016	6	DO NOTHING
Curb Type		Curb & Gutter Type	
STONE		NO CURB AND GUTTER	
Pavement Recommendation		Condition Rating / PCR	
PREVENTIVE MAINTENANCE		GOOD / 90

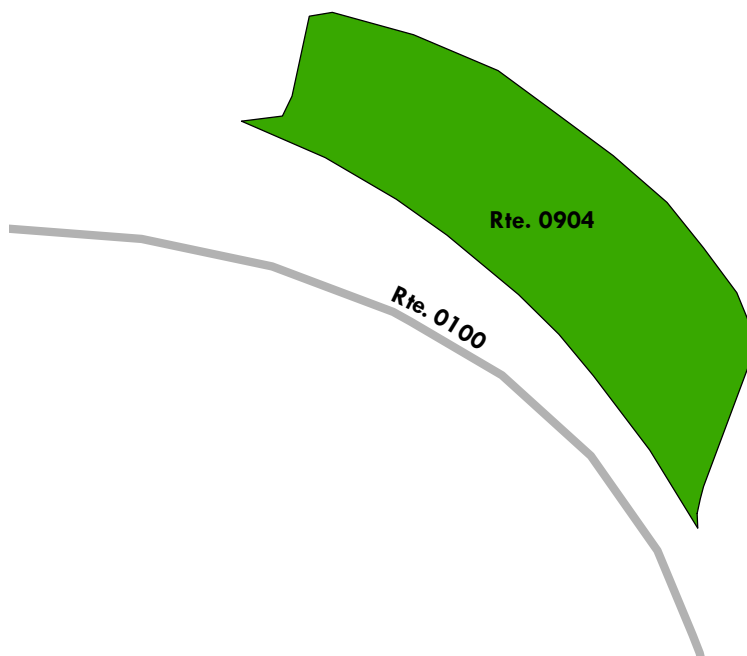
Inspection Date	FMSS Number	User Access	Surface Type
4/7/2018	82251	PUBLIC	ASPHALT
Area (Sq. Ft.)	Lane Miles (11' Widths)	Curb Reveal (Inches)	Curb Recommendation
1,389	0.024	6	DO NOTHING
Curb Type		Curb & Gutter Type	
STONE		NO CURB AND GUTTER	
Pavement Recommendation		Condition Rating / PCR	
PREVENTIVE MAINTENANCE		GOOD / 90

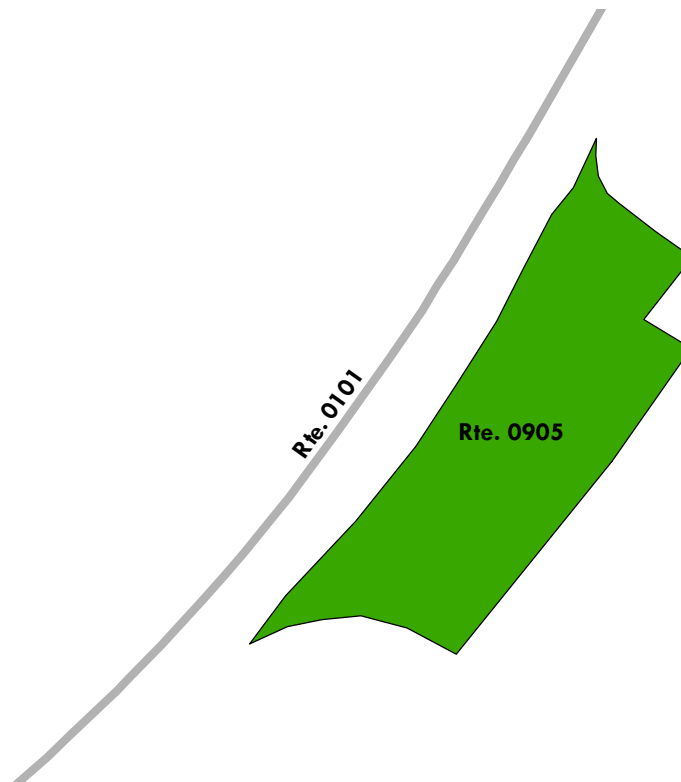
Inspection Date	FMSS Number	User Access	Surface Type
4/7/2018	82252	PUBLIC	ASPHALT
Area (Sq. Ft.)	Lane Miles (11' Widths)	Curb Reveal (Inches)	Curb Recommendation
3,903	0.067	4	DO NOTHING
Curb Type		Curb & Gutter Type	
STONE		NO CURB AND GUTTER	
Pavement Recommendation		Condition Rating / PCR	
PREVENTIVE MAINTENANCE		GOOD / 90
