Final Report

Road Inventory and Condition Assessment of Paved Routes Indiana Dunes National Park

Prepared By: Federal Highway Administration Eastern Federal Lands Highway Division Road Inventory Program (RIP)

Report Date: January 2021

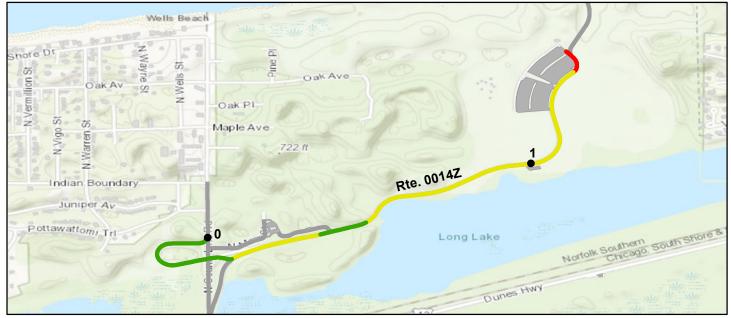
Indiana Dunes National Park ROUTE 0014Z: WEST BEACH ACCESS ROAD

Route	Condition Legend – Pav	ement Condi	ition Rating (PCR)		
Poor (0 - 60			(85 - 94)	Excellent (9		Not Rated	
Colors o	on map represent con	dition scores at 0.10-mile	intervals. Se	e Appendix fo	r definition	s and formulas.	
Inspection Date:	6/21/2019	Beginning Section MP	0	1			
Paved Length (Miles	s): 1.37	Section Length (MI)	1	0.37			
Surface Type:	ASPHALT	Route Summary		• • • •		• •	
Roadway Condition	Information						
Pavement Condition	n Rating (PCR)	78	80	74			
Surface Condition Ra	ating (SCR)	63	66	56			
Roughness Condition	n Index (RCI)	100	100	100			
Distress Index Value	es						
Structural Crack Inc	lex	100	100	99			
Alligator Crack Ind	ex	100	100	100			
Longitudinal Crack	Index	100	100	99			
Transverse Cracking	g Index	63	66	56			
Patching Index		100	100	100			
Rutting Index		100	100	100			
International Rough	ness Index (IRI)	99	98	102			
Lane & Width Infor	mation						
Number of Lanes		2	2	2

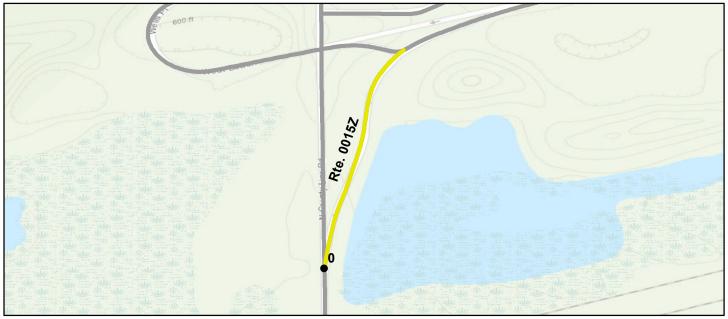
Indiana Dunes National Park ROUTE 0015Z: WEST BEACH ENTRY ROAD

Route Condition Legend – Pavement Condition Rating (PCR)						
Poor (0 - 60) Fair (6	61-84) Good	(85 - 94)	Excellent (95 - 100)	Not Rated		
Colors on map represent con	dition scores at 0.10-mile	e intervals. Se	e Appendix for definition	ns and formulas.		
Inspection Date: 6/21/2019	Beginning Section MP	0				
Paved Length (Miles): 0.19	Section Length (MI)	0.19				
Surface Type: ASPHALT	Route Summary					
Roadway Condition Information						
Pavement Condition Rating (PCR)	66	66				
Surface Condition Rating (SCR)	66	66				
Roughness Condition Index (RCI)	N/A	N/A				
Distress Index Values						
Structural Crack Index	98	98				
Alligator Crack Index	100	100				
Longitudinal Crack Index	98	98				
Transverse Cracking Index	66	66				
Patching Index	100	100				
Rutting Index	100	100				
International Roughness Index (IRI)	N/A	N/A				
Lane & Width Information						
Number of Lanes	2	2				
Paved Width (ft)	19.5	19.5

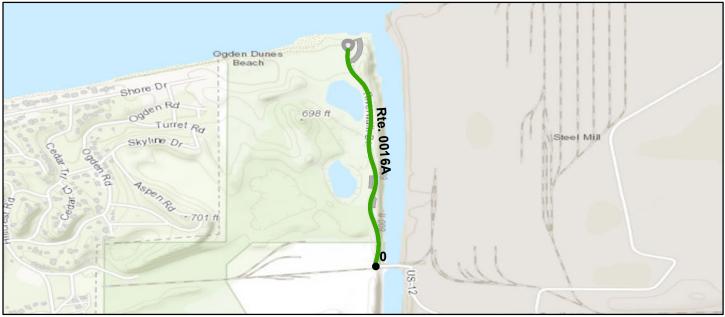
Indiana Dunes National Park ROUTE 0016A: PORTAGE LAKEFRONT ENTRANCE ROAD

Route Condition Legend – Pavement Condition Rating (PCR)						
Poor (0 - 60) Fair	61- 84) Good	(85 - 94)	Excellent (95 - 100)	Not Rated		
Colors on map represent co	ndition scores at 0.10-mile	e intervals. Se	e Appendix for definitio	ns and formulas.		
Inspection Date: 6/21/2019	Beginning Section MP	0				
Paved Length (Miles): 0.63	Section Length (MI)	0.63				
Surface Type: ASPHALT	Route Summary					
Roadway Condition Information						
Pavement Condition Rating (PCR)	91	91				
Surface Condition Rating (SCR)	90	90				
Roughness Condition Index (RCI)	92	92				
Distress Index Values						
Structural Crack Index	99	99				
Alligator Crack Index	100	100				
Longitudinal Crack Index	99	99				
Transverse Cracking Index	90	90				
Patching Index	100	100				
Rutting Index	99	99				
International Roughness Index (IRI)	135	135				
Lane & Width Information						
Number of Lanes	2	2				
Paved Width (ft)	25.2	25.2				
Lane Width (ft)	10.7	10.7

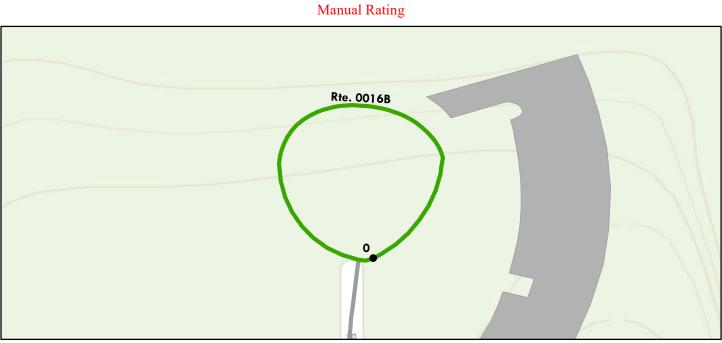
ROUTE 0016B: PORTAGE LAKEFRONT TURNAROUND

Route Condition Legend – Pavement Condition Rating (PCR)								
Poor (0 - 60)	Fair (<mark>61- 84) Good (</mark>	85 - 94)	Excellent (95 - 100)	Not Rated			
See Appendix for definitions and formulas								
Inspection Date:	11/11/2018	Beginning Section MP	0.00					
Paved Length (Miles): 0.06	Section Length (MI)	0.06					
Surface Type:	CONCRETE	Route Summary		• •				
Roadway Condition	Information							
Pavement Condition	Rating (PCR)	90	90					
Surface Condition Ra	ting (SCR)	90	90					
Roughness Condition	Index (RCI)	N/A	N/A					
Distress Index Values	S							
Structural Crack Ind	ex	N/A	N/A					
Alligator Crack Inde	X	N/A	N/A					
Longitudinal Crack	Index	N/A	N/A					
Transverse Cracking	g Index	N/A	N/A					
Patching Index		N/A	N/A					
Rutting Index		N/A	N/A					
International Rough	ness Index (IRI)	N/A	N/A					
Lane & Width Inform	mation							
Number of Lanes		2	2					
Paved Width (ft)		23	23					
Lane Width (ft)		11	11

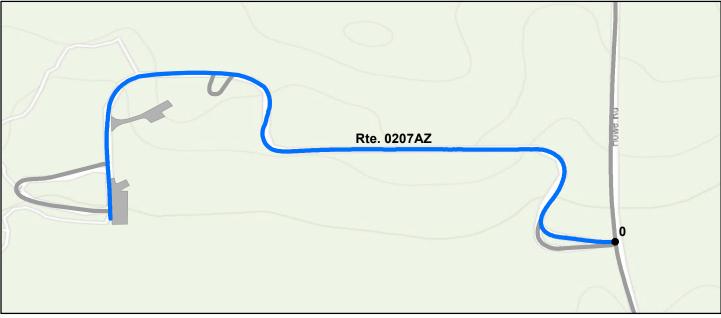
Indiana Dunes National Park ROUTE 0207AZ: GOOD FELLOW CAMP ROAD DLC

Route Condition Legend – Pavement Condition Rating (PCR)						
Poor (0 - 60) Fair (6	1- 84) Good	(85 - 94)	Excellent (95 - 100)) Not Rated		
Colors on map represent con	dition scores at 0.10-mile	e intervals. Se	e Appendix for defini	tions and formulas.		
Inspection Date: 6/21/2019	Beginning Section MP	0				
Paved Length (Miles): 0.44	Section Length (MI)	0.44				
Surface Type: ASPHALT	Route Summary					
Roadway Condition Information						
Pavement Condition Rating (PCR)	98	98				
Surface Condition Rating (SCR)	98	98				
Roughness Condition Index (RCI)	N/A	N/A				
Distress Index Values						
Structural Crack Index	99	99				
Alligator Crack Index	100	100				
Longitudinal Crack Index	99	99				
Transverse Cracking Index	98	98				
Patching Index	100	100				
Rutting Index	100	100				
International Roughness Index (IRI)	N/A	N/A				
Lane & Width Information						
Number of Lanes	2	2				
Paved Width (ft)	20	20				
Lane Width (ft)	11.2	11.2

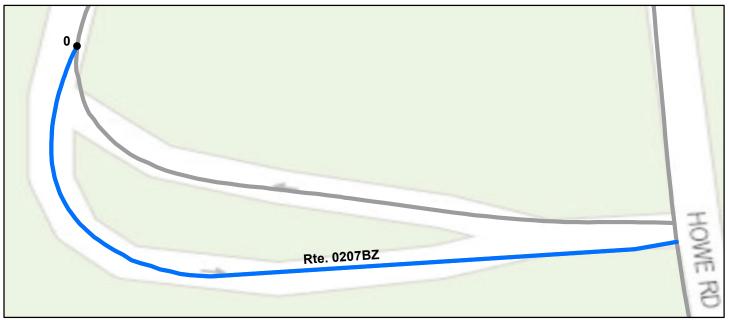
Indiana Dunes National Park ROUTE 0207BZ: GOOD FELLOW CAMP EXIT ROAD DLC

Route Condition Legend – Pavement Condition Rating (PCR)						
Poor (0 - 60) Fa	ir (61- 84) Good	(85 - 94)	Excellent (95 - 100)	Not Rated		
Colors on map represent	condition scores at 0.10-mil	e intervals. Se	e Appendix for definition	ns and formulas.		
Inspection Date: 6/21/2019	Beginning Section MP	0				
Paved Length (Miles): 0.05	Section Length (MI)	0.05				
Surface Type: ASPHALT	Route Summary					
Roadway Condition Information						
Pavement Condition Rating (PCR)	97	97				
Surface Condition Rating (SCR)	97	97				
Roughness Condition Index (RCI)	N/A	N/A				
Distress Index Values						
Structural Crack Index	99	99				
Alligator Crack Index	100	100				
Longitudinal Crack Index	99	99				
Transverse Cracking Index	100	100				
Patching Index	100	100				
Rutting Index	97	97				
International Roughness Index (IRI)	N/A	N/A				
Lane & Width Information						
Number of Lanes	1	1				
Paved Width (ft)	14.3	14.3				
Lane Width (ft)	10.7	10.7

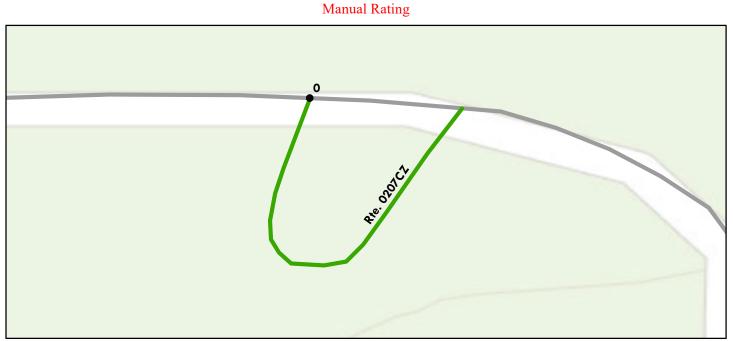
Subcomponent of Route INDU-0207ZZ

Route Condition Legend – Pavement Condition Rating (PCR)									
Poor (0 - 60) Fai	r (61- 84) Good	(85 - 94)	Excellent (95 - 100)	Not Rated					
	See Appendix for definitions and formulas								
Inspection Date: 11/11/2018	Beginning Section MP	0.00							
Paved Length (Miles): 0.03	Section Length (MI)	0.03							
Surface Type: ASPHALT	Route Summary		• •						
Roadway Condition Information									
Pavement Condition Rating (PCR)	90	90							
Surface Condition Rating (SCR)	90	90							
Roughness Condition Index (RCI)	N/A	N/A							
Distress Index Values									
Structural Crack Index	N/A	N/A							
Alligator Crack Index	97	97							
Longitudinal Crack Index	90	90							
Transverse Cracking Index	90	90							
Patching Index	97	97							
Rutting Index	97	97							
International Roughness Index (IRI)	N/A	N/A							
Lane & Width Information									
Number of Lanes	2	2							
Paved Width (ft)	20	20							
Lane Width (ft)	10	10

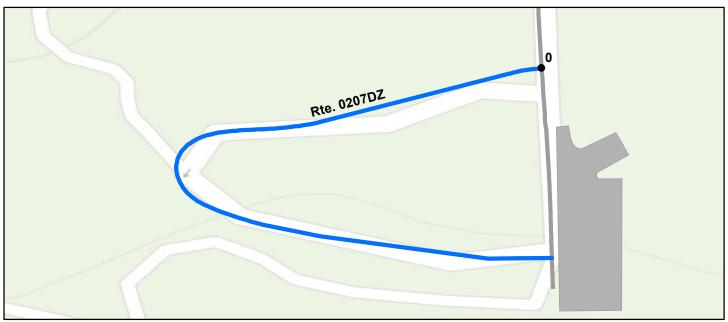
Indiana Dunes National Park ROUTE 0207DZ: GOOD FELLOW CAMP LOOP DLC

Route Condition Legend – Pavement Condition Rating (PCR)						
Poor (0 - 60) Fair (6	1- 84) Good ((85 - 94)	Excellent (95 -	100) Not Rated		
Colors on map represent con	dition scores at 0.10-mile	e intervals. Se	e Appendix for det	initions and formulas.	-	
Inspection Date: 6/21/2019	Beginning Section MP	0				
Paved Length (Miles): 0.1	Section Length (MI)	0.1				
Surface Type: ASPHALT	Route Summary		•			
Roadway Condition Information						
Pavement Condition Rating (PCR)	98	98				
Surface Condition Rating (SCR)	98	98				
Roughness Condition Index (RCI)	N/A	N/A				
Distress Index Values						
Structural Crack Index	100	100				
Alligator Crack Index	100	100				
Longitudinal Crack Index	100	100				
Transverse Cracking Index	99	99				
Patching Index	100	100				
Rutting Index	98	98				
International Roughness Index (IRI)	N/A	N/A				
Lane & Width Information						
Number of Lanes	1	1				
Paved Width (ft)	11.5	11.5
