LABE Cycle 6

Final Report

Road Inventory and Condition Assessment of Paved Routes Lava Beds National Monument

Report Date: November 2015

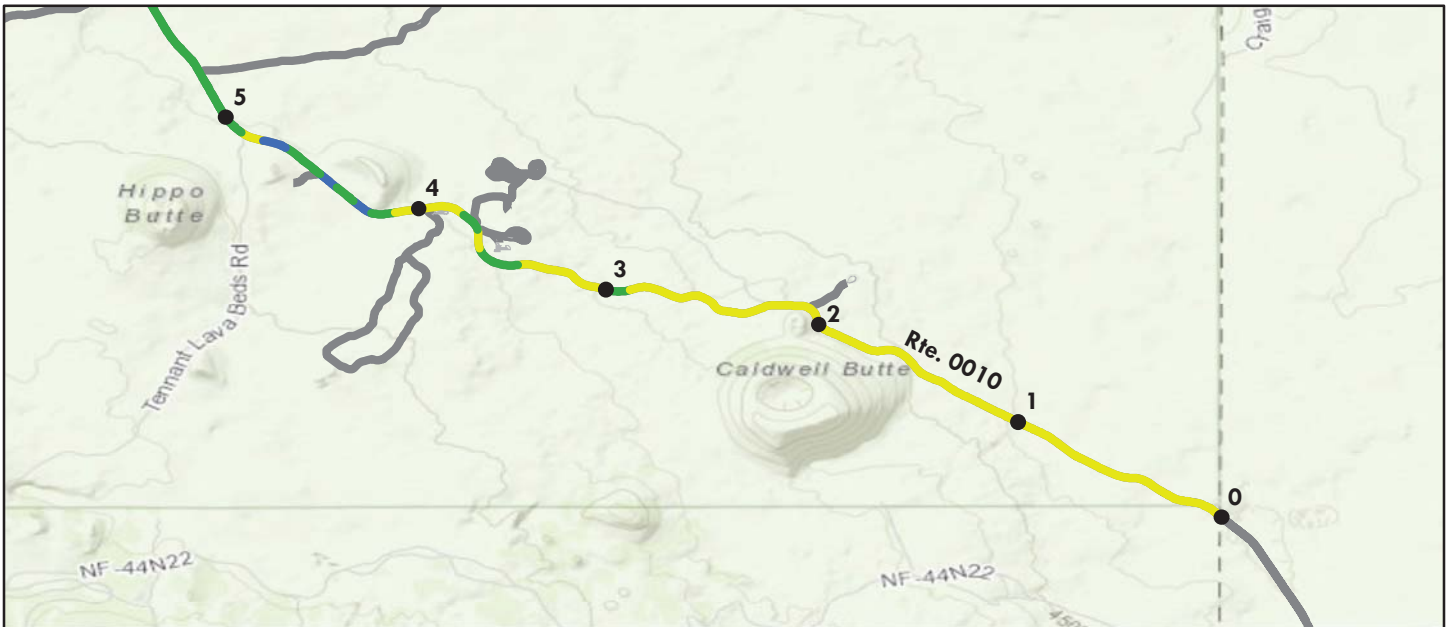
Data Collection Vehicle (DCV) Rating

Route Condition Legend – Pavement Condition Rating (PCR)						
Poor (0 - 60)	Fair (61- 84)	Good (85 - 94)	Excellent (95 - 100)	Not Rated		
See Appendix for definitions and formulas						
Inspection Date: 5/24/2015	Beginning Section MP	0	1	2	3	4
Paved Length (Miles): 20.25	Section Length (MI)	1	1	1	1	1
Surface Type: ASPHALT	Route Summary					
Roadway Condition Information						
Pavement Condition Rating (PCR)	84	74	74	76	82	90
Surface Condition Rating (SCR)	90	87	88	84	86	93
Roughness Condition Index (RCI)	75	54	52	65	77	85
Distress Index Values						
Structural Crack Index	98	96	96	89	96	98
Alligator Crack Index	100	99	100	100	100	100
Longitudinal Crack Index	98	97	96	89	96	98
Transverse Cracking Index	90	87	88	84	86	93
Patching Index	100	100	100	100	100	100
Rutting Index	95	94	93	98	99	98
International Roughness Index (IRI)	184	265	273	219	178	153
Lane & Width Information						
Number of Lanes	2	2	2	2	2	2
Paved Width (ft)	25.3	23.9	23.5	26.1	25.6	25.8

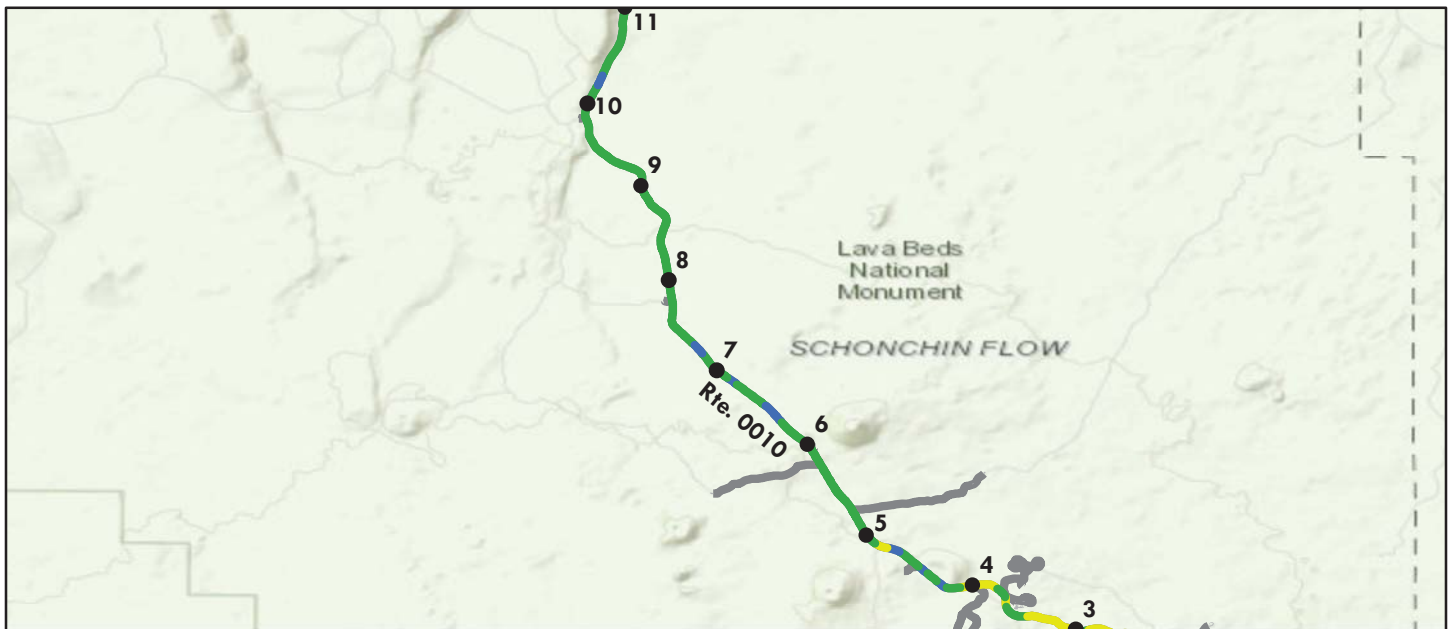
Data Collection Vehicle (DCV) Rating

Route Condition Legend – Pavement Condition Rating (PCR)						
Poor (0 - 60)	Fair (61- 84)	Good (85 - 94)	Excellent (95 - 100)	Not Rated		
See Appendix for definitions and formulas						
Inspection Date: 5/24/2015	Beginning Section MP	5	6	7	8	9
Paved Length (Miles): 20.25	Section Length (MI)	1	1	1	1	1
Surface Type: ASPHALT	Route Summary					
Roadway Condition Information						
Pavement Condition Rating (PCR)	84	92	93	92	88	89
Surface Condition Rating (SCR)	90	95	93	94	94	90
Roughness Condition Index (RCI)	75	87	93	88	80	88
Distress Index Values						
Structural Crack Index	98	99	99	99	98	98
Alligator Crack Index	100	100	100	100	100	100
Longitudinal Crack Index	98	99	99	99	98	98
Transverse Cracking Index	90	95	96	97	95	90
Patching Index	100	100	100	100	100	100
Rutting Index	95	95	93	94	94	97
International Roughness Index (IRI)	184	149	133	147	169	147
Lane & Width Information						
Number of Lanes	2	2	2	2	2	2

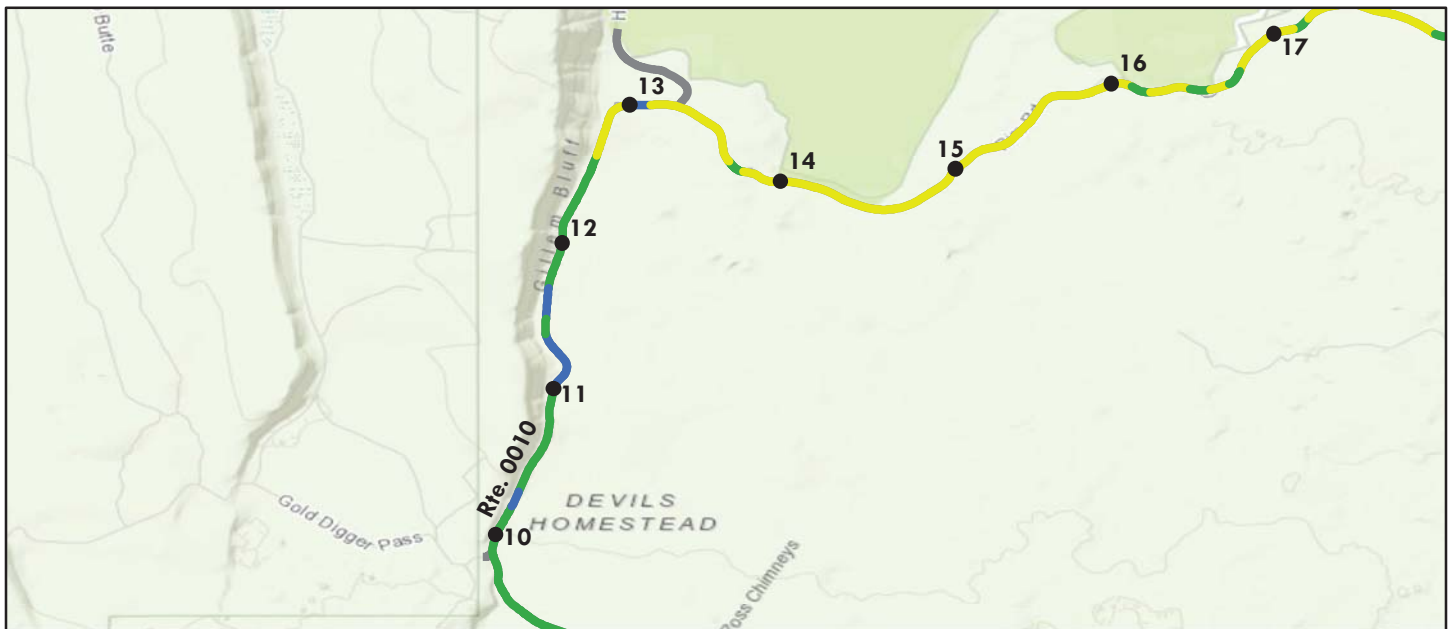
Data Collection Vehicle (DCV) Rating

Route Condition Legend – Pavement Condition Rating (PCR)						
Poor (0 - 60)	Fair (61- 84)	Good (85 - 94)	Excellent (95 - 100)	Not Rated		
See Appendix for definitions and formulas						
Inspection Date: 5/24/2015	Beginning Section MP	10	11	12	13	14
Paved Length (Miles): 20.25	Section Length (MI)	1	1	1	1	1
Surface Type: ASPHALT	Route Summary					
Roadway Condition Information						
Pavement Condition Rating (PCR)	84	92	95	89	81	75
Surface Condition Rating (SCR)	90	92	94	90	86	82
Roughness Condition Index (RCI)	75	92	96	87	74	64
Distress Index Values						
Structural Crack Index	98	99	99	97	99	98
Alligator Crack Index	100	100	100	100	100	100
Longitudinal Crack Index	98	99	99	97	99	98
Transverse Cracking Index	90	92	94	90	86	82
Patching Index	100	100	100	100	100	100
Rutting Index	95	96	96	91	95	94
International Roughness Index (IRI)	184	134	123	147	187	223
Lane & Width Information						
Number of Lanes	2	2	2	2	2	2

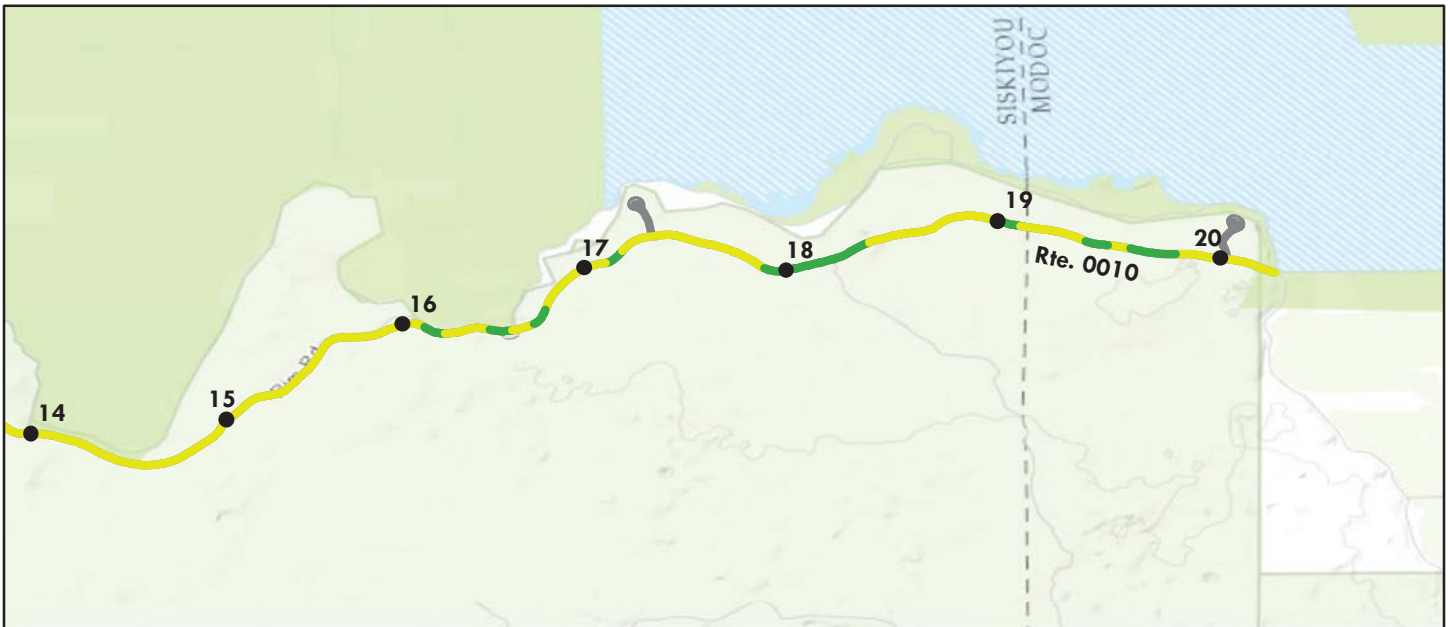
Data Collection Vehicle (DCV) Rating

Route Condition Legend – Pavement Condition Rating (PCR)						
Poor (0 - 60)	Fair (61- 84)	Good (85 - 94)	Excellent (95 - 100)	Not Rated		
See Appendix for definitions and formulas						
Inspection Date: 5/24/2015	Beginning Section MP	15	16	17	18	19
Paved Length (Miles): 20.25	Section Length (MI)	1	1	1	1	1
Surface Type: ASPHALT	Route Summary					
Roadway Condition Information						
Pavement Condition Rating (PCR)	84	76	82	80	82	83
Surface Condition Rating (SCR)	90	84	88	90	92	89
Roughness Condition Index (RCI)	75	65	72	66	67	74
Distress Index Values						
Structural Crack Index	98	99	98	98	98	97
Alligator Crack Index	100	100	100	100	100	100
Longitudinal Crack Index	98	99	98	98	98	97
Transverse Cracking Index	90	84	88	90	92	89
Patching Index	100	100	100	100	100	100
Rutting Index	95	95	95	93	96	96
International Roughness Index (IRI)	184	221	194	214	211	188
Lane & Width Information						
Number of Lanes	2	2	2	2	2	2

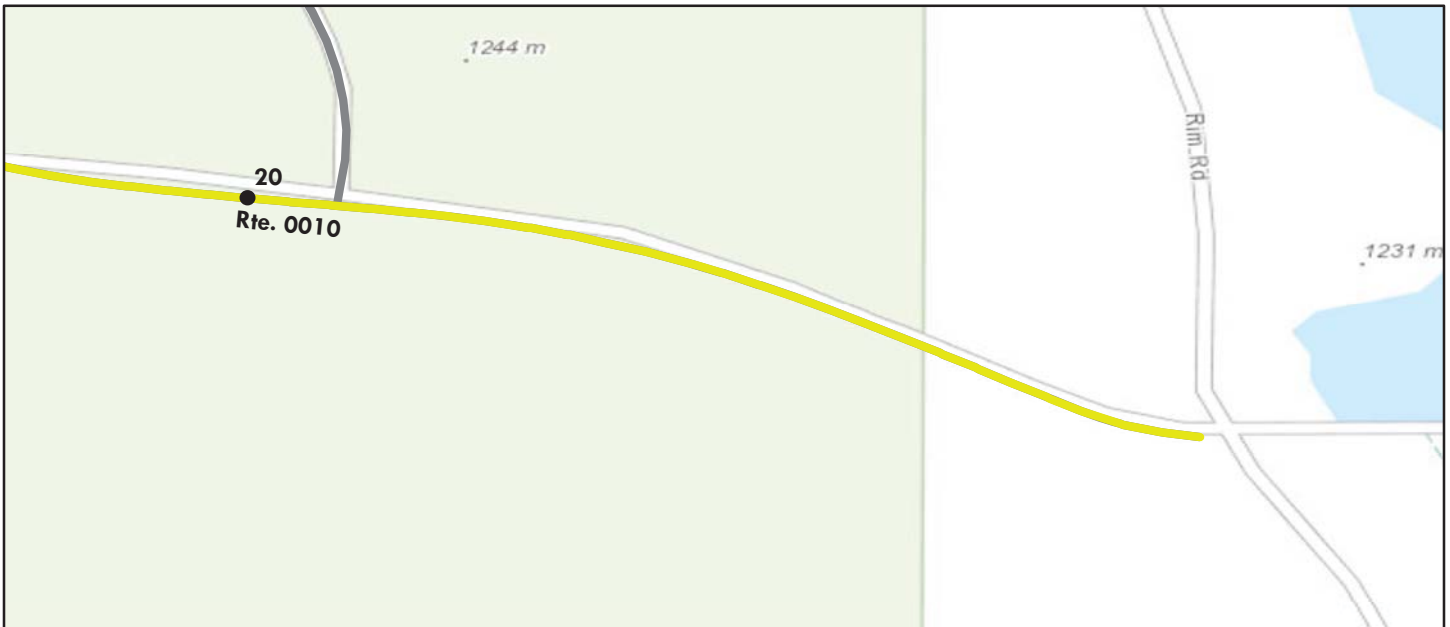
Data Collection Vehicle (DCV) Rating

Route Condition Legend – Pavement Condition Rating (PCR)						
Poor (0 - 60)	Fair (61- 84)	Good (85 - 94)	Excellent (95 - 100)	Not Rated		
See Appendix for definitions and formulas						
Inspection Date: 5/24/2015	Beginning Section MP	20				
Paved Length (Miles): 20.25	Section Length (MI)	0.25				
Surface Type: ASPHALT	Route Summary					
Roadway Condition Information						
Pavement Condition Rating (PCR)	84	77				
Surface Condition Rating (SCR)	90	85				
Roughness Condition Index (RCI)	75	65				
Distress Index Values						
Structural Crack Index	98	97				
Alligator Crack Index	100	100				
Longitudinal Crack Index	98	97				
Transverse Cracking Index	90	85				
Patching Index	100	100				
Rutting Index	95	91				
International Roughness Index (IRI)	184	220				
Lane & Width Information						
Number of Lanes	2	2				
Paved Width (ft)	25.3	26.2				
Lane Width (ft)	12	12.5

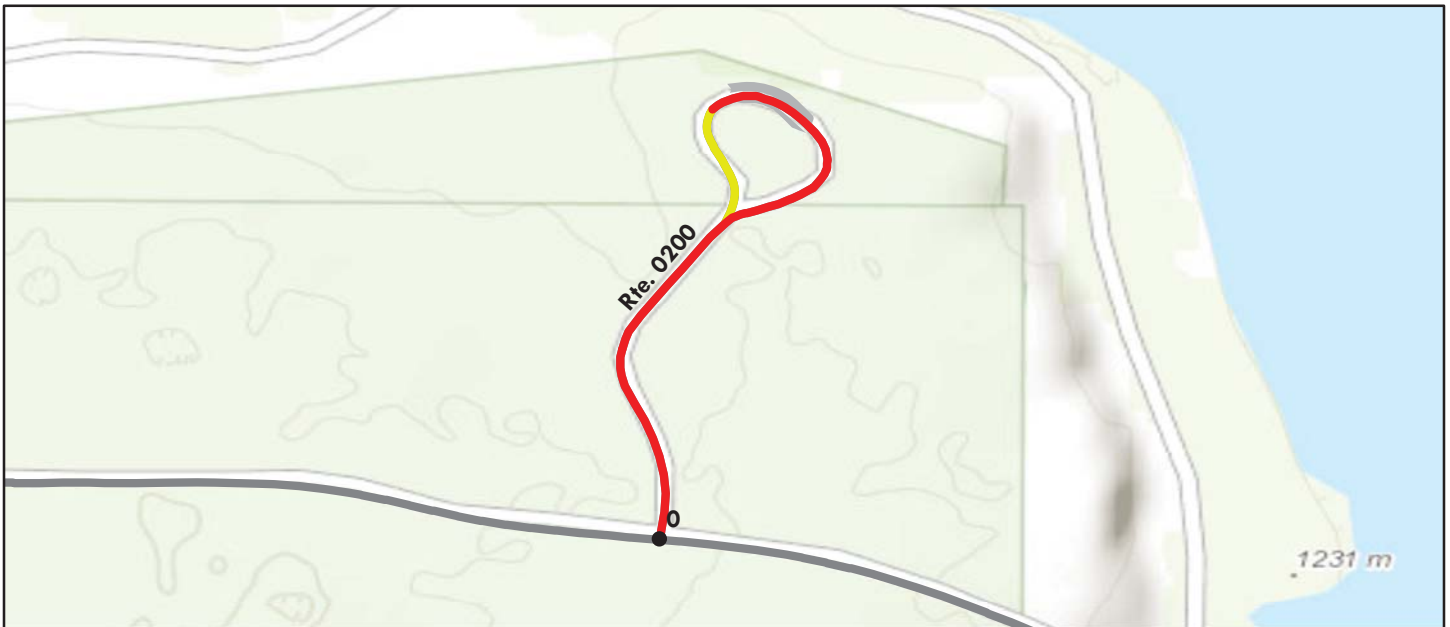
Data Collection Vehicle (DCV) Rating

Route Condition Legend – Pavement Condition Rating (PCR)						
Poor (0 - 60)	Fair (61- 84)	Good (85 - 94)	Excellent (95 - 100)	Not Rated		
See Appendix for definitions and formulas						
Inspection Date: 5/24/2015	Beginning Section MP	0				
Paved Length (Miles): 0.36	Section Length (MI)	0.36				
Surface Type: ASPHALT	Route Summary					
Roadway Condition Information						
Pavement Condition Rating (PCR)	54	54				
Surface Condition Rating (SCR)	54	54				
Roughness Condition Index (RCI)	N/A	N/A				
Distress Index Values						
Structural Crack Index	90	90				
Alligator Crack Index	100	100				
Longitudinal Crack Index	90	90				
Transverse Cracking Index	54	54				
Patching Index	100	100				
Rutting Index	96	96				
International Roughness Index (IRI)	N/A	N/A				
Lane & Width Information						
Number of Lanes	2	2				
Paved Width (ft)	17.4	17.4				
Lane Width (ft)	10.6	10.6

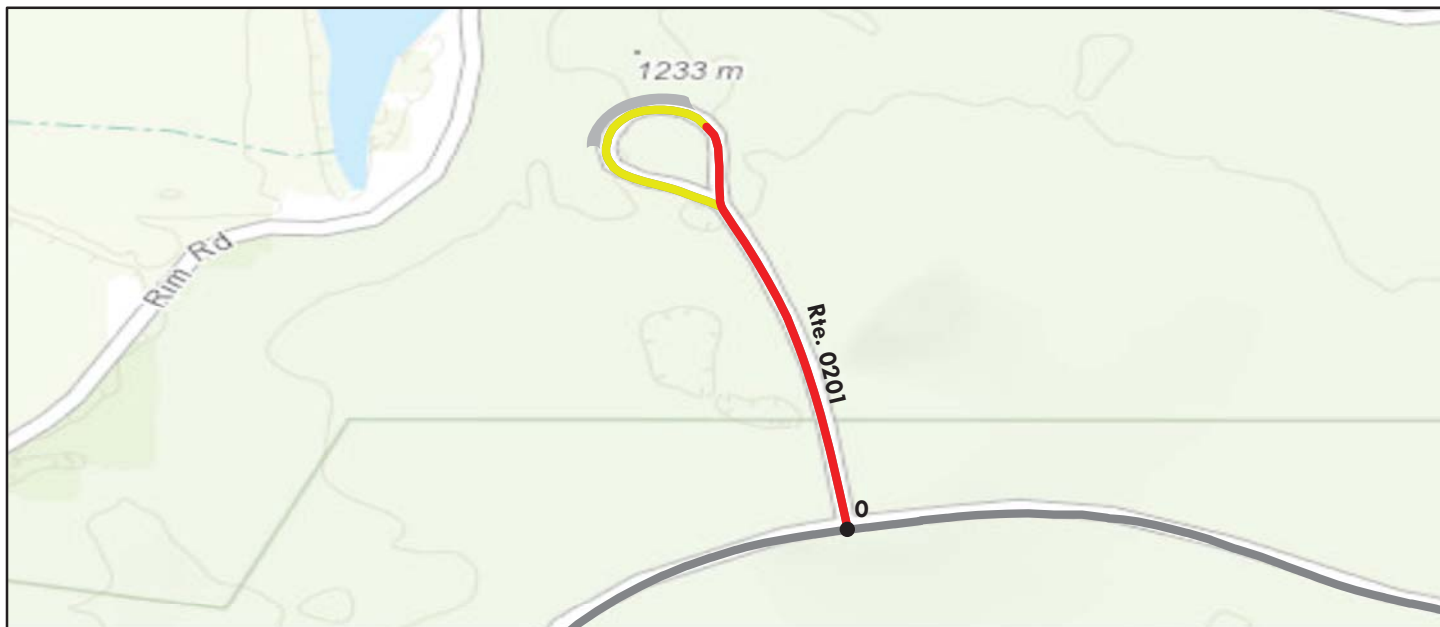
Data Collection Vehicle (DCV) Rating

Route Condition Legend – Pavement Condition Rating (PCR)						
Poor (0 - 60)	Fair (61- 84)	Good (85 - 94)	Excellent (95 - 100)	Not Rated		
See Appendix for definitions and formulas						
Inspection Date: 5/24/2015	Beginning Section MP	0				
Paved Length (Miles): 0.3	Section Length (MI)	0.3				
Surface Type: ASPHALT	Route Summary					
Roadway Condition Information						
Pavement Condition Rating (PCR)	60	60				
Surface Condition Rating (SCR)	60	60				
Roughness Condition Index (RCI)	N/A	N/A				
Distress Index Values						
Structural Crack Index	95	95				
Alligator Crack Index	100	100				
Longitudinal Crack Index	95	95				
Transverse Cracking Index	60	60				
Patching Index	100	100				
Rutting Index	93	93				
International Roughness Index (IRI)	N/A	N/A				
Lane & Width Information						
Number of Lanes	2	2				
Paved Width (ft)	15.7	15.7				
Lane Width (ft)	10.4	10.4

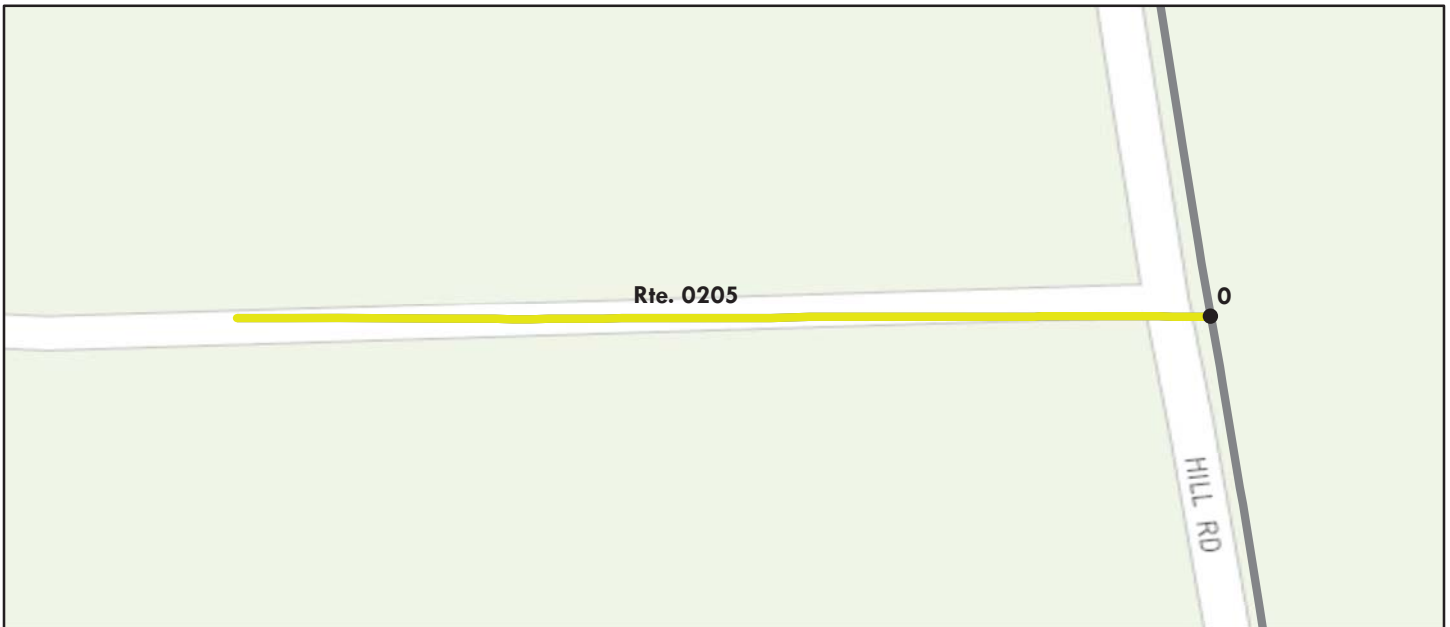
Data Collection Vehicle (DCV) Rating

Route Condition Legend – Pavement Condition Rating (PCR)						
Poor (0 - 60)	Fair (61- 84)	Good (85 - 94)	Excellent (95 - 100)	Not Rated		
See Appendix for definitions and formulas						
Inspection Date: 5/24/2015	Beginning Section MP	0				
Paved Length (Miles): 0.06	Section Length (MI)	0.06				
Surface Type: ASPHALT	Route Summary					
Roadway Condition Information						
Pavement Condition Rating (PCR)	80	80				
Surface Condition Rating (SCR)	80	80				
Roughness Condition Index (RCI)	N/A	N/A				
Distress Index Values						
Structural Crack Index	99	99				
Alligator Crack Index	100	100				
Longitudinal Crack Index	99	99				
Transverse Cracking Index	80	80				
Patching Index	100	100				
Rutting Index	96	96				
International Roughness Index (IRI)	N/A	N/A				
Lane & Width Information						
Number of Lanes	2	2				
Paved Width (ft)	21	21				
Lane Width (ft)	10.5	10.5

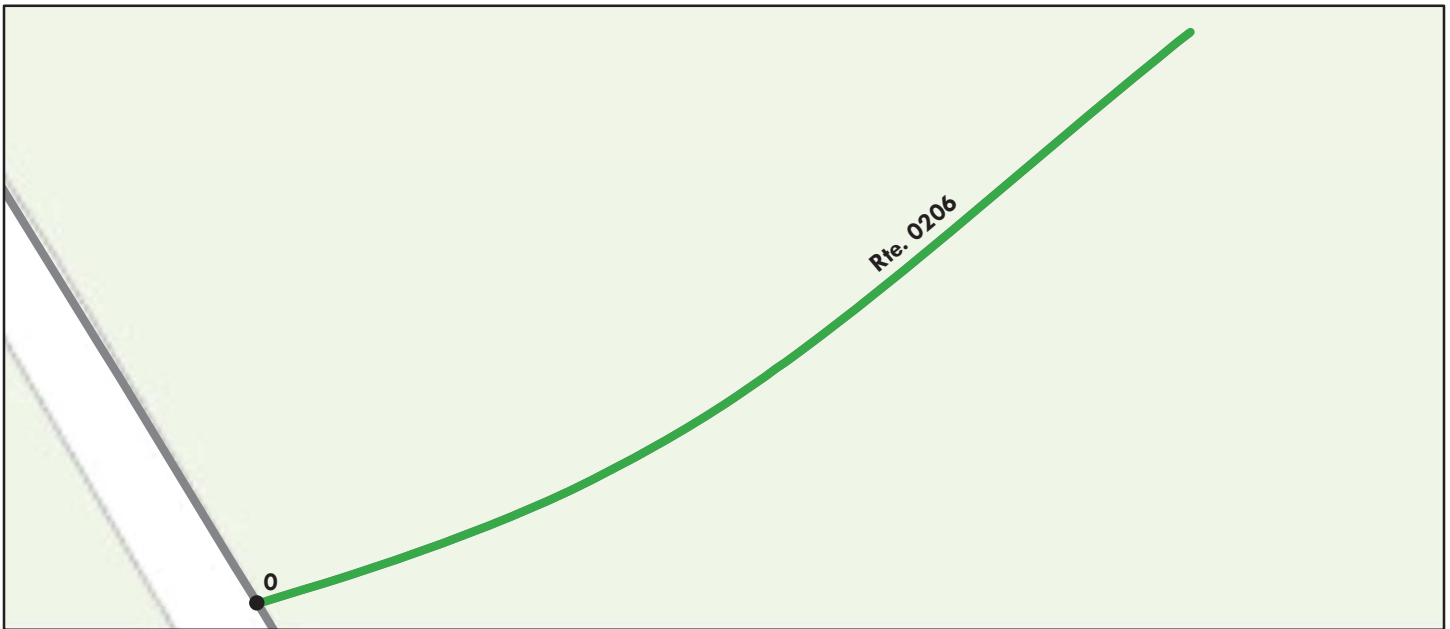
Data Collection Vehicle (DCV) Rating

Route Condition Legend – Pavement Condition Rating (PCR)						
Poor (0 - 60)	Fair (61- 84)	Good (85 - 94)	Excellent (95 - 100)	Not Rated		
See Appendix for definitions and formulas						
Inspection Date: 5/24/2015	Beginning Section MP	0				
Paved Length (Miles): 0.04	Section Length (MI)	0.04				
Surface Type: ASPHALT	Route Summary					
Roadway Condition Information						
Pavement Condition Rating (PCR)	87	87				
Surface Condition Rating (SCR)	87	87				
Roughness Condition Index (RCI)	N/A	N/A				
Distress Index Values						
Structural Crack Index	100	100				
Alligator Crack Index	100	100				
Longitudinal Crack Index	100	100				
Transverse Cracking Index	87	87				
Patching Index	100	100				
Rutting Index	92	92				
International Roughness Index (IRI)	N/A	N/A				
Lane & Width Information						
Number of Lanes	2	2				
Paved Width (ft)	19.1	19.1				
Lane Width (ft)	9.5	9.5

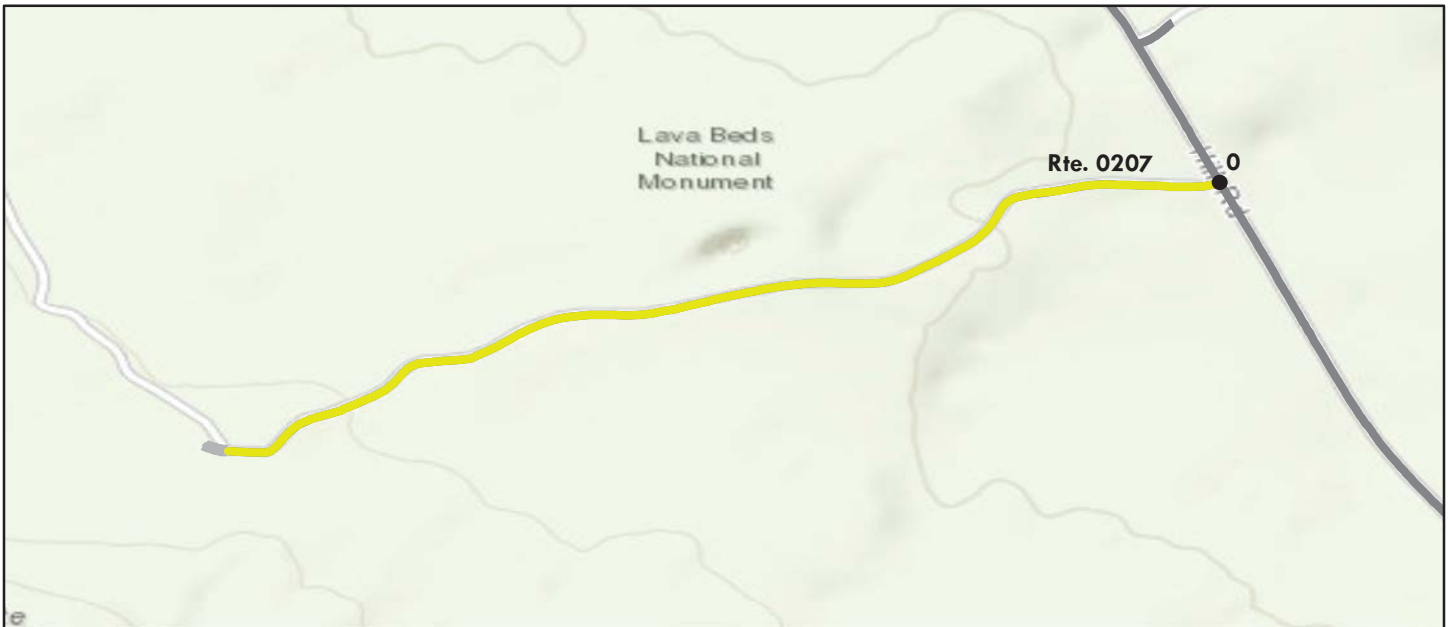
Data Collection Vehicle (DCV) Rating

Route Condition Legend – Pavement Condition Rating (PCR)						
Poor (0 - 60)	Fair (61- 84)	Good (85 - 94)	Excellent (95 - 100)	Not Rated		
See Appendix for definitions and formulas						
Inspection Date: 5/24/2015	Beginning Section MP	0				
Paved Length (Miles): 0.89	Section Length (MI)	0.89				
Surface Type: ASPHALT	Route Summary					
Roadway Condition Information						
Pavement Condition Rating (PCR)	78	78				
Surface Condition Rating (SCR)	92	92				
Roughness Condition Index (RCI)	58	58				
Distress Index Values						
Structural Crack Index	99	99				
Alligator Crack Index	100	100				
Longitudinal Crack Index	99	99				
Transverse Cracking Index	92	92				
Patching Index	100	100				
Rutting Index	98	98				
International Roughness Index (IRI)	249	249				
Lane & Width Information						
Number of Lanes	2	2				
Paved Width (ft)	20.9	20.9				
Lane Width (ft)	9.9	9.9

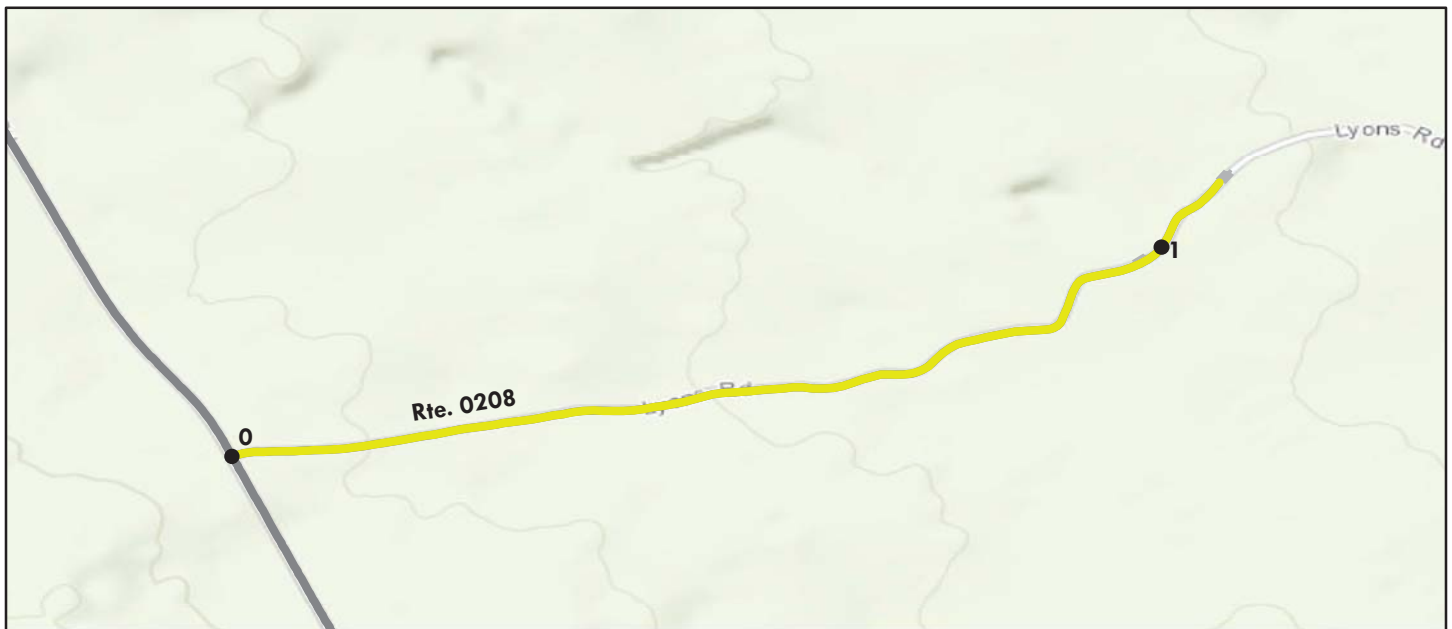
Data Collection Vehicle (DCV) Rating

Route Condition Legend – Pavement Condition Rating (PCR)						
Poor (0 - 60)	Fair (61- 84)	Good (85 - 94)	Excellent (95 - 100)	Not Rated		
See Appendix for definitions and formulas						
Inspection Date: 5/24/2015	Beginning Section MP	0	1			
Paved Length (Miles): 1.1	Section Length (MI)	1	0.1			
Surface Type: ASPHALT	Route Summary					
Roadway Condition Information						
Pavement Condition Rating (PCR)	77	77	79			
Surface Condition Rating (SCR)	91	91	89			
Roughness Condition Index (RCI)	57	57	64			
Distress Index Values						
Structural Crack Index	100	100	100			
Alligator Crack Index	100	100	100			
Longitudinal Crack Index	100	100	100			
Transverse Cracking Index	91	91	89			
Patching Index	100	100	100			
Rutting Index	99	99	99			
International Roughness Index (IRI)	250	252	224			
Lane & Width Information						
Number of Lanes	2	2	2			
Paved Width (ft)	22.4	22.4	22.4			
Lane Width (ft)	10.3	10.3	9.6

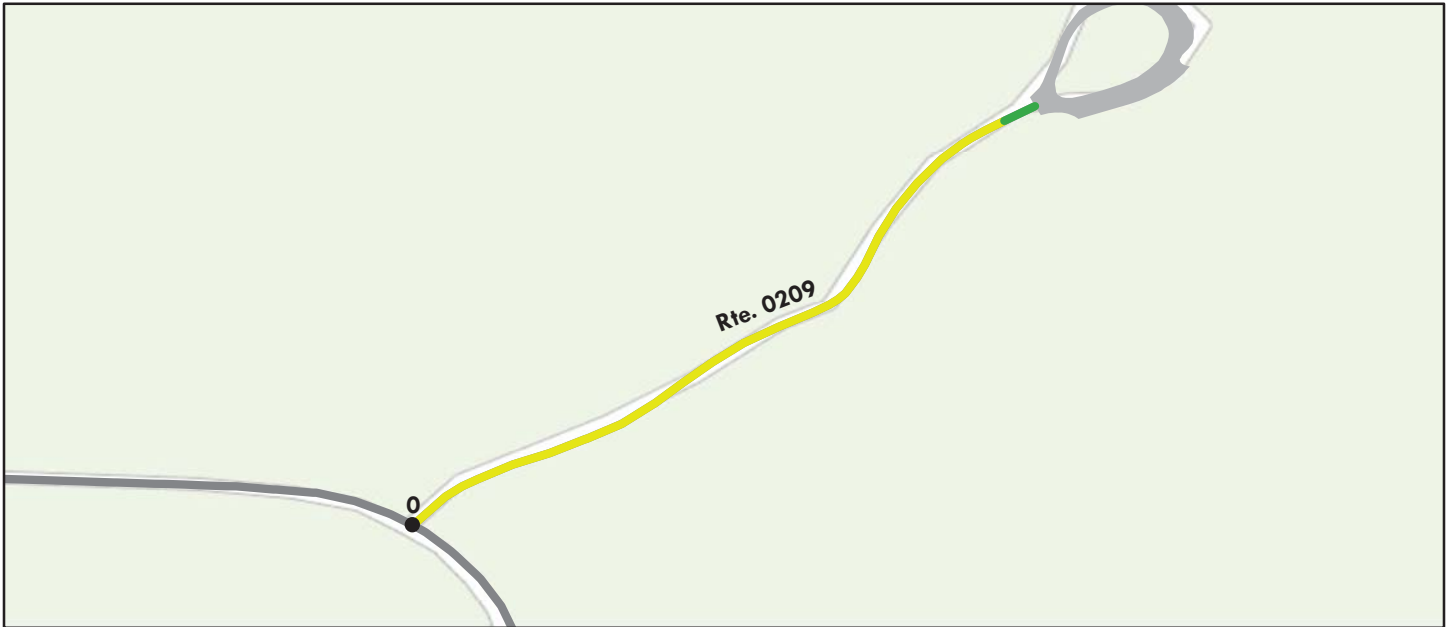
Data Collection Vehicle (DCV) Rating

Route Condition Legend – Pavement Condition Rating (PCR)						
Poor (0 - 60)	Fair (61- 84)	Good (85 - 94)	Excellent (95 - 100)	Not Rated		
See Appendix for definitions and formulas						
Inspection Date: 5/24/2015	Beginning Section MP	0				
Paved Length (Miles): 0.21	Section Length (MI)	0.21				
Surface Type: ASPHALT	Route Summary					
Roadway Condition Information						
Pavement Condition Rating (PCR)	82	82				
Surface Condition Rating (SCR)	82	82				
Roughness Condition Index (RCI)	N/A	N/A				
Distress Index Values						
Structural Crack Index	100	100				
Alligator Crack Index	100	100				
Longitudinal Crack Index	100	100				
Transverse Cracking Index	82	82				
Patching Index	100	100				
Rutting Index	99	99				
International Roughness Index (IRI)	N/A	N/A				
Lane & Width Information						
Number of Lanes	2	2				
Paved Width (ft)	25.4	25.4				
Lane Width (ft)	11.8	11.8

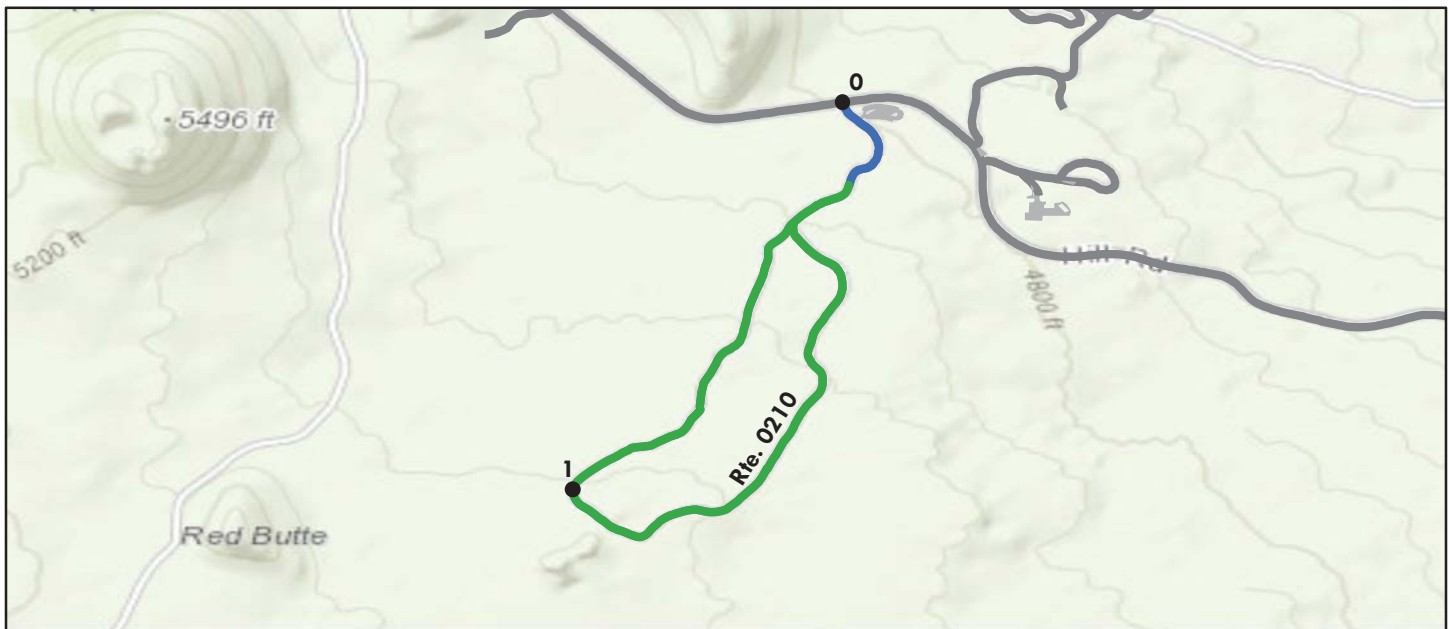
Data Collection Vehicle (DCV) Rating

Route Condition Legend – Pavement Condition Rating (PCR)						
Poor (0 - 60)	Fair (61- 84)	Good (85 - 94)	Excellent (95 - 100)	Not Rated		
See Appendix for definitions and formulas						
Inspection Date: 5/24/2015	Beginning Section MP	0	1			
Paved Length (Miles): 1.96	Section Length (MI)	1	0.96			
Surface Type: ASPHALT	Route Summary					
Roadway Condition Information						
Pavement Condition Rating (PCR)	91	91	91			
Surface Condition Rating (SCR)	91	91	91			
Roughness Condition Index (RCI)	N/A	N/A	N/A			
Distress Index Values						
Structural Crack Index	99	99	99			
Alligator Crack Index	100	100	100			
Longitudinal Crack Index	99	99	99			
Transverse Cracking Index	91	91	91			
Patching Index	100	100	100			
Rutting Index	97	97	96			
International Roughness Index (IRI)	N/A	N/A	N/A			
Lane & Width Information						
Number of Lanes	1	1	1			
Paved Width (ft)	14	15.6	12.4			
Lane Width (ft)	12	11.6	12.4

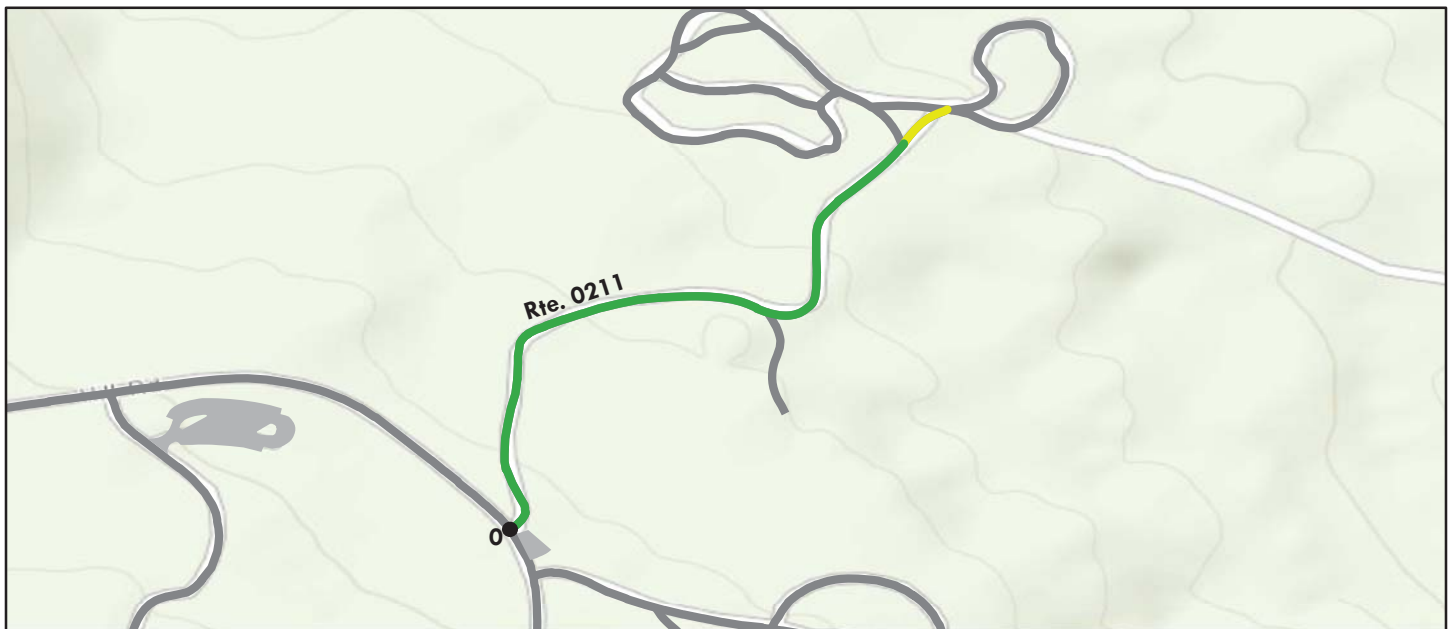
Data Collection Vehicle (DCV) Rating

Route Condition Legend – Pavement Condition Rating (PCR)						
Poor (0 - 60)	Fair (61- 84)	Good (85 - 94)	Excellent (95 - 100)	Not Rated		
See Appendix for definitions and formulas						
Inspection Date: 5/24/2015	Beginning Section MP	0				
Paved Length (Miles): 0.43	Section Length (MI)	0.43				
Surface Type: ASPHALT	Route Summary					
Roadway Condition Information						
Pavement Condition Rating (PCR)	90	90				
Surface Condition Rating (SCR)	90	90				
Roughness Condition Index (RCI)	N/A	N/A				
Distress Index Values						
Structural Crack Index	98	98				
Alligator Crack Index	100	100				
Longitudinal Crack Index	98	98				
Transverse Cracking Index	90	90				
Patching Index	100	100				
Rutting Index	98	98				
International Roughness Index (IRI)	N/A	N/A				
Lane & Width Information						
Number of Lanes	2	2				
Paved Width (ft)	20.2	20.2				
Lane Width (ft)	9.8	9.8

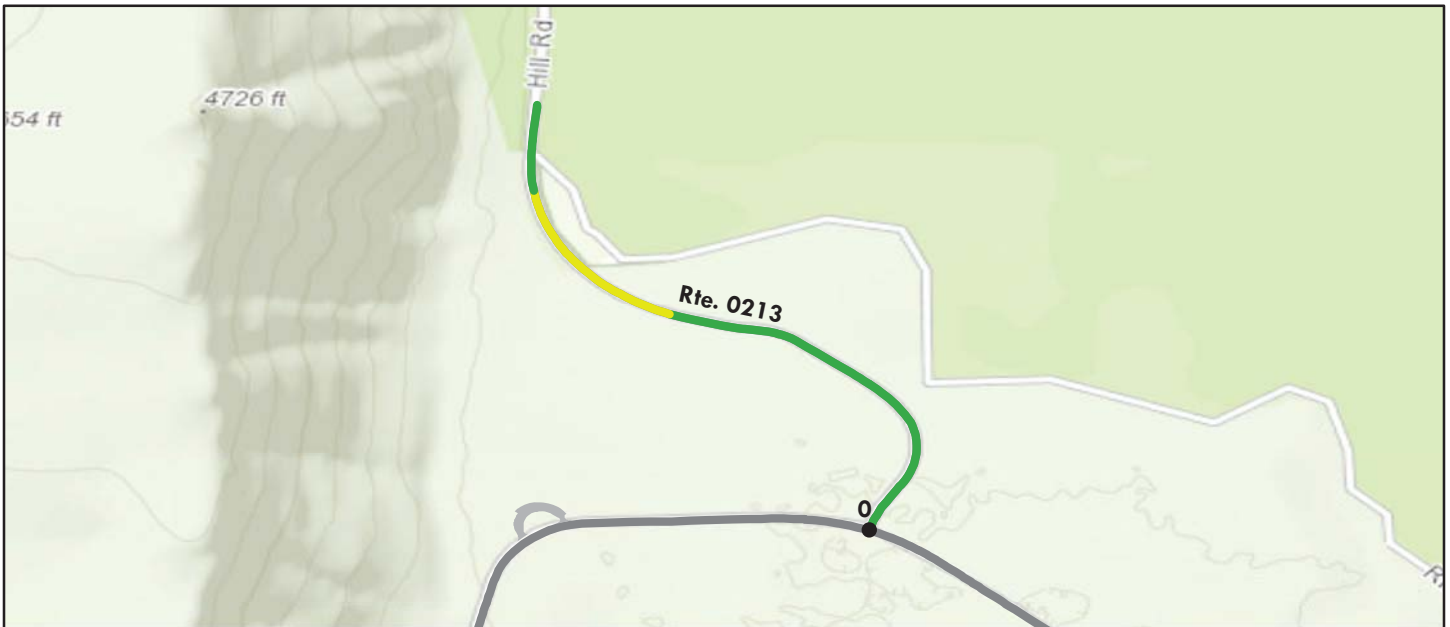
Data Collection Vehicle (DCV) Rating

Route Condition Legend – Pavement Condition Rating (PCR)						
Poor (0 - 60)	Fair (61- 84)	Good (85 - 94)	Excellent (95 - 100)	Not Rated		
See Appendix for definitions and formulas						
Inspection Date: 5/24/2015	Beginning Section MP	0				
Paved Length (Miles): 0.7	Section Length (MI)	0.7				
Surface Type: ASPHALT	Route Summary					
Roadway Condition Information						
Pavement Condition Rating (PCR)	85	85				
Surface Condition Rating (SCR)	87	87				
Roughness Condition Index (RCI)	81	81				
Distress Index Values						
Structural Crack Index	98	98				
Alligator Crack Index	100	100				
Longitudinal Crack Index	98	98				
Transverse Cracking Index	87	87				
Patching Index	100	100				
Rutting Index	97	97				
International Roughness Index (IRI)	165	165				
Lane & Width Information						
Number of Lanes	2	2				
Paved Width (ft)	17.4	17.4				
Lane Width (ft)	8.2	8.2

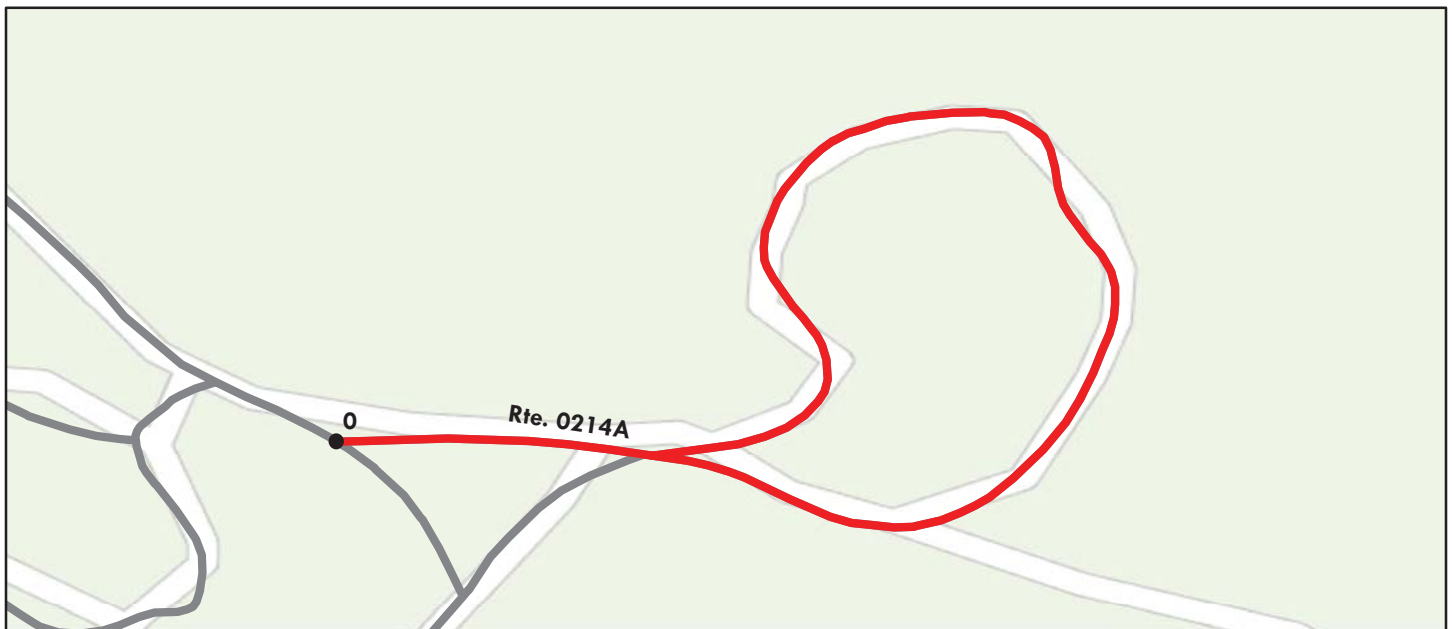
Data Collection Vehicle (DCV) Rating

Route Condition Legend – Pavement Condition Rating (PCR)						
Poor (0 - 60)	Fair (61- 84)	Good (85 - 94)	Excellent (95 - 100)	Not Rated		
See Appendix for definitions and formulas						
Inspection Date: 5/24/2015	Beginning Section MP	0				
Paved Length (Miles): 0.23	Section Length (MI)	0.23				
Surface Type: ASPHALT	Route Summary					
Roadway Condition Information						
Pavement Condition Rating (PCR)	44	44				
Surface Condition Rating (SCR)	44	44				
Roughness Condition Index (RCI)	N/A	N/A				
Distress Index Values						
Structural Crack Index	72	72				
Alligator Crack Index	100	100				
Longitudinal Crack Index	72	72				
Transverse Cracking Index	44	44				
Patching Index	100	100				
Rutting Index	94	94				
International Roughness Index (IRI)	N/A	N/A				
Lane & Width Information						
Number of Lanes	1	1				
Paved Width (ft)	16.9	16.9				
Lane Width (ft)	14.3	14.3
