# LAMR Cycle 6

## Final Report

### Road Inventory and Condition Assessment of Paved Routes Lake Meredith National Recreation Area

Report Date: April 2018

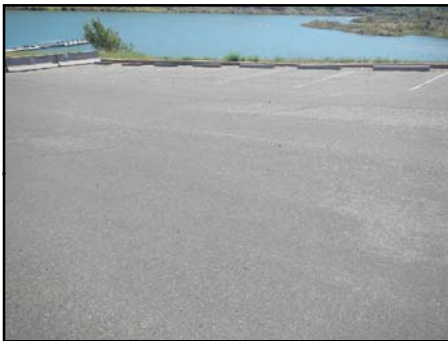
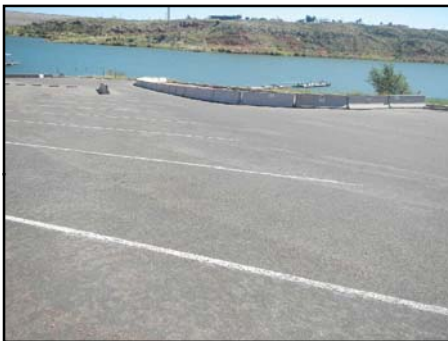
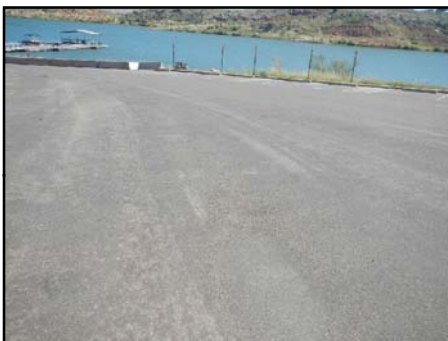
Note: The closed off area was not factored into the pavement condition rating, however, this area requires further action to address the erosion and undercutting.
