LAVO Cycle 6

Final Report

Road Inventory and Condition Assessment of Paved Routes Lassen Volcanic National Park

Report Date: March 2016

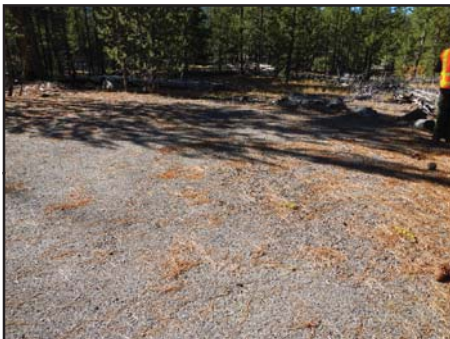
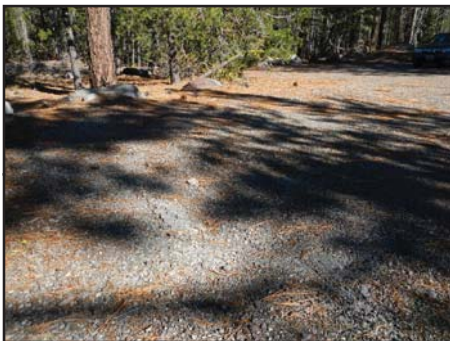
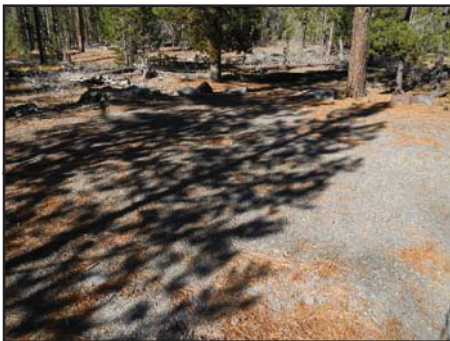
The parking surface was covered with gravel, therefore, the pavement condition could not be assessed.

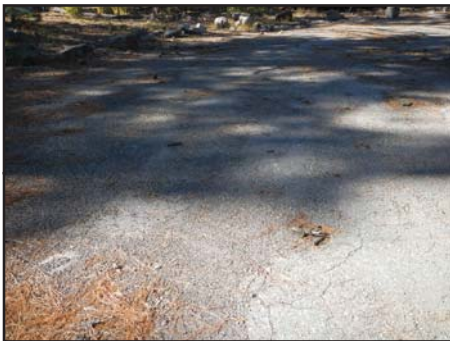
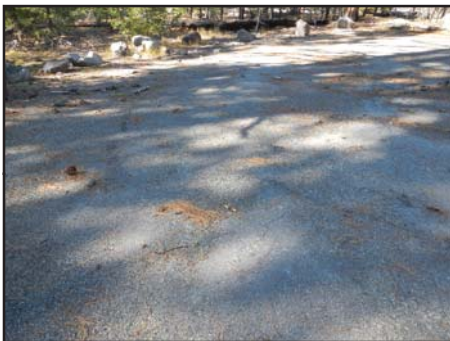
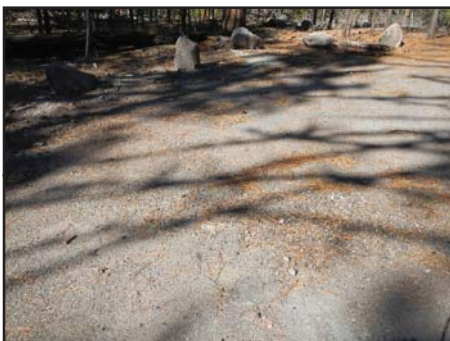
The parking surface was covered with gravel and debris, therefore, the pavement condition could not be assessed.
