LIHO Cycle 6

Final Report

Road Inventory and Condition Assessment of Paved Routes Lincoln Home National Historic Site

Report Date: September 2018

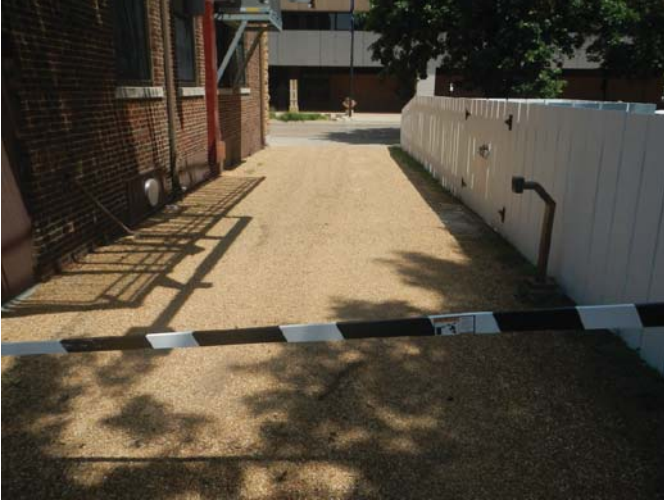
LIHO_0400_3907.JPG

Note: Pavement condition was unable to be assessed due to gravel covering the paved surface.

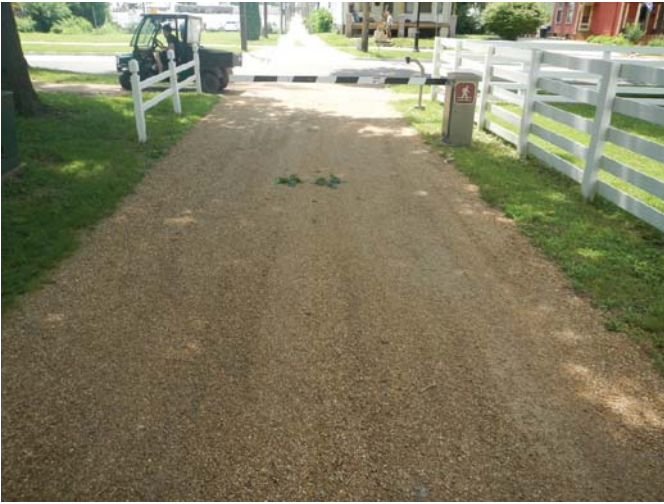
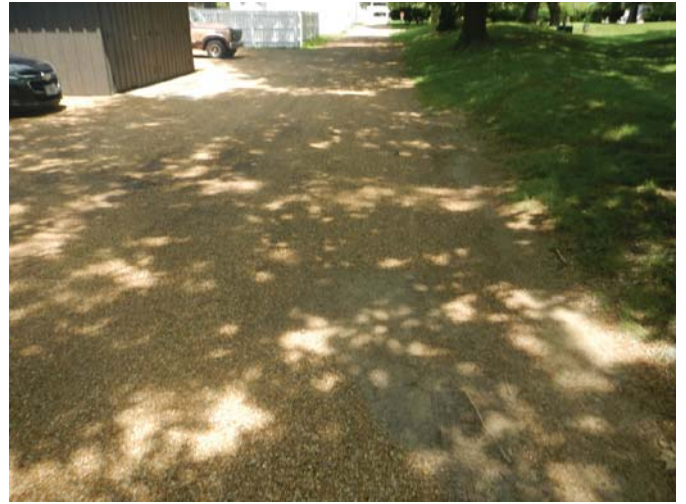
Note: Pavement condition was unable to be assessed due to gravel covering the paved surface.

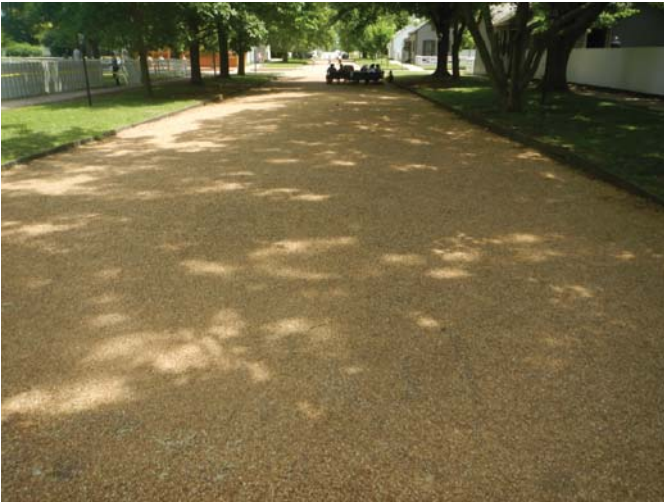
LIHO_0403BZ_3940.JPG

Note: Pavement condition was unable to be assessed due to gravel covering the paved surface.

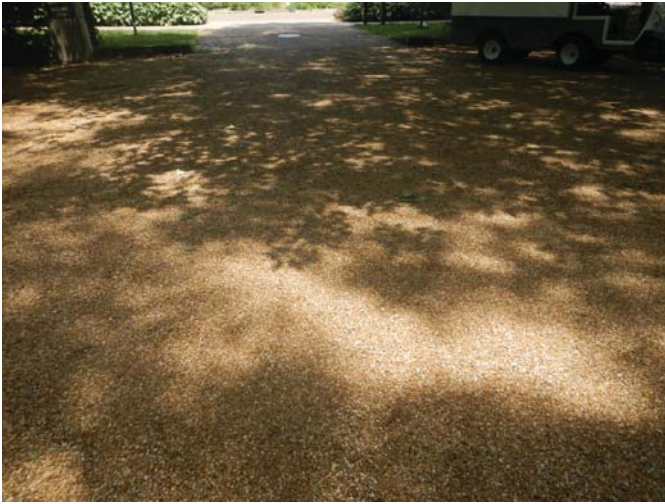
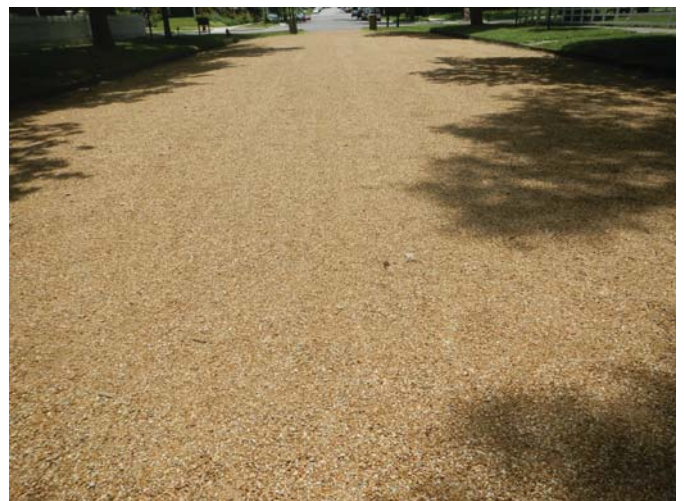
Note: Pavement condition was unable to be assessed due to gravel covering the paved surface.

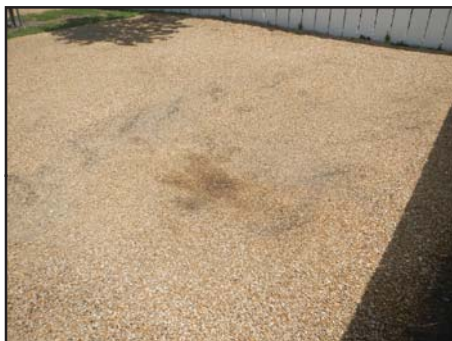
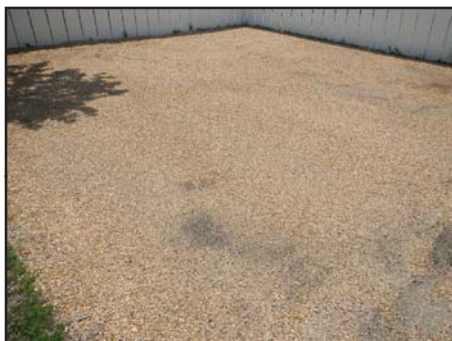
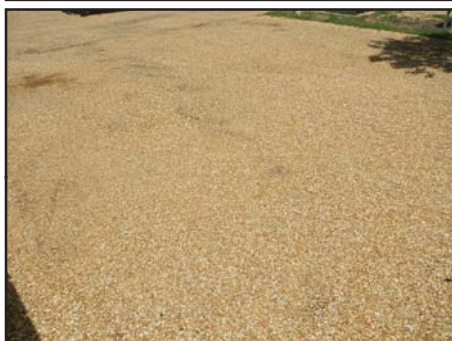
Note: Pavement condition not rated due to gravel covering the paved surface.

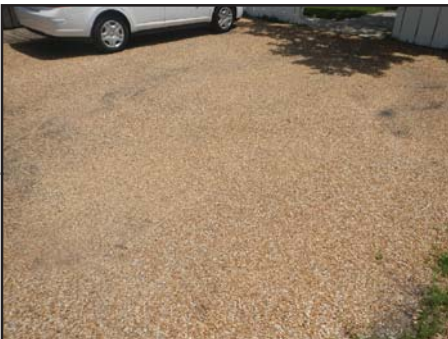
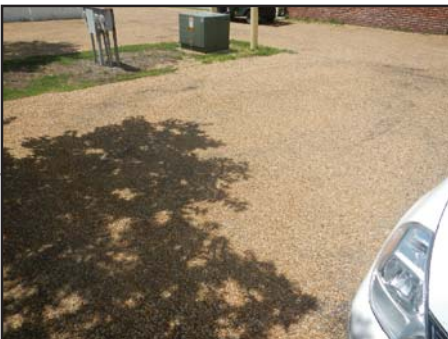
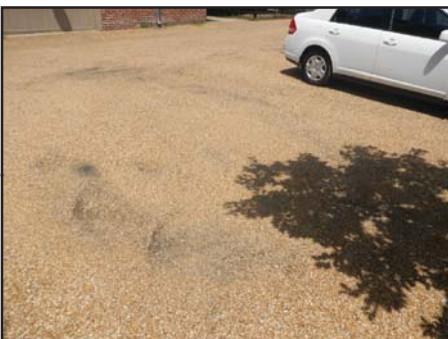
Note: Pavement condition not rated due to gravel covering the paved surface.

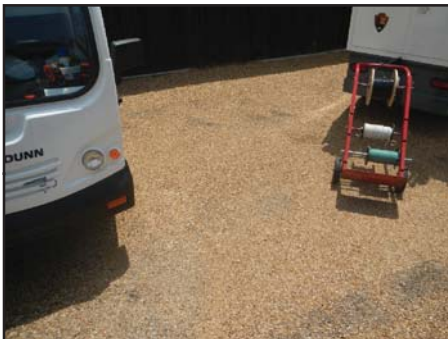
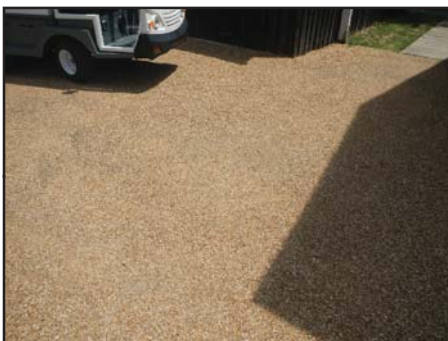
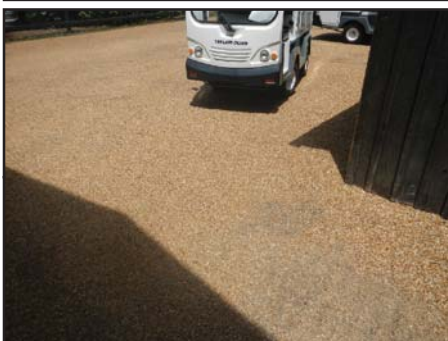
Note: Pavement condition not rated due to gravel covering the paved surface.

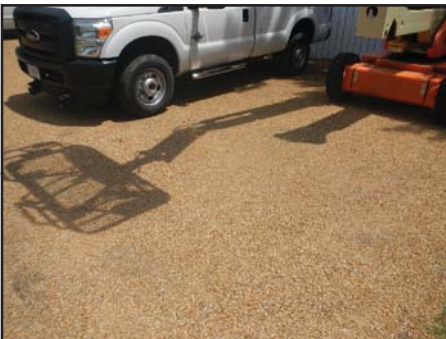
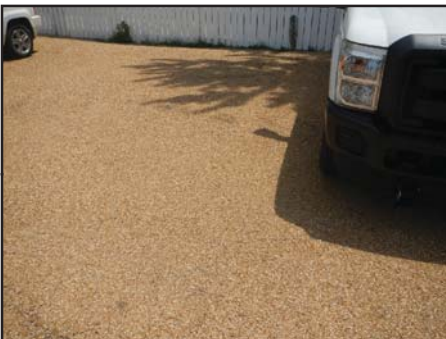
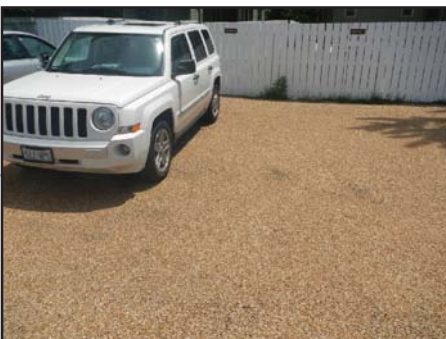
Note: Pavement condition not rated due to gravel covering the paved surface.

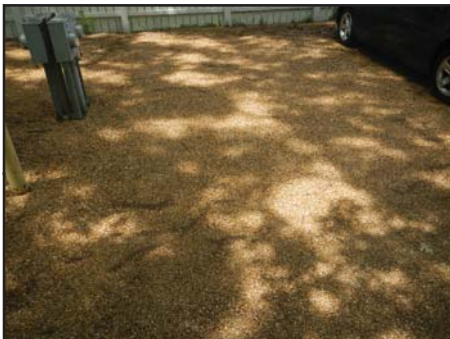
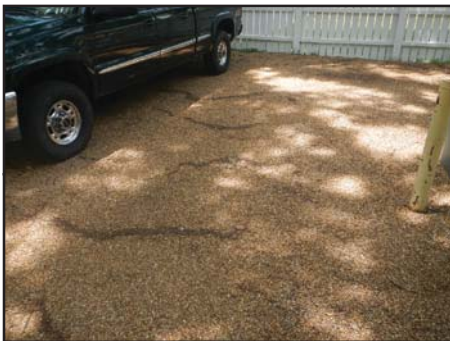
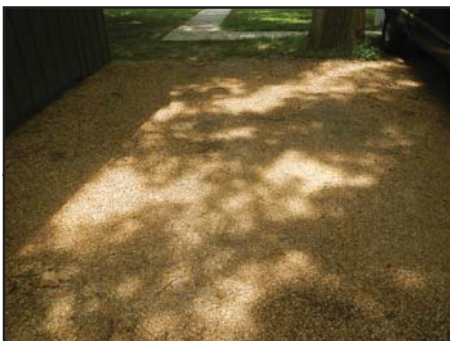
Note: Pavement condition not rated due to gravel covering the paved surface.

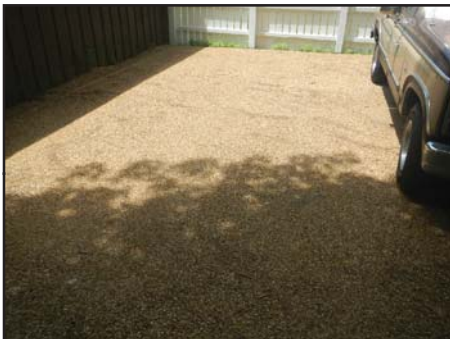
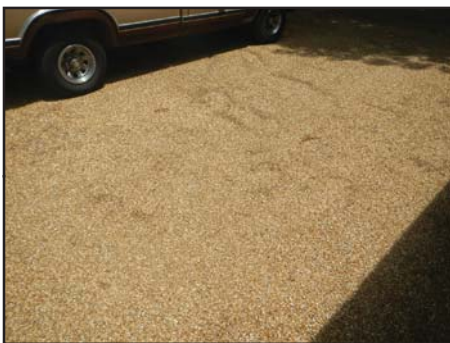
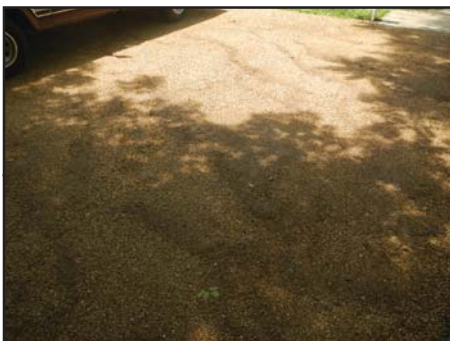
Note: Pavement condition not rated due to gravel covering the paved surface.

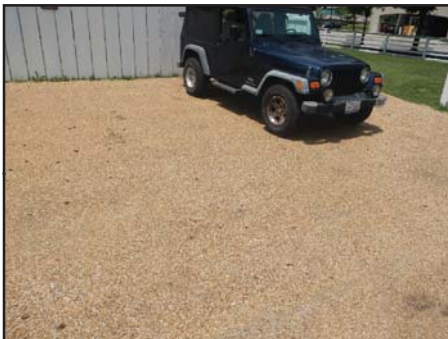
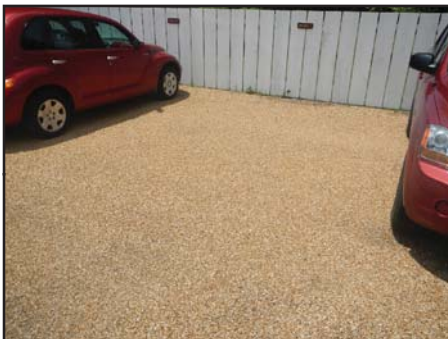
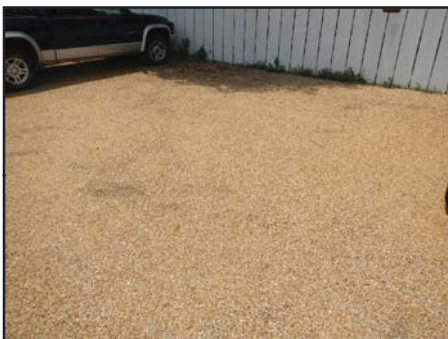
Note: Pavement condition not rated due to gravel covering the paved surface.

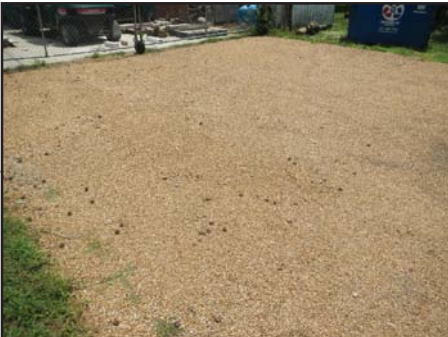
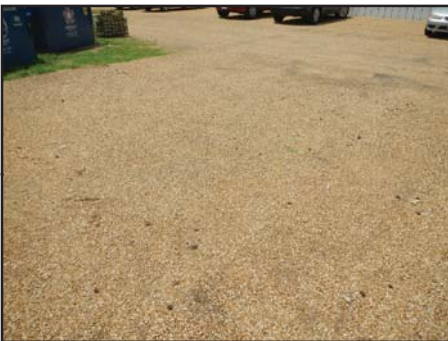
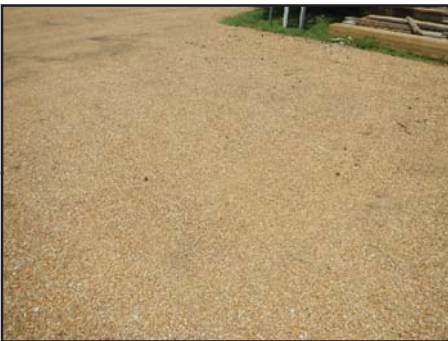
Note: Pavement condition not rated due to gravel covering the paved surface.
