# LYJO Cycle 6

## Final Report

### Road Inventory and Condition Assessment of Paved Routes Lyndon B. Johnson National Historical Park

**Report Date: July 2017**

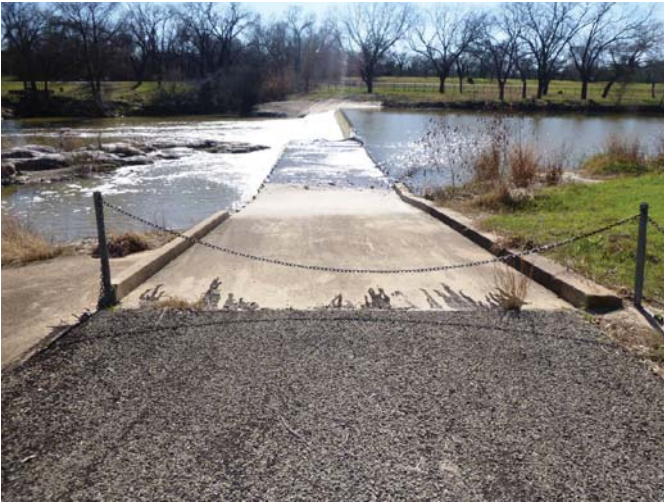
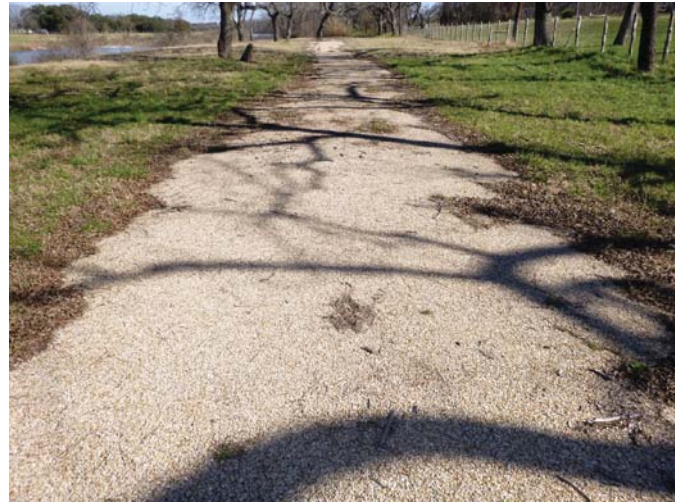
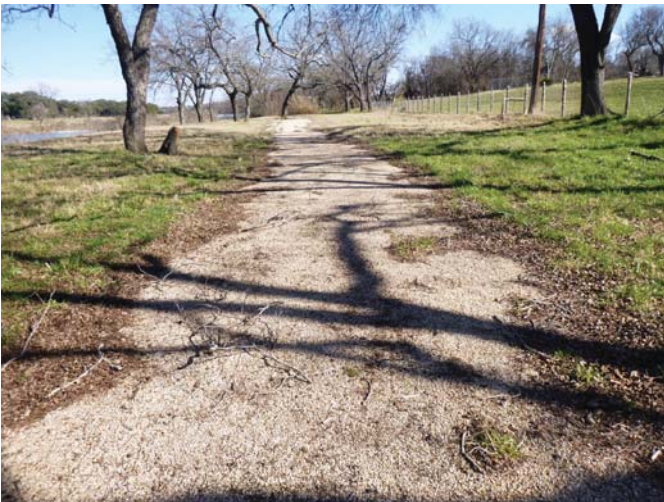
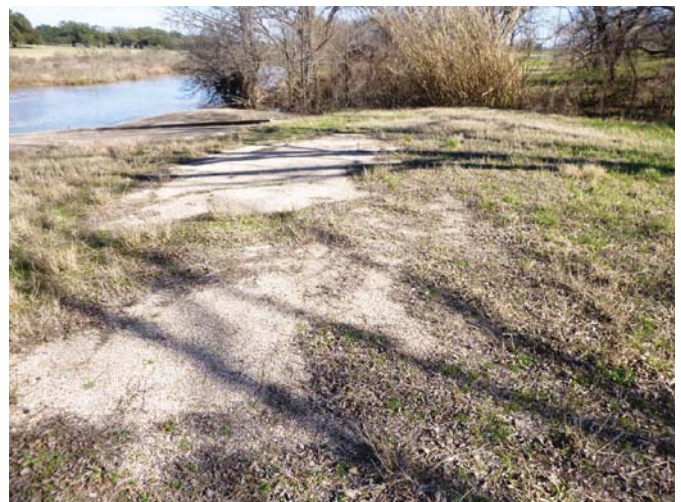
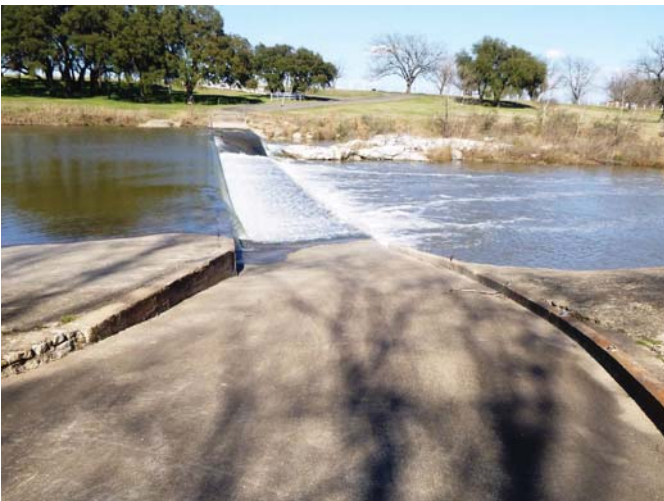
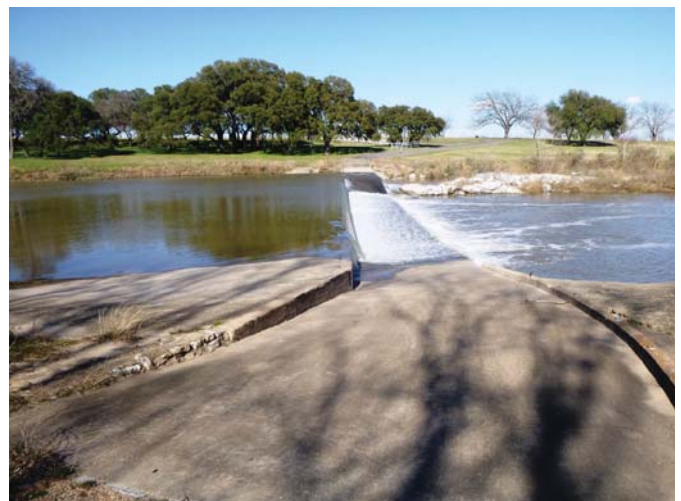
Parking area was given a POOR Pavement Condition Rating (PCR = 0) because it is in very poor condition and appears to be unpaved.
