NACE Cycle 6

Final Report

Road Inventory and Condition Assessment of Paved Routes National Capital Parks - East

Report Date: October 2019

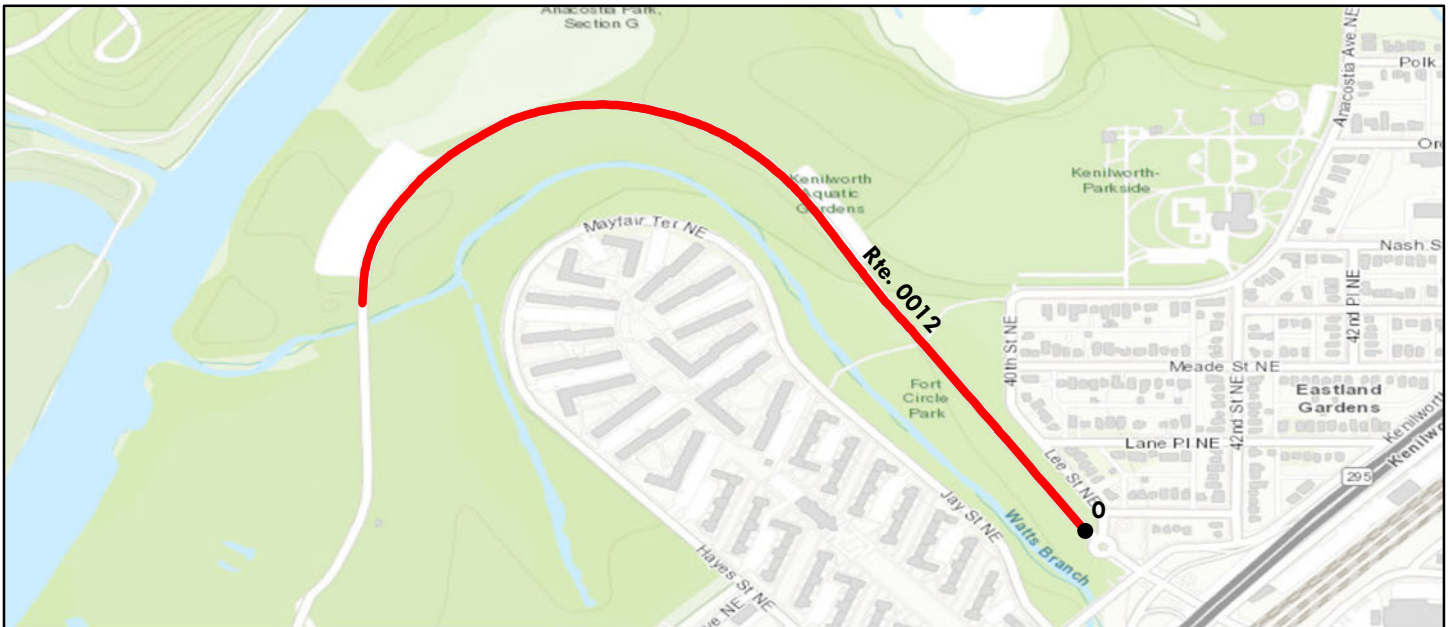
Inspection Date: 6/8/2018	Beginning Section MP	0				
Paved Length (Miles): 0.78	Section Length (MI)	0.78				
Surface Type: ASPHALT	Route Summary					
Roadway Condition Information						
Pavement Condition Rating (PCR)	0	0				
Surface Condition Rating (SCR)	0	0				
Roughness Condition Index (RCI)	N/A	N/A				
Distress Index Values						
Structural Crack Index	36	36				
Alligator Crack Index	99	99				
Longitudinal Crack Index	37	37				
Transverse Cracking Index	0	0				
Patching Index	95	95				
Rutting Index	92	92				
International Roughness Index (IRI)	N/A	N/A				
Lane & Width Information						
Number of Lanes	2	2				
Paved Width (ft)	21	21.1				
Lane Width (ft)	10.3	10.3

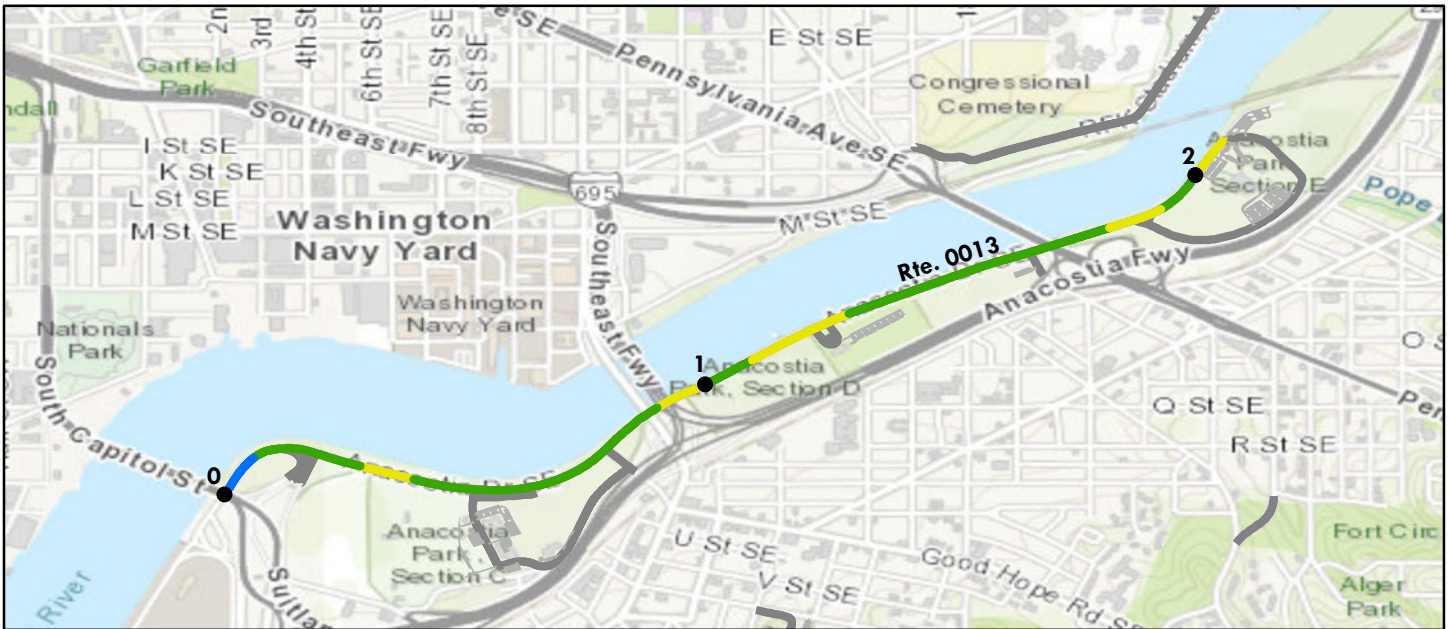
Inspection Date: 6/7/2018	Beginning Section MP	0	1	2		
Paved Length (Miles): 2.05	Section Length (MI)	1	1	0.05		
Surface Type: ASPHALT	Route Summary					
Roadway Condition Information						
Pavement Condition Rating (PCR)	87	87	87	79		
Surface Condition Rating (SCR)	99	99	99	99		
Roughness Condition Index (RCI)	69	70	69	50		
Distress Index Values						
Structural Crack Index	99	99	100	99		
Alligator Crack Index	100	100	100	100		
Longitudinal Crack Index	99	99	100	99		
Transverse Cracking Index	99	99	100	100		
Patching Index	100	100	100	100		
Rutting Index	99	99	99	99		
International Roughness Index (IRI)	205	201	205	282		
Lane & Width Information						
Number of Lanes	2	2	2	2		
Paved Width (ft)	20.2	20.7	19.9	19.6		
Lane Width (ft)	10.4	10.9	9.9	10
