ORPI Cycle 6

Final Report

Road Inventory and Condition Assessment of Paved Routes Organ Pipe Cactus National Monument

Report Date: July 2017

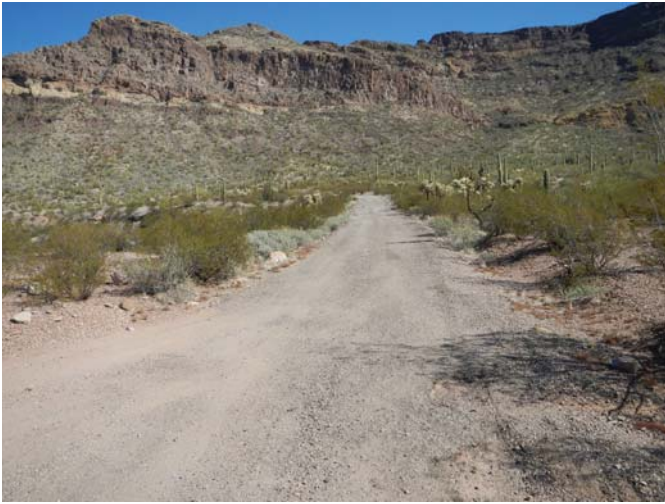
ORPI_0011_MP 5.76-5.86_3151.JPG

Condition Photos Section 10 (5.76 MP To 5.86 MP)

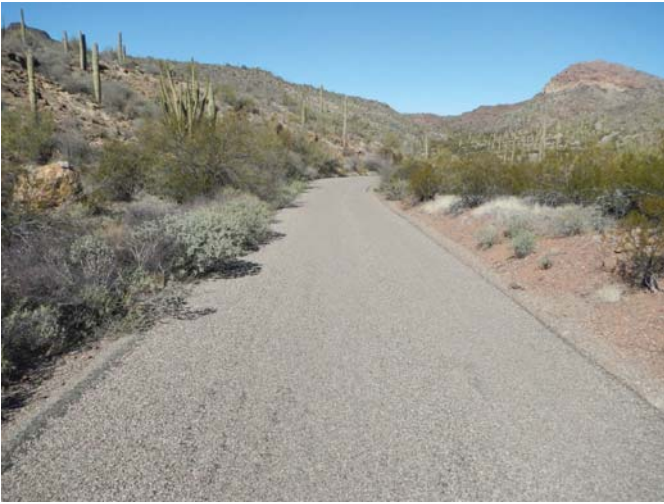
ORPI_0011_MP 5.86-6.36_3157.JPG

Section 11 (5.86 MP To 6.36 MP) and Section 12 (6.36 MP To 6.44 MP)

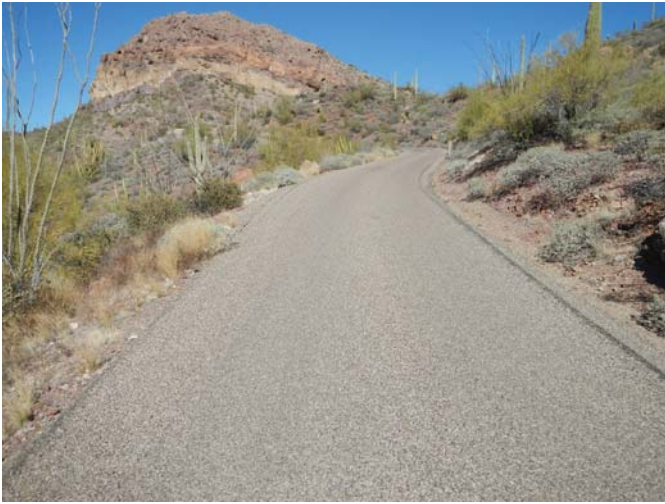
ORPI_0011_MP 6.46-6.86_3163.JPG

Section 13 (6.46 MP To 6.86 MP) and Section 14 (6.86 MP To 7.36 MP)

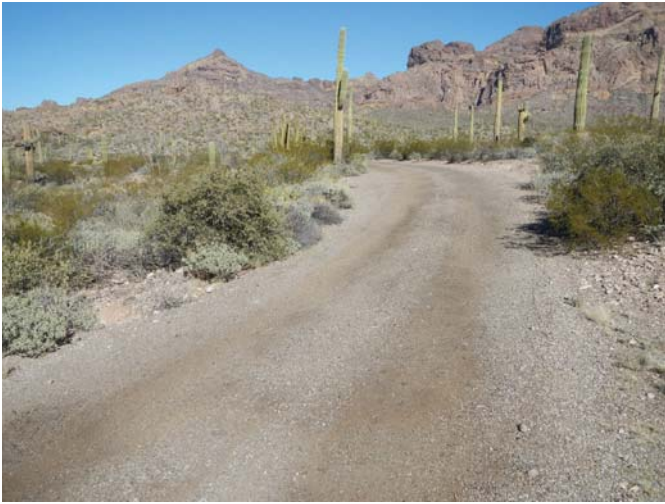
ORPI_0011_MP 7.36-7.46_3170.JPG

Section 15 (7.36 MP To 7.46 MP) and Section 16 (7.46 MP To 7.66 MP)

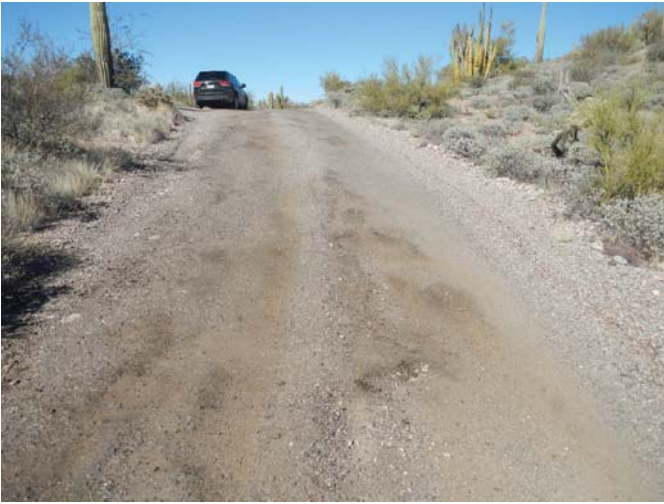
ORPI_0011_MP 7.66-7.89_3177.JPG

Section 17 (7.66 MP To 7.89 MP) and Section 23 (10.37 MP To 10.52 MP)

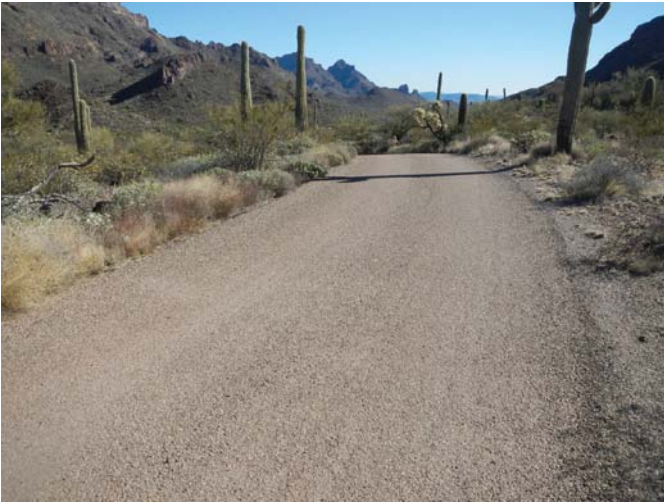
ORPI_0011_MP 10.52-10.70_3205.JPG

Section 24 (10.52 MP To 10.70 MP) and Section 27 (16.79 MP To 16.98 MP)

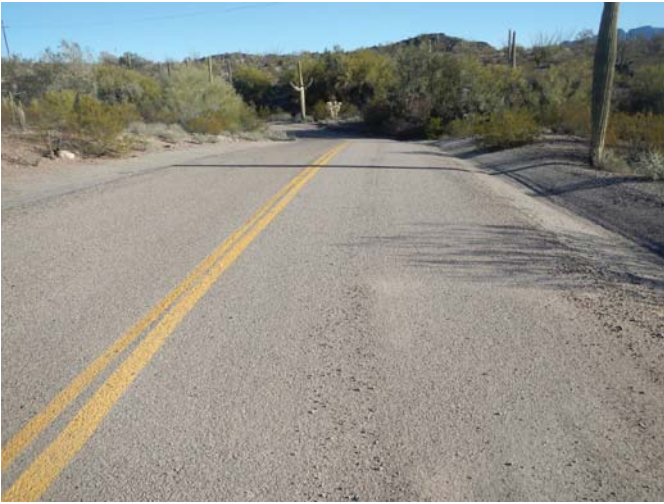
ORPI_0012_MP 0.50-0.65_3043.JPG

Condition Photos Section 2 (0.50 MP To 0.65 MP)

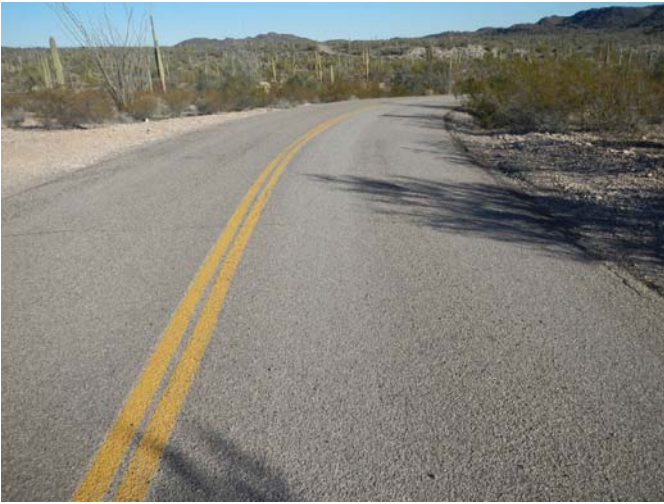
ORPI_0012_MP 1.05-1.13_3049.JPG

Condition Photos Section 4 (1.05 MP To 1.13 MP)

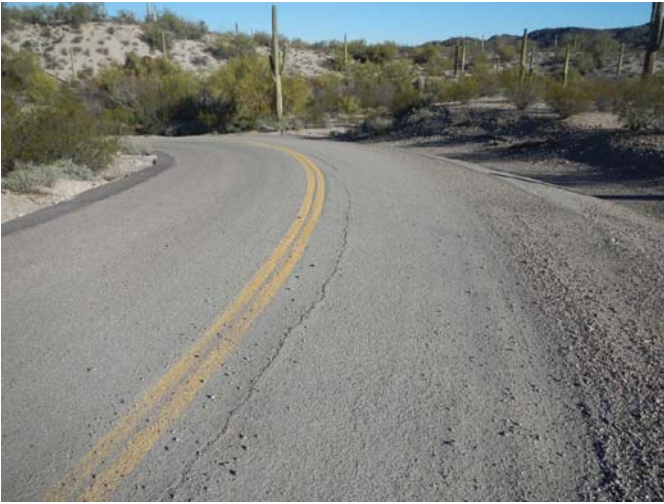
ORPI_0012_MP 1.24-1.42_3055.JPG

Condition Photos Section 6 (1.24 MP To 1.42 MP)

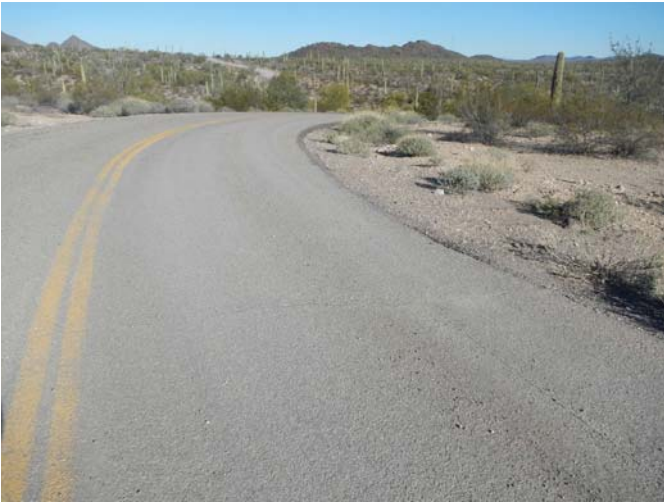
ORPI_0012_MP 1.65-1.75_3061.JPG

Condition Photos Section 8 (1.65 MP To 1.75 MP)

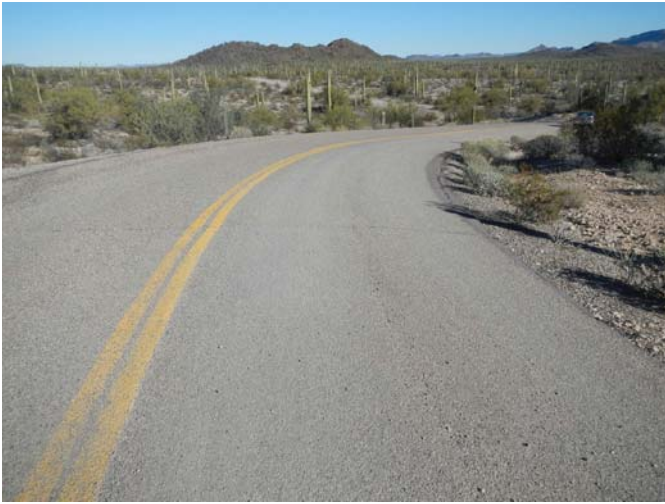
ORPI_0012_MP 1.91-2.00_3067.JPG

Condition Photos Section 10 (1.91 MP To 2.00 MP)

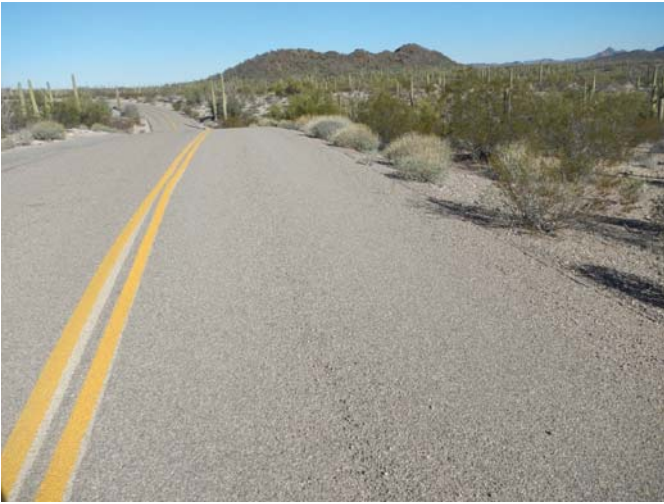
ORPI_0012_MP 2.05-2.15_3073.JPG

Condition Photos Section 12 (2.05 MP To 2.15 MP)

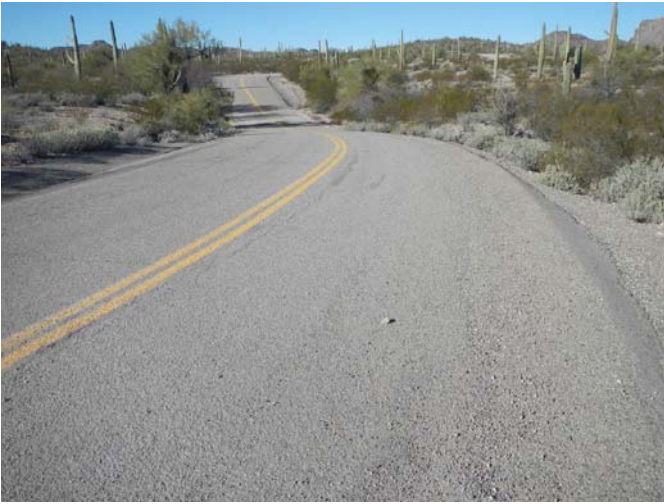
ORPI_0012_MP 2.25-2.32_3079.JPG

Condition Photos Section 14 (2.25 MP To 2.32 MP)

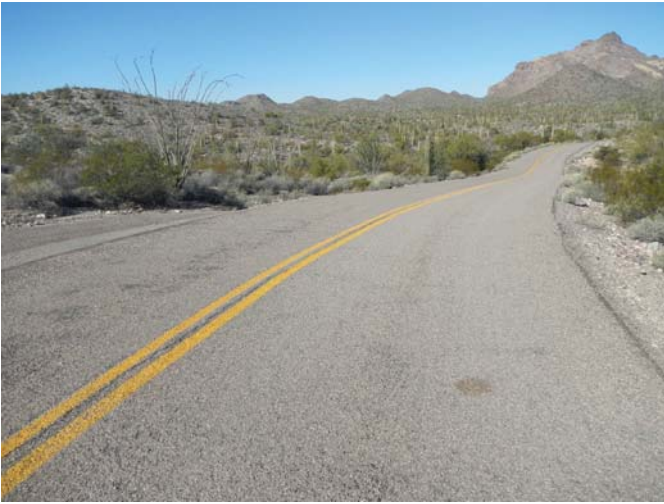
ORPI_0012_MP 2.89-3.04_3085.JPG

Condition Photos Section 16 (2.89 MP To 3.04 MP)

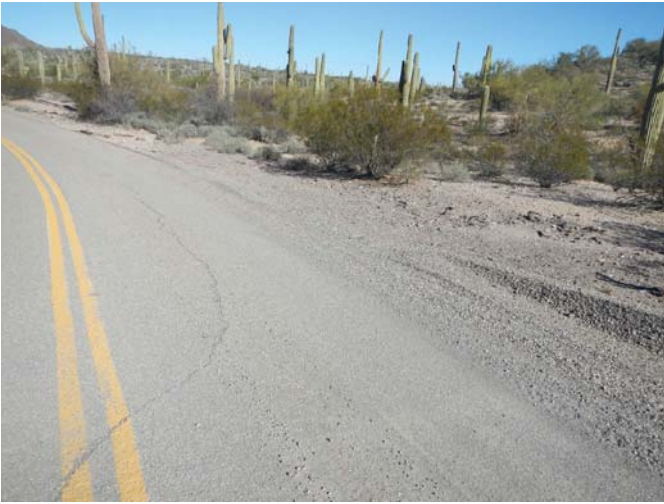
ORPI_0012_MP 3.10-3.12_3091.JPG

Condition Photos Section 18 (3.10 MP To 3.12 MP)

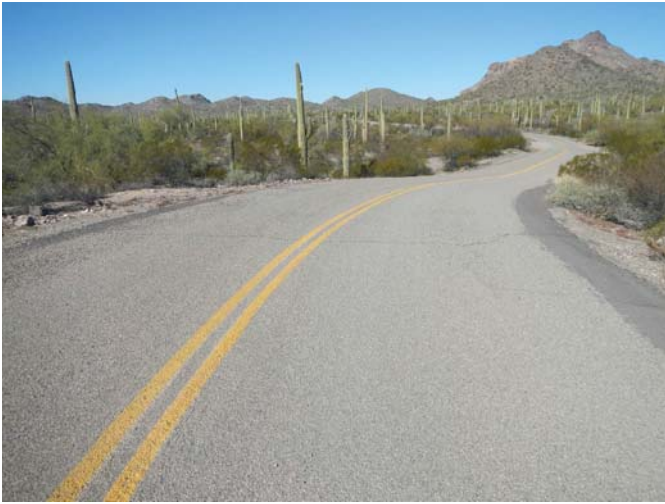
ORPI_0012_MP 3.19-3.30_3097.JPG

Condition Photos Section 20 (3.19 MP To 3.30 MP)

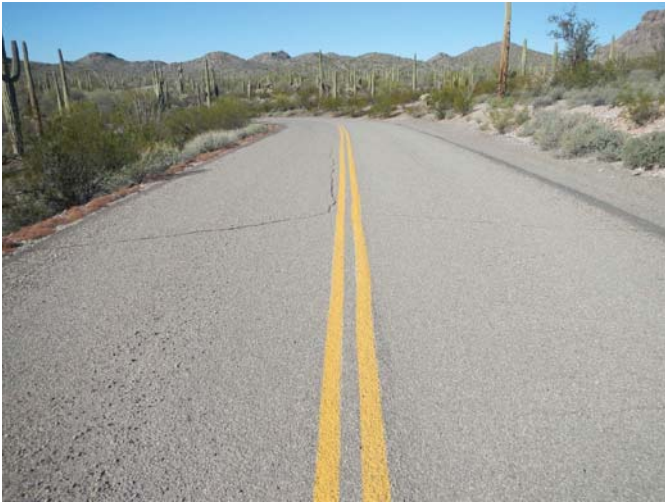
ORPI_0012_MP 3.46-3.56_3103.JPG

Section 22 (3.46 MP To 3.56 MP)

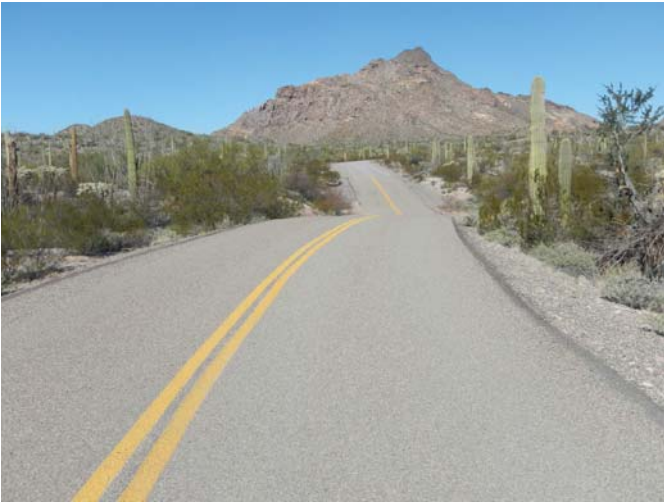
ORPI_0012_MP 3.73-3.79_3109.JPG

Condition Photos Section 24 (3.73 MP To 3.79 MP)

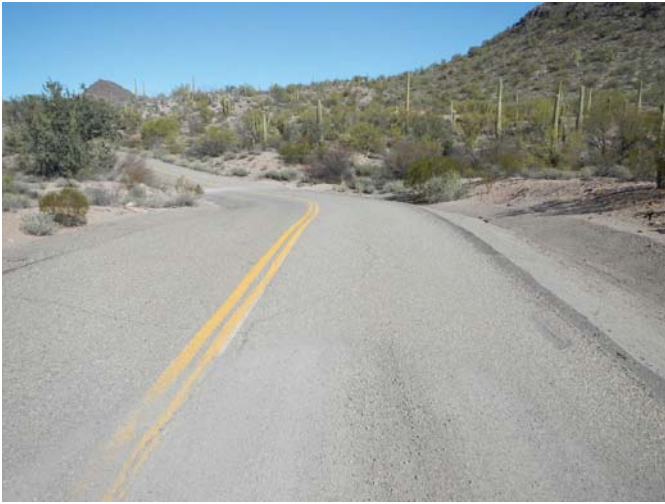
ORPI_0012_MP 3.89-4.08_3115.JPG

Condition Photos Section 26 (3.89 MP To 4.08 MP)

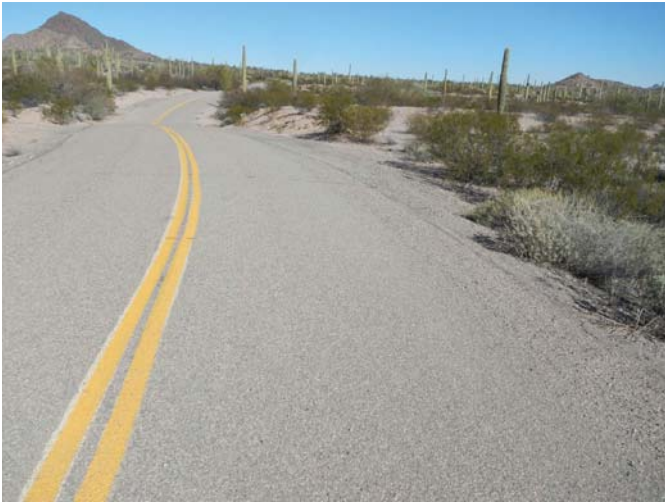
ORPI_0012_MP 4.15-4.20_3121.JPG

Condition Photos Section 28 (4.15 MP To 4.20 MP)

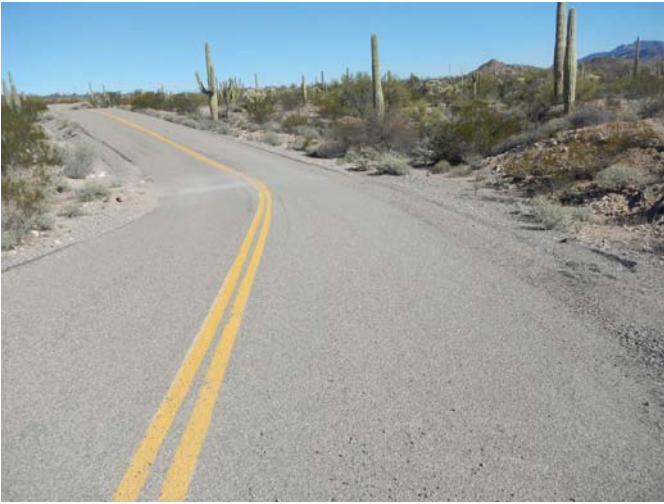
ORPI_0012_MP 4.27-4.38_3127.JPG

Condition Photos Section 30 (4.27 MP To 4.38 MP)

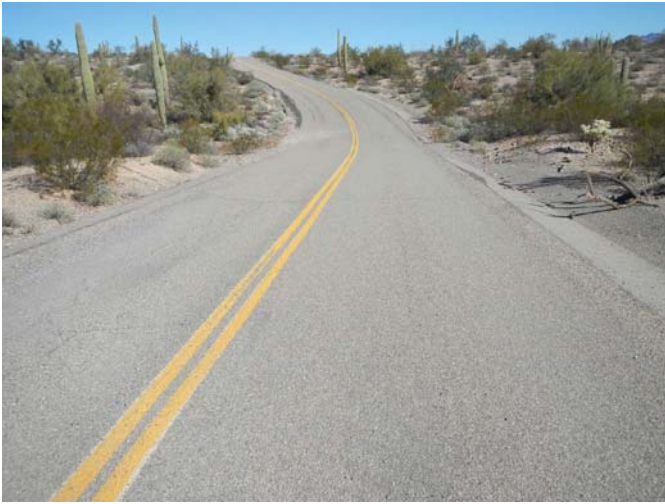
ORPI_0012_MP 4.42-4.49_3133.JPG

Condition Photos
Section 32 (4.42 MP To 4.49 MP)
