# PAIS Cycle 6

### Road Inventory and Condition Assessment of Paved Routes Padre Island National Seashore

Federal Highway Administration  
Eastern Federal Lands Highway Division  
Road Inventory Program (RIP)

Report Date: July 2017

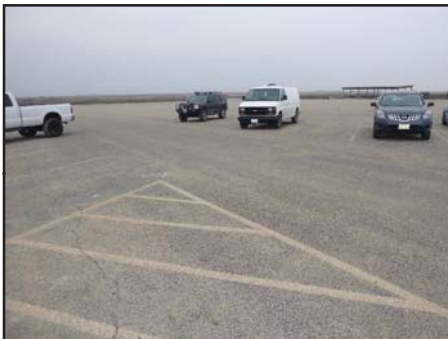
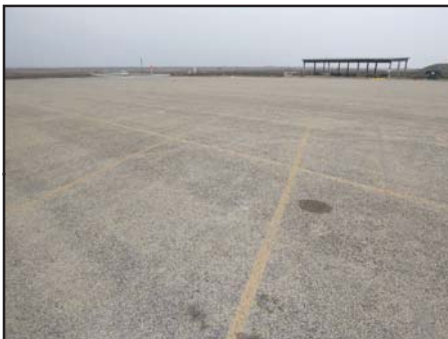
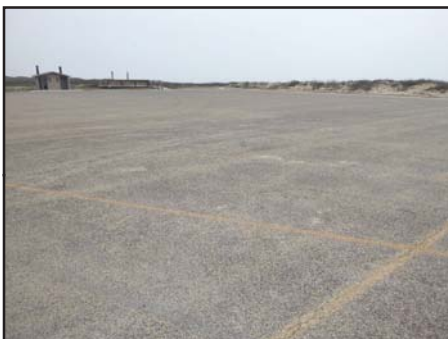
Inspection Date	FMSS Number	User Access	Surface Type
2/19/2017	54316	PUBLIC	ASPHALT
Area (Sq. Ft.)	Lane Miles (11' Widths)	Curb Reveal (Inches)	Curb Recommendation
439,815	7.573	NOT APPLICABLE	DO NOTHING
Curb Type		Curb & Gutter Type	
NO CURB		CONCRETE	
Pavement Recommendation		Condition Rating / PCR	
LIGHT 3R TREATMENTS		FAIR / 73

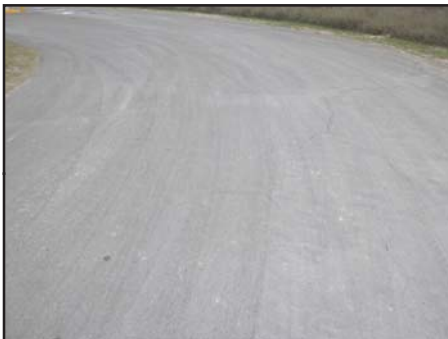
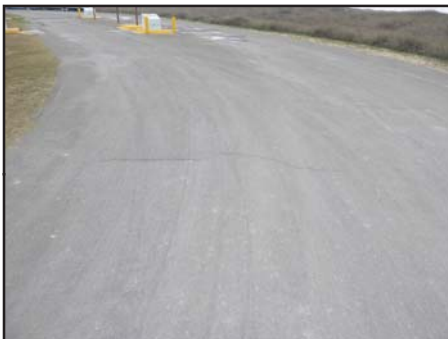
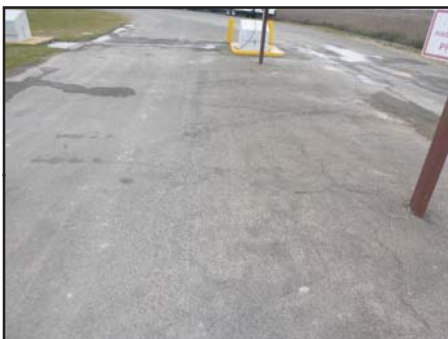
## ROUTE 0901AZ: DUMP STATION PARKING

Inspection Date	FMSS Number	User Access	Surface Type
2/19/2017	55128	PUBLIC	ASPHALT
Area (Sq. Ft.)	Lane Miles (11' Widths)	Curb Reveal (Inches)	Curb Recommendation
11,391	0.196	NOT APPLICABLE	NOT APPLICABLE
Curb Type		Curb & Gutter Type	
NO CURB		NO CURB AND GUTTER	
Pavement Recommendation		Condition Rating / PCR	
LIGHT 3R TREATMENTS		FAIR / 73

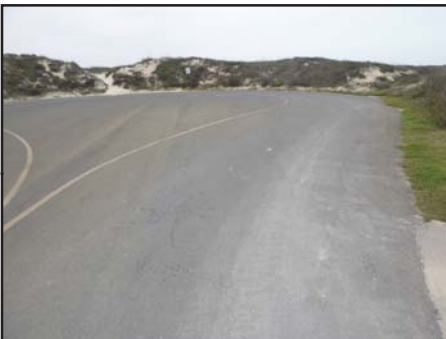
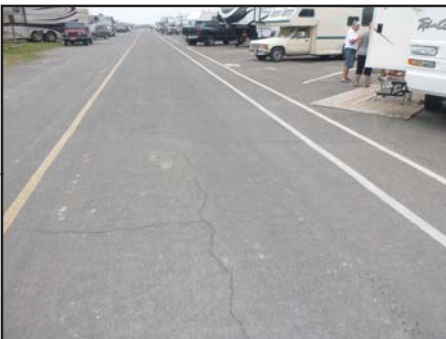
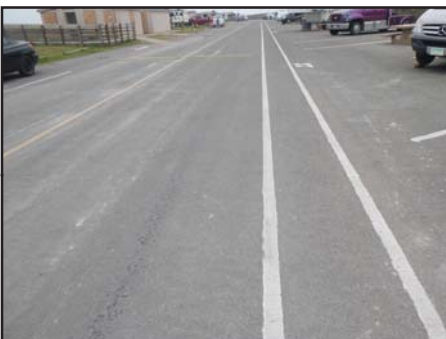
## ROUTE 0901BZ: CAMPGROUND PARKING

Inspection Date	FMSS Number	User Access	Surface Type
2/19/2017	55128	PUBLIC	ASPHALT
Area (Sq. Ft.)	Lane Miles (11' Widths)	Curb Reveal (Inches)	Curb Recommendation
96,367	1.659	NOT APPLICABLE	NOT APPLICABLE
Curb Type		Curb & Gutter Type	
NO CURB		NO CURB AND GUTTER	
Pavement Recommendation		Condition Rating / PCR	
LIGHT 3R TREATMENTS		FAIR / 73

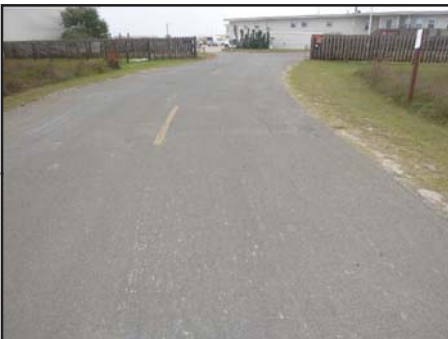
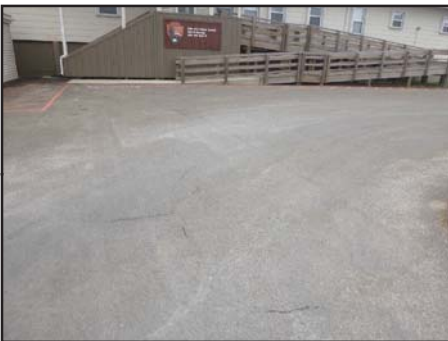
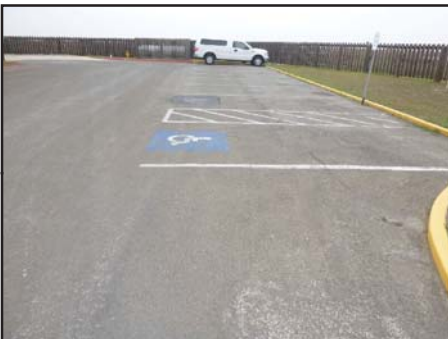
## ROUTE 0902: HEADQUARTERS NORTH VISITORS PARKING

Inspection Date	FMSS Number	User Access	Surface Type
2/19/2017	61506	PUBLIC	ASPHALT
Area (Sq. Ft.)	Lane Miles (11' Widths)	Curb Reveal (Inches)	Curb Recommendation
13,411	0.231	3	DO NOTHING
Curb Type		Curb & Gutter Type	
CONCRETE		NO CURB AND GUTTER	
Pavement Recommendation		Condition Rating / PCR	
PREVENTIVE MAINTENANCE		GOOD / 90

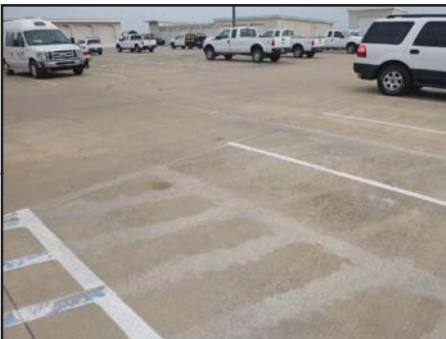
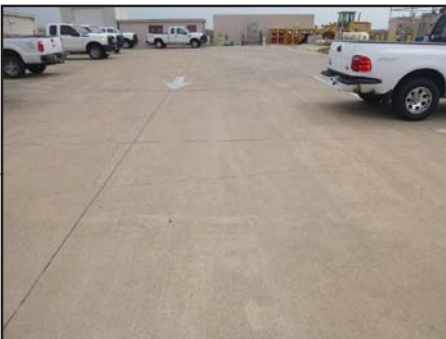
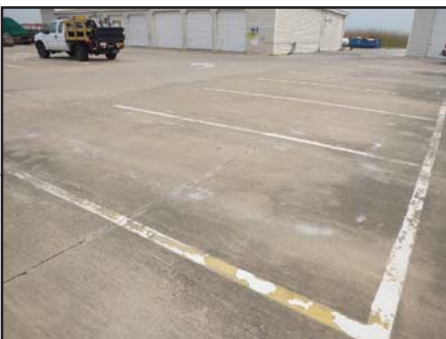
## ROUTE 0903: HEADQUARTERS EAST PARKING

Inspection Date	FMSS Number	User Access	Surface Type
2/19/2017	54320	NONPUBLIC	CONCRETE
Area (Sq. Ft.)	Lane Miles (11' Widths)	Curb Reveal (Inches)	Curb Recommendation
43,573	0.75	NOT APPLICABLE	NOT APPLICABLE
Curb Type		Curb & Gutter Type	
NO CURB		NO CURB AND GUTTER	
Pavement Recommendation		Condition Rating / PCR	
PREVENTIVE MAINTENANCE		GOOD / 90

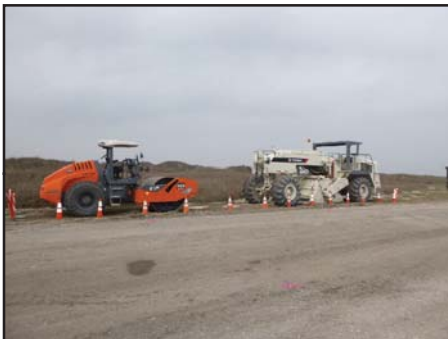
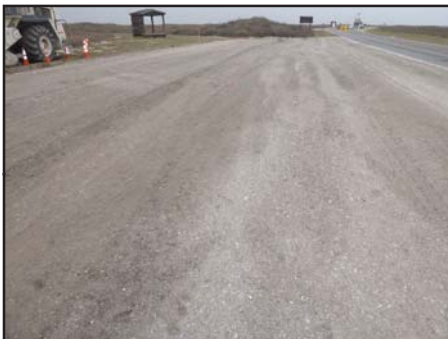
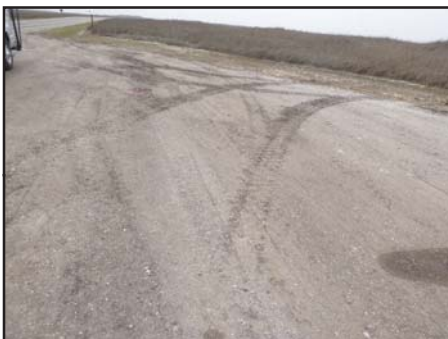
## ROUTE 0904: NATURE TRAIL PARKING

Note: Parking area was under construction, therefore, it could not be rated..

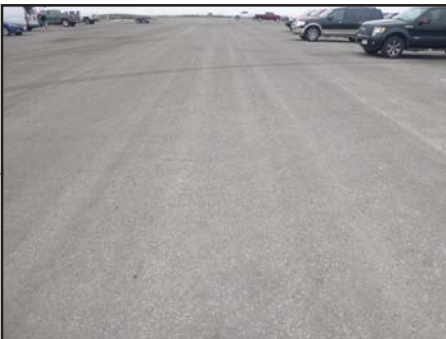
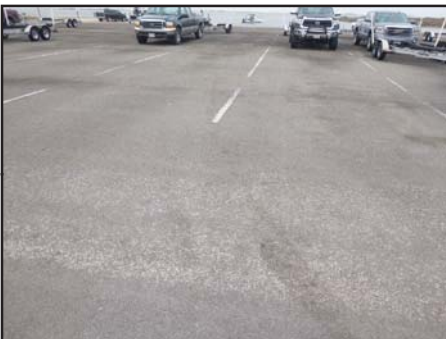
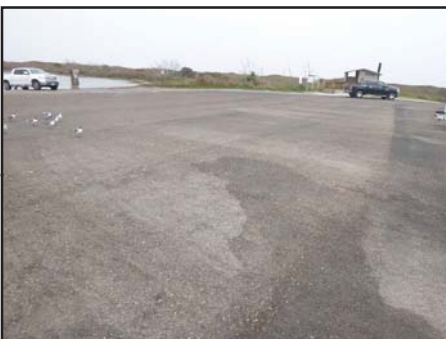
## ROUTE 0905: BOAT RAMP PARKING AREA

Inspection Date	FMSS Number	User Access	Surface Type
2/19/2017	110433	PUBLIC	ASPHALT
Area (Sq. Ft.)	Lane Miles (11' Widths)	Curb Reveal (Inches)	Curb Recommendation
121,099	2.085	NOT APPLICABLE	NOT APPLICABLE
Curb Type		Curb & Gutter Type	
NO CURB		NO CURB AND GUTTER	
Pavement Recommendation		Condition Rating / PCR	
LIGHT 3R TREATMENTS		FAIR / 73

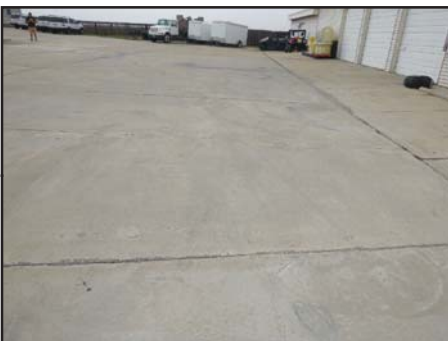
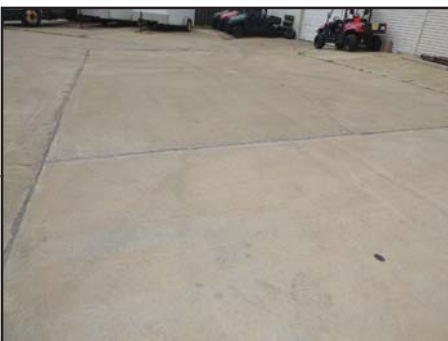
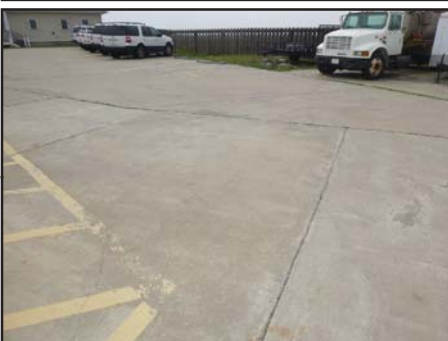
## ROUTE 0906: HEADQUARTERS WEST PARKING

Inspection Date	FMSS Number	User Access	Surface Type
2/19/2017	99803	NONPUBLIC	CONCRETE
Area (Sq. Ft.)	Lane Miles (11' Widths)	Curb Reveal (Inches)	Curb Recommendation
18,544	0.319	NOT APPLICABLE	NOT APPLICABLE
Curb Type		Curb & Gutter Type	
NO CURB		NO CURB AND GUTTER	
Pavement Recommendation		Condition Rating / PCR	
PREVENTIVE MAINTENANCE		GOOD / 90
