# PEFO Cycle 6

## Final Report

### Road Inventory and Condition Assessment of Paved Routes Petrified Forest National Park

Report Date: June 2017

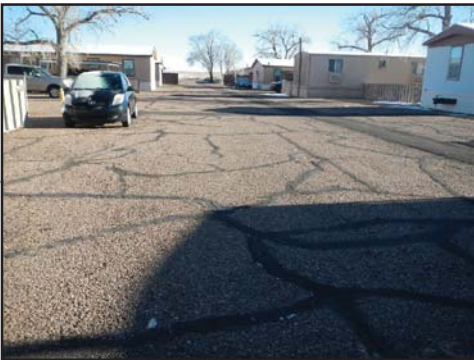
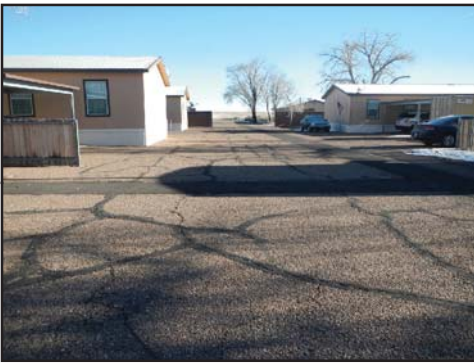
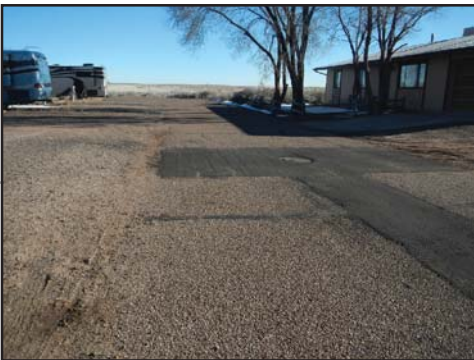
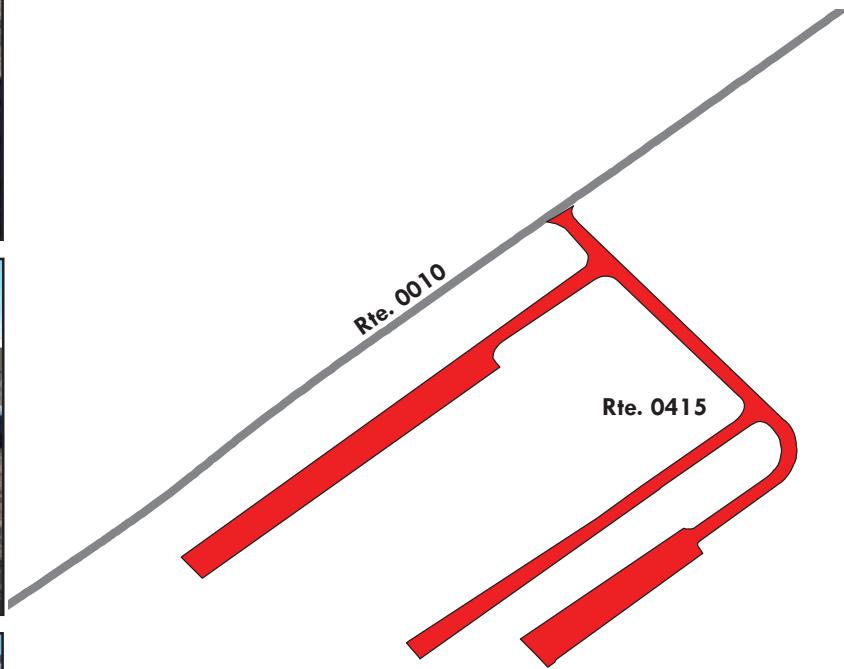
Inspection Date	FMSS Number	User Access	Surface Type
1/12/2016	74063	NONPUBLIC	ASPHALT
Area (Sq. Ft.)	Lane Miles (11' Widths)	Pavement Recommendation	
81,730	1.407	HEAVY 3R TREATMENTS	
Condition Rating / PCR			
POOR / 53			
Route Condition Legend – Pavement Condition Rating (PCR)			
Poor (0 - 60)	Fair (61- 84)	Good (85 - 94)	Excellent (95 - 100)
Not Rated			
See Appendix for definitions and formulas

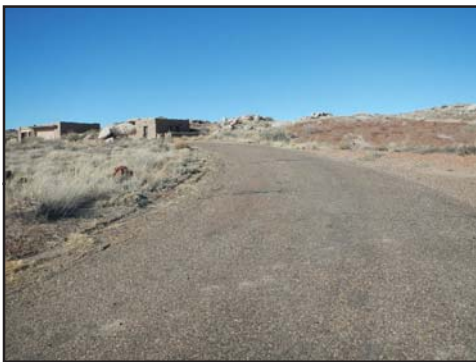
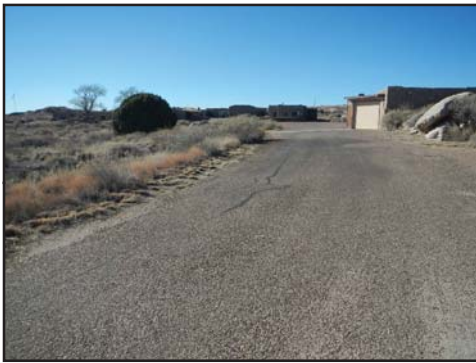
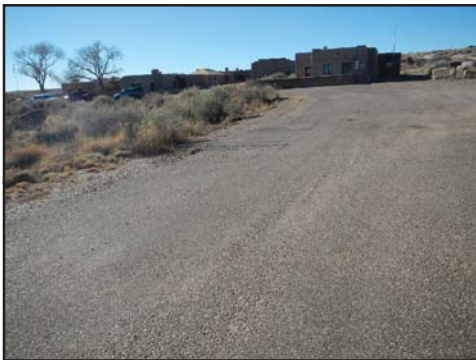
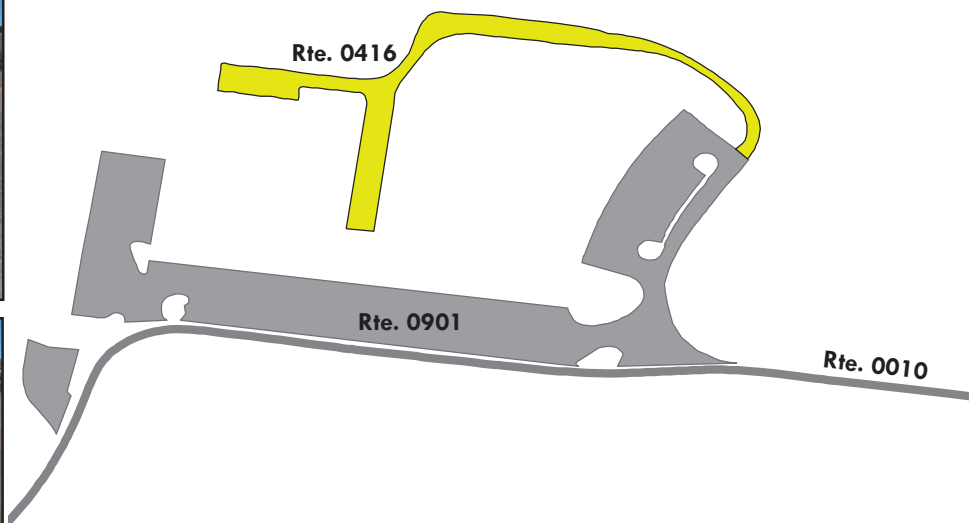
Inspection Date	FMSS Number	User Access	Surface Type
1/12/2016	74070	NONPUBLIC	ASPHALT
Area (Sq. Ft.)	Lane Miles (11' Widths)	Pavement Recommendation	
19,650	0.338	LIGHT 3R TREATMENTS	
Condition Rating / PCR			
FAIR / 73			
Route Condition Legend – Pavement Condition Rating (PCR)			
Poor (0 - 60)	Fair (61- 84)	Good (85 - 94)	Excellent (95 - 100)
Not Rated			
See Appendix for definitions and formulas

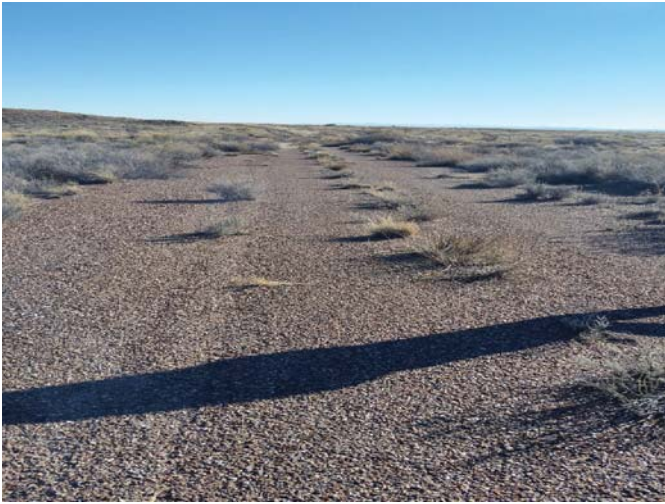
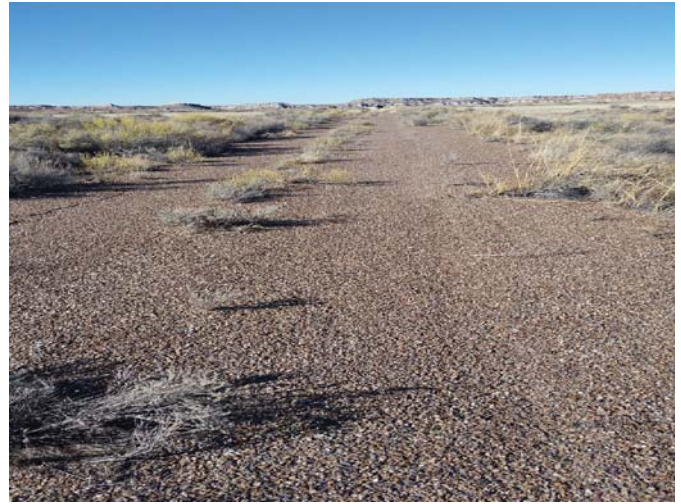
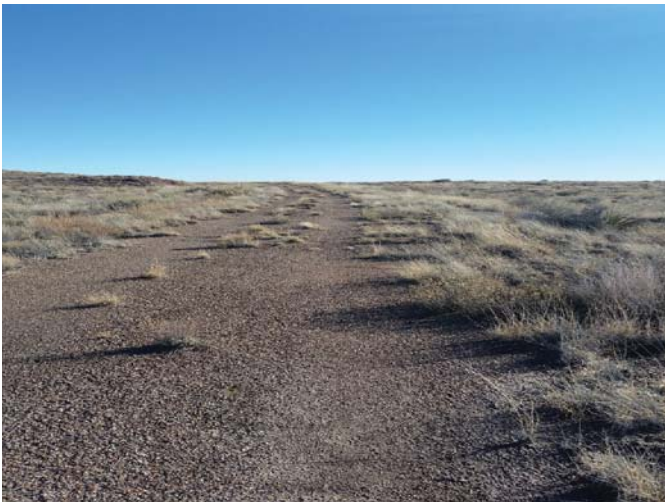
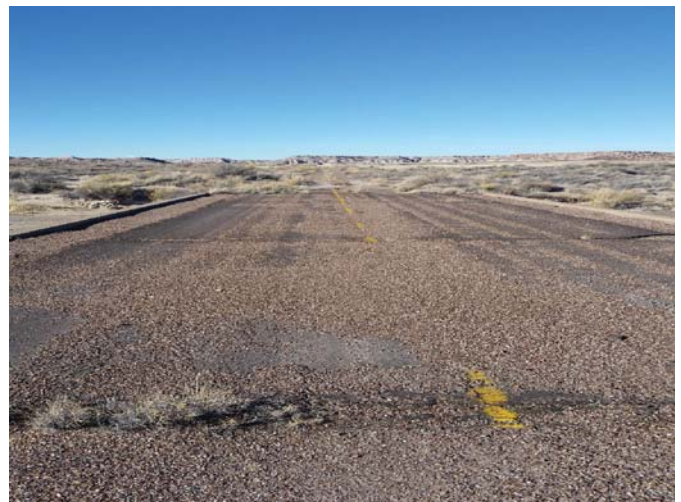
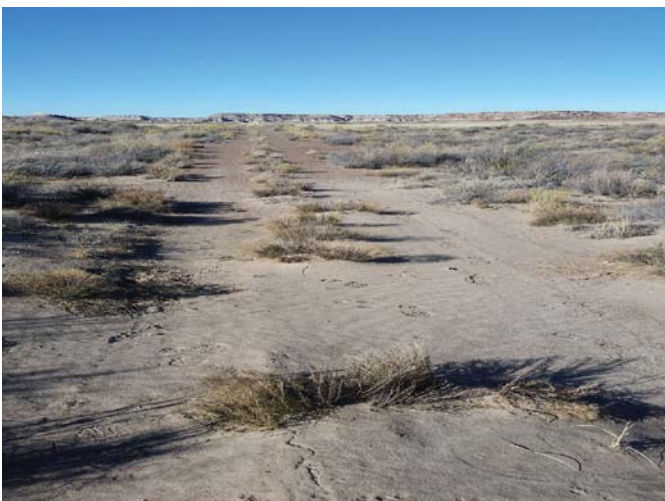
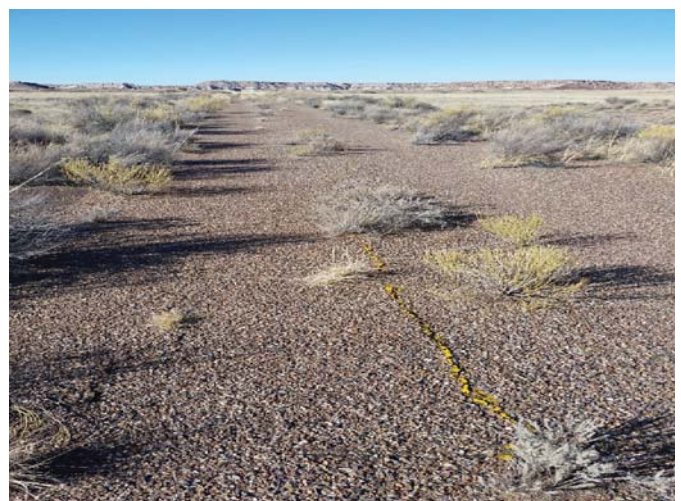
Route was given a Pavement Condition Rating (PCR) of 0 because it is in very poor condition. Individual distress indices could not be determined because of the poor condition and missing sections of pavement.

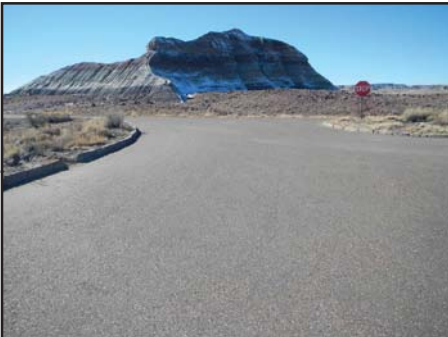
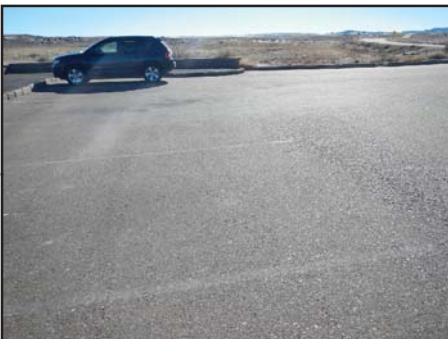
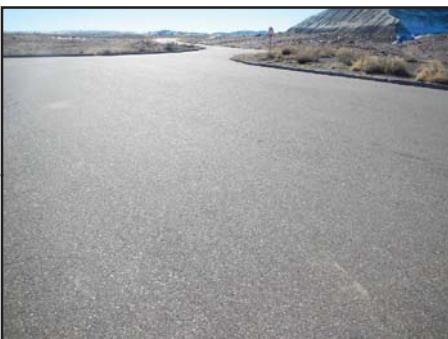
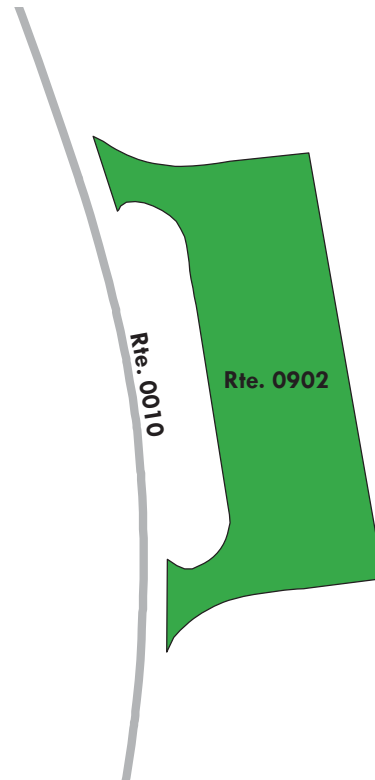
Inspection Date	FMSS Number	User Access	Surface Type
1/12/2016	74080	PUBLIC	ASPHALT
Area (Sq. Ft.)	Lane Miles (11' Widths)	Curb Reveal (Inches)	Curb Recommendation
22,519	0.388	6	DO NOTHING
Curb Type		Curb & Gutter Type	
STONE		NO CURB AND GUTTER	
Pavement Recommendation		Condition Rating / PCR	
PREVENTIVE MAINTENANCE		GOOD / 90
