PETE Cycle 6

Final Report

Road Inventory and Condition Assessment of Paved Routes Petersburg National Battlefield

Federal Highway Administration Eastern Federal Lands Highway Division Road Inventory Program (RIP)

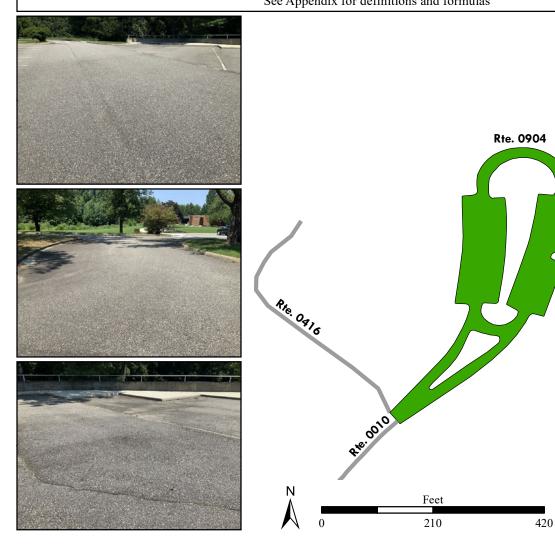
ROUTE 0905: MAINTENANCE AREA ACCESS ROAD & PARKING

Inspection Date	FMSS Number	User Access	Surface Type
8/25/2020	45869	PUBLIC	ASPHALT
Area (Sq. Ft.)	Lane Miles (11' Widths)	Curb Reveal (Inches)	Curb Recommendation
47,678	0.821	NOT APPLICABLE	NOT APPLICABLE
Curb	Туре	Curb & Gutter Type	
NO (CURB	NO CURB AND GUTTER	
Pavement Rec	Pavement Recommendation		Rating / PCR
PREVENTIVE MAINTENANCE		GOOD / 90	
Route Condition Legend – Payement Condition Rating (PCR)
