PETR Cycle 6

Final Report

Road Inventory and Condition Assessment of Paved Routes Petroglyph National Monument

Report Date: November 2017

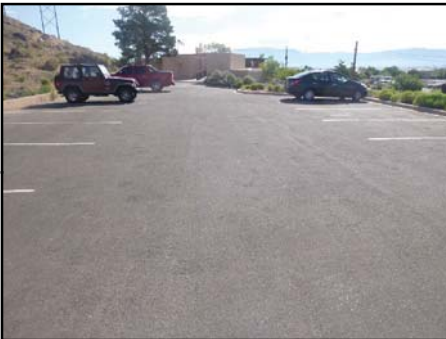
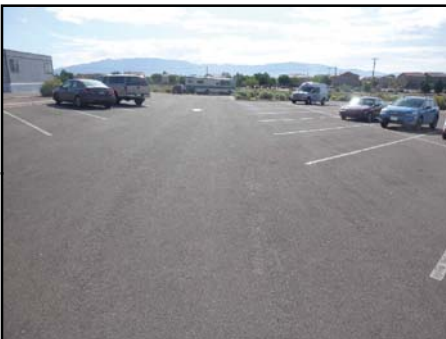
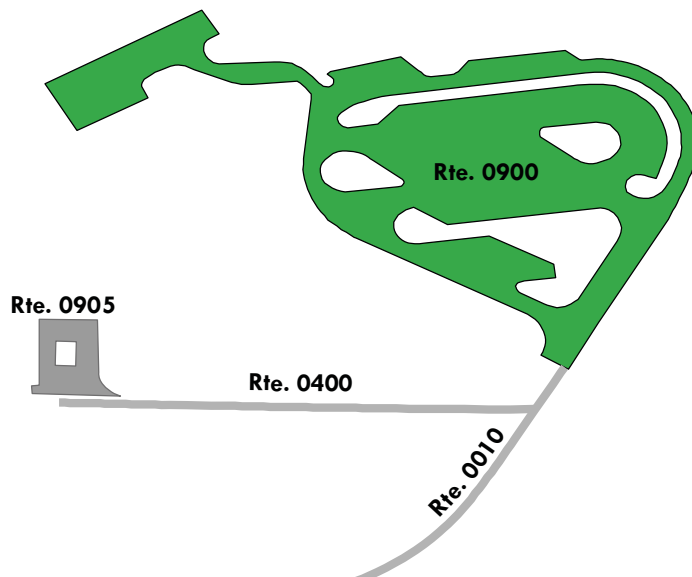
Inspection Date	FMSS Number	User Access	Surface Type
6/3/2017	27269	PUBLIC	ASPHALT
Area (Sq. Ft.)	Lane Miles (11' Widths)	Curb Reveal (Inches)	Curb Recommendation
56,485	0.973	NOT APPLICABLE	LIGHT REPAIR
Curb Type		Curb & Gutter Type	
NO CURB		CONCRETE	
Pavement Recommendation		Condition Rating / PCR	
PREVENTIVE MAINTENANCE		GOOD / 90

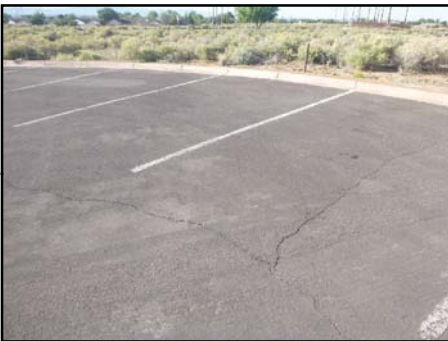
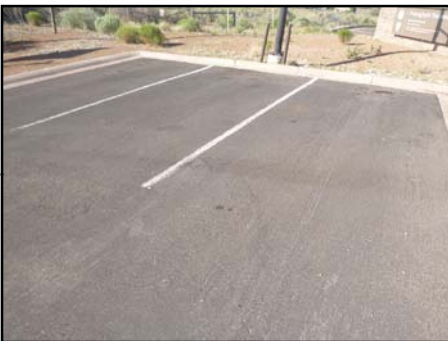
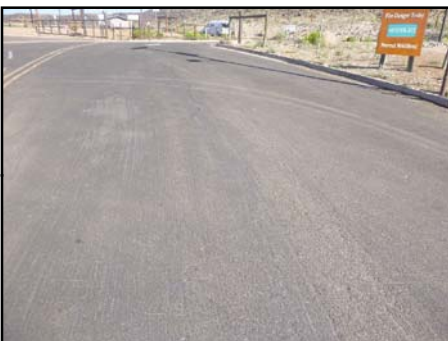
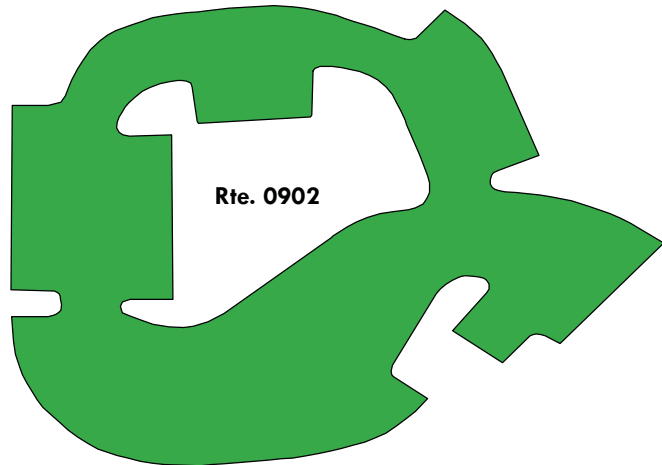
ROUTE 0902: RINCONADA CANYON PARKING LOT

Inspection Date	FMSS Number	User Access	Surface Type
6/3/2017	27267	PUBLIC	ASPHALT
Area (Sq. Ft.)	Lane Miles (11' Widths)	Curb Reveal (Inches)	Curb Recommendation
29,803	0.513	NOT APPLICABLE	DO NOTHING
Curb Type		Curb & Gutter Type	
NO CURB		CONCRETE	
Pavement Recommendation		Condition Rating / PCR	
PREVENTIVE MAINTENANCE		GOOD / 90

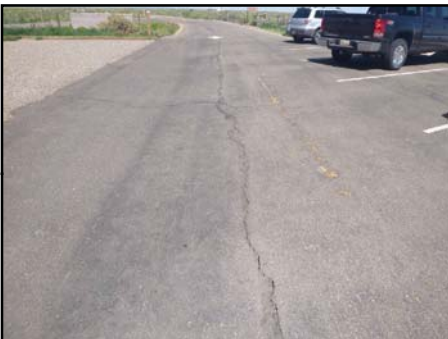
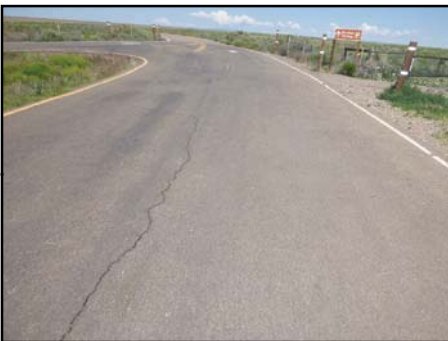
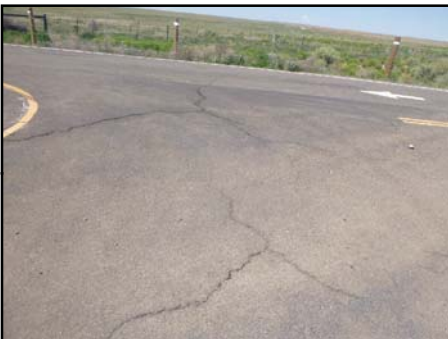
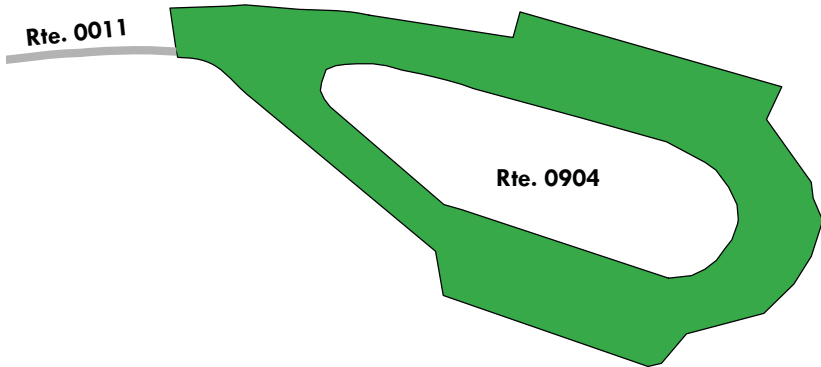
ROUTE 0904: VOLCANO DAY-USE PARKING LOT

Inspection Date	FMSS Number	User Access	Surface Type
6/3/2017	27265	PUBLIC	ASPHALT
Area (Sq. Ft.)	Lane Miles (11' Widths)	Curb Reveal (Inches)	Curb Recommendation
14,264	0.246	5	DO NOTHING
Curb Type		Curb & Gutter Type	
WOOD		NO CURB AND GUTTER	
Pavement Recommendation		Condition Rating / PCR	
PREVENTIVE MAINTENANCE		GOOD / 90

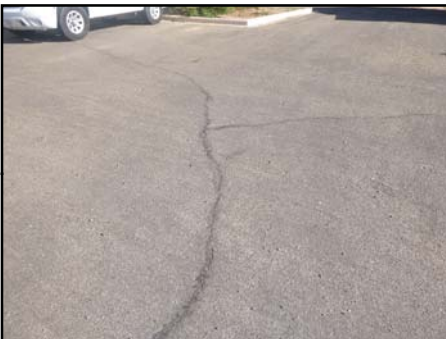
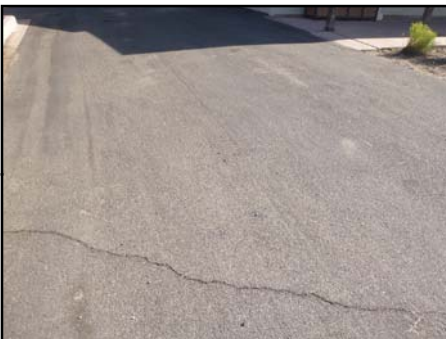
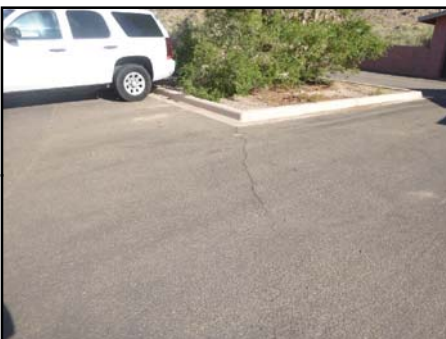
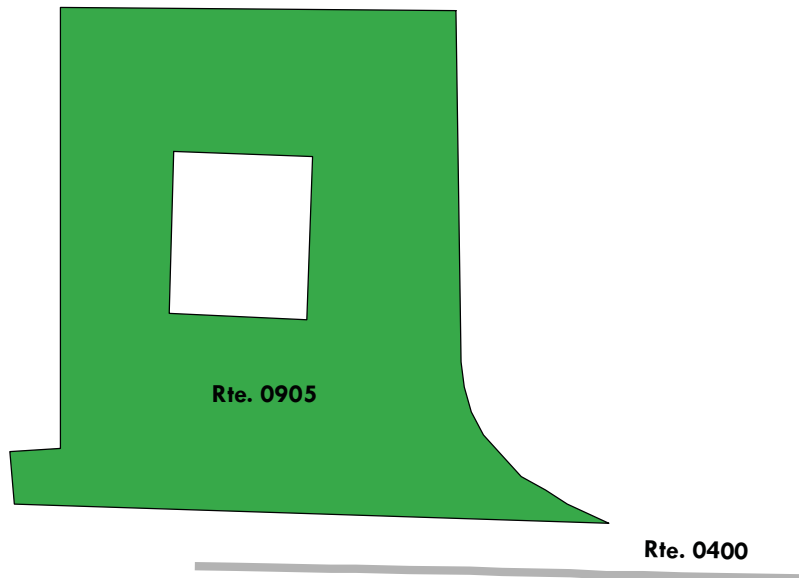
ROUTE 0905: LAVA SHADOWS PARKING LOT

Inspection Date	FMSS Number	User Access	Surface Type
6/3/2017	27270	PUBLIC	ASPHALT
Area (Sq. Ft.)	Lane Miles (11' Widths)	Curb Reveal (Inches)	Curb Recommendation
3,326	0.057	NOT APPLICABLE	DO NOTHING
Curb Type		Curb & Gutter Type	
NO CURB		CONCRETE	
Pavement Recommendation		Condition Rating / PCR	
PREVENTIVE MAINTENANCE		GOOD / 90

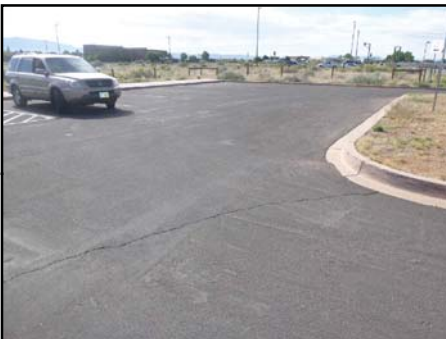
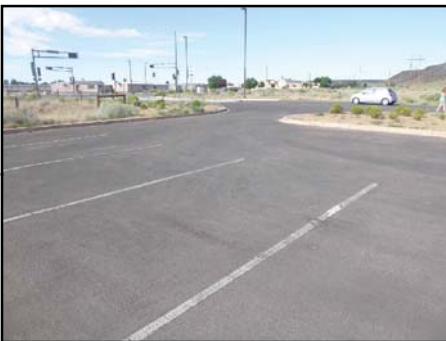
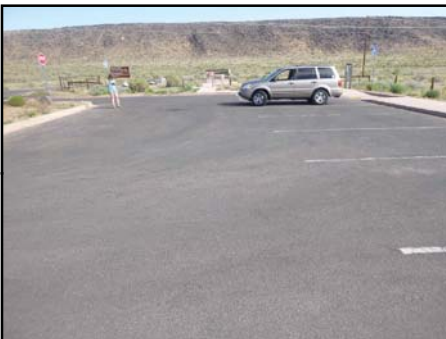
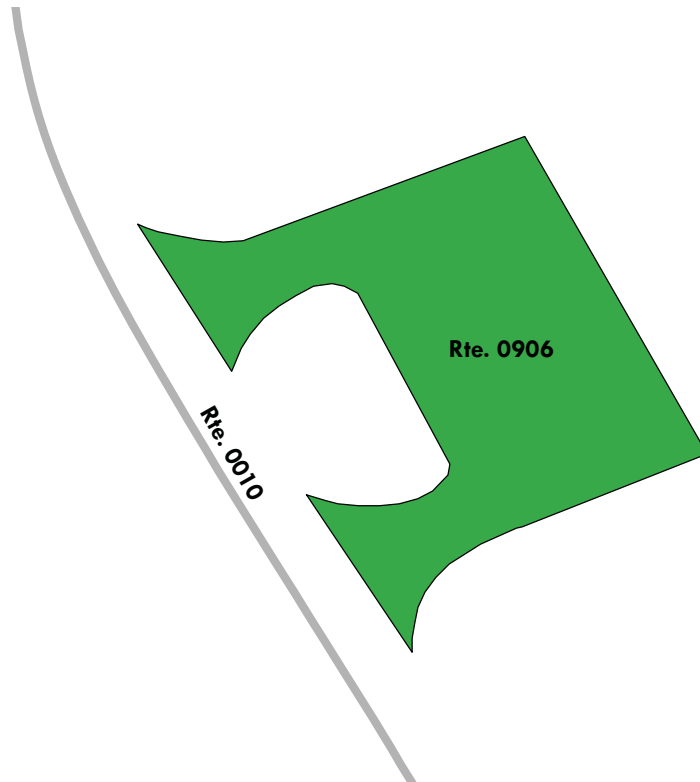
ROUTE 0906: LA CUESTA PARKING AREA

Inspection Date	FMSS Number	User Access	Surface Type
6/3/2017	67317	PUBLIC	ASPHALT
Area (Sq. Ft.)	Lane Miles (11' Widths)	Curb Reveal (Inches)	Curb Recommendation
4,559	0.078	NOT APPLICABLE	DO NOTHING
Curb Type		Curb & Gutter Type	
NO CURB		CONCRETE	
Pavement Recommendation		Condition Rating / PCR	
PREVENTIVE MAINTENANCE		GOOD / 90

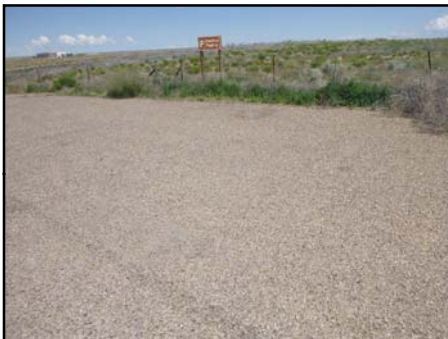
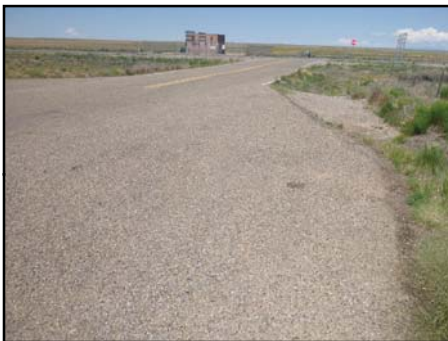
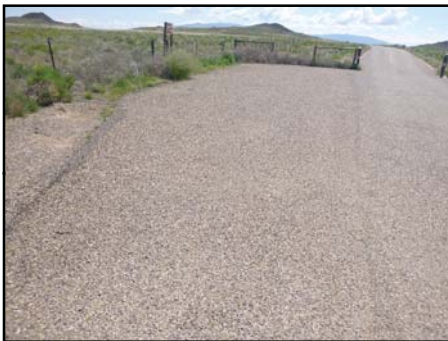
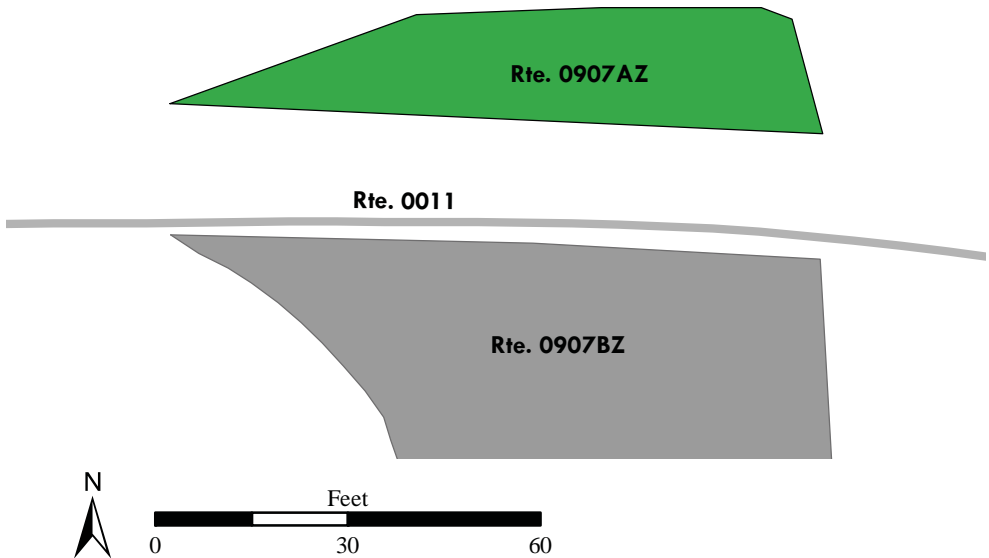
ROUTE 0907AZ: VOLCANOES OVERFLOW PARKING NORTH

Inspection Date	FMSS Number	User Access	Surface Type
6/3/2017	248295	PUBLIC	ASPHALT
Area (Sq. Ft.)	Lane Miles (11' Widths)	Curb Reveal (Inches)	Curb Recommendation
1,131	0.019	NOT APPLICABLE	NOT APPLICABLE
Curb Type		Curb & Gutter Type	
NO CURB		NO CURB AND GUTTER	
Pavement Recommendation		Condition Rating / PCR	
PREVENTIVE MAINTENANCE		GOOD / 90

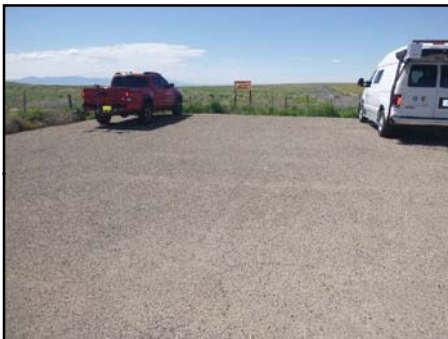
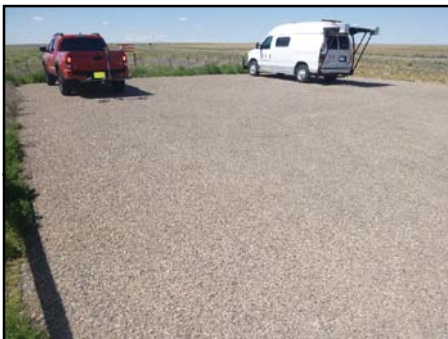
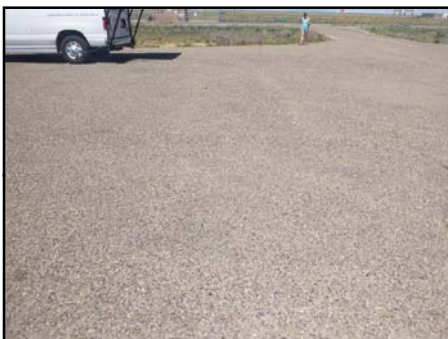
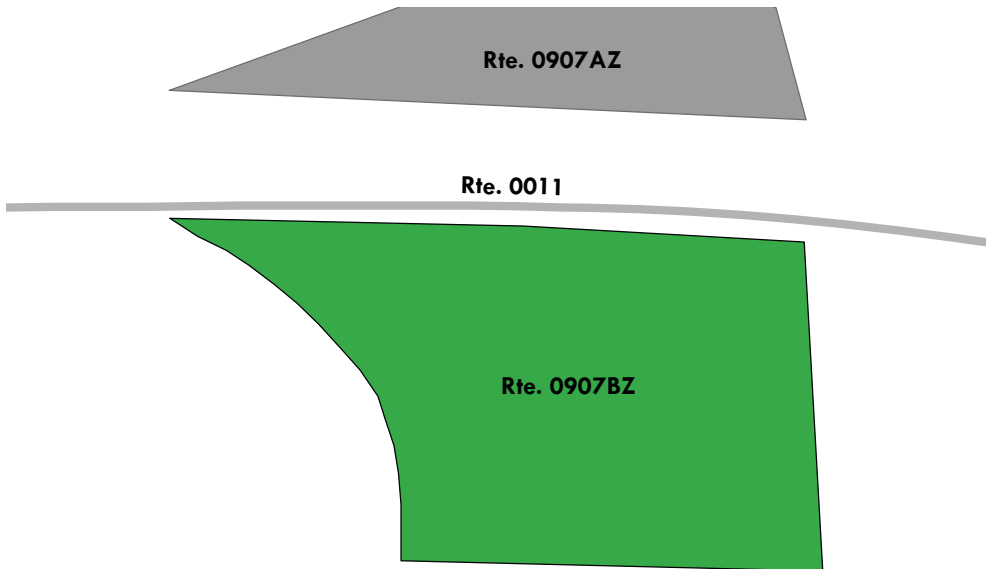
ROUTE 0907BZ: VOLCANOES OVERFLOW PARKING SOUTH

Inspection Date	FMSS Number	User Access	Surface Type
6/3/2017	248295	PUBLIC	ASPHALT
Area (Sq. Ft.)	Lane Miles (11' Widths)	Curb Reveal (Inches)	Curb Recommendation
3,290	0.057	NOT APPLICABLE	NOT APPLICABLE
Curb Type		Curb & Gutter Type	
NO CURB		NO CURB AND GUTTER	
Pavement Recommendation		Condition Rating / PCR	
PREVENTIVE MAINTENANCE		GOOD / 90

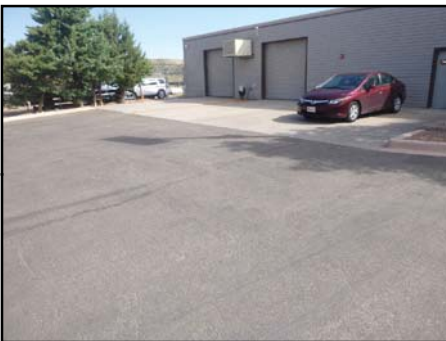
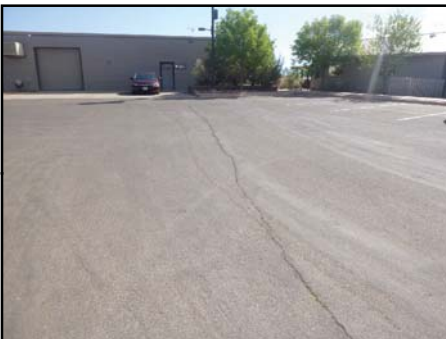
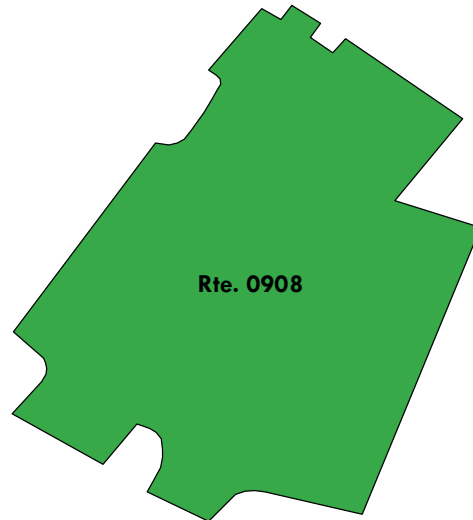
ROUTE 0908: HEADQUARTERS PARKING

Inspection Date	FMSS Number	User Access	Surface Type
6/3/2017	11295	PUBLIC	ASPHALT
Area (Sq. Ft.)	Lane Miles (11' Widths)	Curb Reveal (Inches)	Curb Recommendation
10,819	0.186	NOT APPLICABLE	DO NOTHING
Curb Type		Curb & Gutter Type	
NO CURB		CONCRETE	
Pavement Recommendation		Condition Rating / PCR	
PREVENTIVE MAINTENANCE		GOOD / 90

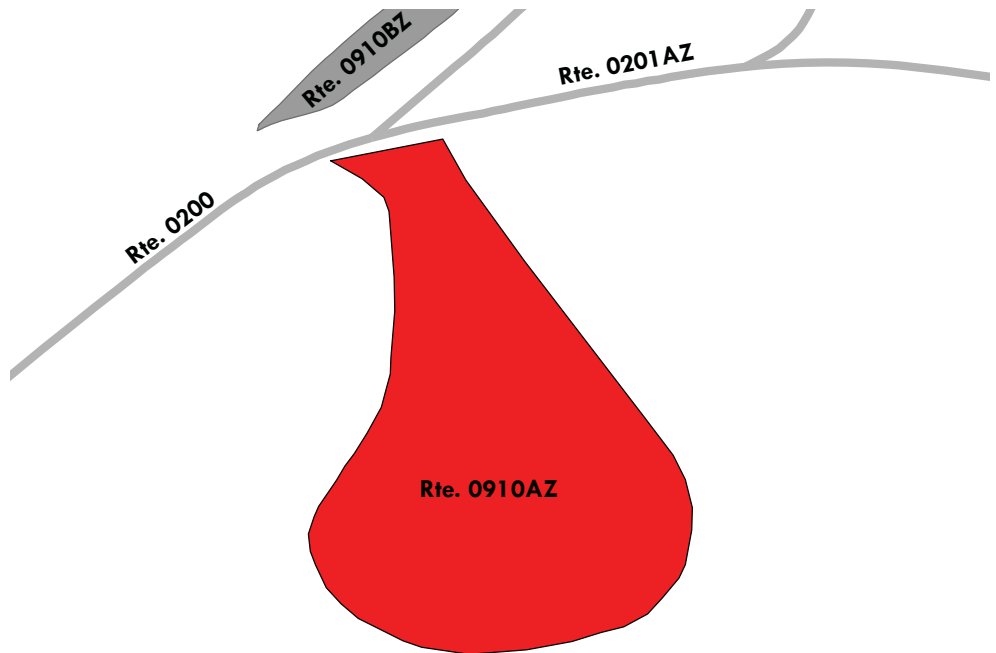
ROUTE 0910AZ: BOCA NEGRA OVERFLOW PARKING AREA A

Inspection Date	FMSS Number	User Access	Surface Type
6/3/2017	90001	PUBLIC	ASPHALT
Area (Sq. Ft.)	Lane Miles (11' Widths)	Curb Reveal (Inches)	Curb Recommendation
14,905	0.257	NOT APPLICABLE	NOT APPLICABLE
Curb Type		Curb & Gutter Type	
NO CURB		NO CURB AND GUTTER	
Pavement Recommendation		Condition Rating / PCR	
HEAVY 3R TREATMENTS		POOR / 53

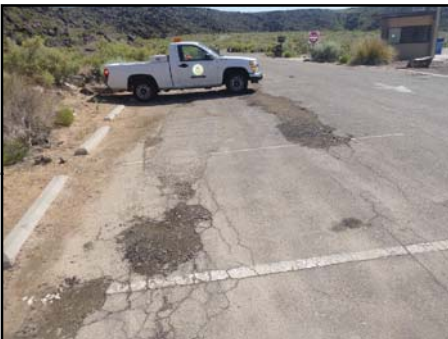
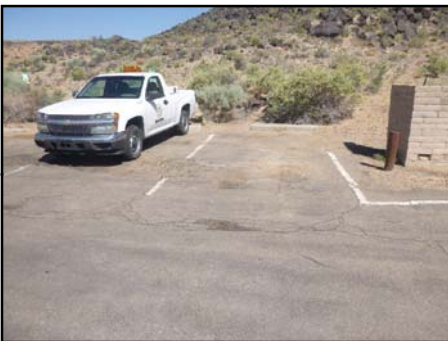
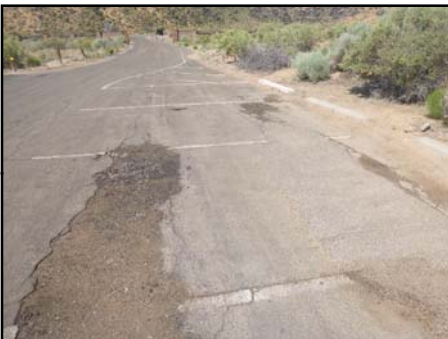
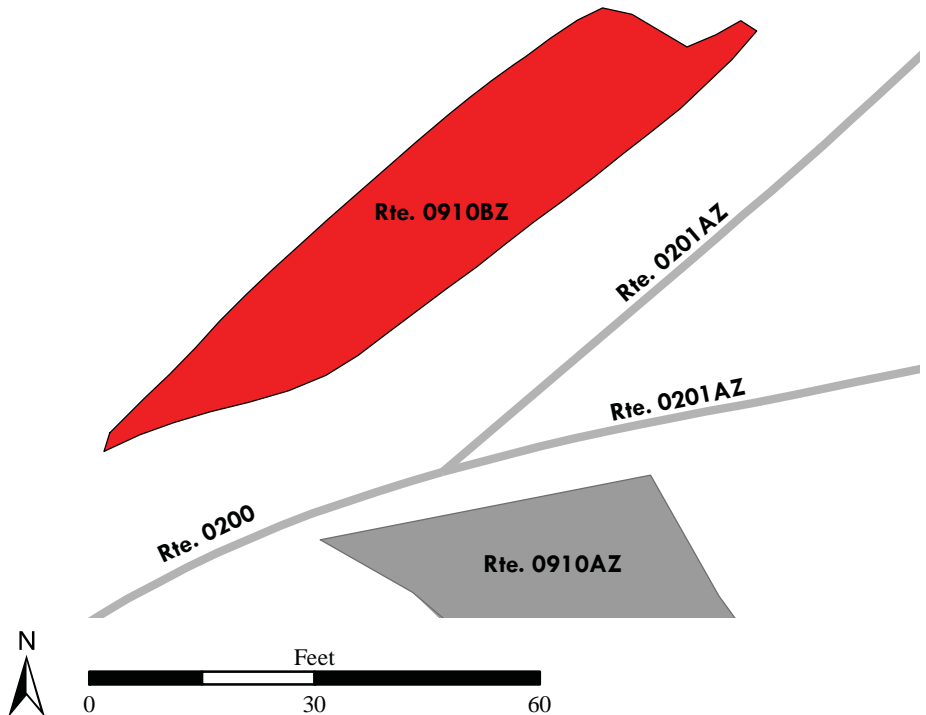
ROUTE 0910BZ: BOCA NEGRA OVERFLOW PARKING AREA B

Inspection Date	FMSS Number	User Access	Surface Type
6/3/2017	90001	PUBLIC	ASPHALT
Area (Sq. Ft.)	Lane Miles (11' Widths)	Curb Reveal (Inches)	Curb Recommendation
1,124	0.019	NOT APPLICABLE	NOT APPLICABLE
Curb Type		Curb & Gutter Type	
NO CURB		NO CURB AND GUTTER	
Pavement Recommendation		Condition Rating / PCR	
RECONSTRUCTION		POOR / 30

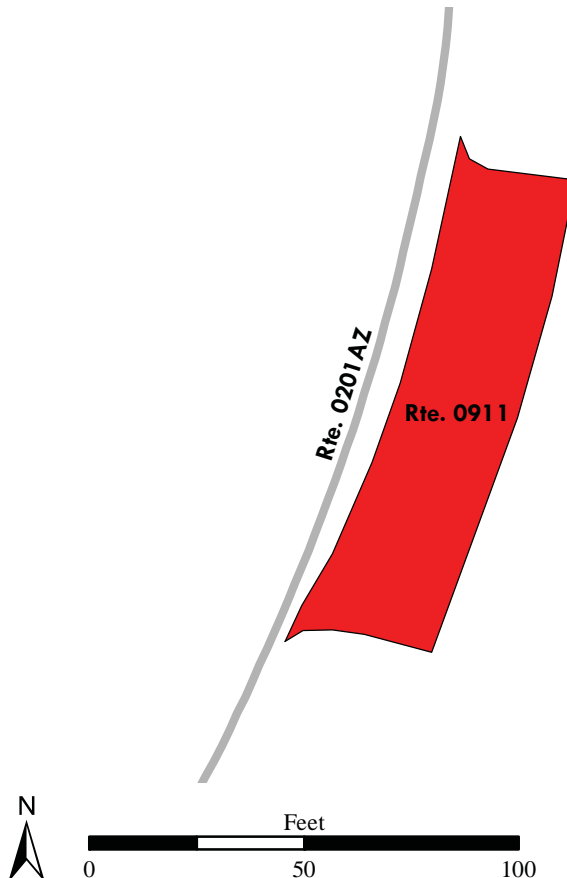
ROUTE 0911: MESA POINT TRAIL PARKING AREA

Inspection Date	FMSS Number	User Access	Surface Type
6/3/2017	90002	PUBLIC	ASPHALT
Area (Sq. Ft.)	Lane Miles (11' Widths)	Curb Reveal (Inches)	Curb Recommendation
2,721	0.047	NOT APPLICABLE	NOT APPLICABLE
Curb Type		Curb & Gutter Type	
NO CURB		NO CURB AND GUTTER	
Pavement Recommendation		Condition Rating / PCR	
HEAVY 3R TREATMENTS		POOR / 53

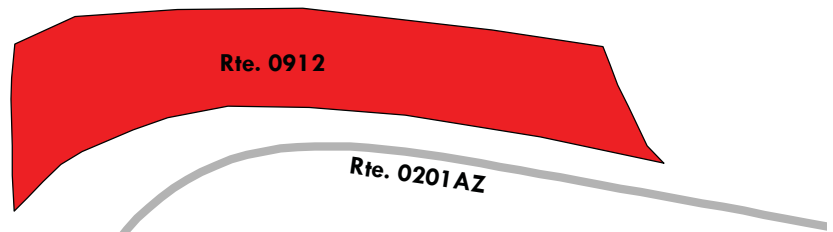
ROUTE 0912: CLIFF BASE/MACAOW PARKING AREA

Inspection Date	FMSS Number	User Access	Surface Type
6/3/2017	90003	PUBLIC	ASPHALT
Area (Sq. Ft.)	Lane Miles (11' Widths)	Curb Reveal (Inches)	Curb Recommendation
3,419	0.059	NOT APPLICABLE	NOT APPLICABLE
Curb Type		Curb & Gutter Type	
NO CURB		NO CURB AND GUTTER	
Pavement Recommendation		Condition Rating / PCR	
HEAVY 3R TREATMENTS		POOR / 53
