Final Report

Road Inventory and Condition Assessment of Paved Routes Pictured Rocks National Lakeshore

**Federal Highway Administration
Eastern Federal Lands Highway Division
Road Inventory Program (RIP)**

Report Date: May 2019

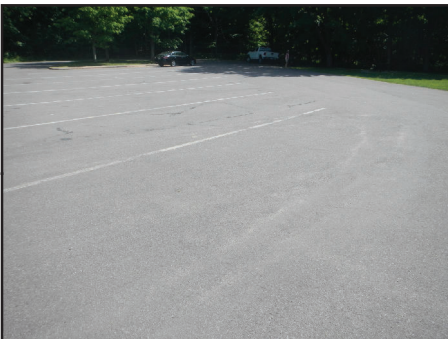
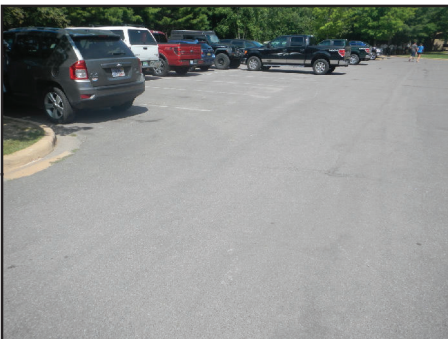
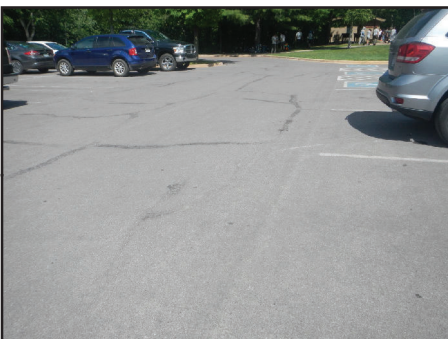
Inspection Date	FMSS Number	User Access	Surface Type
8/8/2018	29750	PUBLIC	ASPHALT
Area (Sq. Ft.)	Lane Miles (11' Widths)	Curb Reveal (Inches)	Curb Recommendation
39,799	0.685	NOT APPLICABLE	DO NOTHING
Curb Type		Curb & Gutter Type	
NO CURB		CONCRETE	
Pavement Recommendation		Condition Rating / PCR	
PREVENTIVE MAINTENANCE		GOOD / 90

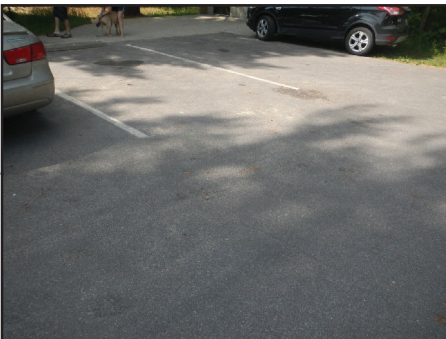
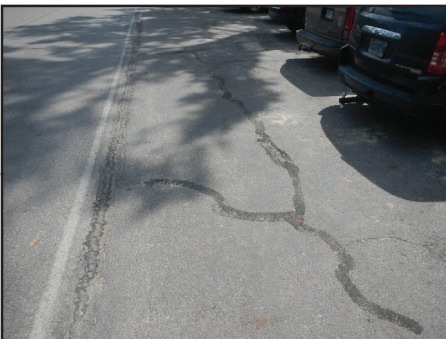
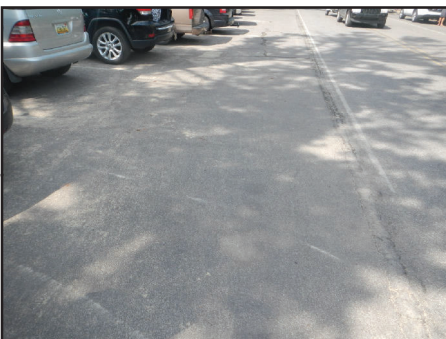
ROUTE 0901Z: SAND POINT BEACH PARKING A

Inspection Date	FMSS Number	User Access	Surface Type
8/8/2018	29608	PUBLIC	ASPHALT
Area (Sq. Ft.)	Lane Miles (11' Widths)	Curb Reveal (Inches)	Curb Recommendation
8,907	0.153	NOT APPLICABLE	NOT APPLICABLE
Curb Type		Curb & Gutter Type	
NO CURB		NO CURB AND GUTTER	
Pavement Recommendation		Condition Rating / PCR	
LIGHT 3R TREATMENTS		FAIR / 73

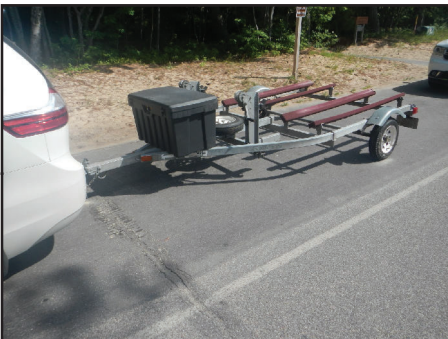
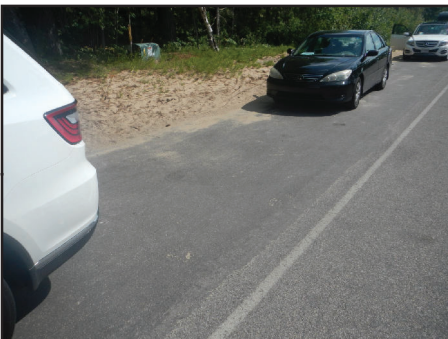
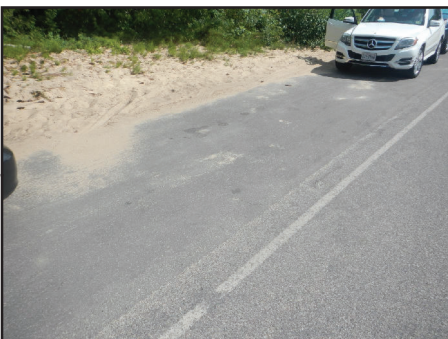
ROUTE 0925Z: SAND POINT BEACH PARKING B

Inspection Date	FMSS Number	User Access	Surface Type
8/8/2018	29608	PUBLIC	ASPHALT
Area (Sq. Ft.)	Lane Miles (11' Widths)	Curb Reveal (Inches)	Curb Recommendation
4,296	0.074	NOT APPLICABLE	NOT APPLICABLE
Curb Type		Curb & Gutter Type	
NO CURB		NO CURB AND GUTTER	
Pavement Recommendation		Condition Rating / PCR	
PREVENTIVE MAINTENANCE		GOOD / 90

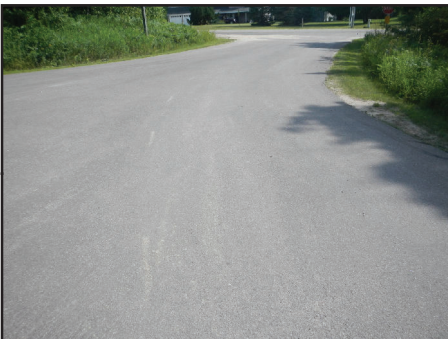
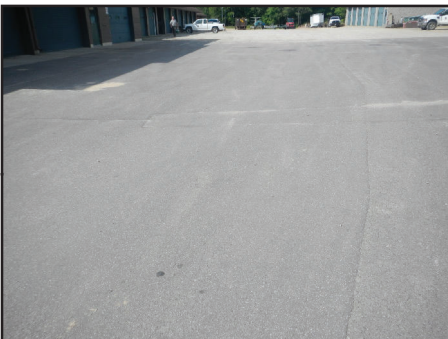
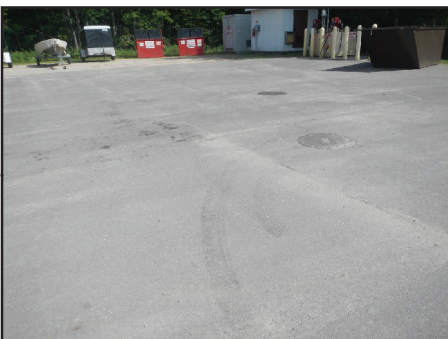
ROUTE 0903A: MUNISING MAINTENANCE SHOP A

Inspection Date	FMSS Number	User Access	Surface Type
8/8/2018	29824	NONPUBLIC	ASPHALT
Area (Sq. Ft.)	Lane Miles (11' Widths)	Curb Reveal (Inches)	Curb Recommendation
23,087	0.398	NOT APPLICABLE	NOT APPLICABLE
Curb Type		Curb & Gutter Type	
NO CURB		NO CURB AND GUTTER	
Pavement Recommendation		Condition Rating / PCR	
PREVENTIVE MAINTENANCE		GOOD / 90

Note: Parking area consists of multiple surface types: 1 part Asphalt at 22,701 square feet; 1 part Concrete at 386 square feet.

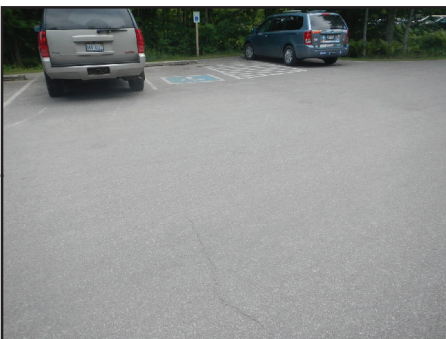
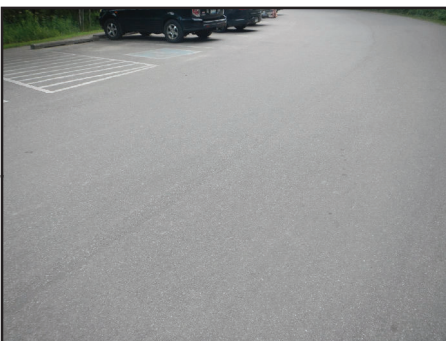
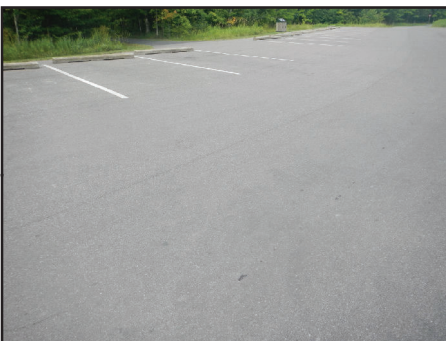
ROUTE 0905: MINERS CASTLE PARKING

Inspection Date	FMSS Number	User Access	Surface Type
8/8/2018	29919	PUBLIC	ASPHALT
Area (Sq. Ft.)	Lane Miles (11' Widths)	Curb Reveal (Inches)	Curb Recommendation
82,147	1.414	NOT APPLICABLE	DO NOTHING
Curb Type		Curb & Gutter Type	
NO CURB		CONCRETE	
Pavement Recommendation		Condition Rating / PCR	
PREVENTIVE MAINTENANCE		GOOD / 90

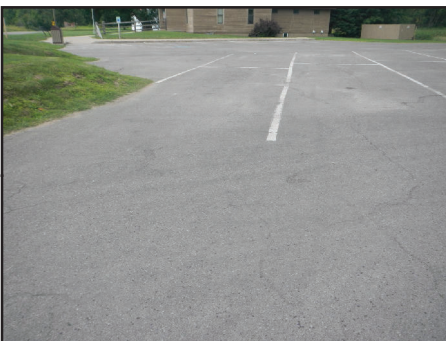
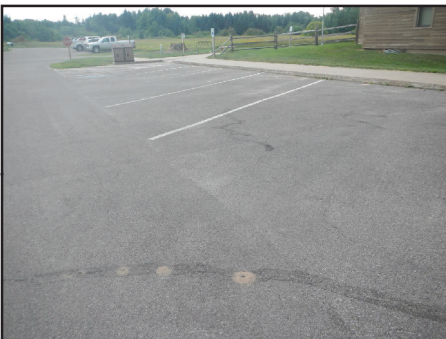
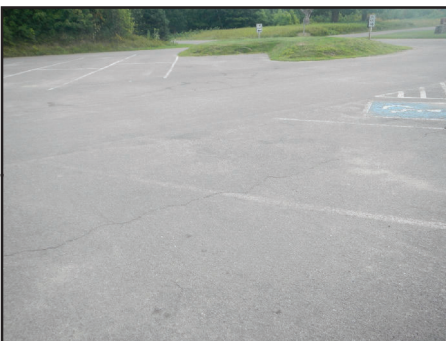
ROUTE 0906: GRAND SABLE VISITOR CENTER PARKING

Inspection Date	FMSS Number	User Access	Surface Type
8/8/2018	30190	PUBLIC	ASPHALT
Area (Sq. Ft.)	Lane Miles (11' Widths)	Curb Reveal (Inches)	Curb Recommendation
12,161	0.209	5	DO NOTHING
Curb Type		Curb & Gutter Type	
CONCRETE		NO CURB AND GUTTER	
Pavement Recommendation		Condition Rating / PCR	
LIGHT 3R TREATMENTS		FAIR / 73

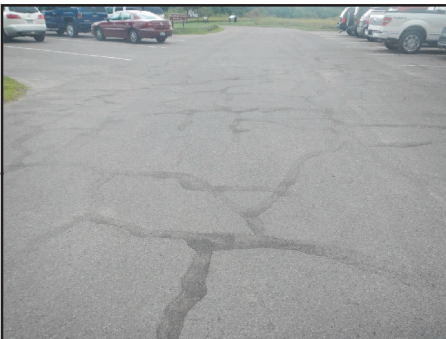
ROUTE 0907: GRAND SABLE TRAILHEAD PARKING

Inspection Date	FMSS Number	User Access	Surface Type
8/8/2018	102146	PUBLIC	ASPHALT
Area (Sq. Ft.)	Lane Miles (11' Widths)	Curb Reveal (Inches)	Curb Recommendation
15,025	0.259	NOT APPLICABLE	NOT APPLICABLE
Curb Type		Curb & Gutter Type	
NO CURB		NO CURB AND GUTTER	
Pavement Recommendation		Condition Rating / PCR	
LIGHT 3R TREATMENTS		FAIR / 73

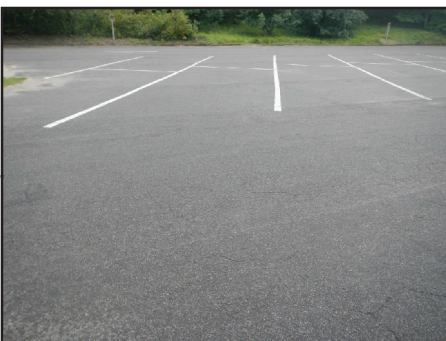
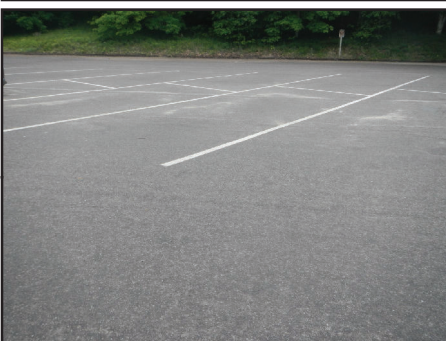
ROUTE 0908: SABLE FALLS PARKING

Inspection Date	FMSS Number	User Access	Surface Type
8/8/2018	30332	PUBLIC	ASPHALT
Area (Sq. Ft.)	Lane Miles (11' Widths)	Curb Reveal (Inches)	Curb Recommendation
56,041	0.965	5	DO NOTHING
Curb Type		Curb & Gutter Type	
CONCRETE		NO CURB AND GUTTER	
Pavement Recommendation		Condition Rating / PCR	
PREVENTIVE MAINTENANCE		GOOD / 90

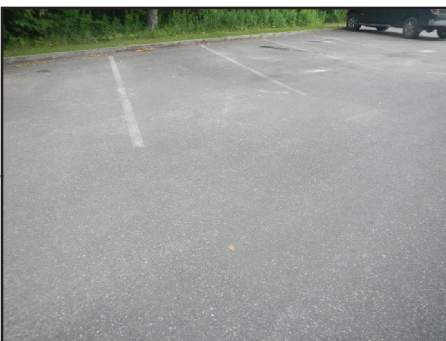
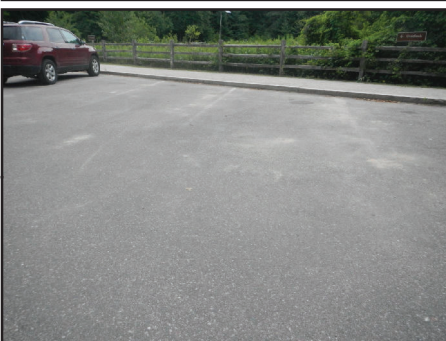
ROUTE 0916: LOG SLIDE PARKING

Inspection Date	FMSS Number	User Access	Surface Type
8/8/2018	30158	PUBLIC	ASPHALT
Area (Sq. Ft.)	Lane Miles (11' Widths)	Curb Reveal (Inches)	Curb Recommendation
33,158	0.571	5	DO NOTHING
Curb Type		Curb & Gutter Type	
WOOD		NO CURB AND GUTTER	
Pavement Recommendation		Condition Rating / PCR	
PREVENTIVE MAINTENANCE		GOOD / 90

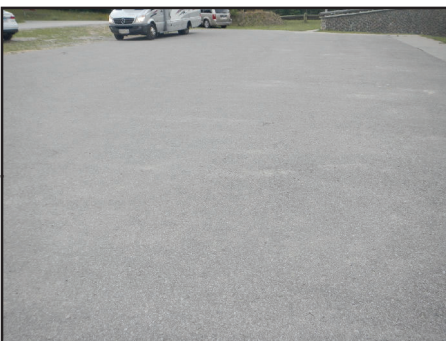
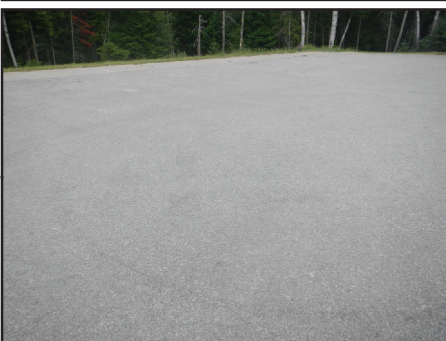
ROUTE 0928: HURRICANE RIVER BRIDGE PARKING

Inspection Date	FMSS Number	User Access	Surface Type
8/8/2018	30075	PUBLIC	ASPHALT
Area (Sq. Ft.)	Lane Miles (11' Widths)	Curb Reveal (Inches)	Curb Recommendation
5,806	0.1	NOT APPLICABLE	NOT APPLICABLE
Curb Type		Curb & Gutter Type	
NO CURB		NO CURB AND GUTTER	
Pavement Recommendation		Condition Rating / PCR	
PREVENTIVE MAINTENANCE		GOOD / 90

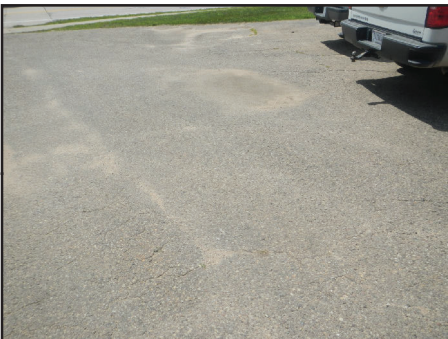
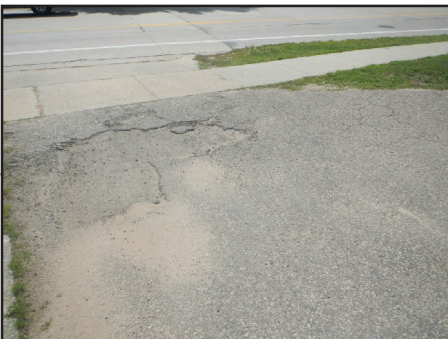
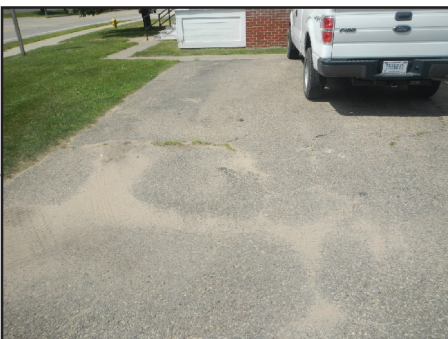
ROUTE 0932: MUNISING RANGE LIGHT PARKING

Inspection Date	FMSS Number	User Access	Surface Type
8/8/2018	29805	NONPUBLIC	ASPHALT
Area (Sq. Ft.)	Lane Miles (11' Widths)	Curb Reveal (Inches)	Curb Recommendation
1,781	0.031	NOT APPLICABLE	NOT APPLICABLE
Curb Type		Curb & Gutter Type	
NO CURB		NO CURB AND GUTTER	
Pavement Recommendation		Condition Rating / PCR	
HEAVY 3R TREATMENTS		POOR / 53

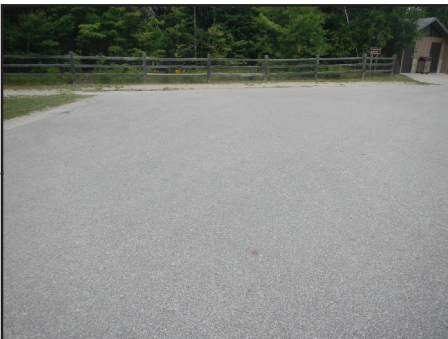
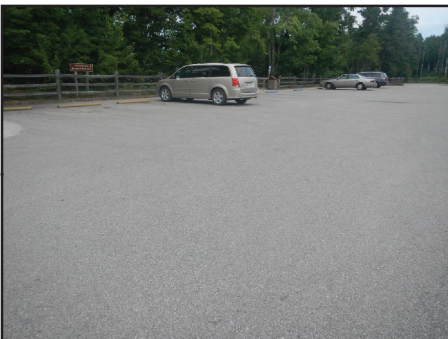
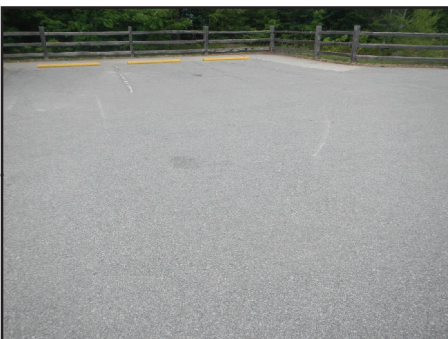
ROUTE 0933: LAKE SUPERIOR OVERLOOK PARKING

Inspection Date	FMSS Number	User Access	Surface Type
8/8/2018	240467	PUBLIC	ASPHALT
Area (Sq. Ft.)	Lane Miles (11' Widths)	Curb Reveal (Inches)	Curb Recommendation
22,669	0.39	NOT APPLICABLE	NOT APPLICABLE
Curb Type		Curb & Gutter Type	
NO CURB		NO CURB AND GUTTER	
Pavement Recommendation		Condition Rating / PCR	
PREVENTIVE MAINTENANCE		GOOD / 90
