PORE Cycle 6

Final Report

Road Inventory and Condition Assessment of Paved Routes Point Reyes National Seashore

Report Date: November 2015

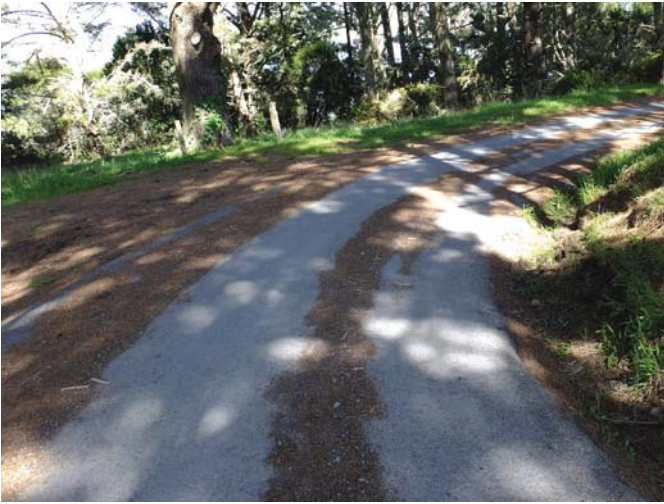
PORE_0103A_5607.JPG

Inspection Date: 4/29/2014	Beginning Section MP	0.00	0.10			
Paved Length (Miles): 0.19	Section Length (MI)	0.10	0.09			
Surface Type: ASPHALT	Route Summary					
Roadway Condition Information						
Pavement Condition Rating (PCR)	64	73	53			
Lane & Width Information						
Number of Lanes	1	1	1			
Paved Width (ft)	11.9	13.5	10			
Lane Width (ft)	11.9	13.5	10
